Report on the investigation of  
the grounding of  
***European Pioneer***  
off Fleetwood  
1 December 2000

Marine Accident Investigation Branch  
First Floor  
Carlton House  
Carlton Place  
Southampton  
United Kingdom  
SO15 2DZ

**Report No 16/2001**

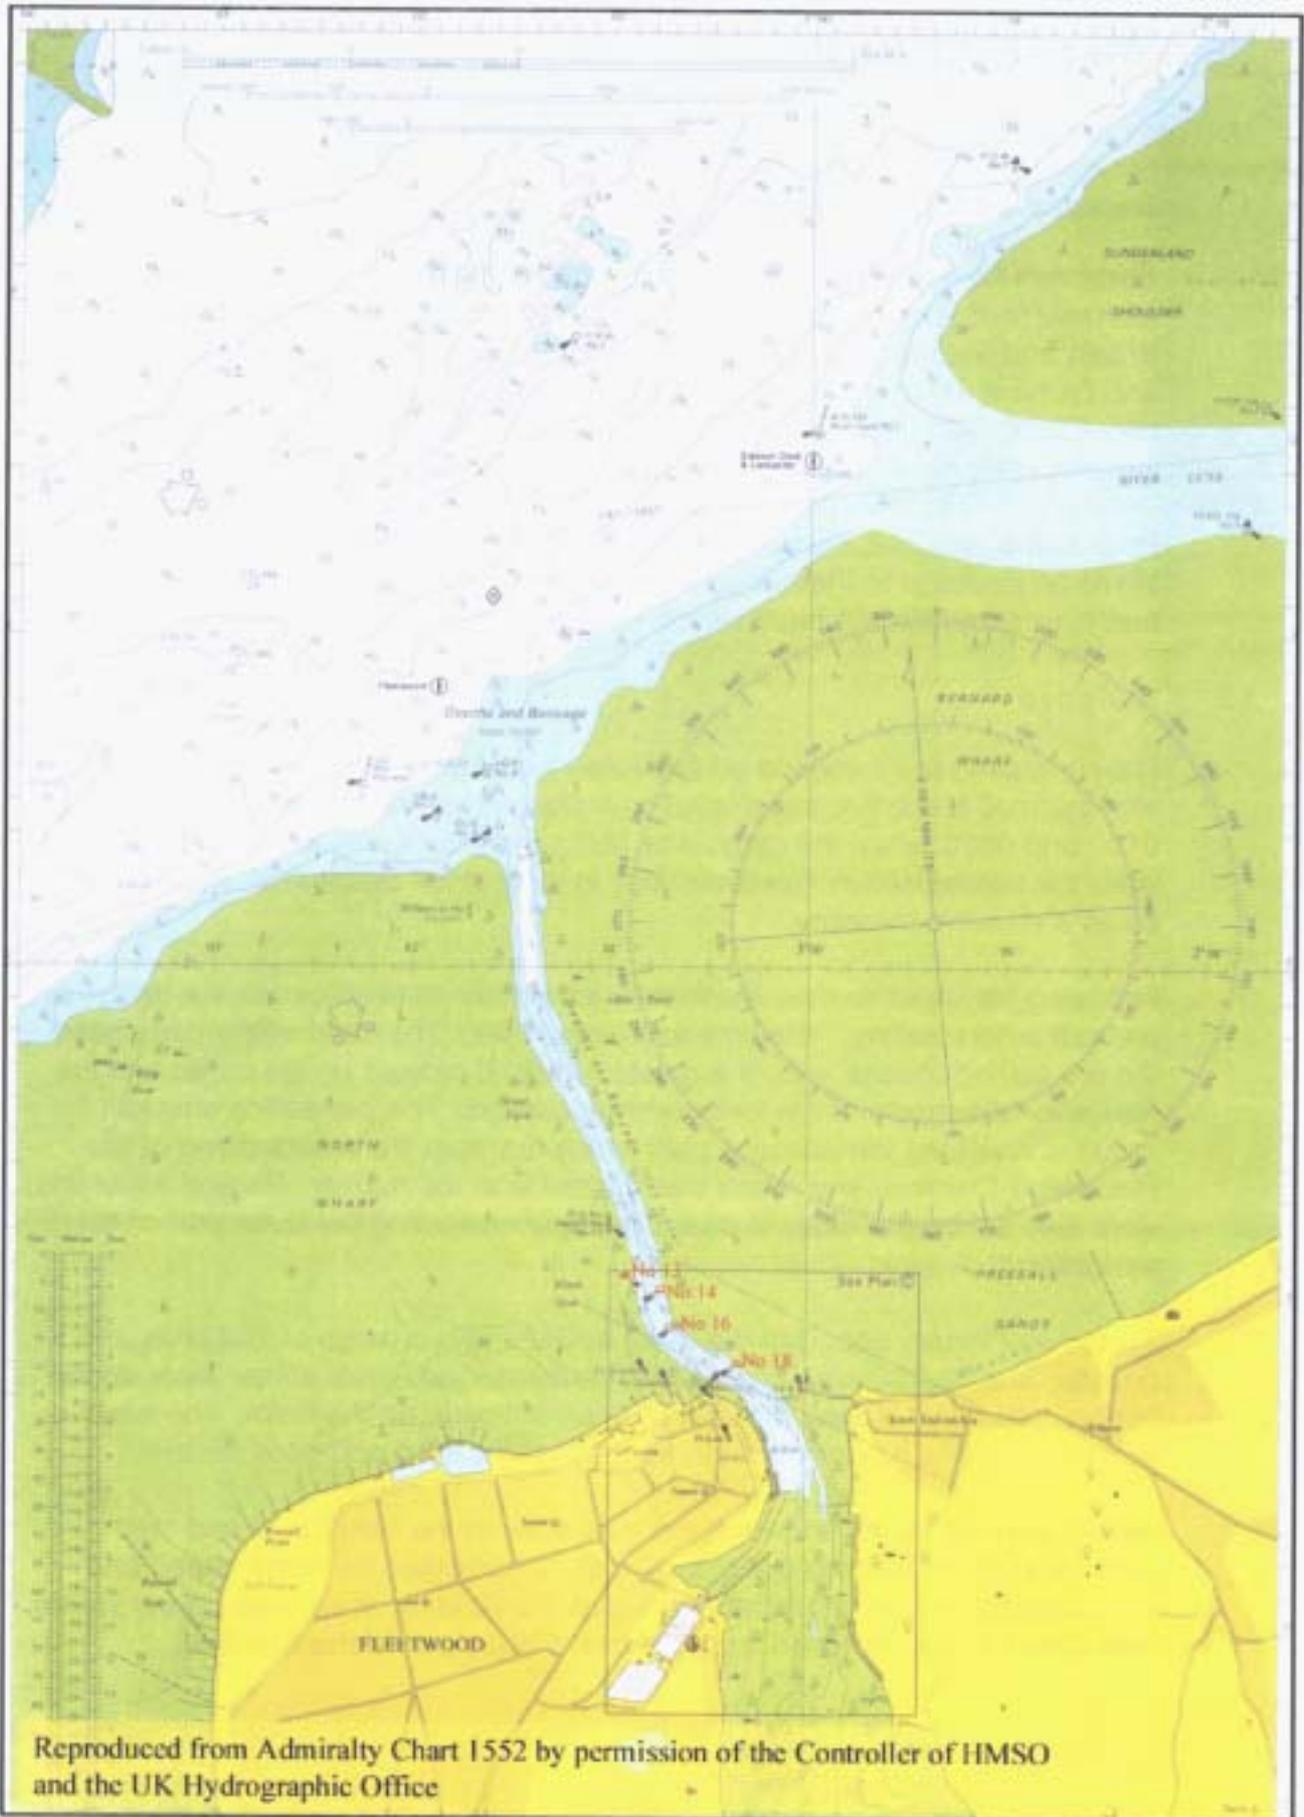
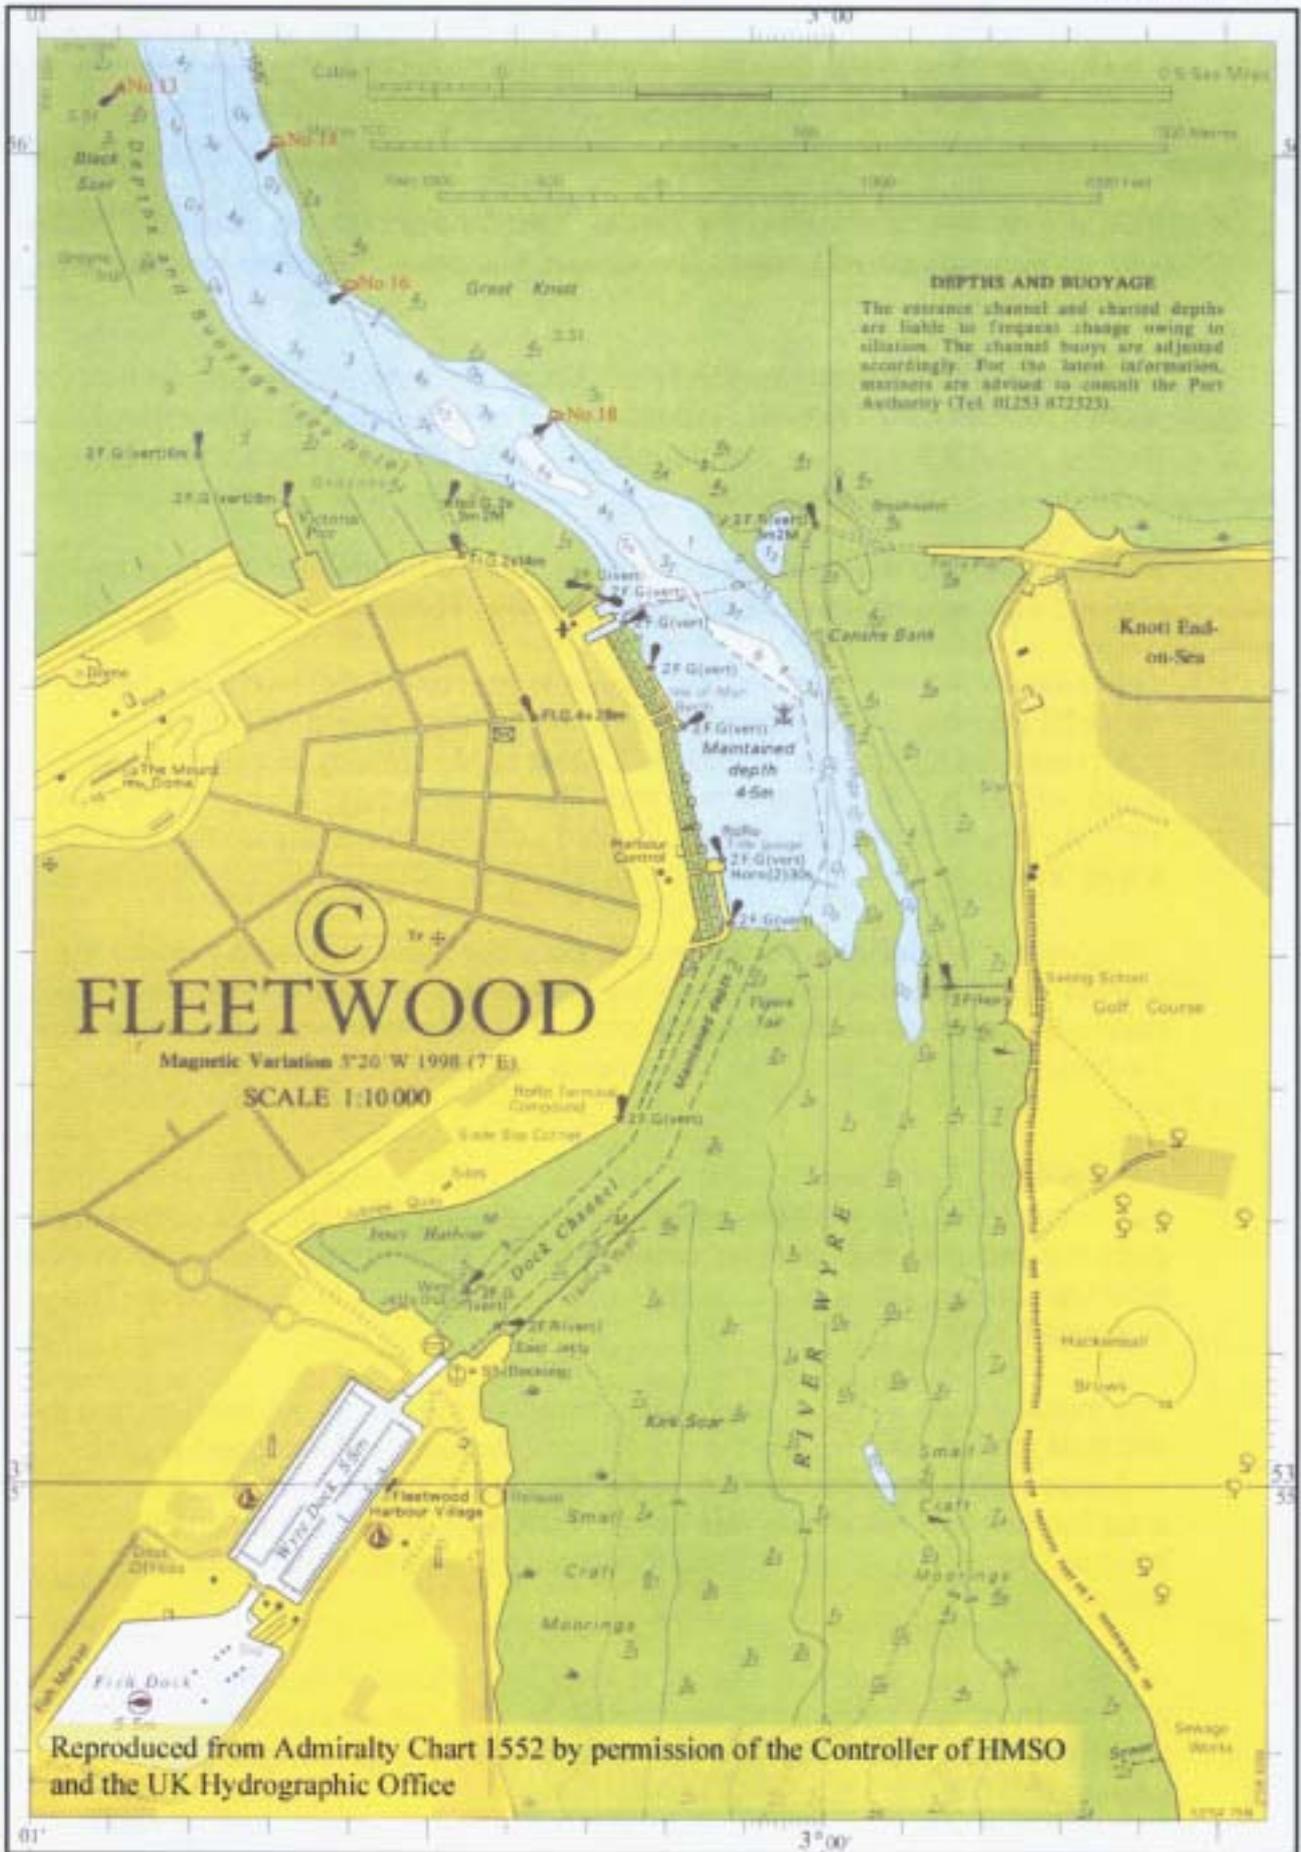
The channel is approximately 1¼ miles long and approximately 150 to 200m wide. The direction of the channel takes a sharp bend close offshore (**see Chart Extracts**).

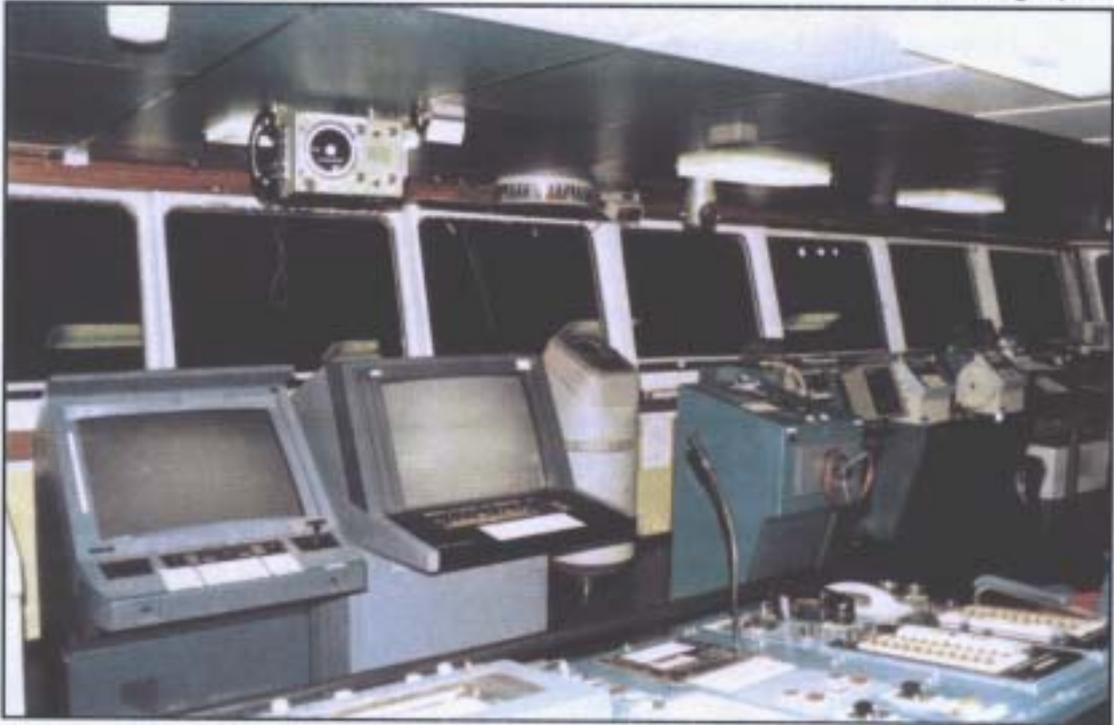
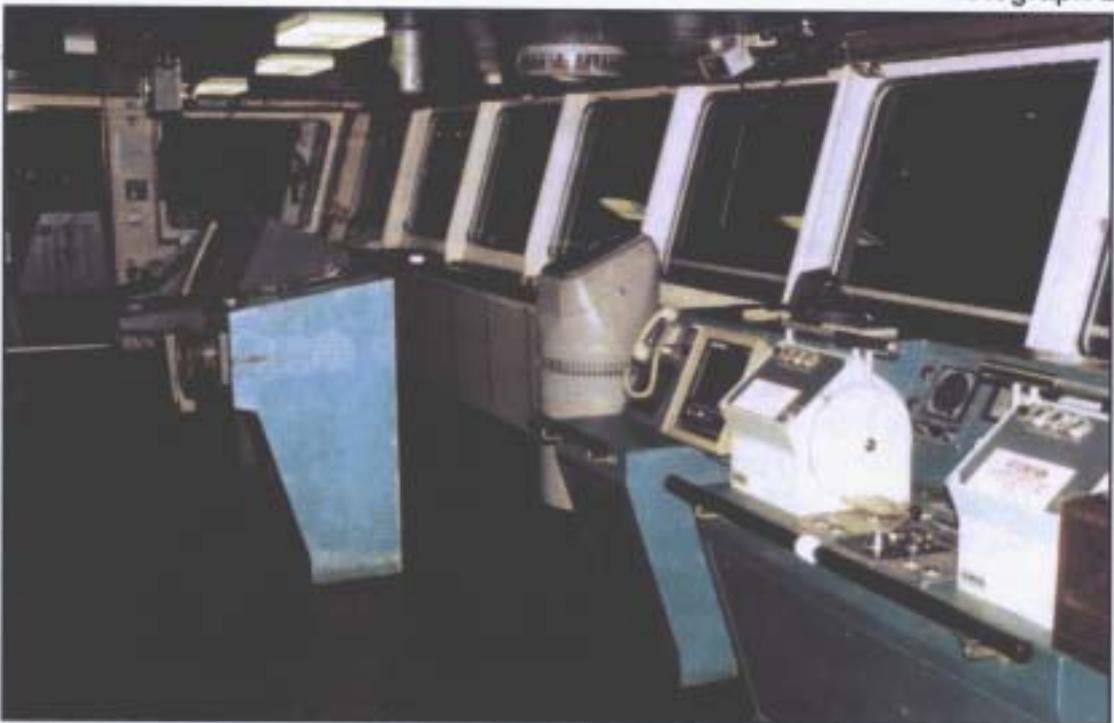
Photograph 1

The wheelhouse (**see Photographs 1 and 2**), which is sited forward on the ship, is well equipped with navigational instruments including:

At the time of the accident, and unbeknown to the officers and crew, there was a major system fault on the Broadgate VER and no data was saved. This major fault went unrecognised because there is only one alarm indicator and there was an existing alarm for a known minor fault.

It was P&O's decision to fit the VDR in *European Pioneer*. It was a decision fully and enthusiastically supported by the MAIB. It is the company's responsibility to ensure that it works properly at all times, and it is very strongly recommended that it reviews its procedures for ensuring this item of equipment is fully operational for every voyage.

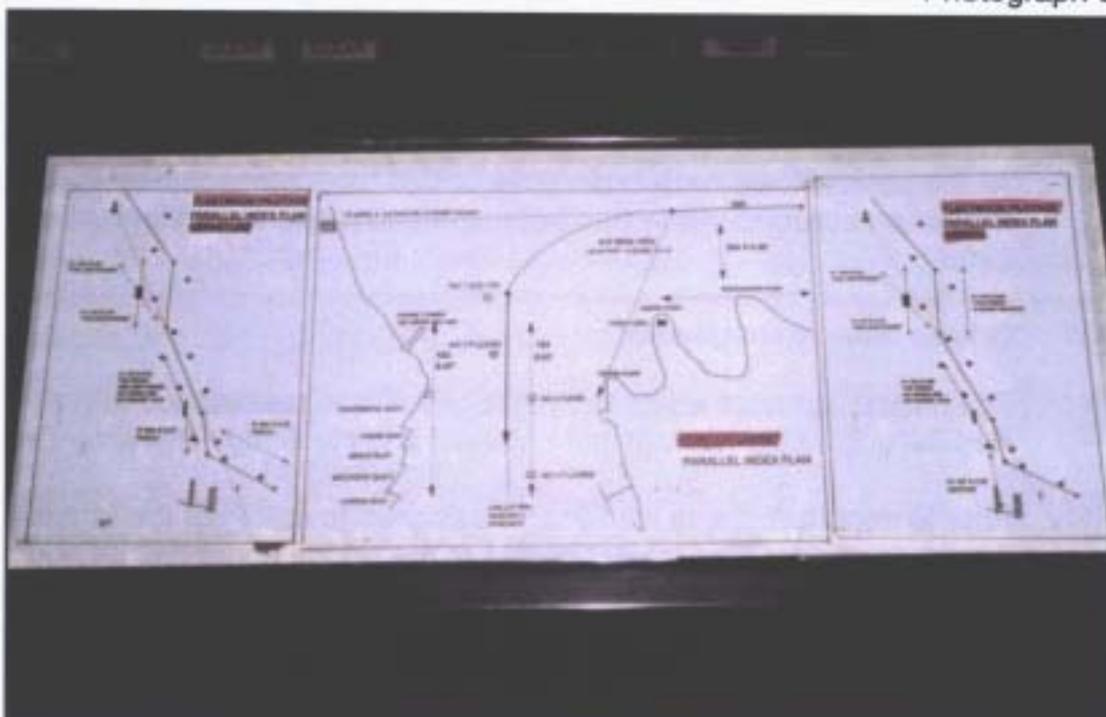
Photograph 3

The pre-departure checks include setting up the appropriate initial radar parallel index lines for the beginning of the passage. A general passage plan for the route has been formed and agreed with P&O Ship Management (Irish Sea) Ltd, which includes suggested parallel index plans for departure and arrival in Fleetwood, and for the Port of Larne. Copies of these plans are displayed close to each radar position (see Photograph 3). The plan for departure Fleetwood includes the area where the accident occurred. During pre-departure checks the chief officer sets up one of the radars with the first two or three parallel index lines only, as experience has shown that too many lines clutter up the radar screen.

On departure from the berth the duty second officer is in charge of one of the mooring stations and comes to the bridge as soon as the vessel clears the berth. When he arrives on the bridge he assumes the role outlined above. Prior to that time no one monitors the radars.

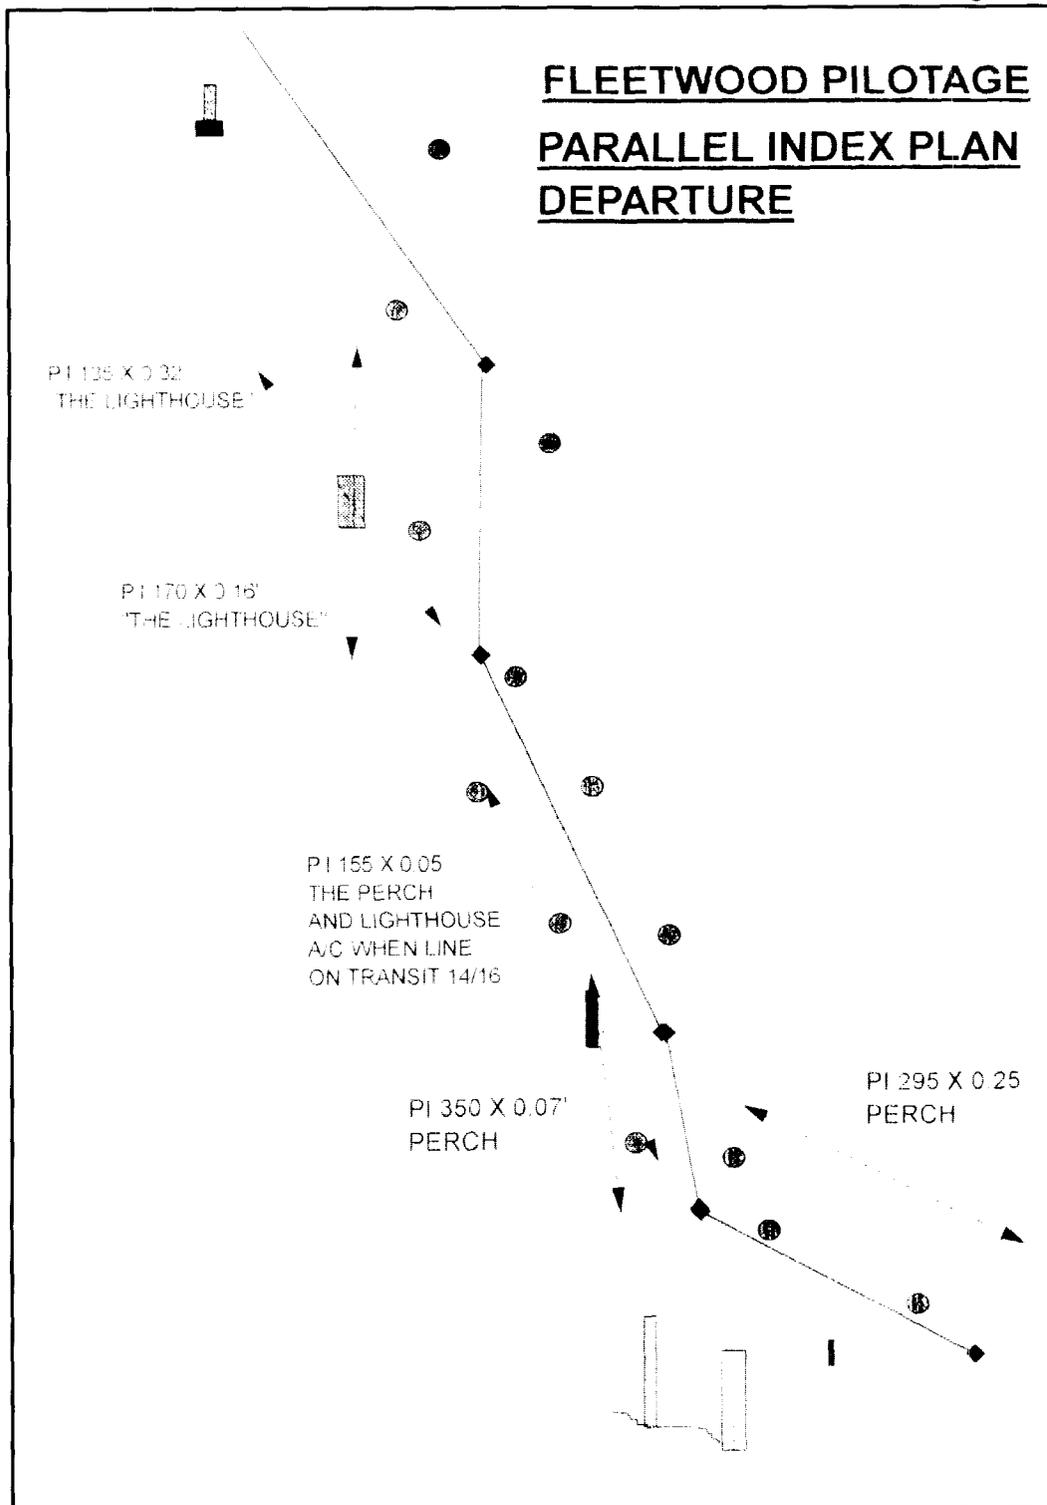
Figure 1

A back-up system did exist. The pilotage passage plan allowed for parallel indexing to ensure the correct line in the channel was achieved (**see Figure 1**). Parallel indexing was taken from fixed marks, so that any discrepancy in the position of a buoy would be easily discernible. Such a method depends on three factors, additional to having the index lines accurately aligned: a competent person using them, a proven system that ensures the operator knows exactly what his responsibilities for monitoring the navigation are, and extensive practice. Nobody was on the radar from sailing, and, as the vessel approached No 16 buoy, the chief officer had other duties. The second officer habitually arrived on the bridge a few minutes after sailing and, according to the Bridge Standing Orders, was to be "stationed at the radar. Reporting as directed by the master". On this occasion his arrival on the bridge coincided with the master altering course to port, to put No 16 buoy on the starboard bow.

At that precise, crucial, moment the back-up system was unavailable. Nobody on the bridge was monitoring the vessel's position, despite the extensive array of available equipment.
