Report on the investigation of  
accident to lifeboat and fast rescue craft from

***European Highway***

in Zeebrugge on 1 December 2000

**Report No 1/2002  
January 2002**

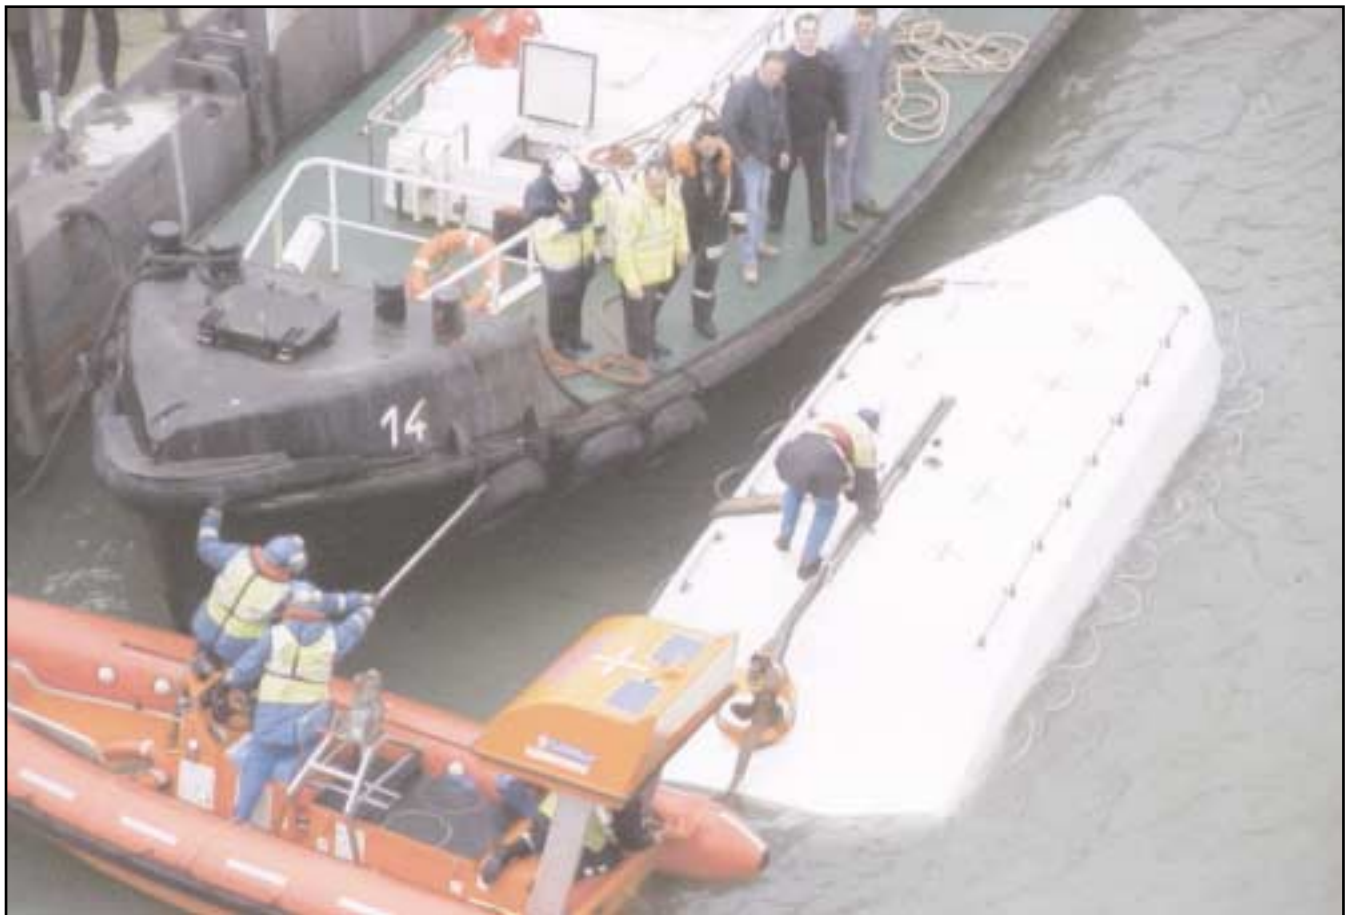
The FRC towed the inverted boat alongside a nearby pilot launch at 0940 **(Figure 1)**. During this brief tow, the trim of the inverted lifeboat altered, causing a change in the height of the air pocket between forward and aft. The depth of the air pocket changed at a rate that alarmed the two men within.

FRC and inverted lifeboat alongside pilot launch

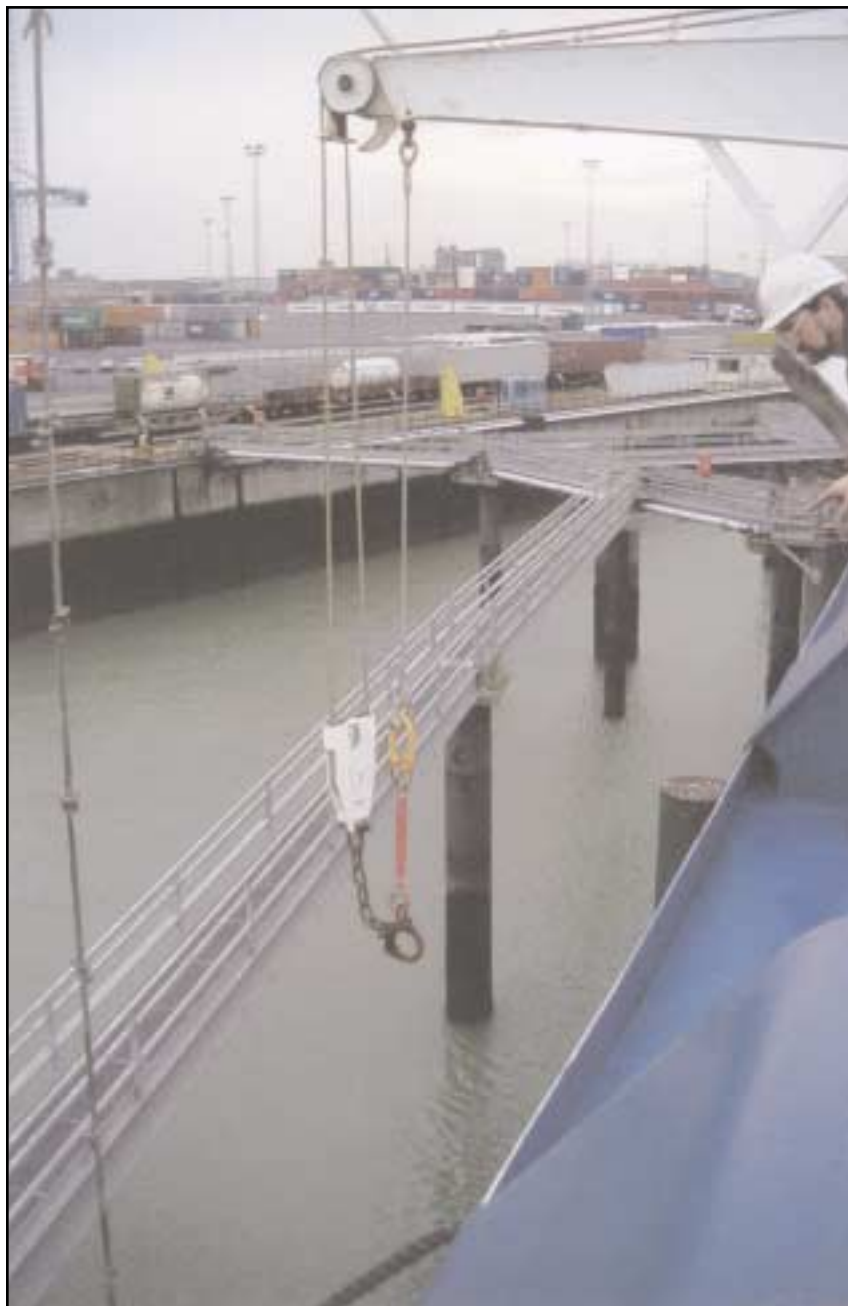
Figure 2

Initial examination of the hanging-off pendants showed they had been connected to the recovery pendants, rather than the hanging-off points of the lifeboat's suspension hooks (**Figure 2**). The lifeboat was towed away for later recovery and transport to the premises of Umoe-Schat-Harding, Gosport, UK.

Hanging off pendant shown connected to yellow lifting ring of recovery pendant

Immediately following this accident, the vessel's own staff made an inspection of the port lifeboat's davits. They found the hanging-off pendants connected to the recovery pendants rather than to the hanging-off lugs (**Figure 2**). This arrangement did not remove the lifeboat's weight from its suspension hooks. Knowing that the suspension hooks needed to be released to perform routine maintenance, they concluded that this incorrect connection had resulted in the lifeboat falling when they were intentionally opened. Nothing later established by the MAIB has cast doubt on this conclusion.

Since this accident, the owners of *European Highway* have fitted modified recovery pendants which make inadvertent connection between the hanging-off and recovery pendants impossible, by virtue of the relative dimensions of their end fittings. However, masters, owners and crews of other vessels should be made aware of the possible hazards of inadvertent connections between these pendants so that they can make a fair risk assessment of their use and, if necessary, consider modifying equipment and procedures on their own vessels.

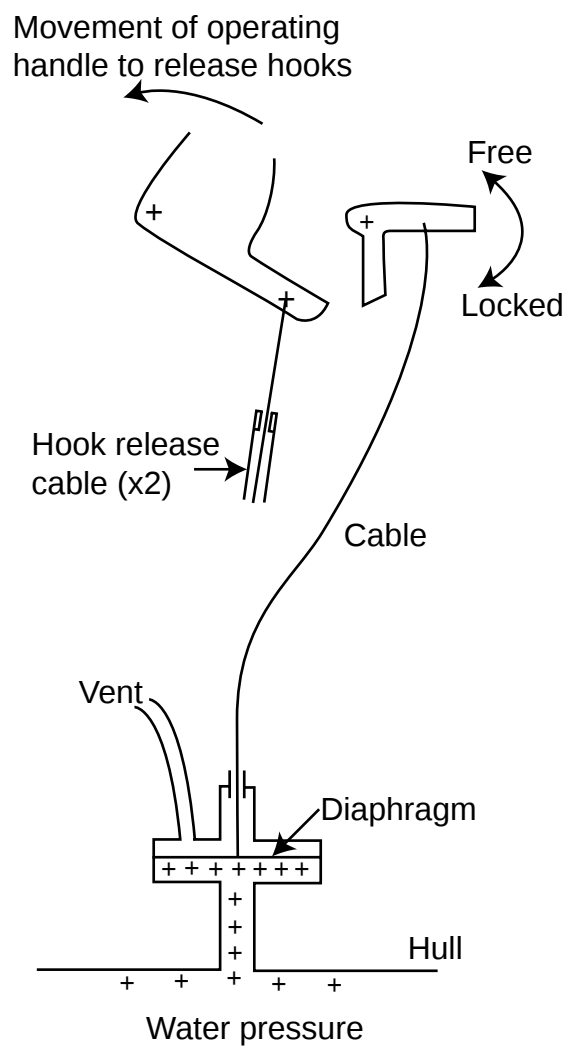
Figure 3

A further safety device, in the form of a hydrostatic interlock, is also fitted. This prevents the hand lever being operated until the lifeboat is waterborne. The sensing device is a unit fitted to the bottom of the lifeboat which, by way of a diaphragm, senses the water pressure generated by a waterborne lifeboat. The diaphragm is deflected by water pressure and this movement is transmitted to an interlock lever by a cable. Until the lifeboat is waterborne, the interlock lever prevents the hand lever being moved (**Figure 3**).

Hydrostatic interlock on suspension hook release lever

Another method of overriding the system is to simulate water pressure on the diaphragm unit, as the carpenter did by applying suction to the space above the diaphragm. Although not a practice recommended by the system's manufacturers, or the job card, this was his usual procedure when performing maintenance on the suspension hooks.

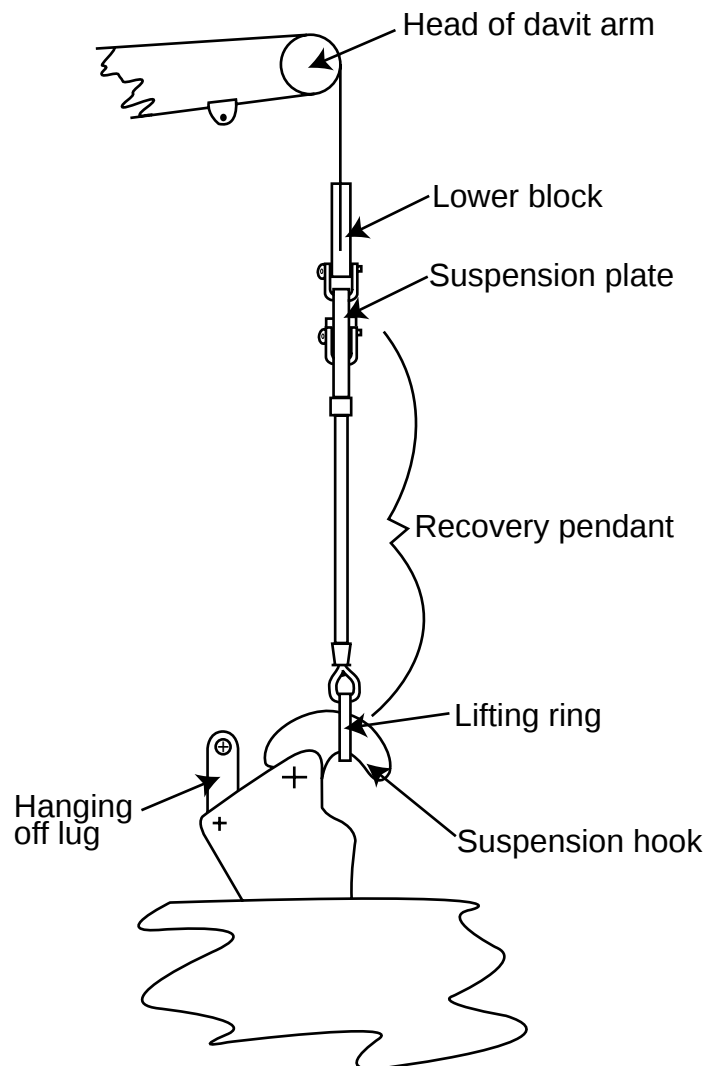
Figure 4

Recovery pendant connection between lower block and suspension hook

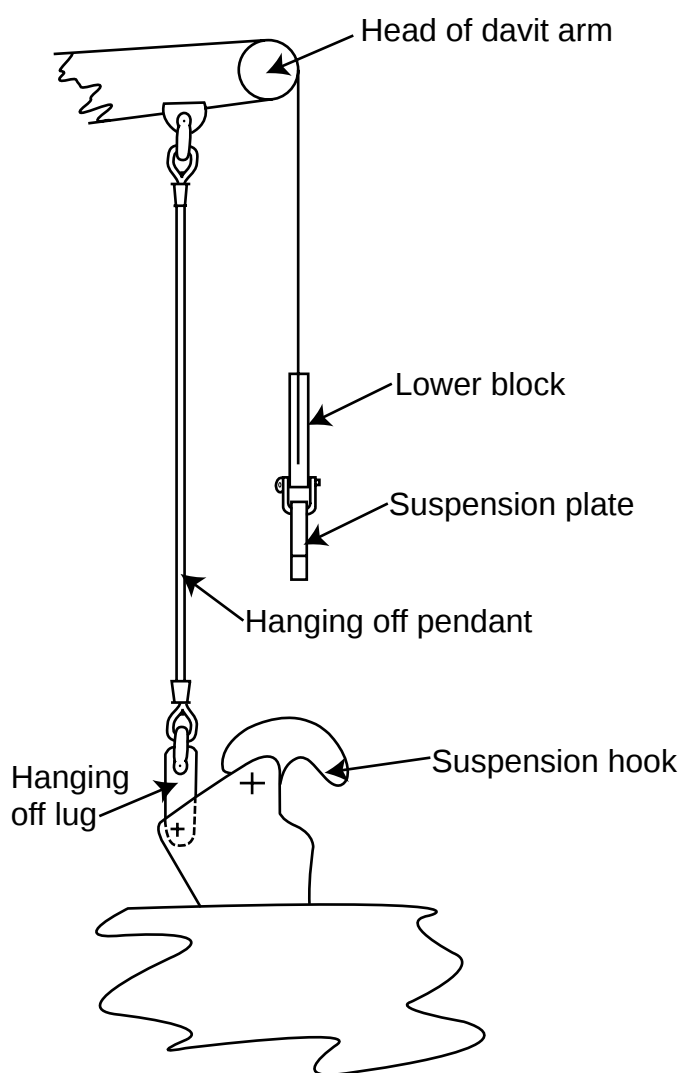
Figure 5

Hanging off pendant connection to support lifeboat's weight

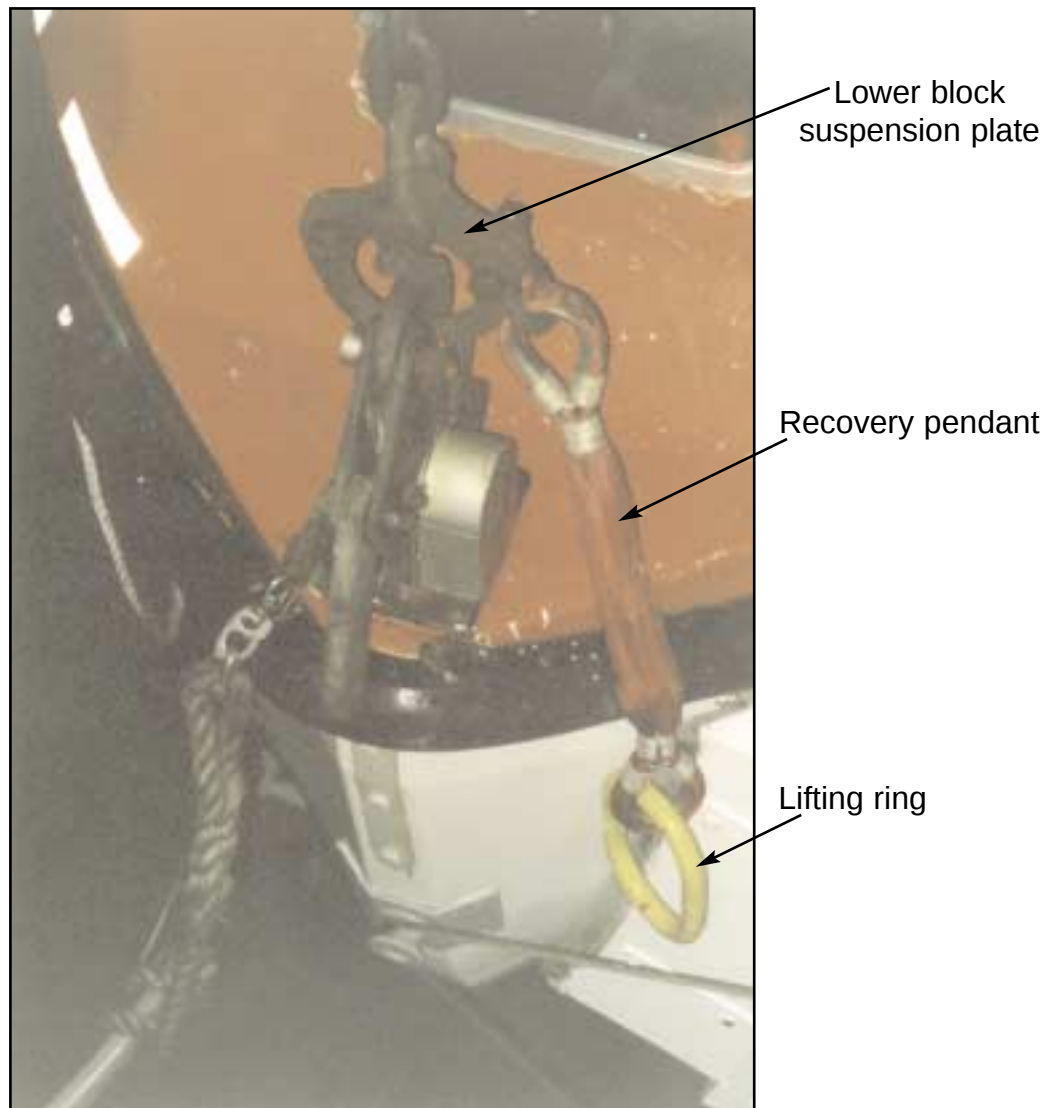
Figure 6

Normal stowage arrangement of recovery pendant

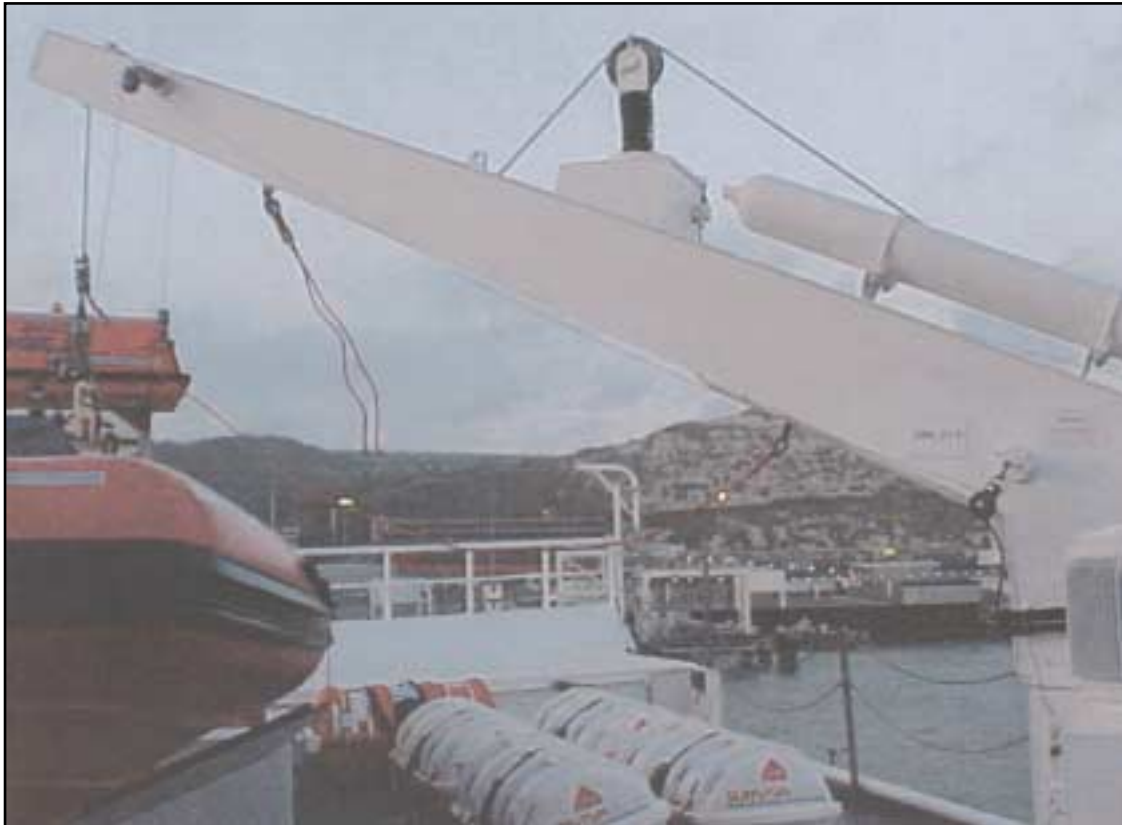
Figure 8

Fast rescue craft and davit

This second feature, namely lack of headroom, was implicitly identified by the MCA surveyor during the demonstration in October 2000, when he recommended adjustment of the davit's cutout switch. During the FRC's recovery on 1 December, lack of headroom resulted in the hand-winding lever being used to raise it slightly once the cutout had shut off power to the hoist motor. As this handle was being turned, both the fall wire and the remote control wires for the davit brake and slewing controls were hauled in together, as designed. However, the handle on the free end of the brake control wire made contact with the davit head and tensioned the control wire. This momentarily released the davit brake, allowing the fall wire, and also the FRC, to lower. The FRC made contact with the liferaft canister and tilted. It is fortunate that the crew were able to retain their positions in the FRC because the direction of tilt was towards the unguarded side of the vessel's deck. Otherwise, any of these men might have been tipped overboard and suffered severe injury, or worse.

As a result of the MCA surveyor's comments, their experience from this accident in Zeebrugge, and their own observations following the davit's installation, the vessel's owners have increased the headroom of the davit by fitting a taller pedestal. This appears a reasonable solution, made with the knowledge of the MCA, and no recommendation is made on this matter.

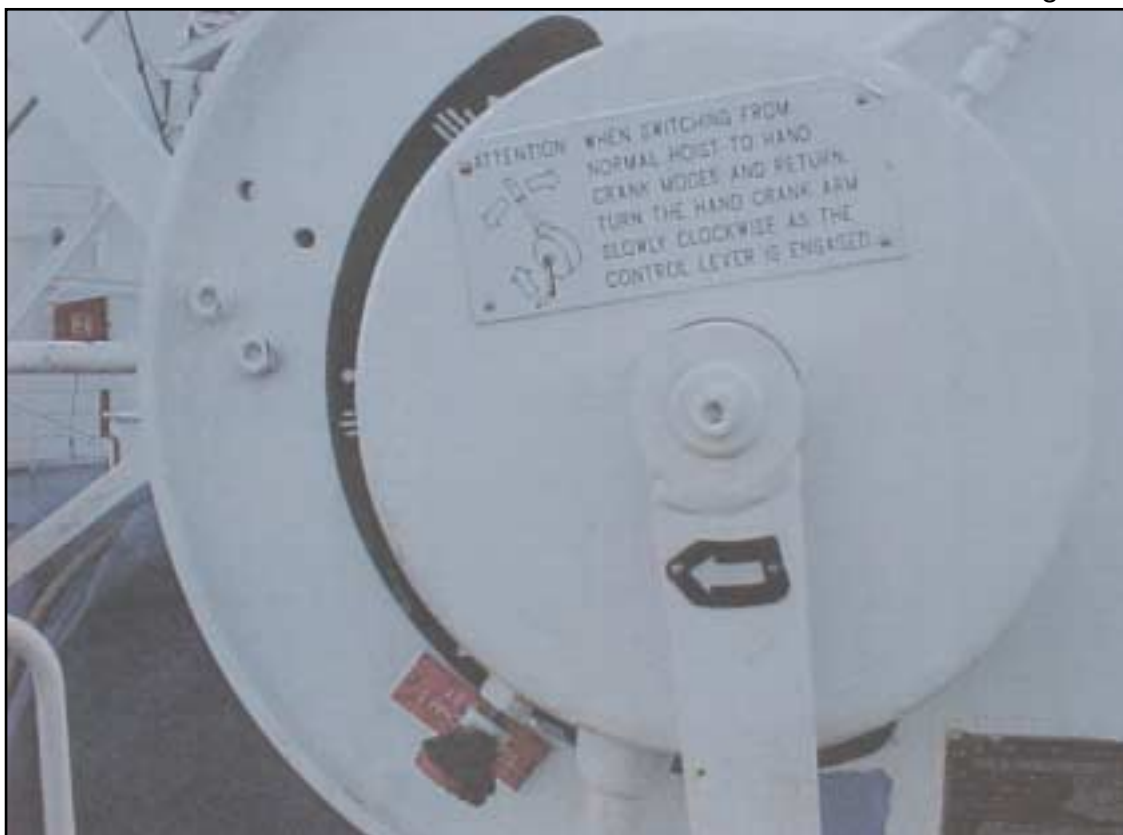
Figure 9

Instruction label for disengaging hand winding handle of FRC davit

prevented from turning when not required. Because of the importance of disengaging this handle, for the safety of personnel, clear and graphical guidance should be included in the manual on the proper settings for the control or selection lever. Notwithstanding doubts concerning the davit's conformity with requirements, and the recommendation that MCA reconsiders the standards required of the davit, the vessel's owners are recommended to supplement the manual to clearly cover these points.

2. Supplement the lifesaving appliance onboard training and instruction manual to clearly show the correct setting of the control lever on the FRC's davit to ensure the manual winding handle is disengaged from internal moving parts.
3. Supplement the onboard training and instruction manual to clearly show the correct methods of using the lifeboats' hanging-off pendants when performing maintenance tasks on lifeboat suspension hooks.
4. Introduce procedures for having an independent check of lifeboat hanging off arrangements whenever it is intended to override the suspension hooks' hydrostatic interlock, other than during emergencies. Alternatively, the practice of performing routine maintenance on lifeboat on/off load suspension hooks, while the lifeboat is hanging-off, should be avoided.
