Report on the investigation  
of a man overboard incident from  
***Atlantic Princess H90***  
in the English Channel  
on 23 November 2000

Marine Accident Investigation Branch  
First Floor, Carlton House  
Carlton Place  
Southampton  
SO15 2DZ

**Report No 32/2001**  
**August 2001**

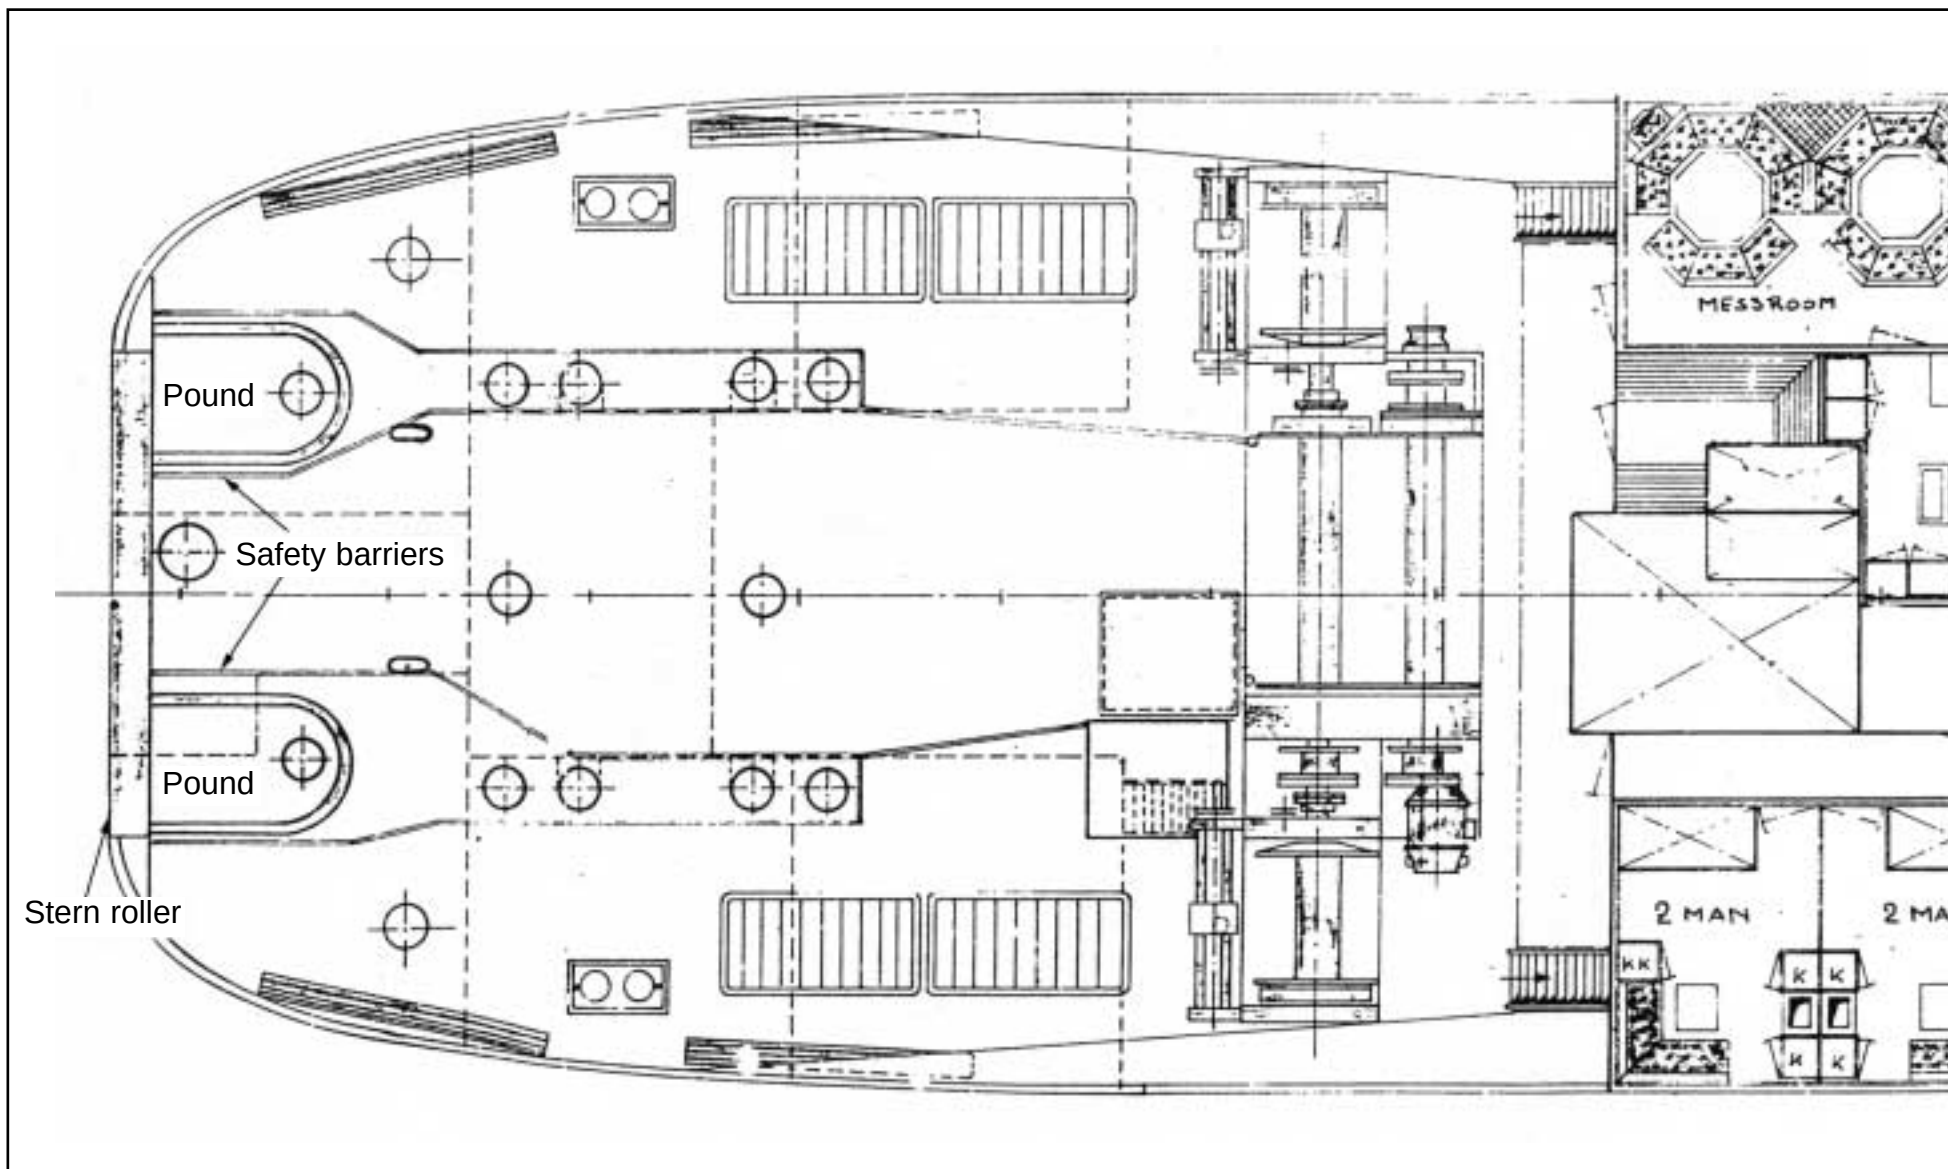
Figure 1

Plan of aft working deck

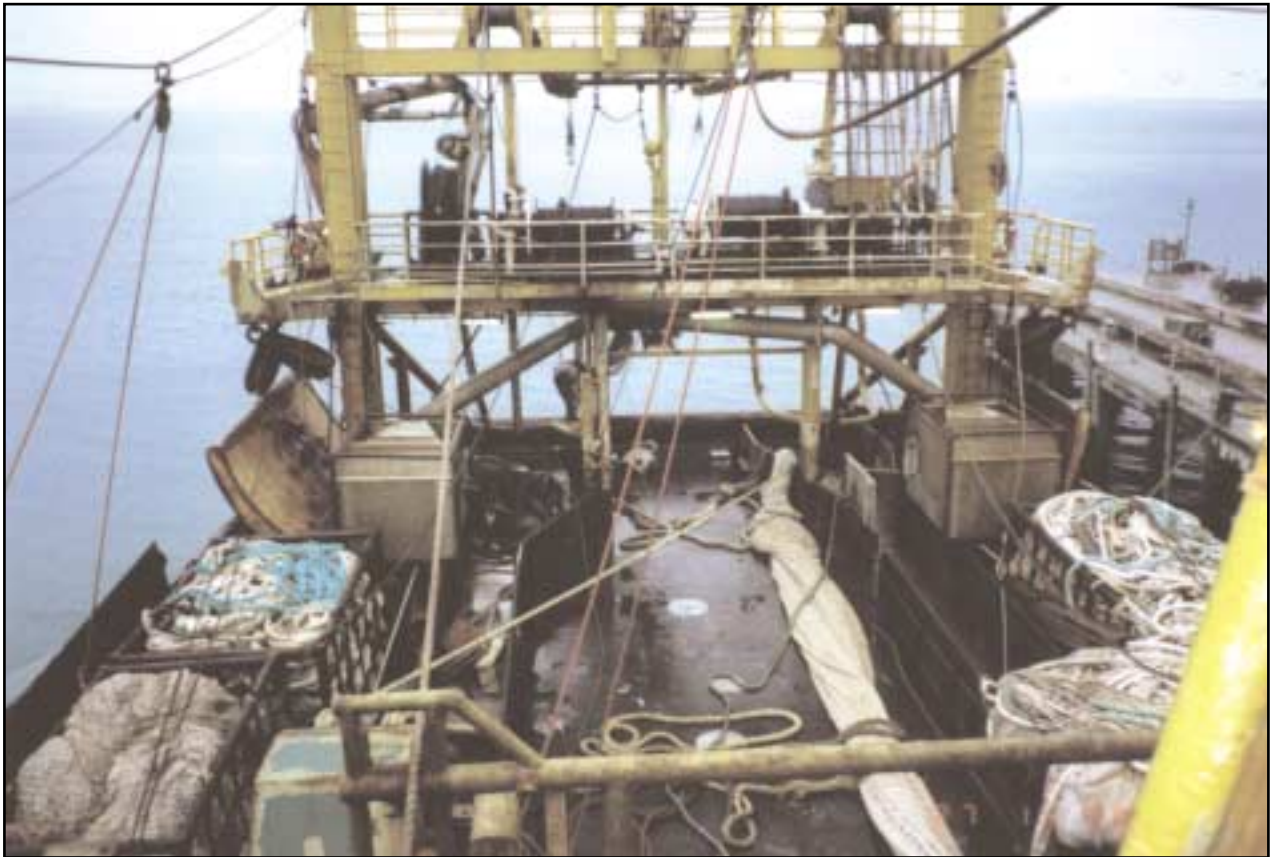
Figure 3

View of aft working deck from winch control station in wheelhouse

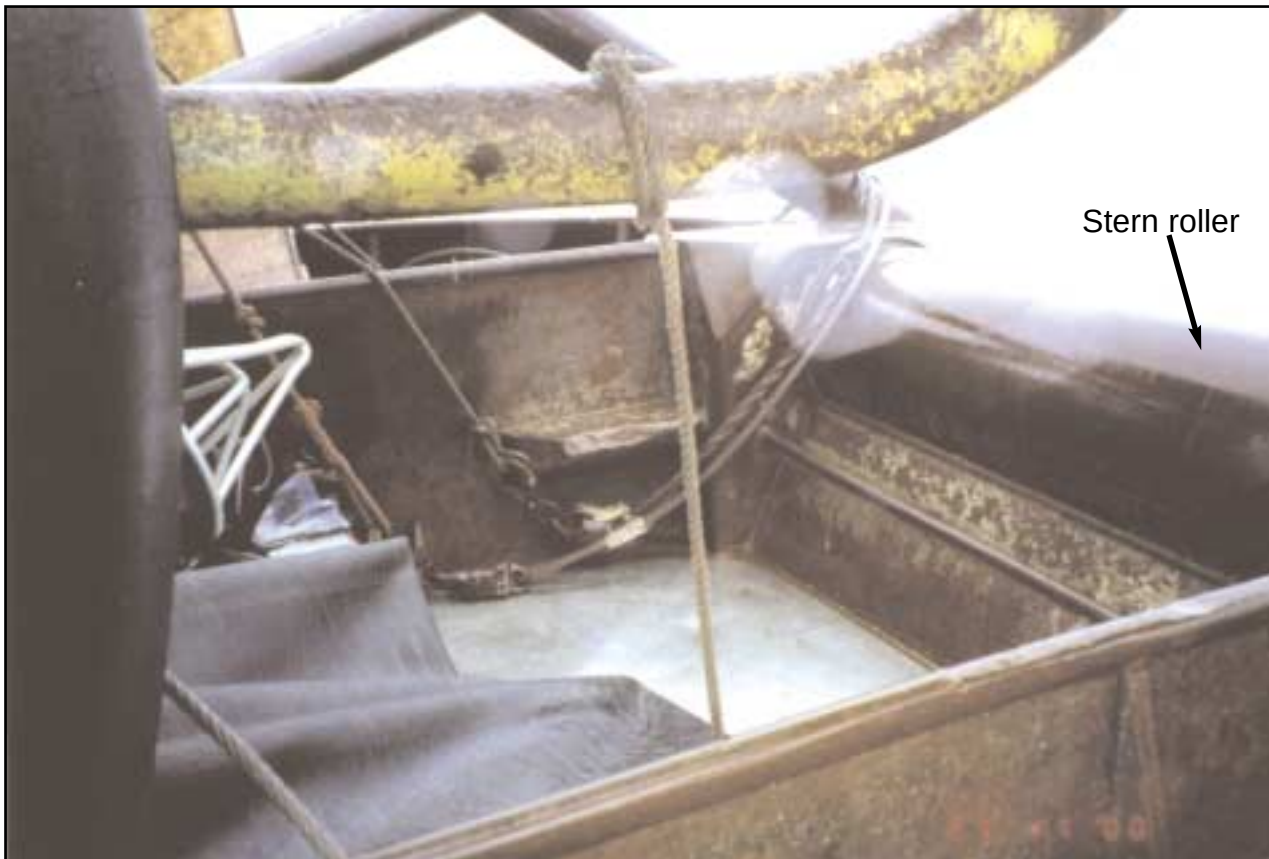
Figure 4

Stern roller

Starboard pound

While working on the aft deck of this vessel, the area where the risk of going overboard is greatest, is probably right aft by the stern roller. Here the stern roller effectively replaces a conventional static guardrail or bulwark. Anyone leaning on the roller as it rotates outboard would, in the absence of any restraint, be dragged overboard.

Although the missing man was not seen to fall, it is probable that he went over the stern as a result of this mechanism. Had a static guardrail been in the place of the roller, this fall would have been much less likely.

Because the stern roller is unpowered, it is probably not viewed as a machine. However, it is a substantial component, which rotates and is unguarded. As with any rotating machinery it has the potential to cause harm and so, if practicable, needs to be separated from personnel.

15. Crew standing in the aft deck pounds were not separated from the stern roller. [2.7]
16. The missing crewman was probably dragged overboard by the rotation of the stern roller.[2.7]
17. There is no evidence to suggest that alcohol or fatigue contributed to this accident. [2.8]

1. The primary cause of this accident was the lack of a safety barrier or guardrail separating deck crew from the stern roller.
2. The missing crewman substantially reduced his chances of recovery because he did not wear his lifejacket correctly.

As the stern roller is important to the efficient operation of the vessel, it is probably not practicable to replace it with a conventional bulwark. However, there appears to be sufficient space in each of the two small pounds just forward of the roller to fit a static guardrail. These could be at a similar height to the other safety barriers surrounding the pounds, and would separate the roller from any crewman standing in either of the pounds. Any crewman standing there would then be within an area totally surrounded by a guardrail or safety barrier. This is likely to improve the safety of the crew.

The vessel's owner is recommended to consider the fitting of a protective rail in these areas. However, it is recognised that consideration must also be given to the vessel's operational needs, and the requirement for the net to be free running as it passes over the stern. The position and size of the suggested guardrails need to take these considerations into account.

1. Give training demonstrations to all crew on the correct use of all types of lifejackets on board the vessel. These should be routinely repeated.
2. Compile and maintain a comprehensive inventory of all lifejackets so that their custodian, servicing and repair history can be clearly and reliably identified at any time.
3. Require the deck crew to use beacon-equipped lifejackets while shooting gear. The long-term objective should be that they are also worn at other times.
4. Consider fitting a short guardrail at the aft end of each small pound, just forward of the stern roller of the vessel.

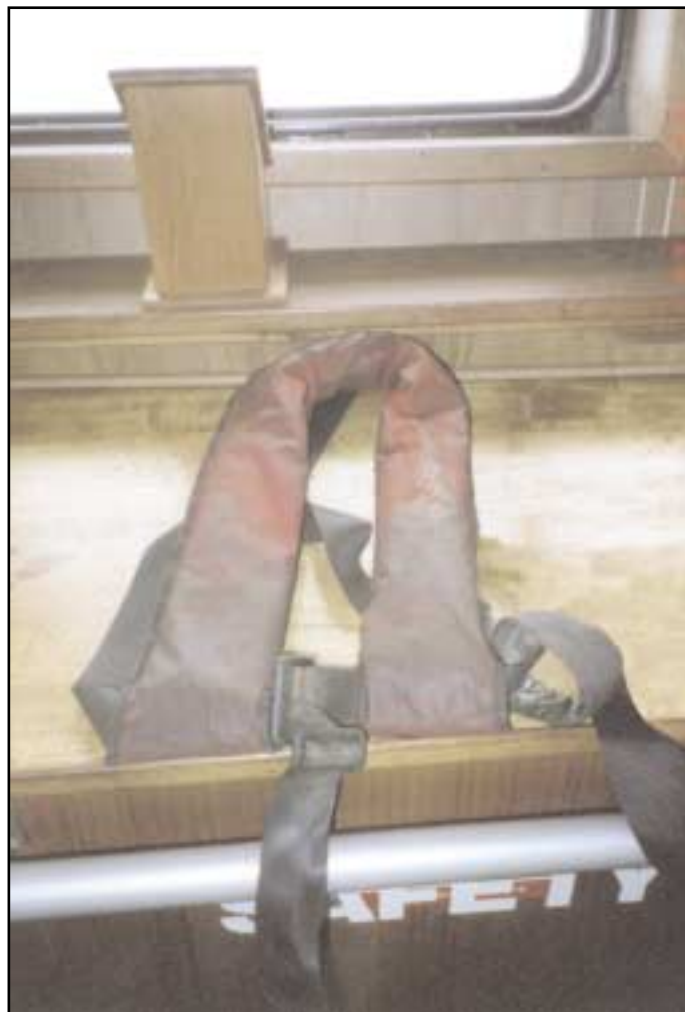
Figure 5

The man lost overboard was wearing a lifejacket not fitted with a beacon. This lifejacket was recovered by rescue helicopter IJ during the SAR operation. It was found fully inflated, with its light illuminated and its harness buckle fastened.

Lifejacket of type without man overboard beacon

The more popular lifejackets among the deck crew are those without a man-overboard beacon. Two reasons are offered for this preference. Firstly they have no crutch strap, making them slightly more comfortable, and secondly they are slightly lighter in weight. The lifejacket worn by the missing man was of this type.

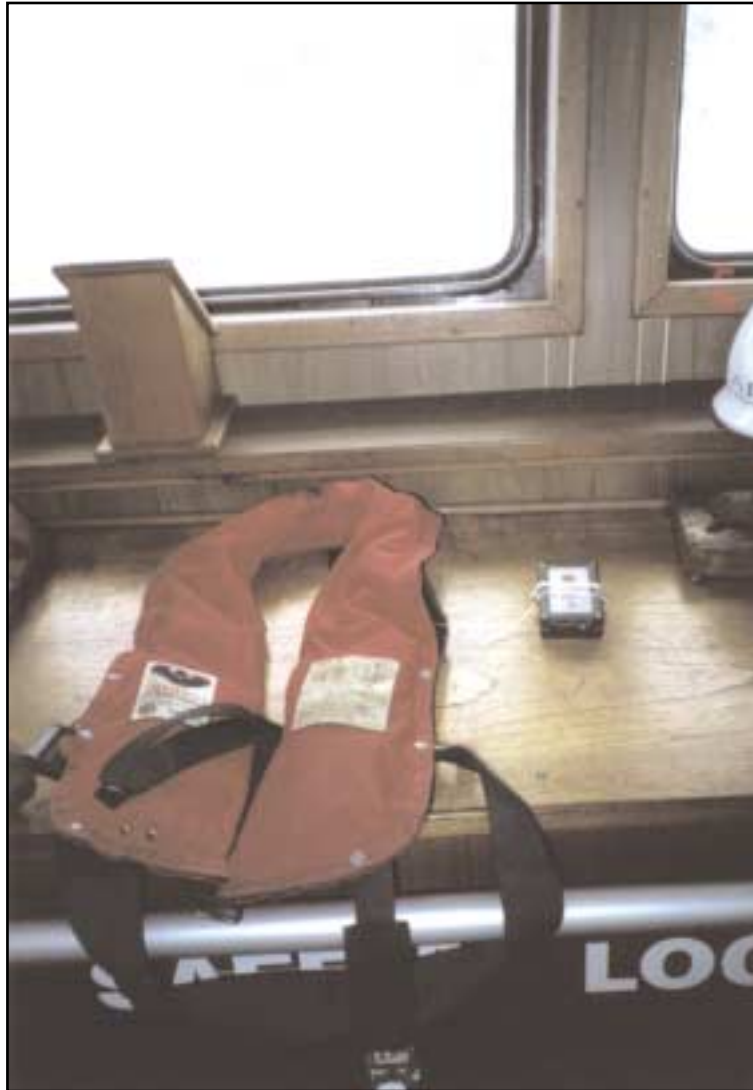
Lifejacket of type with man overboard beacon

This system operates at 433MHz and has an operating range in the order of 100m, depending on antenna efficiency. A beacon is immediately activated when the lifejacket to which it is attached is immersed, as would happen if its wearer fell overboard. In turn, its signal is received by the wheelhouse unit, which activates an audible alarm to alert the watchkeeper.

With the objective of developing increased acceptance of the beacon- equipped lifejackets, the owner is recommended to require the deck crew to use them while shooting gear. The long-term objective should be that they are worn also at other times.

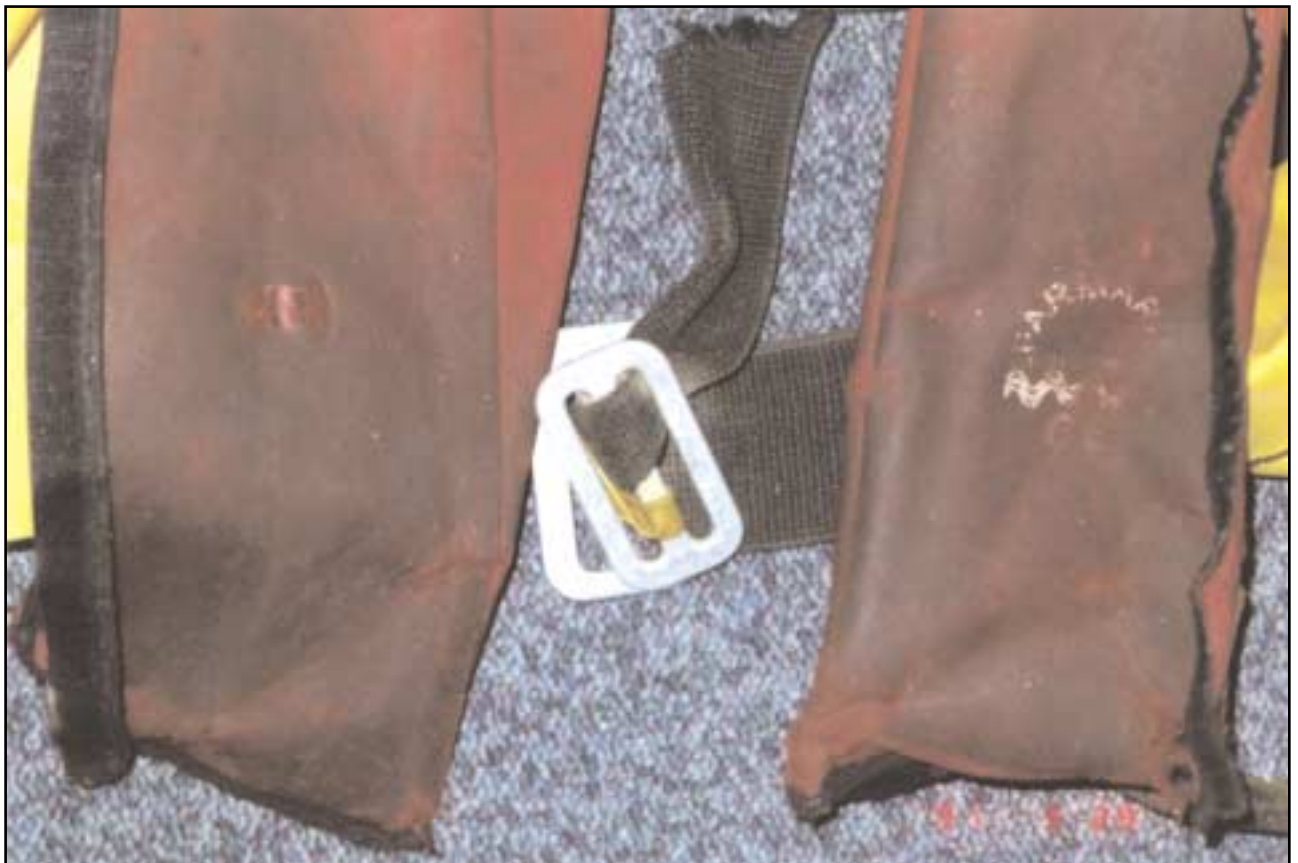
Figure 7

The waistband was found adjusted to a girth of 1320mm, with its buckle closed. The missing man has been described as slim. A person fitting this description is, even when measured over everyday clothing, unlikely to have a waist or chest measurement approaching this figure. From this it is reasonable to suppose that the lifejacket was a loose fit on the missing man.

This slackness, apart from being at variance with manufacturers' donning instructions, makes it possible that the wearer involuntarily slipped free of the lifejacket in the water. However, this would have required the waistband of the harness to slip over his shoulders without being caught under his armpits. Although possible, this is considered unlikely, unless he entered the water feet-first and with his arms stretched above his head.

Following the lifejacket's recovery, it was noted that the webbing was folded where it passes through the buckle (**Figure 7**). Creases in the material suggested this was a long term condition. This fold might have been the result of the webbing losing its elasticity with age and weathering, or the wearer might have folded it so that it maintained its adjustment. To support this possibility, it is noted that without this fold the webbing is able to slip through the buckle, particularly while donning the lifejacket, and when there is no tension on the

webbing. However, a simple trial showed that, with the buckle closed and adjusted to put the webbing under slight tension, as is the case when the lifejacket is correctly donned, slippage is unlikely. Thus, it is considered unlikely that the buckle slipped to cause the slackness found in the harness. The state of the webbing and buckle is, therefore, unlikely to have contributed to the lifejacket slipping from the crewman.

Buckle and webbing of recovered lifejacket
