Report on the investigation of  
a fatal accident to a crew member  
on board the bulk carrier

***Evangelos CH***

at the Zulu Anchorage, River Thames Estuary  
on 20 November 2000

**Report No 29/2001  
August 2001**

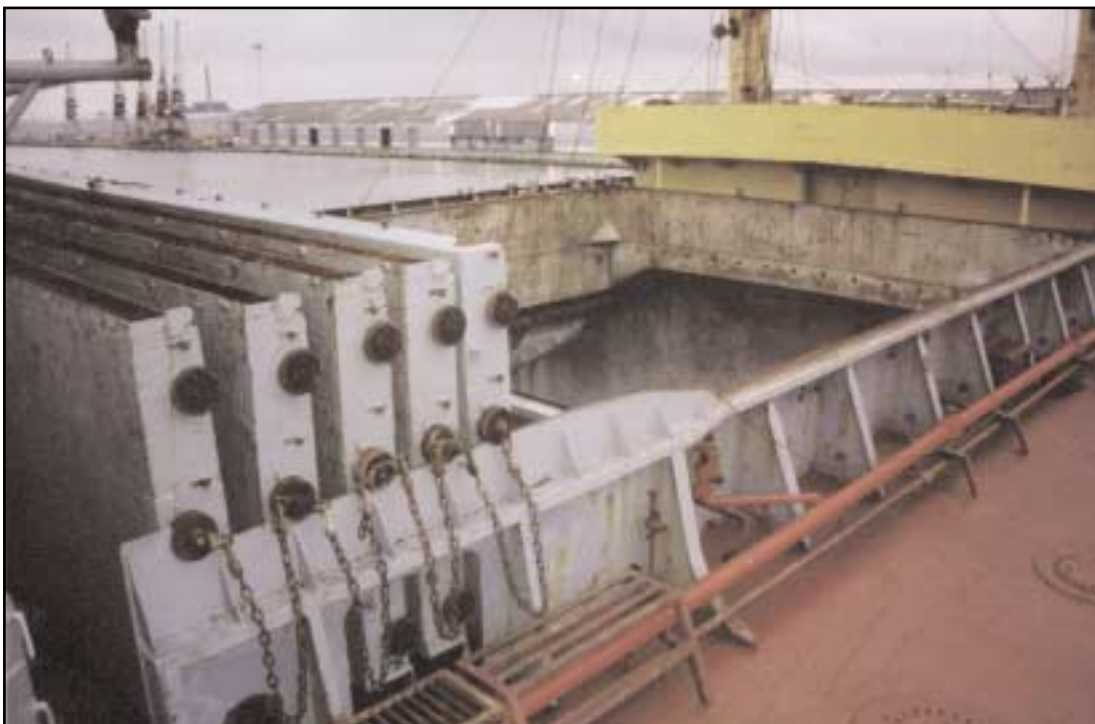
Figure 2

No 3 Hold

The depth of each cargo hold was approximately 12m. All six holds were fitted with standard single pull MacGregor hatch covers (**Figure 2**). The hatch covers on each hold were closed by means of a single wire from a dedicated winch. These winches were housed on one of the three mast house tables situated between the holds, on the main deck.

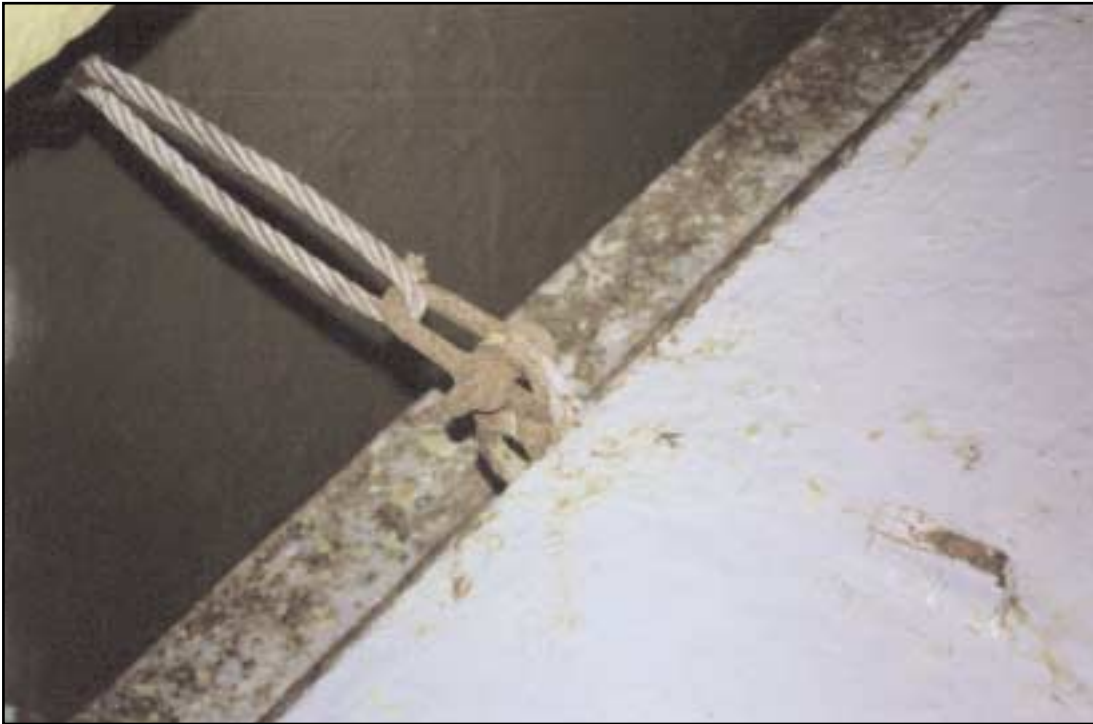
Figure 3

The hatches were closed by heaving a wire on to one of the winches situated on the mast house table. This wire was fed through a pulley to the underside of the table, and shackled to a welded rigid eye on the leading edge of the first section of the hatch covers (**Figure 3**).

Leading edge of hatch cover showing wire, shackle, and butt of old eye

At some time during the life of the vessel, a rigid welded eye, previously used for shackling the heaving wire, had been changed from a position approximately 0.3m from the edge of the hatch cover, to a position right on the leading edge (**Figure 3**).

The butt of the old eye was protruding approximately 50mm above the level of the hatch cover.

It is also possible that the third officer tripped on the butt of the old welded eye or was unable to distinguish the edge of the leading hatch cover because of the shadow area created by the masthouse.

The tripping hazard created by the butt remaining from the previous welded eye.

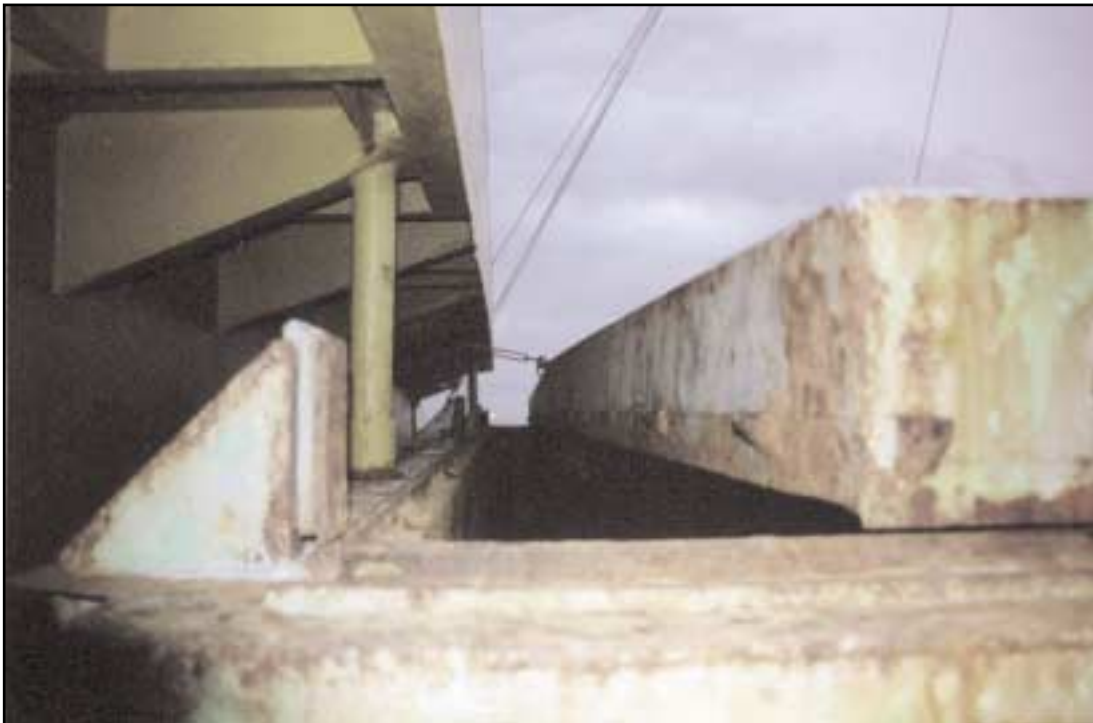
Figure 4

However, when closing the hatches, the crew found it necessary to change the securing point to enable them to close the hatch covers fully. When the hatch covers were partly closed (**Figure 4**), the wire was unshackled from the leading hatch cover and reshackled to another welded fixed eye on a trailing section of the hatch covers.

Leading hatch cover in approximate position at the time of the accident
