Report on the investigation of the

man overboard from

***Koningin Beatrix***

**Report No 39/2001  
December 2001**

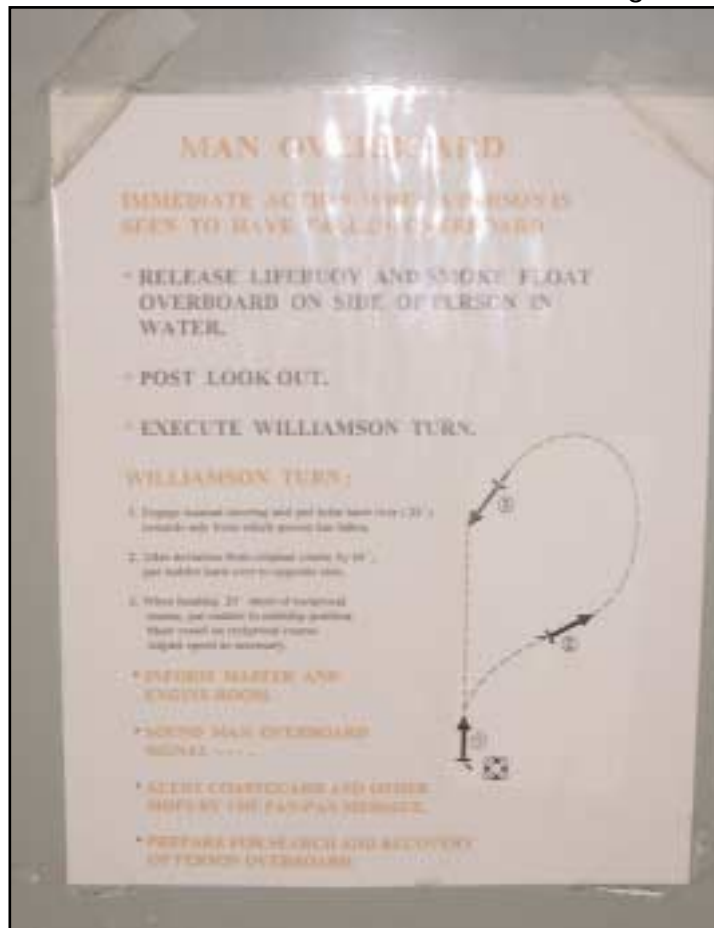
Figure 2

A man overboard notice is by the helm position on the bridge of *Koningin Beatrix*. This appears to have been made up on board the vessel and is not part of a controlled document (**see Figure 2**).

Man overboard notice by helm position

The manoverboard notice by the helm position is a good reference to have to hand during an incident. However, it omits the GPS MOB button action and various other actions found on both the checklist and in the operational procedures manual.

2. Amend its company standing orders and operational procedures manual, sections 3.9.2.1 and 3.9.2.2 to include more detailed procedures to be taken in the event of a man overboard in conditions which do not allow the lowering of a rescue boat.

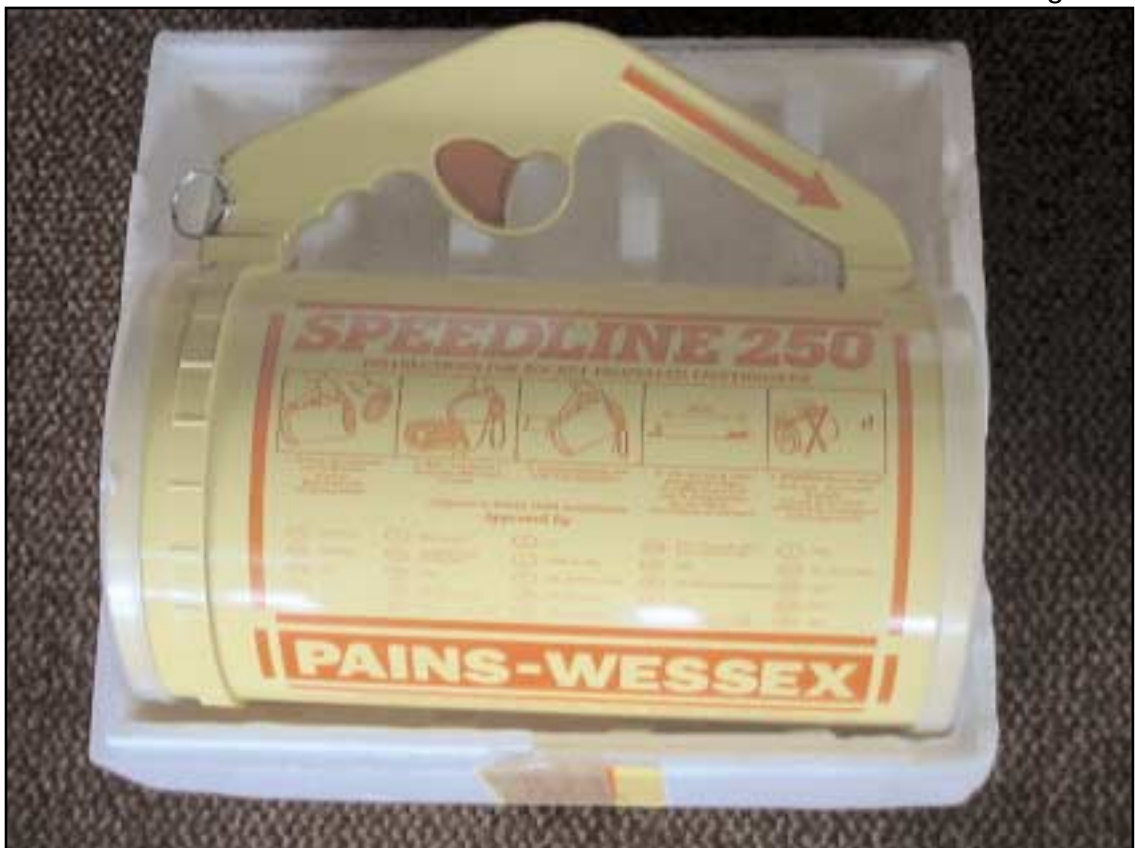
Figure 3

Rocket line throwing apparatus is required to be carried on most sea-going merchant vessels. *Koningin Beatrix* had four such units on board (**see Figure 3**). Each unit consists of 275m of 4mm ready-flaked line and is designed for use in extreme weather conditions. Deck officers have to demonstrate their knowledge of the use and operation of these units when taking their certificates of competency.

One of the four rocket line throwing apparatus units stowed on the bridge of *Koningin Beatrix*

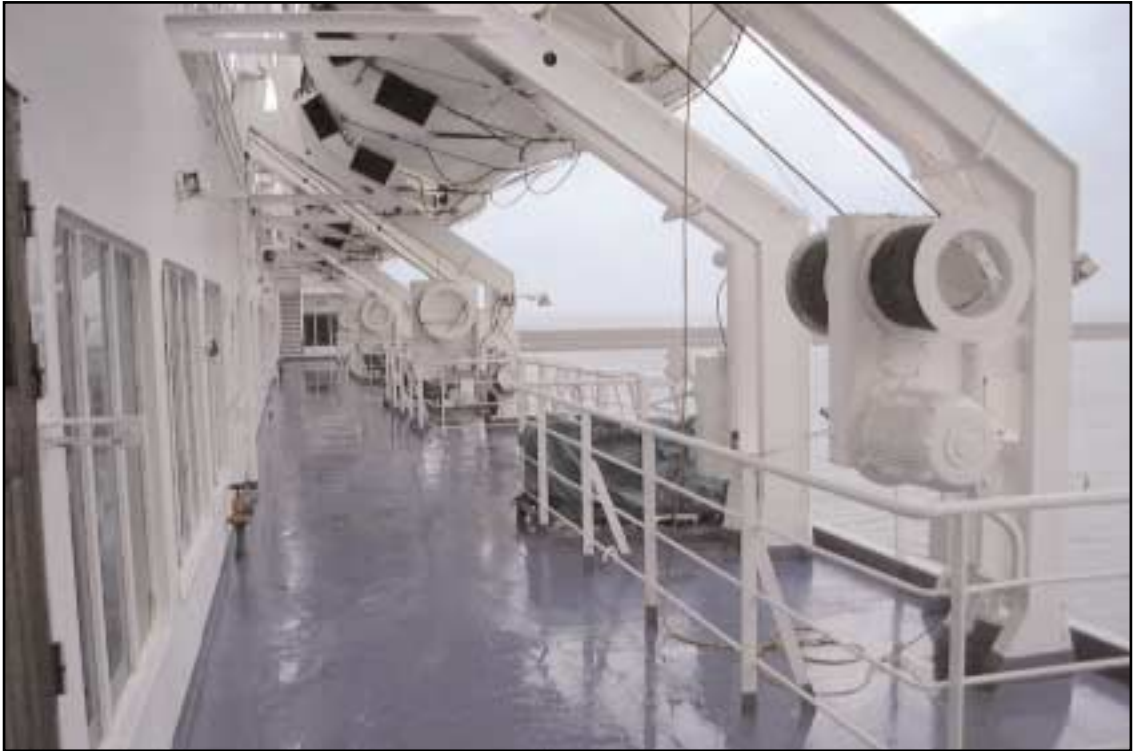
Figure 4

Mr Davis managed to get over or through the handrails, all of which were over 1 metre high and satisfied statutory requirements. All of the outside decks were checked by the police on the vessel's arrival at Fishguard, and were also inspected and measured by MAIB inspectors in early December 2000. No defects were discovered, and none have been reported by the vessel's crew. These handrails are considered to be of sufficient construction and height to prevent personnel falling overboard in normal circumstances. The decks were wet at the time of the incident from spray, and the vessel had some motion because of the adverse weather.

Port side deck looking aft

Someone is unlikely to accidentally fall over these handrails, but it is not impossible. Mr Davis might have been stepping on the bottom rung of the handrails looking at something and fallen over because of the motion of the vessel. He could have, rather unwisely, even been sitting on the top of the handrail and lost his balance, falling backwards. Such behaviour is not unknown on passenger vessels.

7. Undertake a written risk assessment regarding the use of the fast rescue boat and rescue boats in **adverse weather conditions**.
8. Undertake a written risk assessment regarding passenger use of the outside decks, which face overboard, during weather conditions which preclude the lowering of rescue boats.

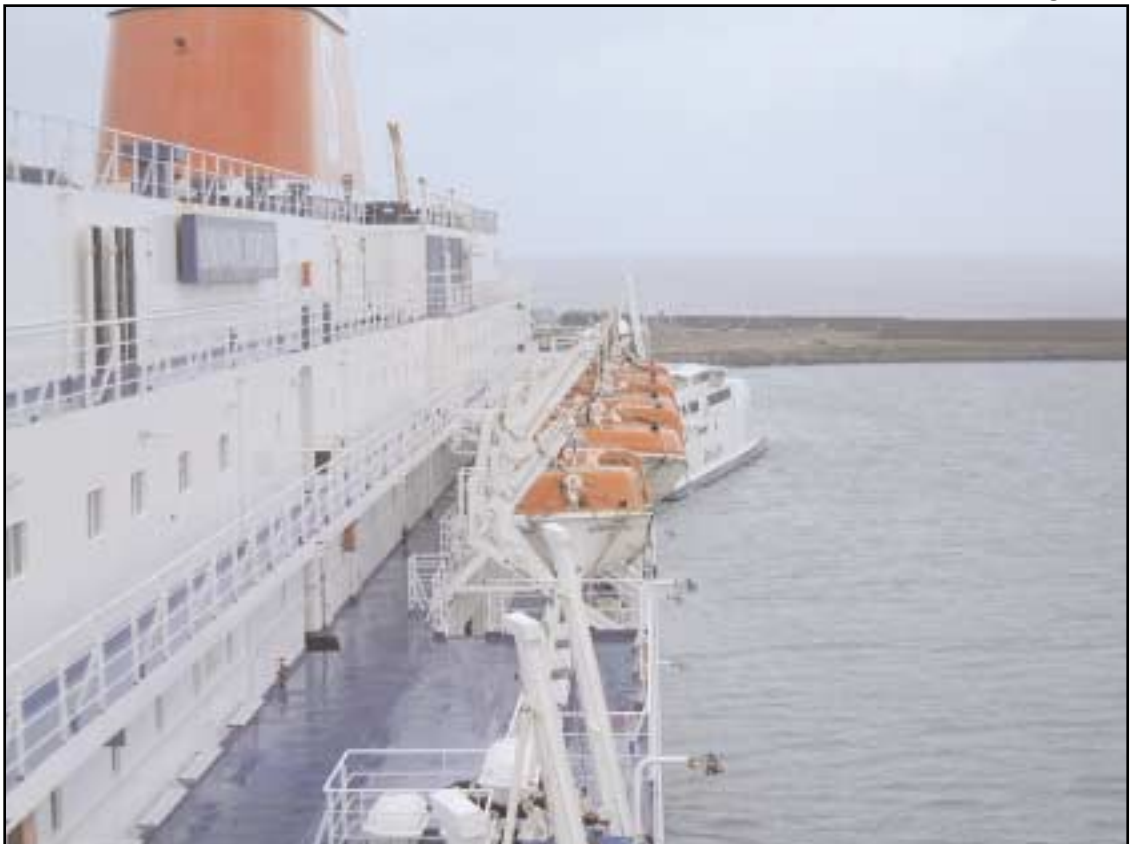
Figure 5

Port side deck 9 looking aft

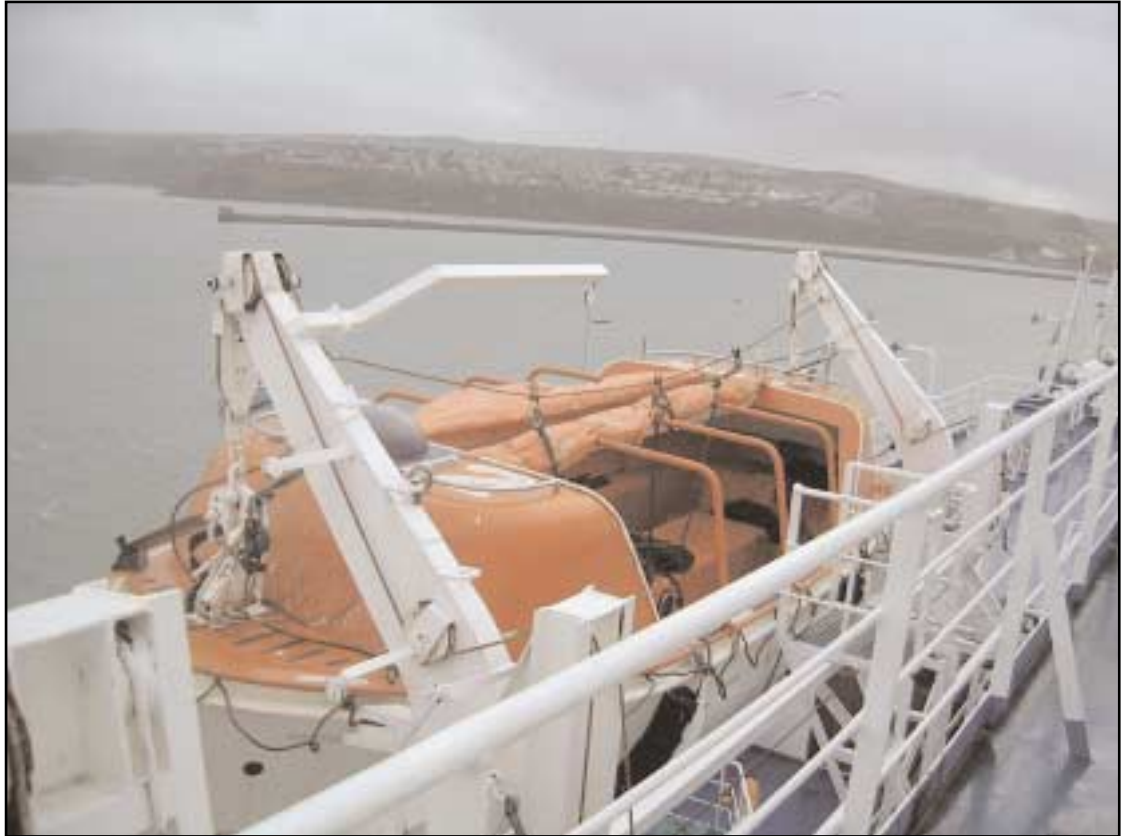
Figure 6

The rescue boats on *Koningin Beatrix* were more akin to traditional semi-enclosed lifeboats with twin falls (**see Figure 6**). They were not fast rescue boats. They complied with the statutory requirements at the time.

Starboard side rescue boat

The master indicated he would not be happy launching the rescue boats in seas much above 2 to 2½ metres; this equates to winds of force 5 on the Beaufort scale.
