Report on the investigation of
the grounding of

mfv Horizonte Claro

Soyea Island, Loch Inver

Report No 23/2001

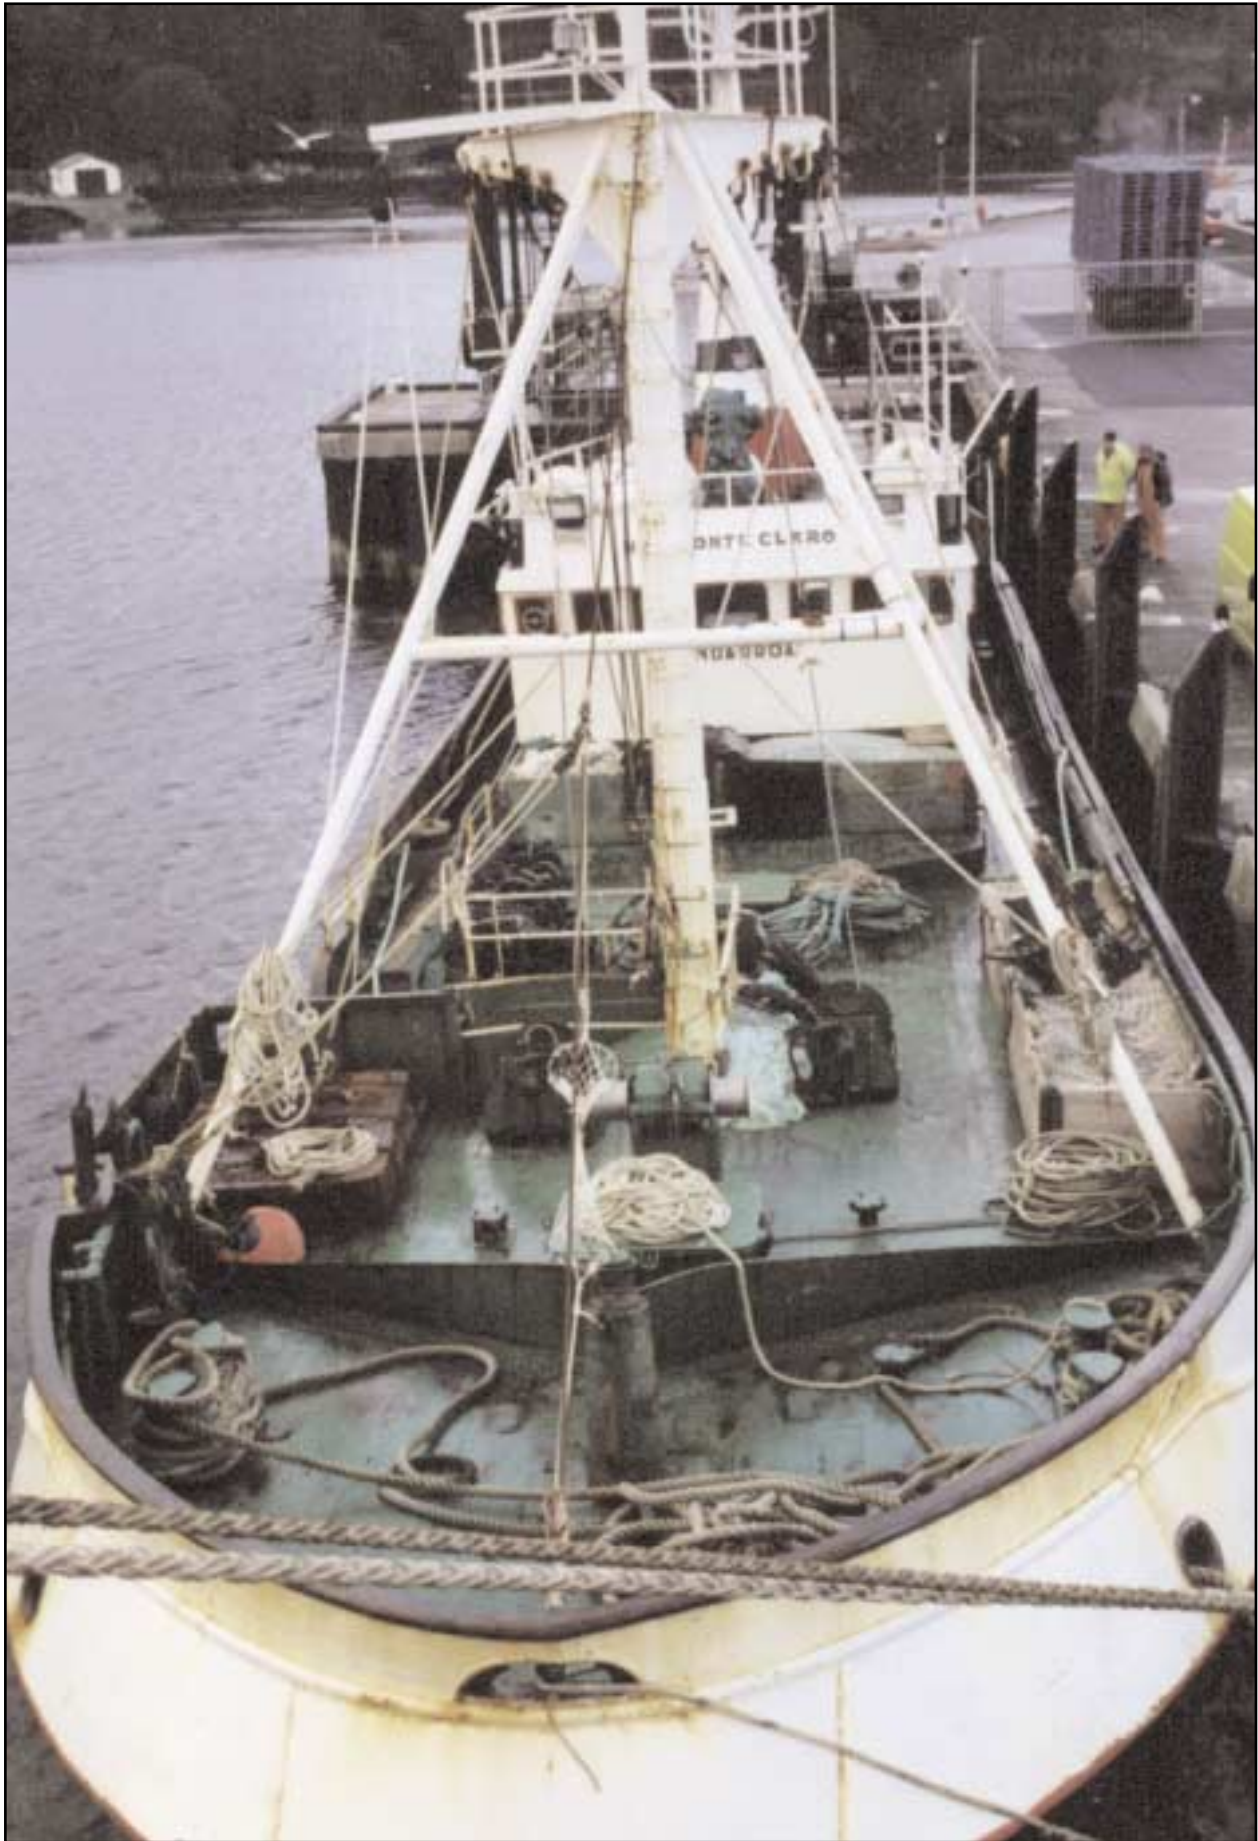
Time and date : 0020(UTC+1) on 21 October 2000
Location of incident : 58° 08.64N 005°18.32W. 090° 0.11 miles from Soyea Island
Persons on board : 14
Injuries/fatalities : None
Damage : Minor damage was confined to the bar keel forward and to the rudder

Horizonte Claro alongside in Stornoway awaiting repair

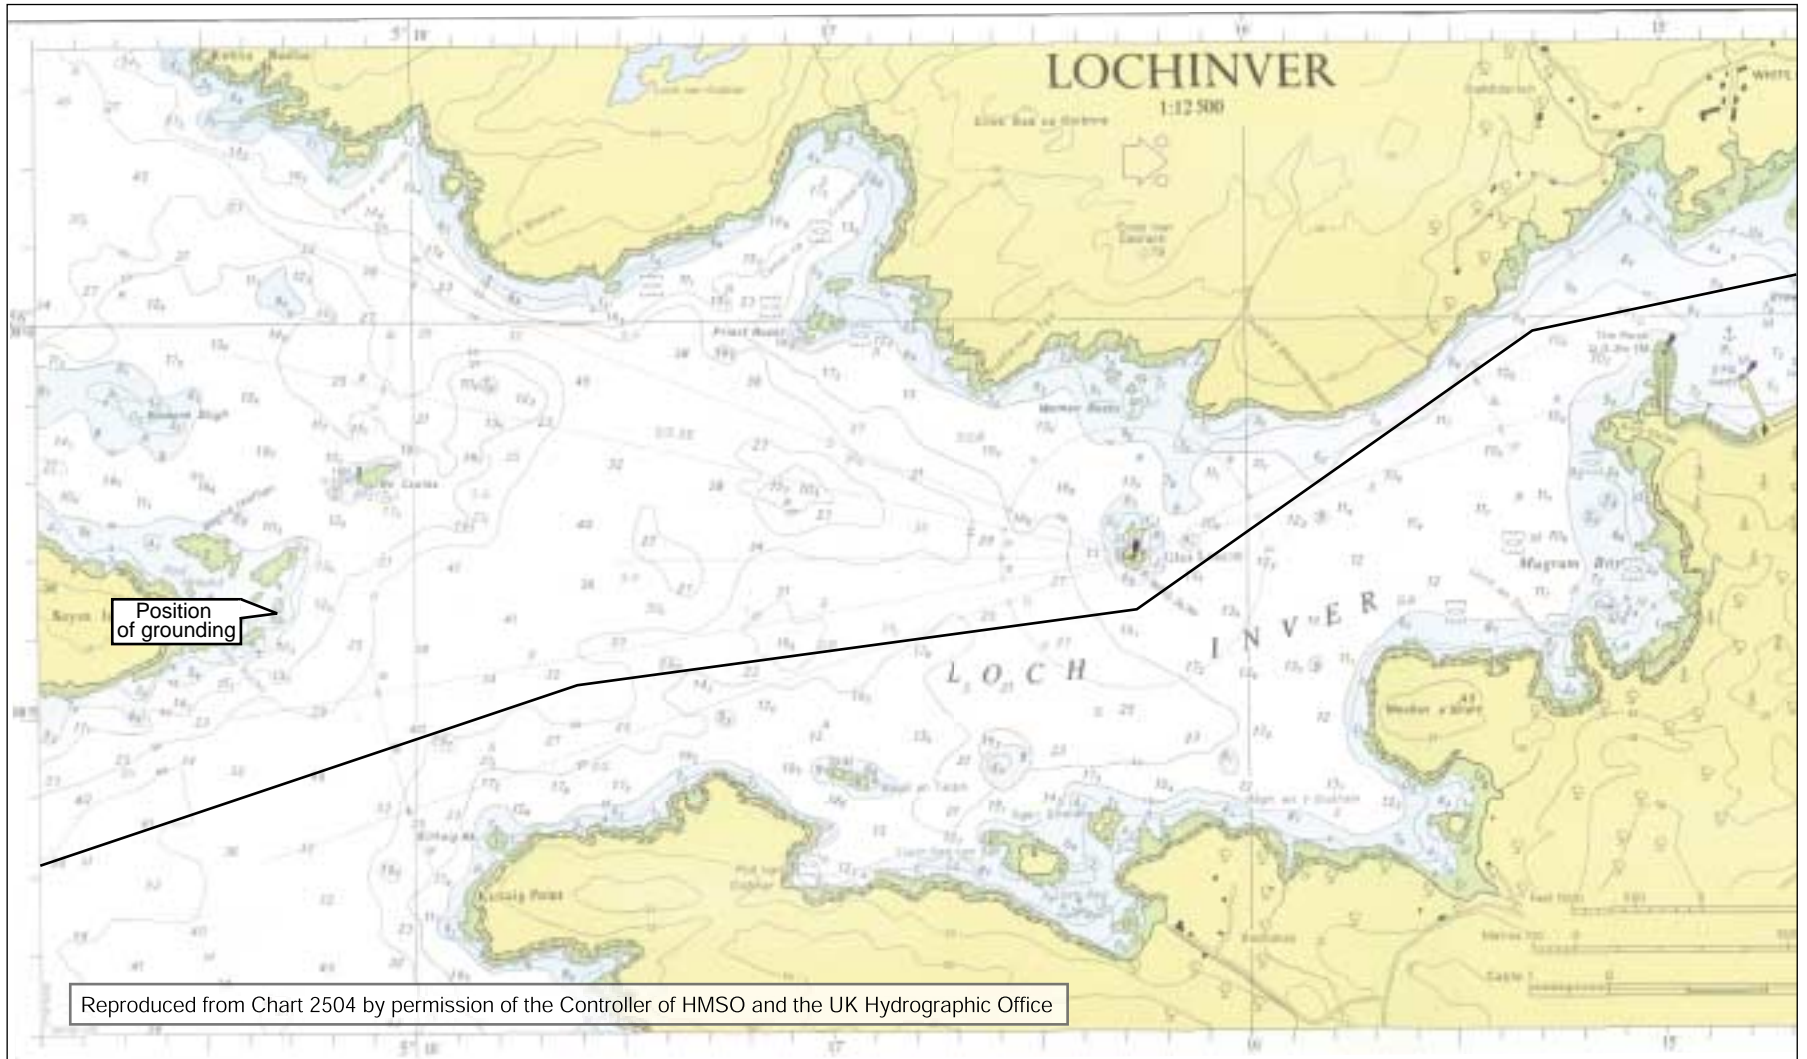
Figure 2

The vessel's intended track was displayed on the plotter. It was based upon waypoints inserted at intervals during a previous entry or departure, and is shown at **Figure 2**. The skipper was of the opinion that, during the departure and when aground, there was no appreciable difference between the DGPS and GPS positions, and both indicated the vessel was on the track displayed on the plotter.

Intended track and position of grounding of *Horizonte Claro*

- 3.1.3 The grounding occurred about 400m north of the intended track. **[Fig 2]**
- 3.1.4 The grounding occurred about two hours before high water in Lochinver at a speed of about 7 knots. [1.3,1.11]

- 3.2.1 The immediate cause of the accident was that the skipper was unaware that *Horizonte Claro* was about 400m north of the intended track and heading towards Soyea Island. [2.1,2.2]
