Report on the investigation of
the grounding and total loss of
the United Kingdom-registered fishing vessel

Arosa (M321)

on Doonguddle rock
off the west coast of Ireland
with the loss of 12 crew members

**Report No 41/2001
December 2001**

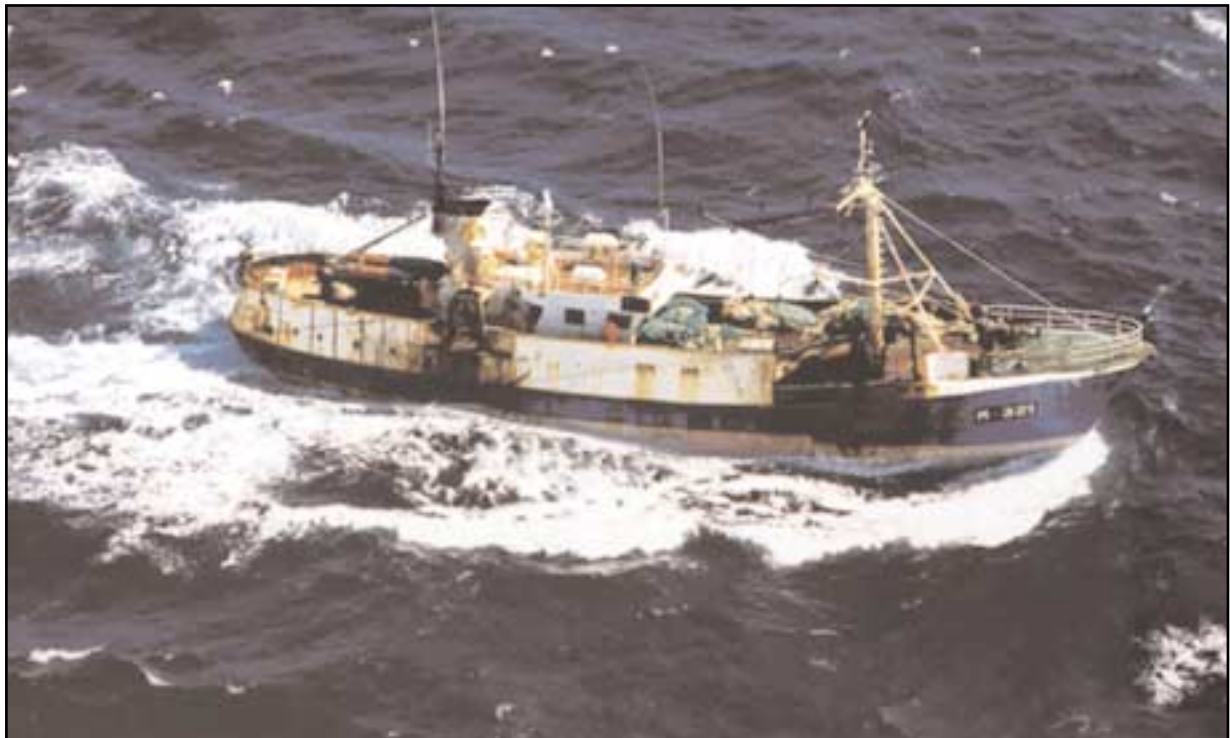
Photograph 2

Arosa engaged in fishing

2 x 16 person inflatable liferafts with 71m long painters. Both were stowed on the wheelhouse top and had been last serviced on 22 September 1999; **(see photograph 2)**

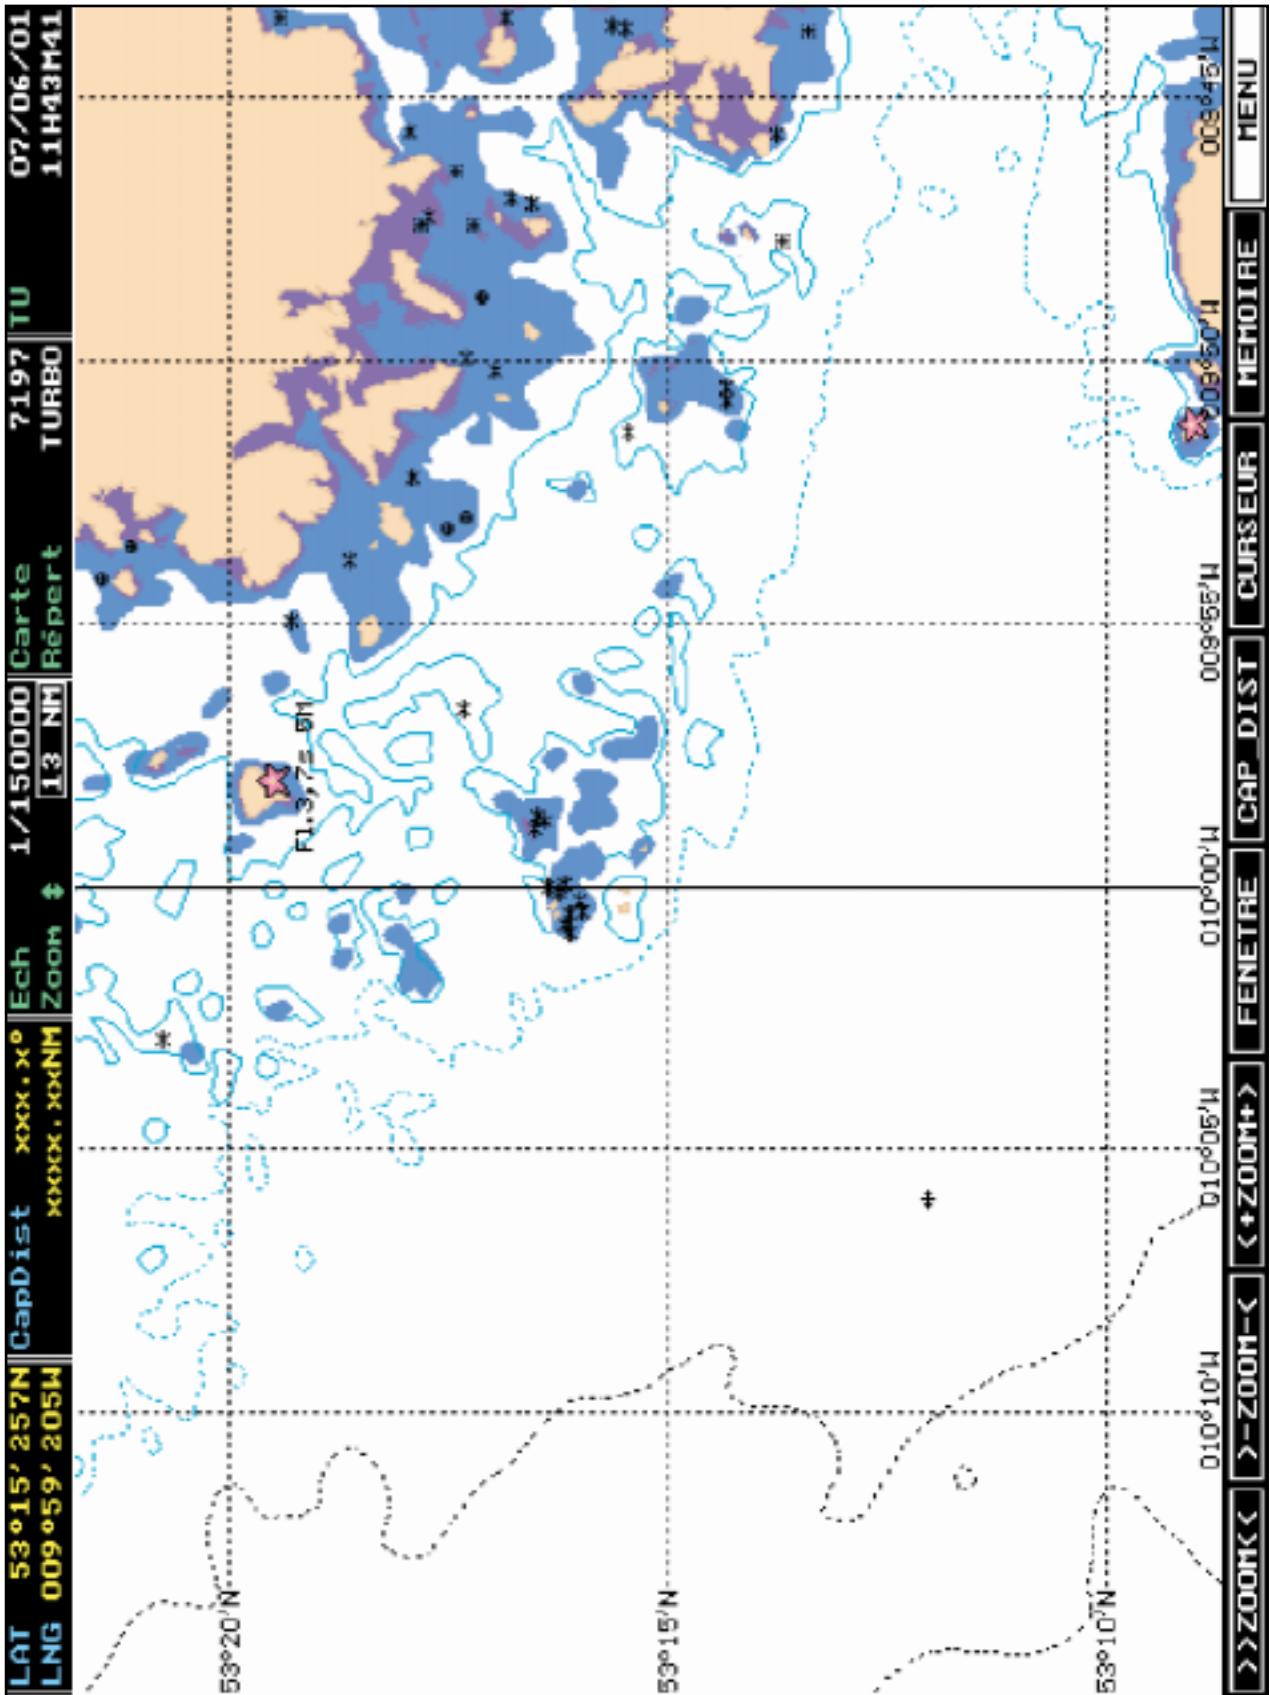
Chart Extract 1 - Extract from the electronic navigation chart in use on Arosa

The electronic navigation chart (**see chart extract 1 overleaf**), for the area in which *Arosa* went aground, was a Sodena digitised/vector version of EPSHOM chart number 7197 of 1988 at a scale of 1:150,000. This was largely based on

Of the eight identified electronic navigation charts which were on board *Arosa*, none were less than a scale of 1:150,000. These are considered suitable for fishing offshore, but not for coastal navigation when the largest scale chart should be used.

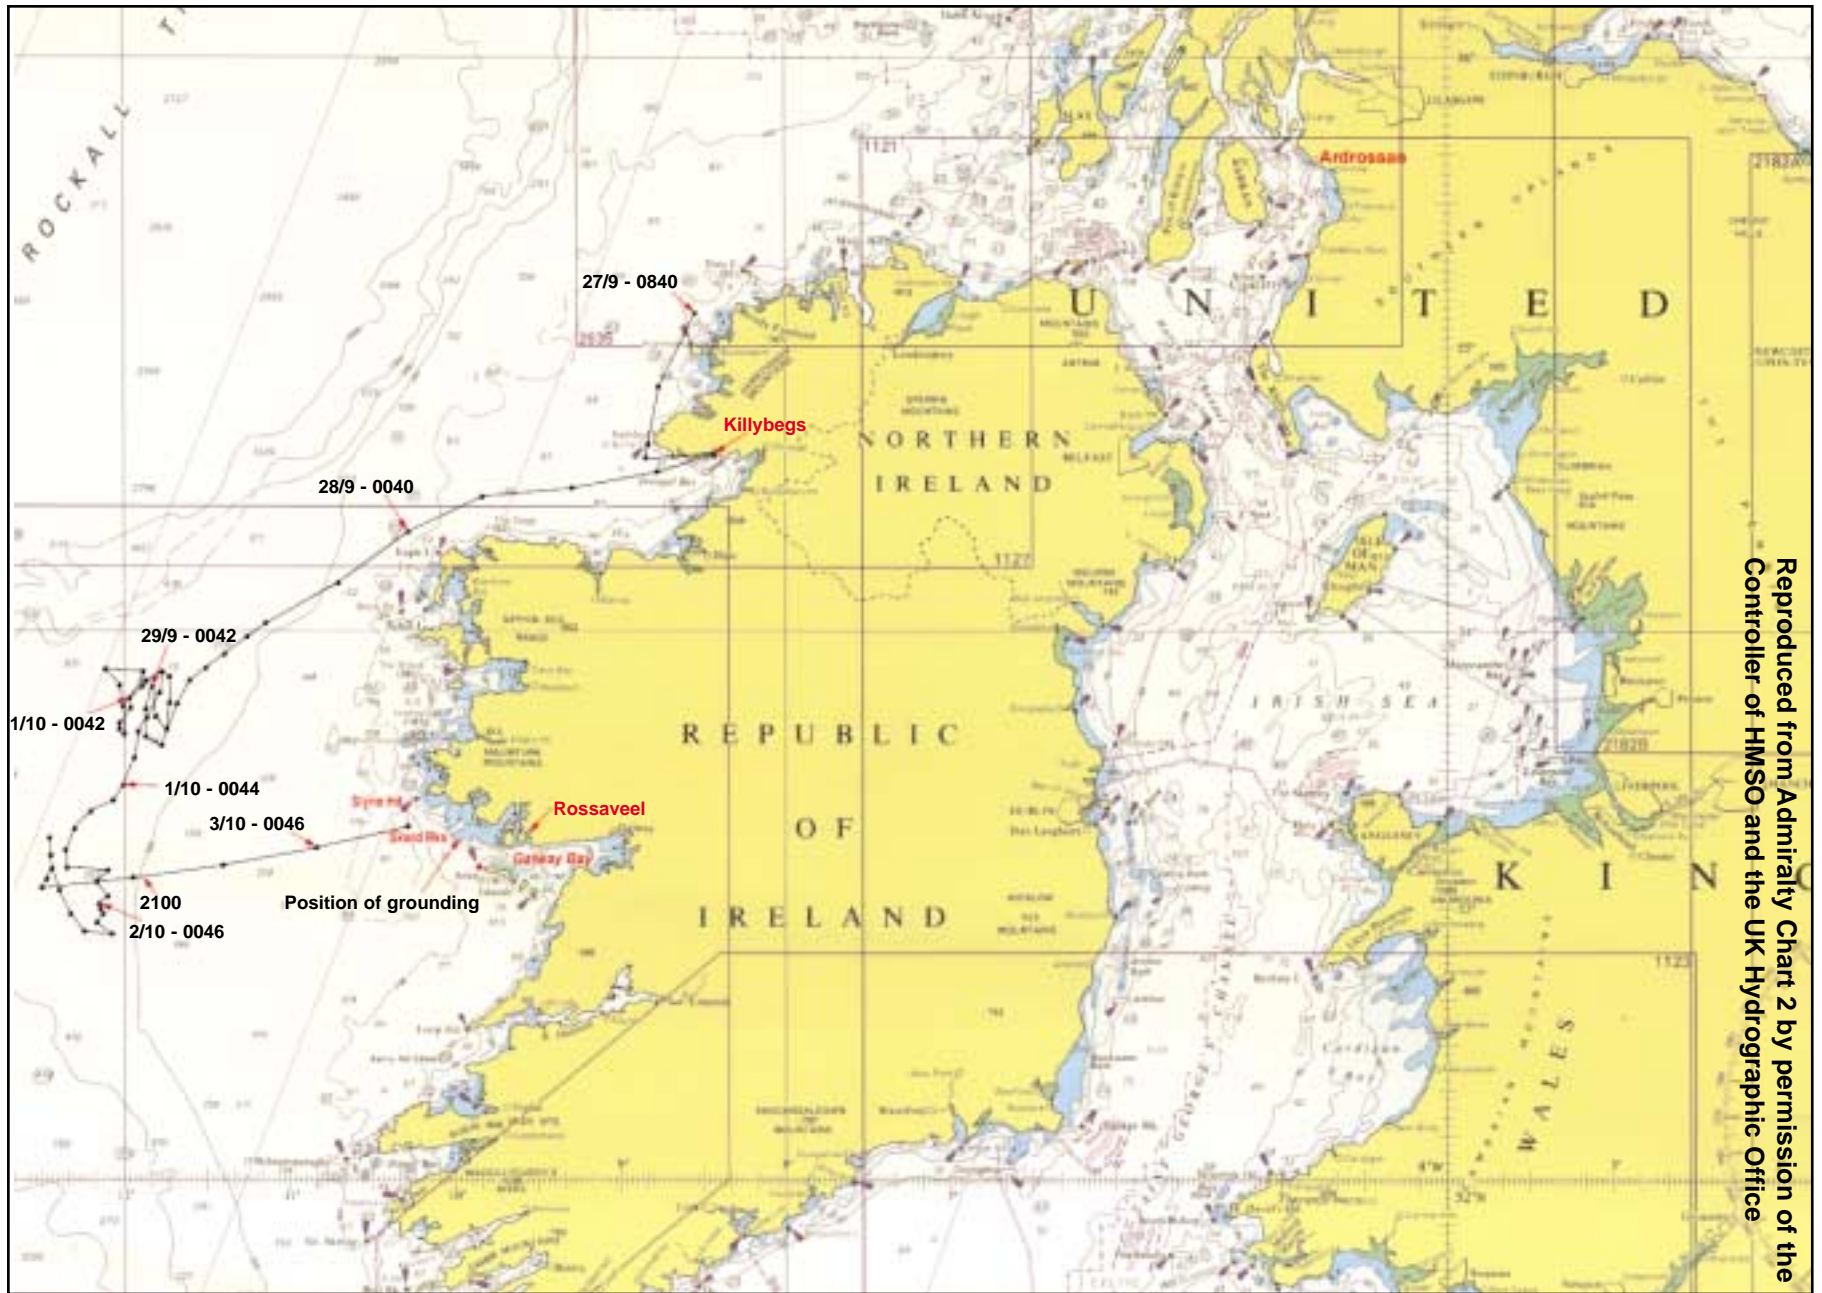
Chart Extract 2 - Showing the vessel monitoring positions (from 0840 27/9/00 to 0246 3/10/00) of Arosa

Using a satellite-based vessel monitoring system, *Arosa* automatically sent her position, speed and course every two hours, whether she was in port or at sea. The monitoring system was an EEC requirement, which had come into effect at the beginning of 2000. The last transmission was sent at 0246 UTC on 3 October 2000, which was just over an hour before the grounding, giving her position as latitude 53° 18' 02" N longitude 010° 17' 53" W, with her course as 080° and her speed as 9 knots.

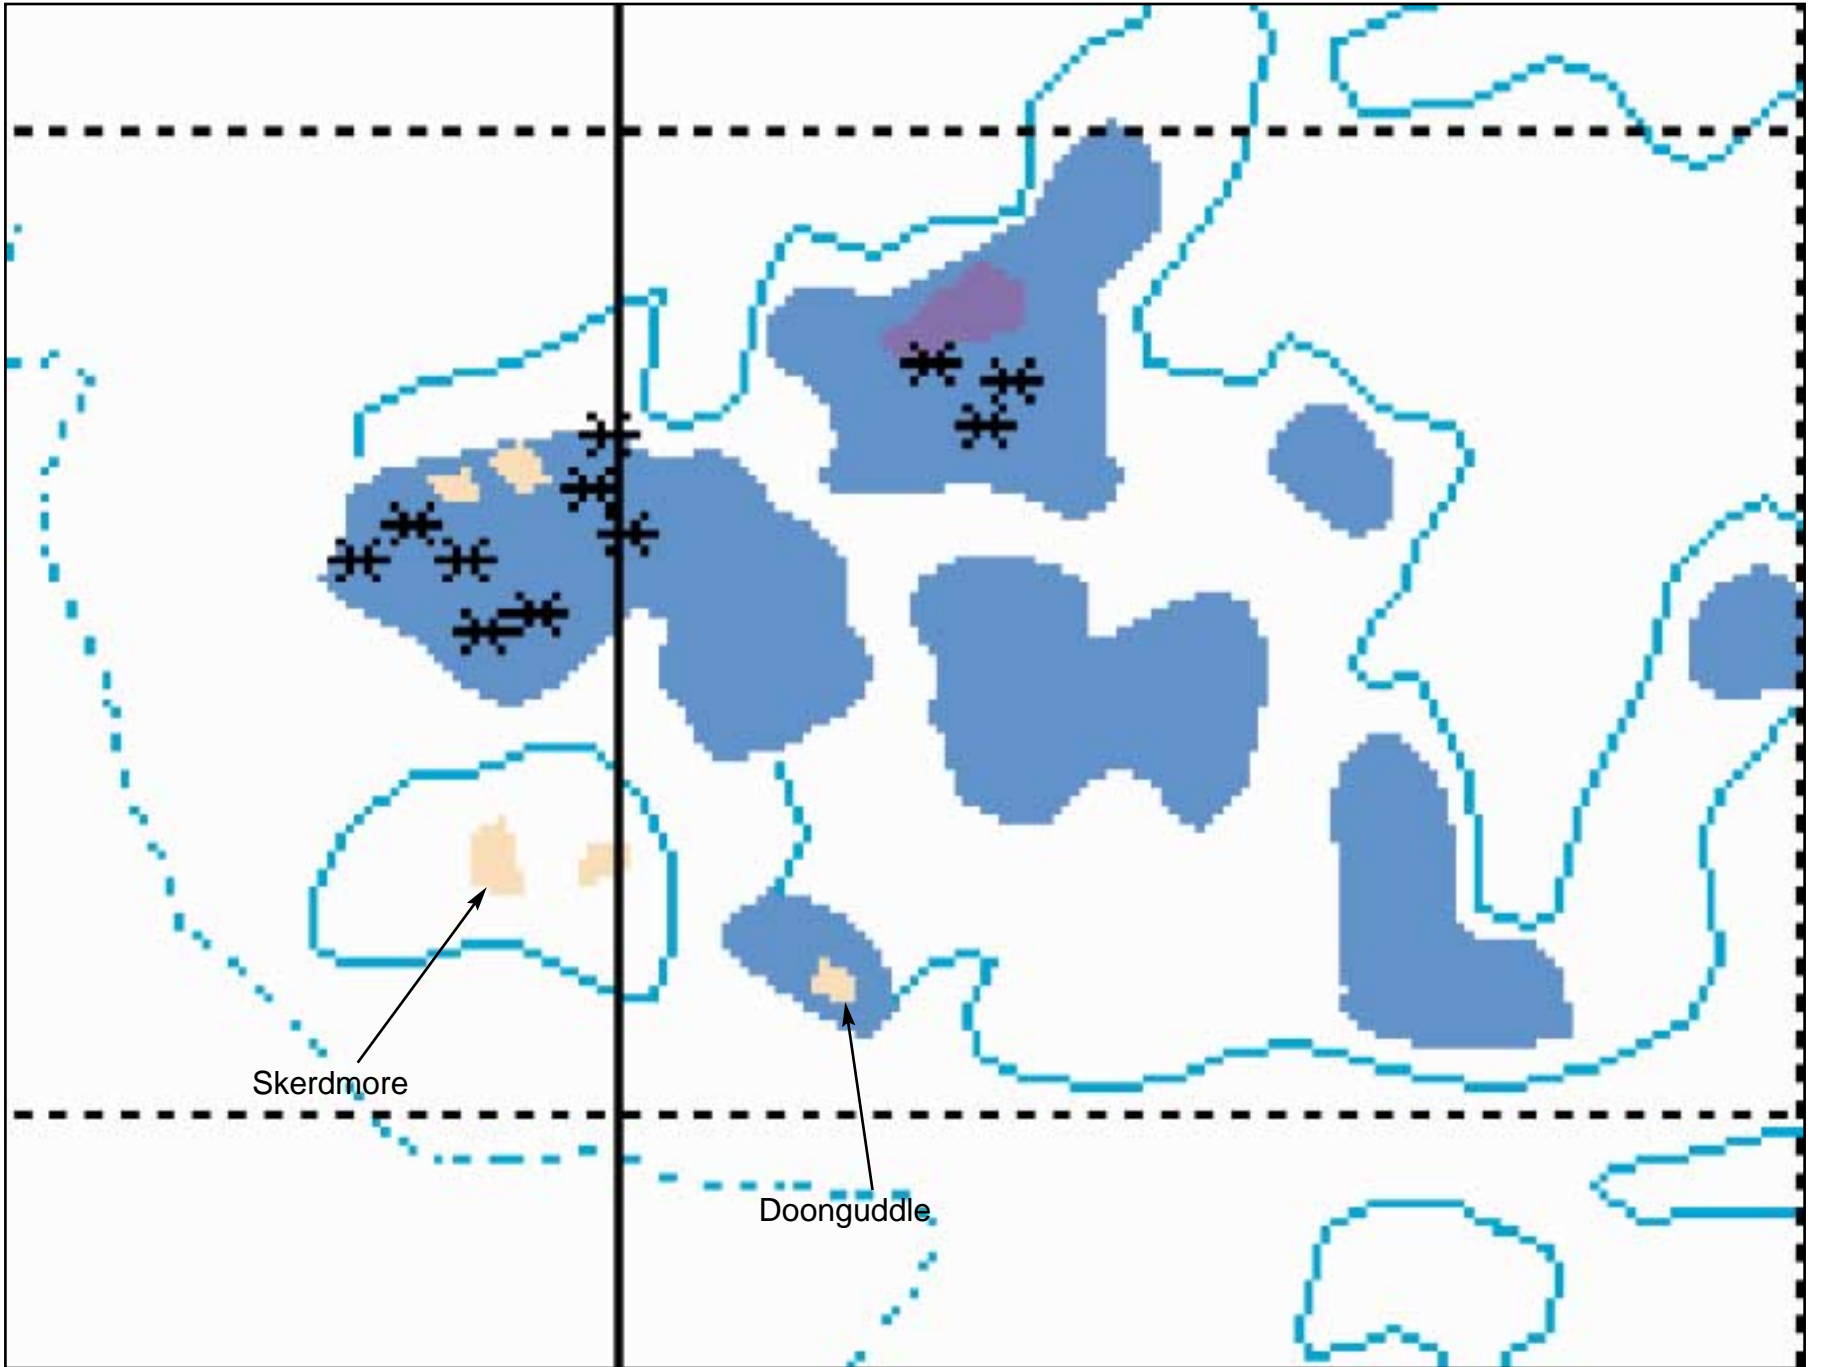
Chart Extract 5 - A computer enlarged version of the electronic navigation chart in use on *Arosa*

It is possible, since leaving the fishing grounds, that track lines had not been set up on the electronic chart (**see point 4 and 5 in section 1.5**). The alteration of course position for Galway Bay might have been arbitrary, and the timing of turn at the patrón de costa's discretion to steer a course that would make it easy for the crew (**see section 2.3**). He might not have entered a track line after the alteration of course towards Galway Bay, and he might have been using the plotter to show the vessel's position only. One of the British skippers had noted that the vessel's position on the electronic chart was indicated by a triangle. The Sodena software has an option in which the vessel's course and speed over the ground can be displayed by a vector originating from the triangle. However, an option can allow the operator to turn off the vector and use the numbers display at the side of the plotter screen for course and speed instead. It is possible the patrón de costa was not using a track line and did not have the vector display in use, both of which would have more readily alerted him that *Arosa* was making leeway towards Skerd Rocks.

By not entering track lines, or the vessel's vector display, the vessel might have approached inadvertently too close to Skerd Rocks. This could have been averted by positions being plotted systematically on a paper chart.

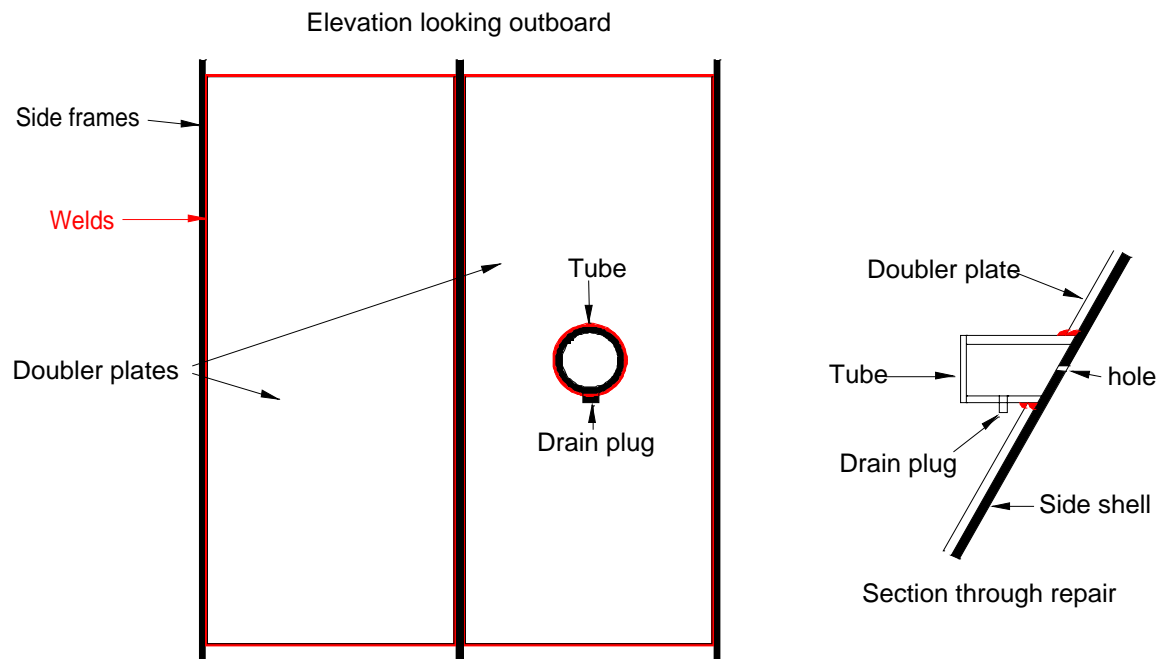
A sketch of the repairs made to *Arosa*

The hole in the starboard shell plating was the size of a person's finger and the soft area was a frame width by 0.3m deep. The hole was in the forward ice compartment of the fish hold. The ship repairers found that the crew removed the local wood panels and fibre-glass insulation and had inserted a wooden plug and a rag into it and there were no more than a drip of water coming through it. To the ship repairers it was not a complicated job and it took about two working days to effect.

First a metal tube was welded to the inside of the shell plate around the hole. The in board end of the tube was sealed off. Water could be drained from the tube by a plug, which had been inserted in the bottom of the tube. Then a steel doubler plate, with a hole cut into it almost the same diameter as the tube, was welded to the shell plate and around the tube. The plate was as wide as the frame width. A second doubler plate was welded in to the frame space forward of the hole.
