Report on the investigation of
the capsizing of

Atlantic Eagle

off St Justinians, Ramsey Sound

**Report No 24/2001
25 May 2001**

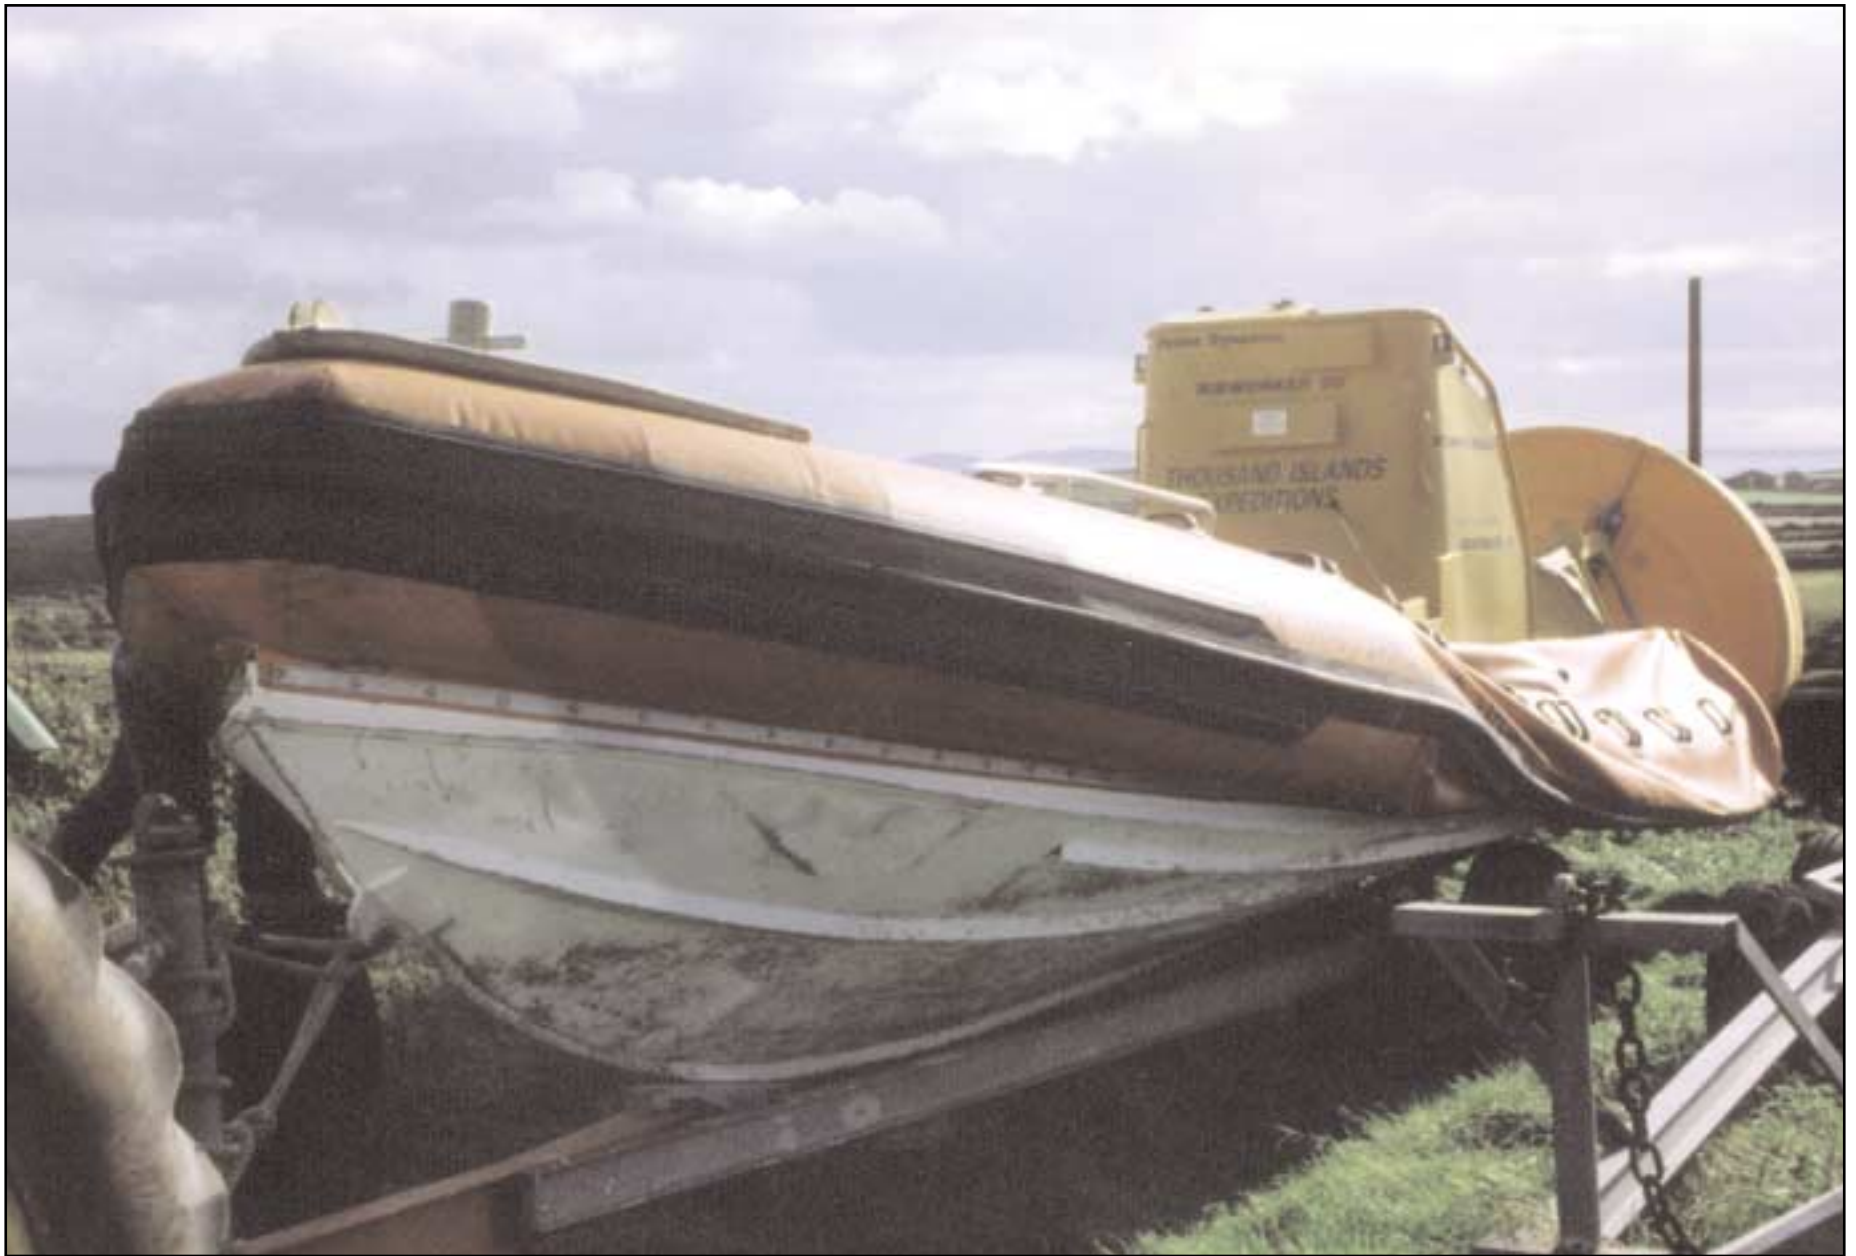
Figure 1

Damage : Water immersion of engine and electrical equipment. Rubber tube and hull damaged during recovery.

Atlantic Eagle after capsizе and recovery

Initially making good about 20 knots through the water when transiting to the west of the rock, the boat's speed would have been considerably reduced following the turn to starboard. Once out of the turn, and in the back eddy to the north of Horse Rock, it is feasible that she began to surf on the front of a southerly-moving wave. When the bows entered the tide rip or whirlpool, the boat would have been influenced by two opposing forces: the wave, and the whirlpool. Under such conditions, severe and unexpected movement is likely. In this case *Atlantic Eagle* sheered to port, decelerated rapidly and her port quarter was lifted to an irrecoverable angle, causing capsize.

Capsize was caused by hydrodynamic forces lifting the boat's port quarter to an irrecoverable angle. [2.3]
