Report on the investigation of
the capsizing of

Atlantic Eagle

off St Justinians, Ramsey Sound

**Report No 24/2001
25 May 2001**

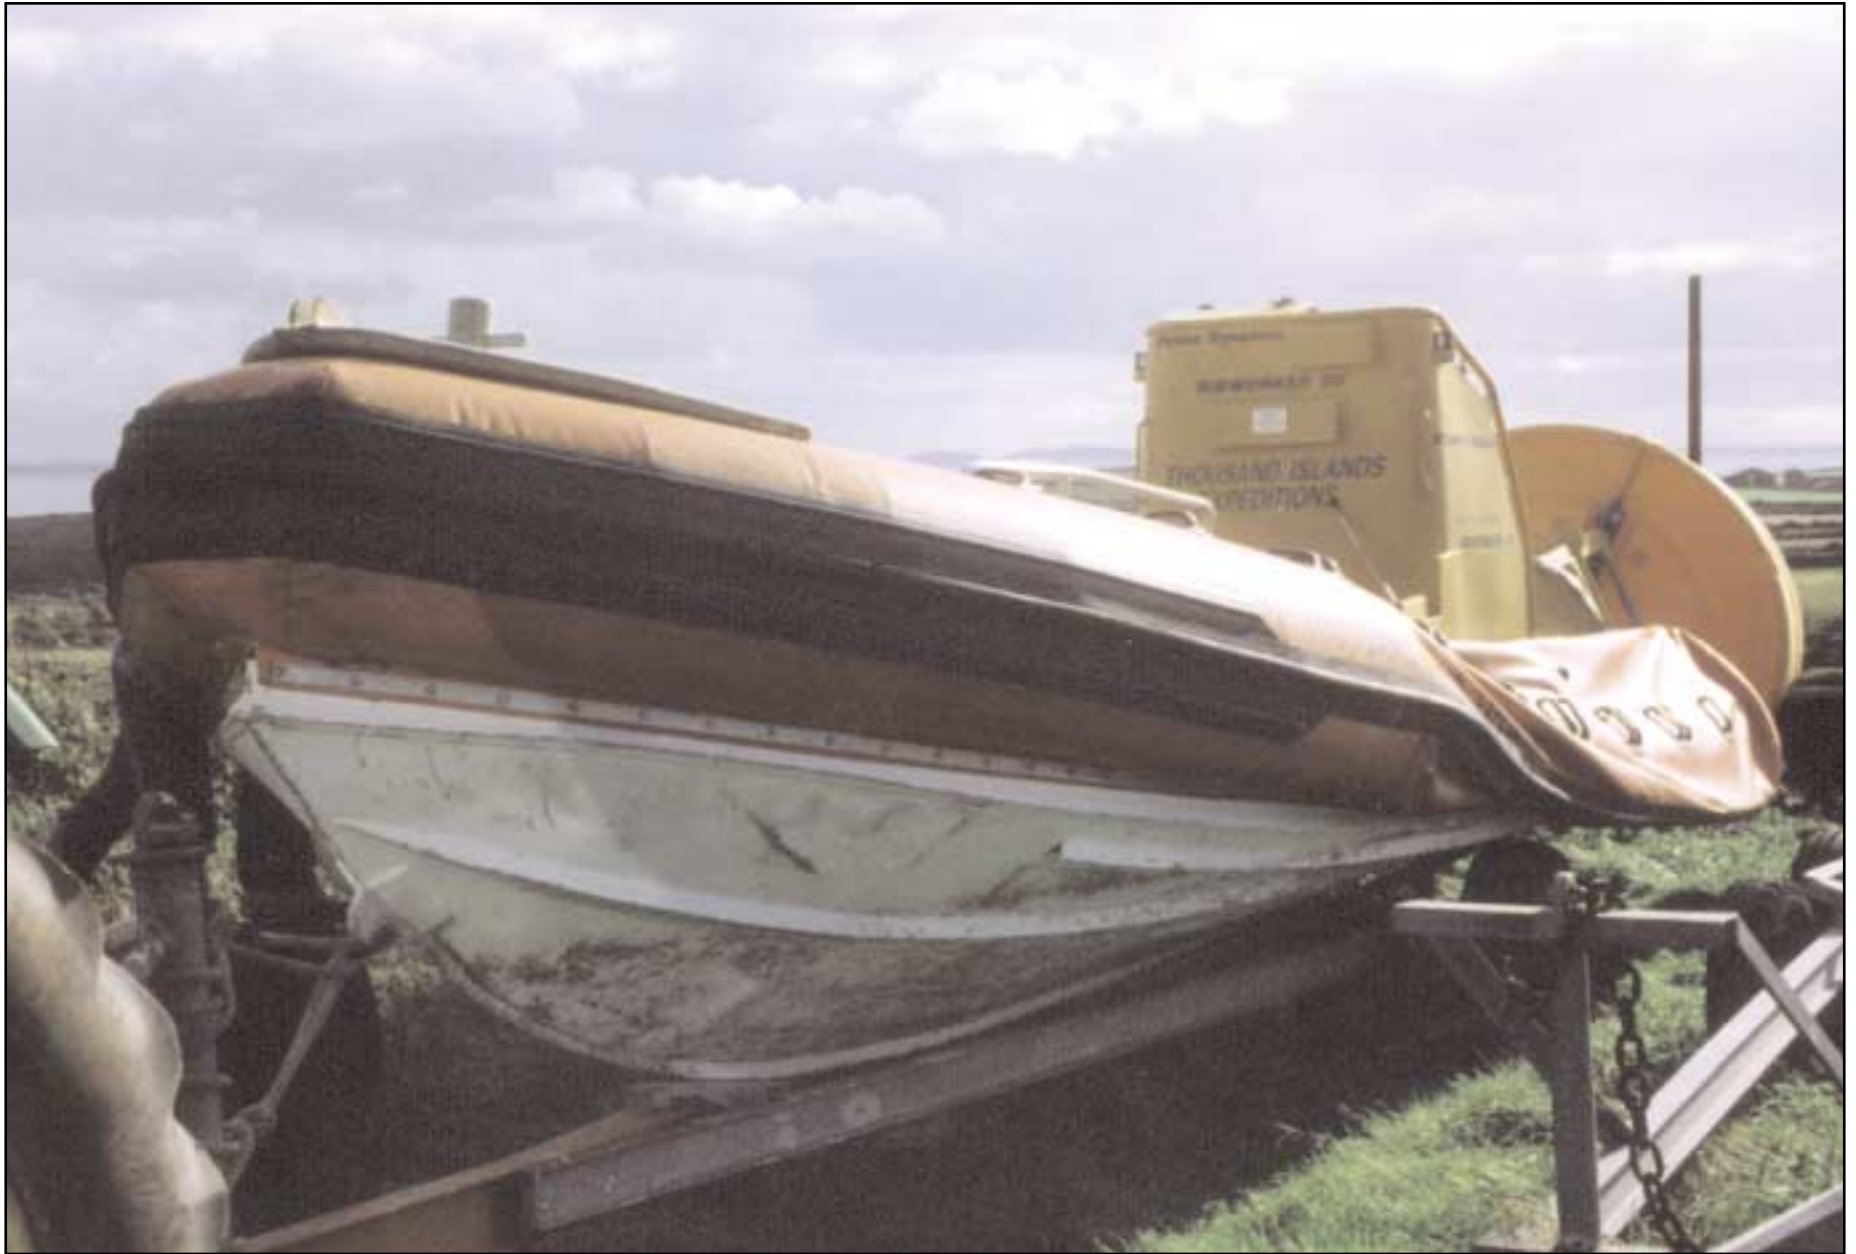
Figure 1

Damage : Water immersion of engine and electrical equipment. Rubber tube and hull damaged during recovery.

Atlantic Eagle after capsizing and recovery

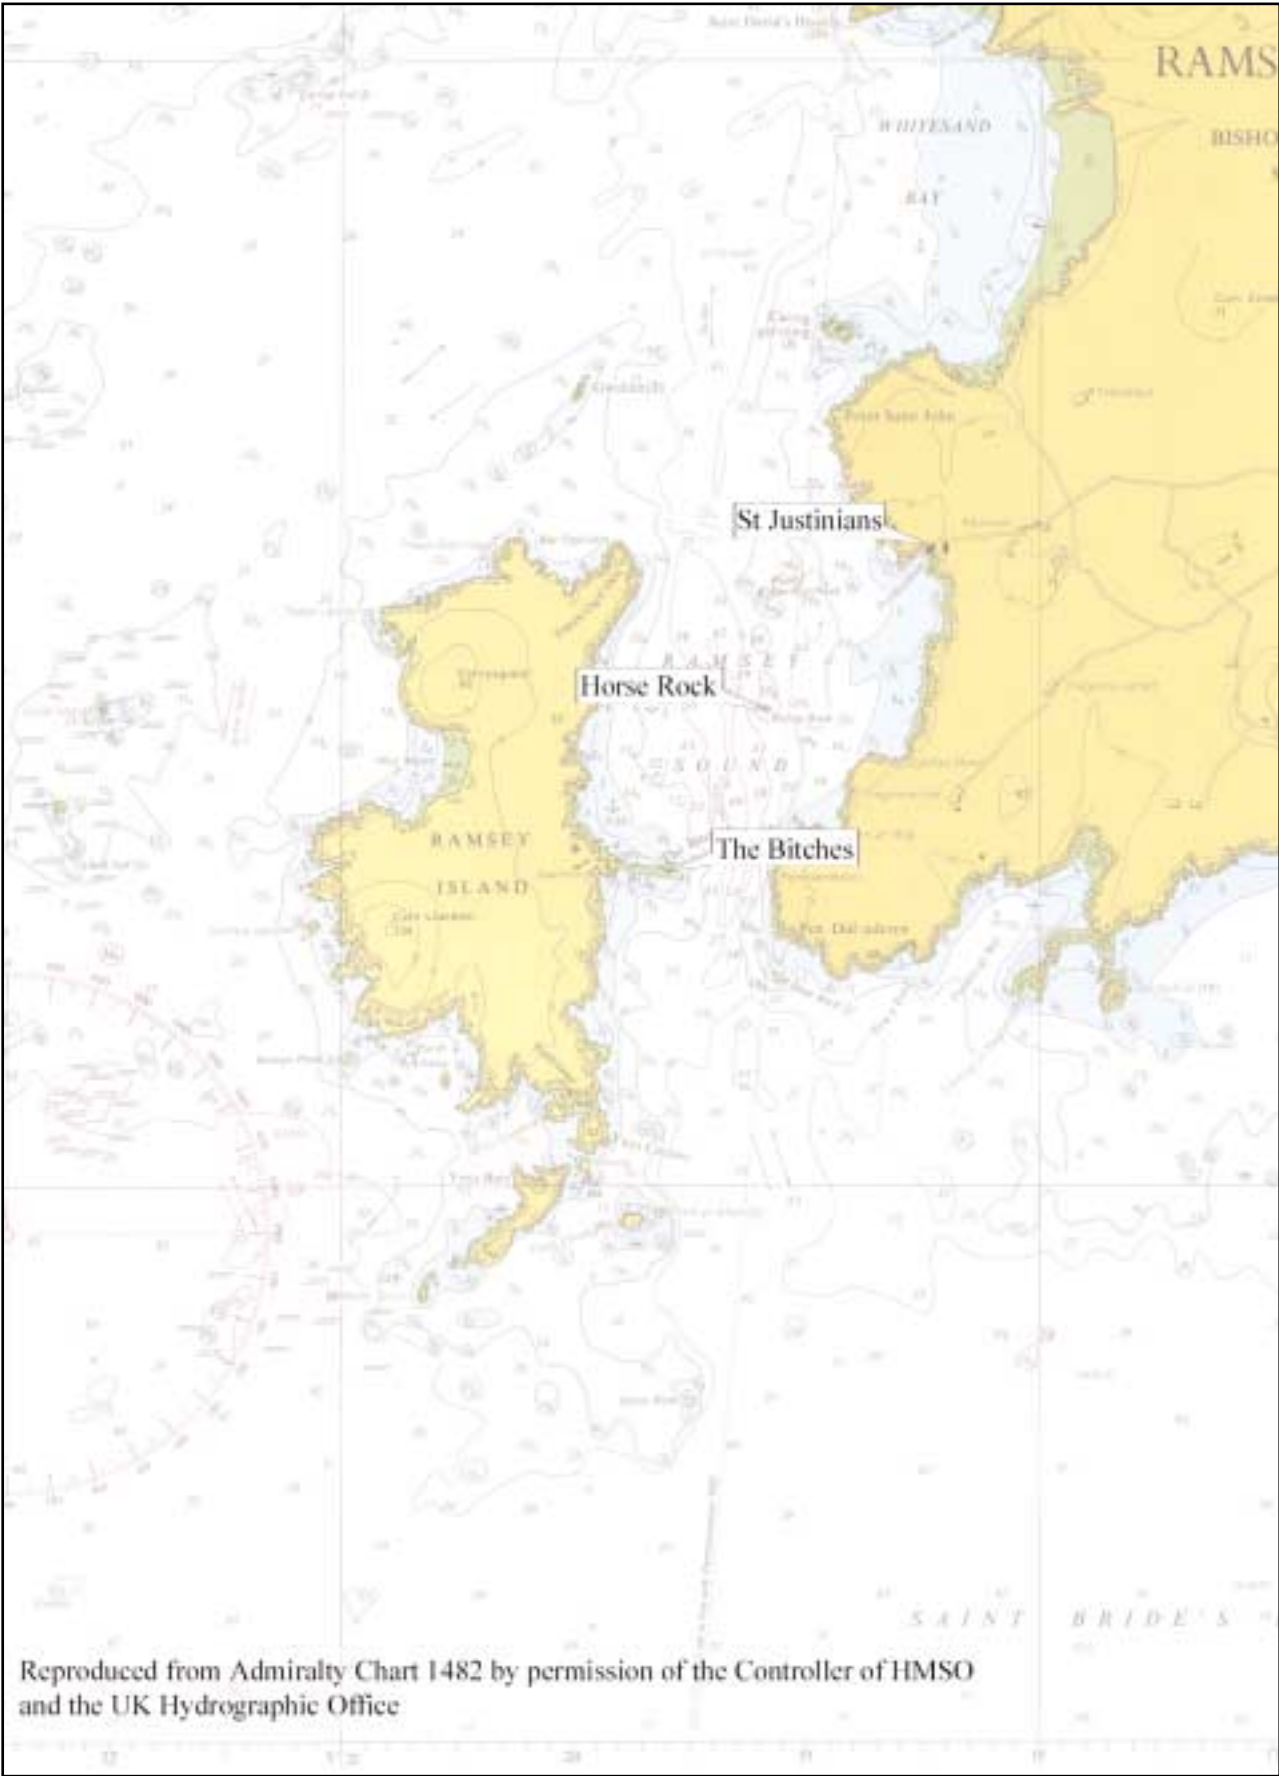
Figure 2

All times are UTC (+1). A chart extract of Ramsey Sound can be seen at **Figure 2**.

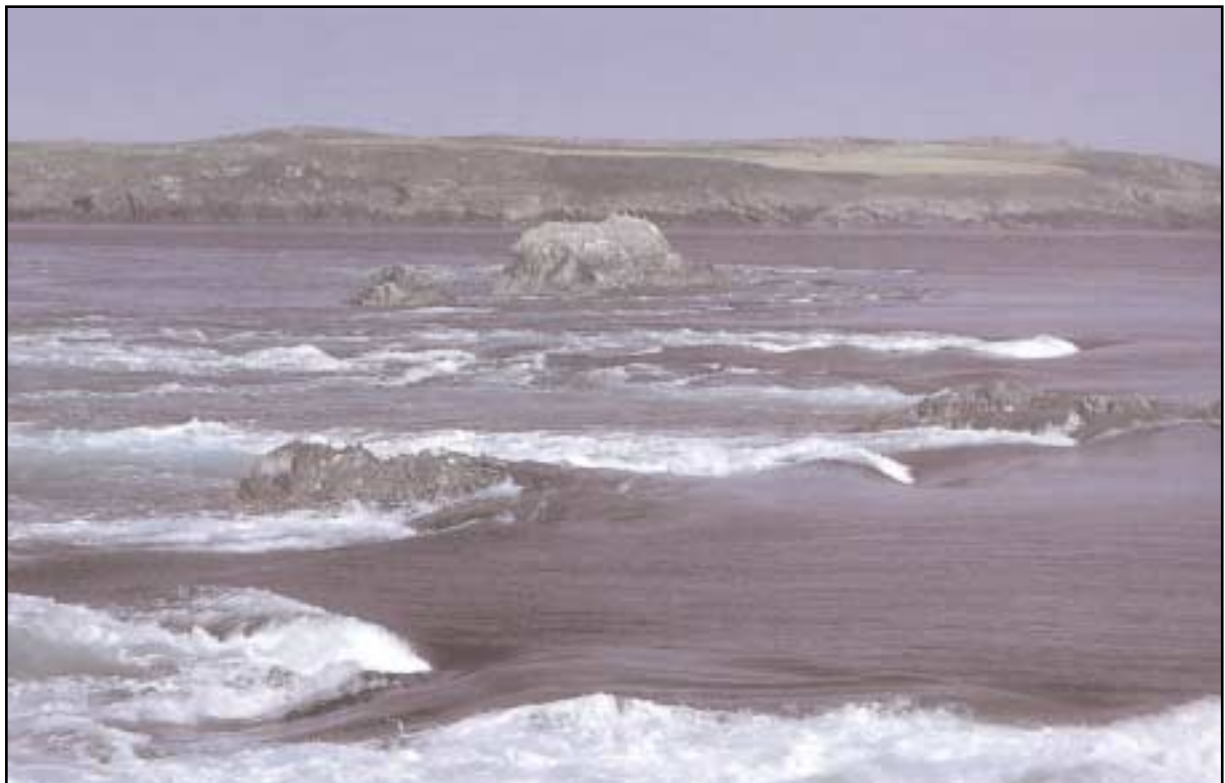
Figure 3

The Bitches is a ledge of rocks extending 2 cables from the middle of the eastern side of Ramsey Island. A picture of The Bitches can be seen in **(Figure 3)**.

The Bitches
