Report on the investigation of
the collision between the
Irish registered cargo ship

Eastfern

Kinsale

Report No 18/2001

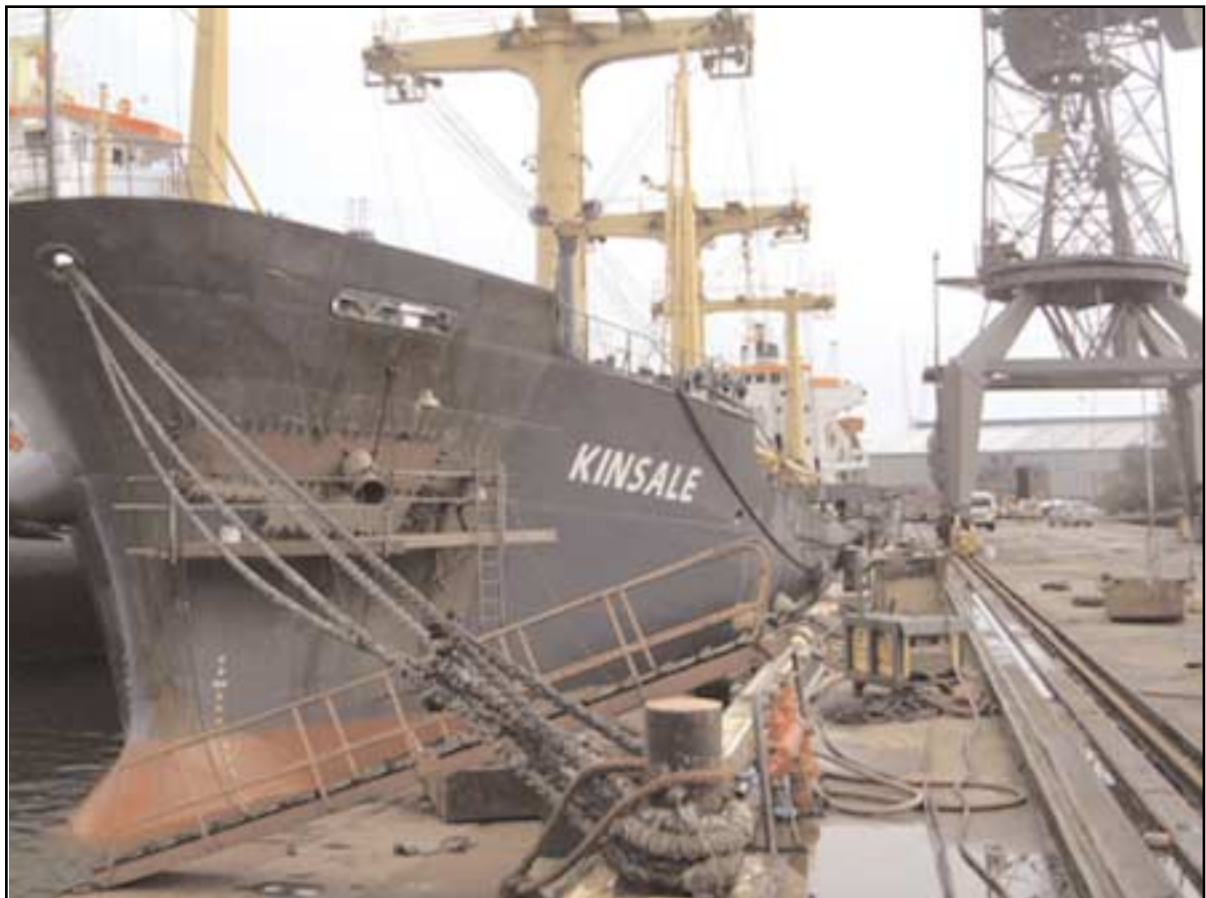
Kinsale undergoing repairs in the port of Rotterdam

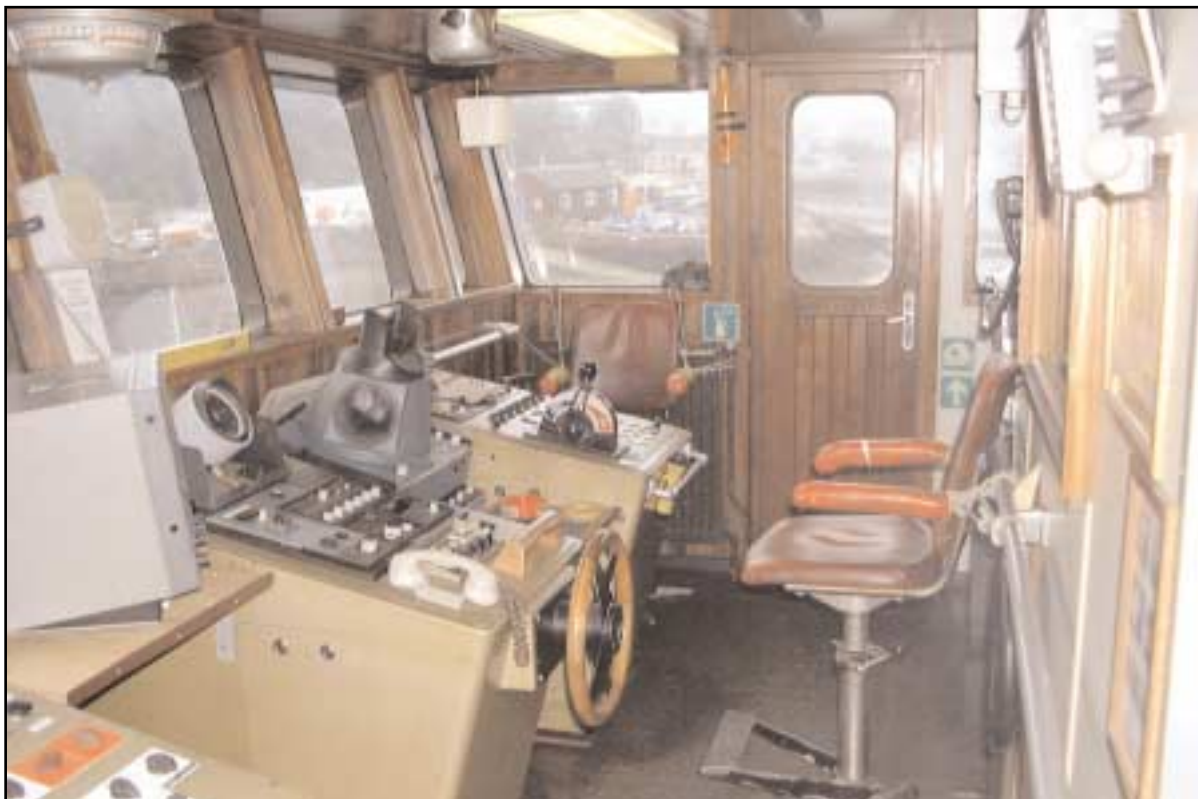
Directly behind the mate's chair was a chartroom, off which was a toilet and wash-basin. On the starboard side of the console the lookout was sitting on another chair, fixed so that it faced inboard and to port (**see photograph 3 overleaf**).

Eastfern's bridge

Ships travelling at a relatively slow speed are frequently approached from astern. It therefore becomes even more crucial to keep a good visual lookout astern, despite invariably being a stand-on vessel. This is also important when considering that the radar is reported to have had a shadow sector right astern, because the scanner was sited in front of the mainmast.

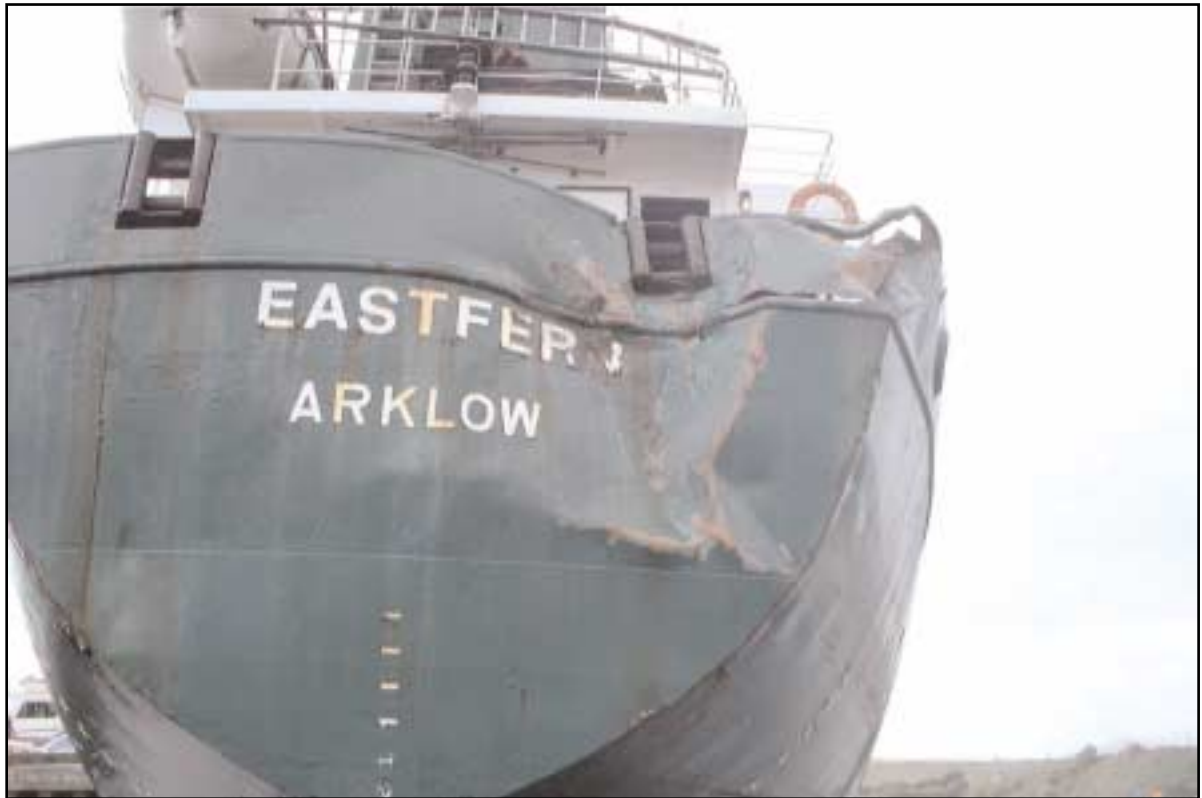
Photograph 4

There was a "V" shaped indent to the starboard side transom bulwark, extending down to just above the next deck. At the apex of the indentation, the bulwark was set in by about 1m, causing buckling of the poop deck back to the corner of the accommodation superstructure. The rails were bent at the after starboard side of the boat deck (**see photographs 4 and 5 opposite**).

A view of the damage to the stern

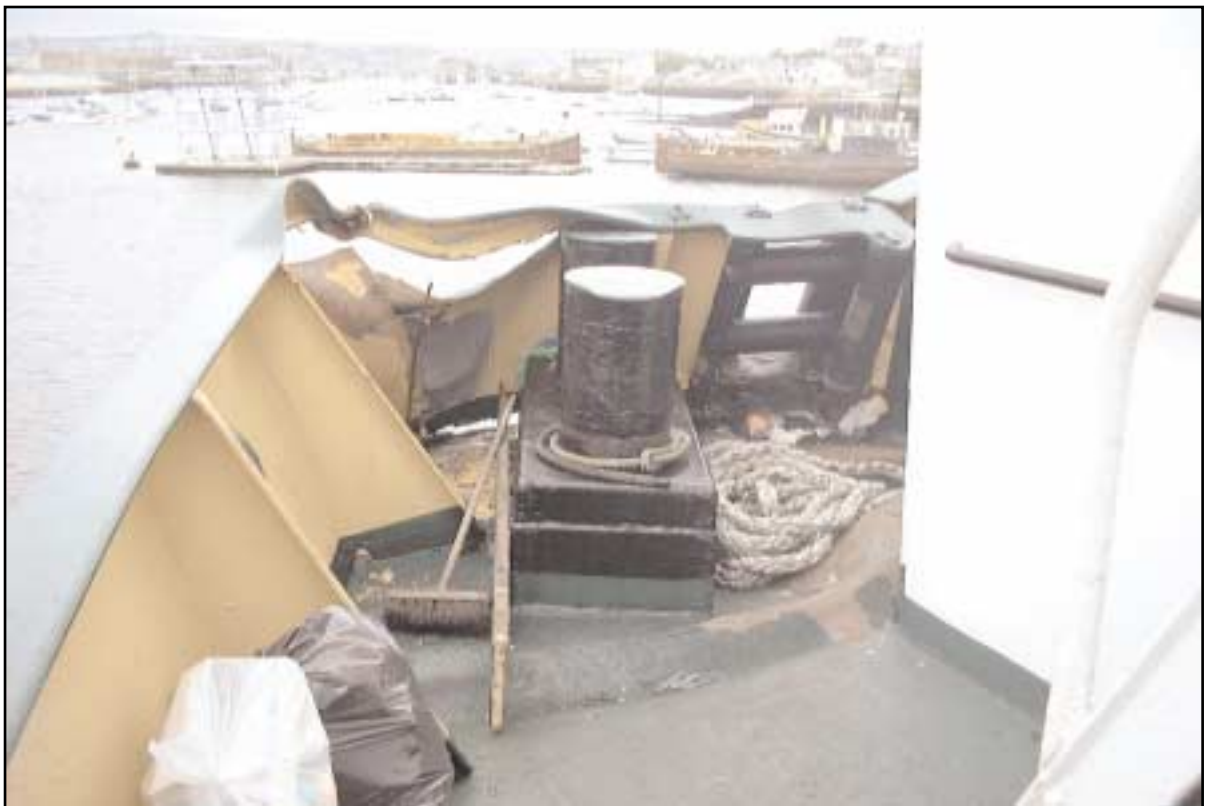
Photograph 5

Eastfern - A view of the damage of the starboard side of the poop deck

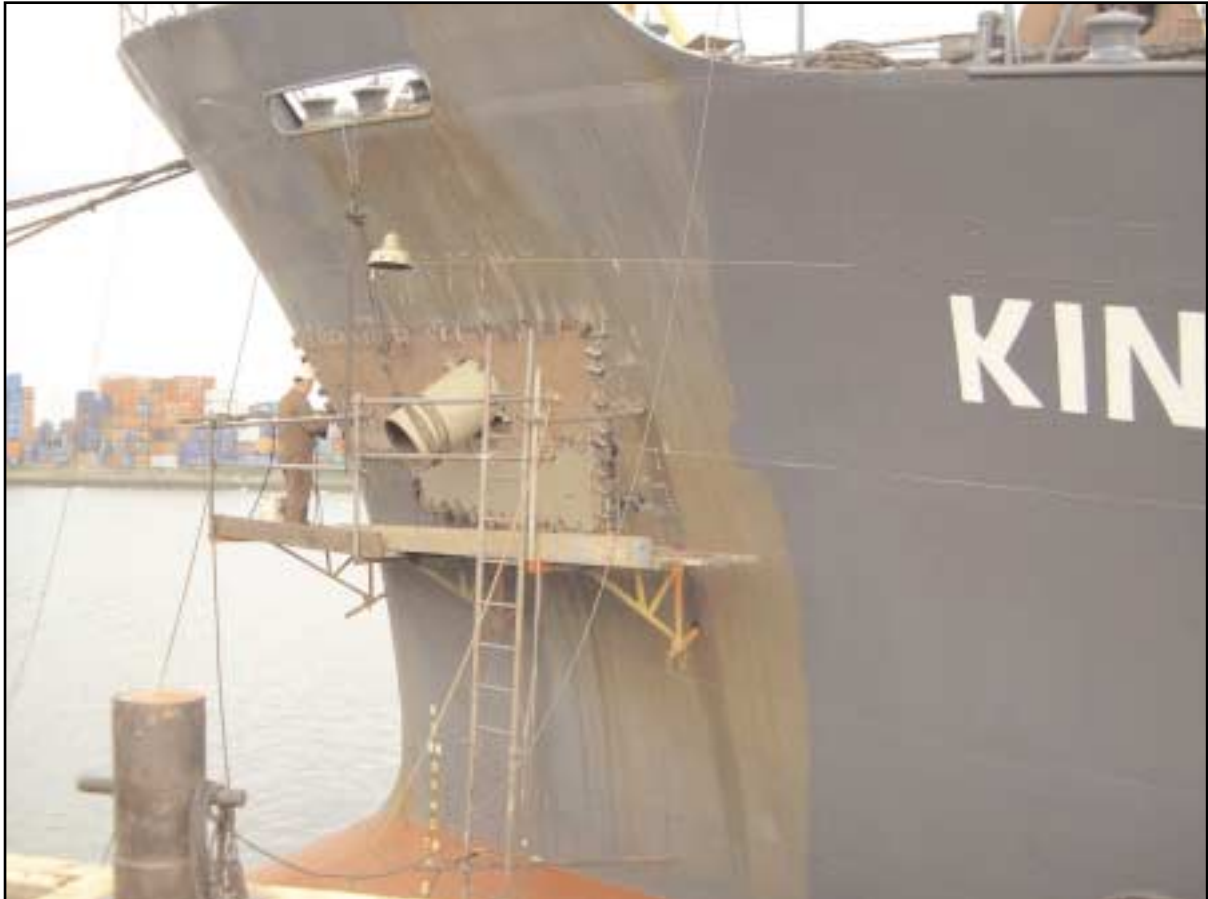
Photograph 6

There was a 2m long, 30 to 40cm wide, split in the hull, just forward of the port anchor, and well above the waterline (see photograph 6).

A view of the repair being carried out on *Kinsale*

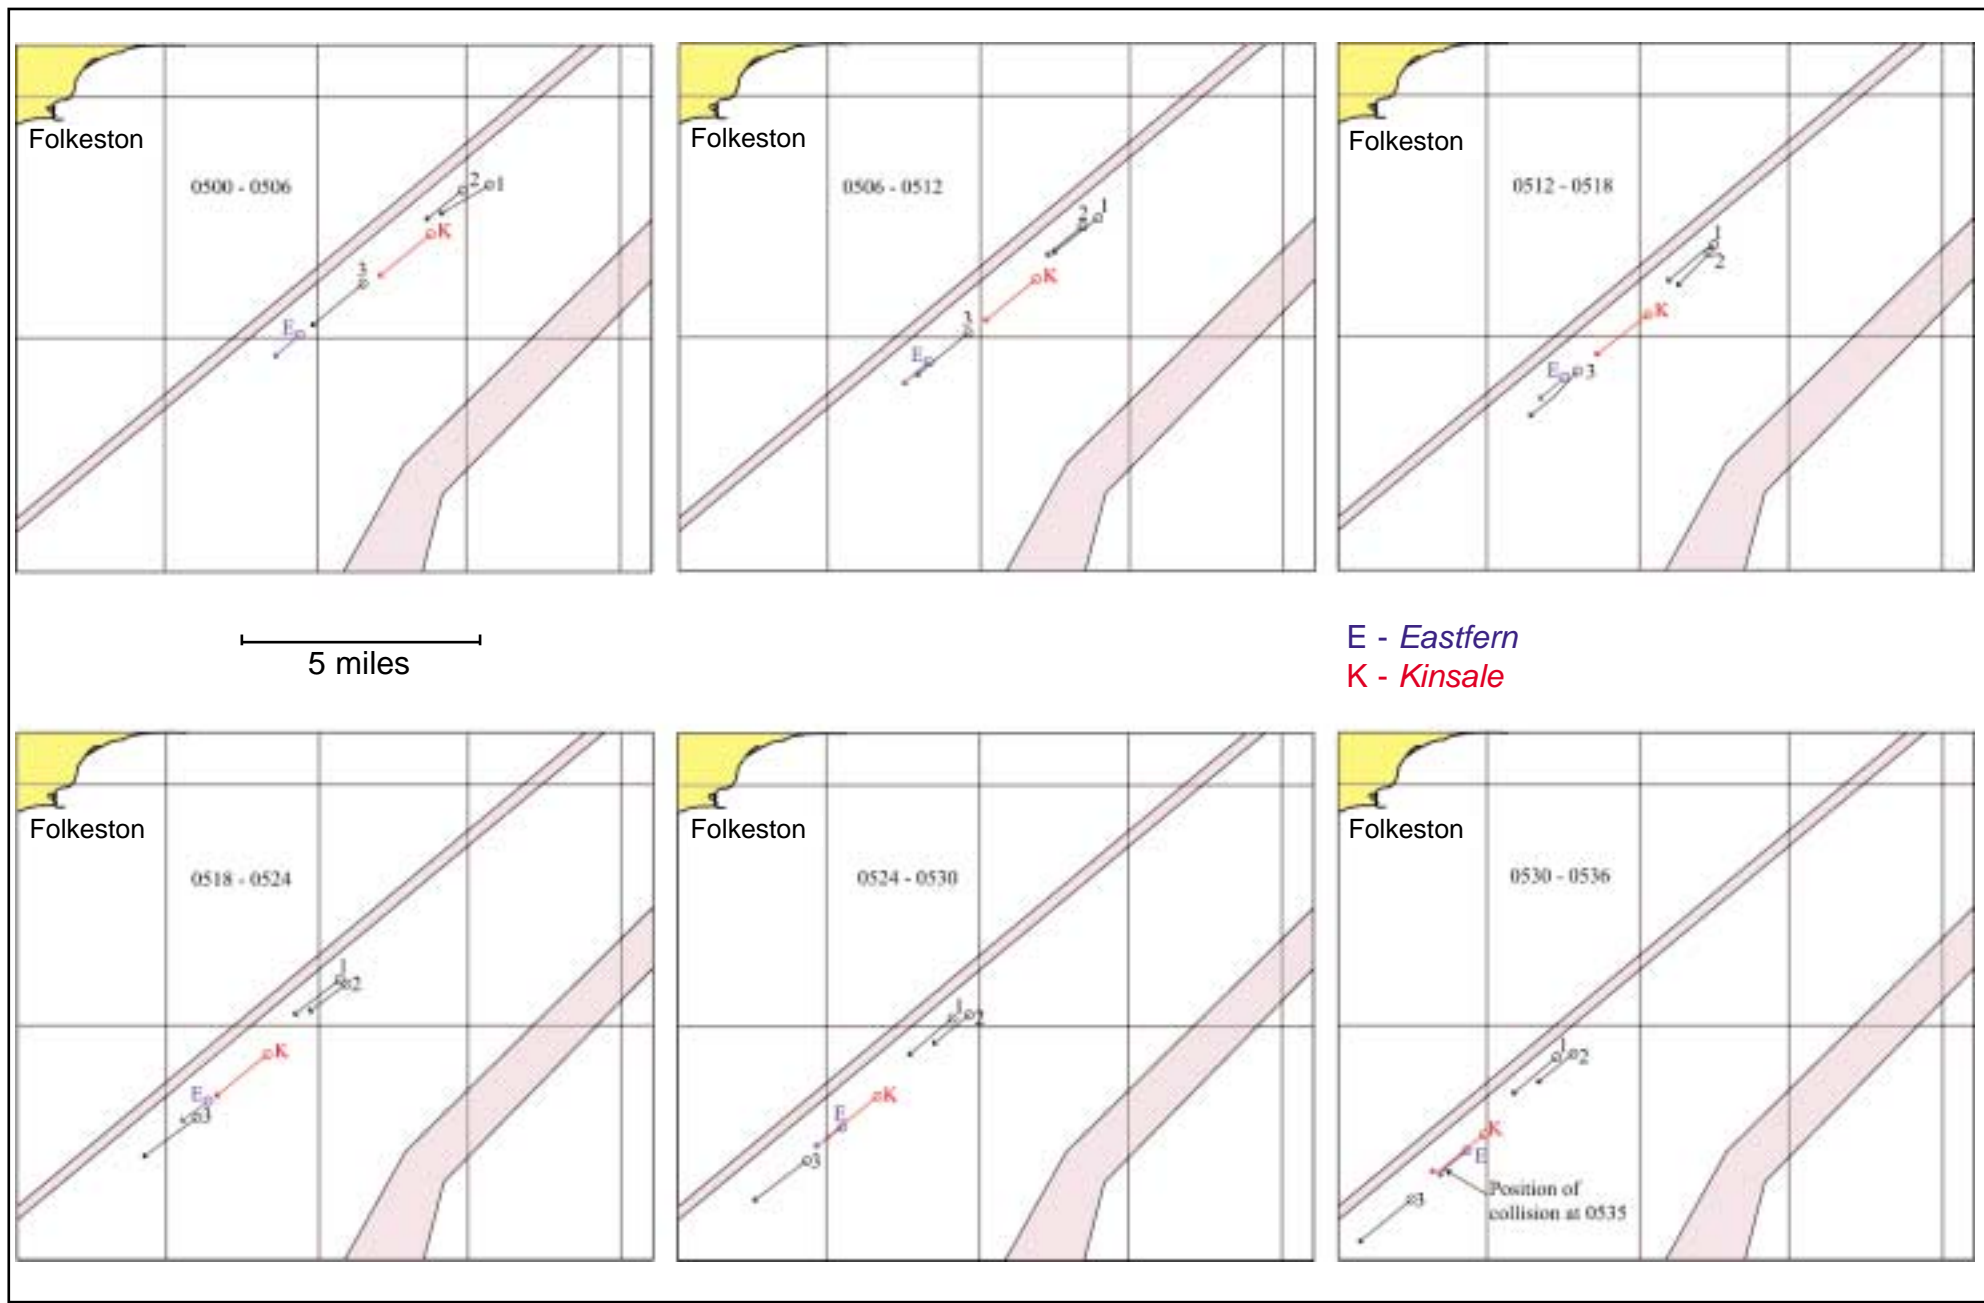
Vessels 1 and 2 did not play any part in the incident. *Vessel 3* was directly astern of *Eastfern* and overtaking. By 0512, she was 2.5 cables from her. Several minutes later she altered course to port to pass down *Eastfern's* port side by a distance of about 1.5 cables. By 0518, *Vessel 3* was about 3 cables on *Eastfern's* port bow and was steadily pulling away.

Dover Coastguard radar tracking plots showing collision sequence

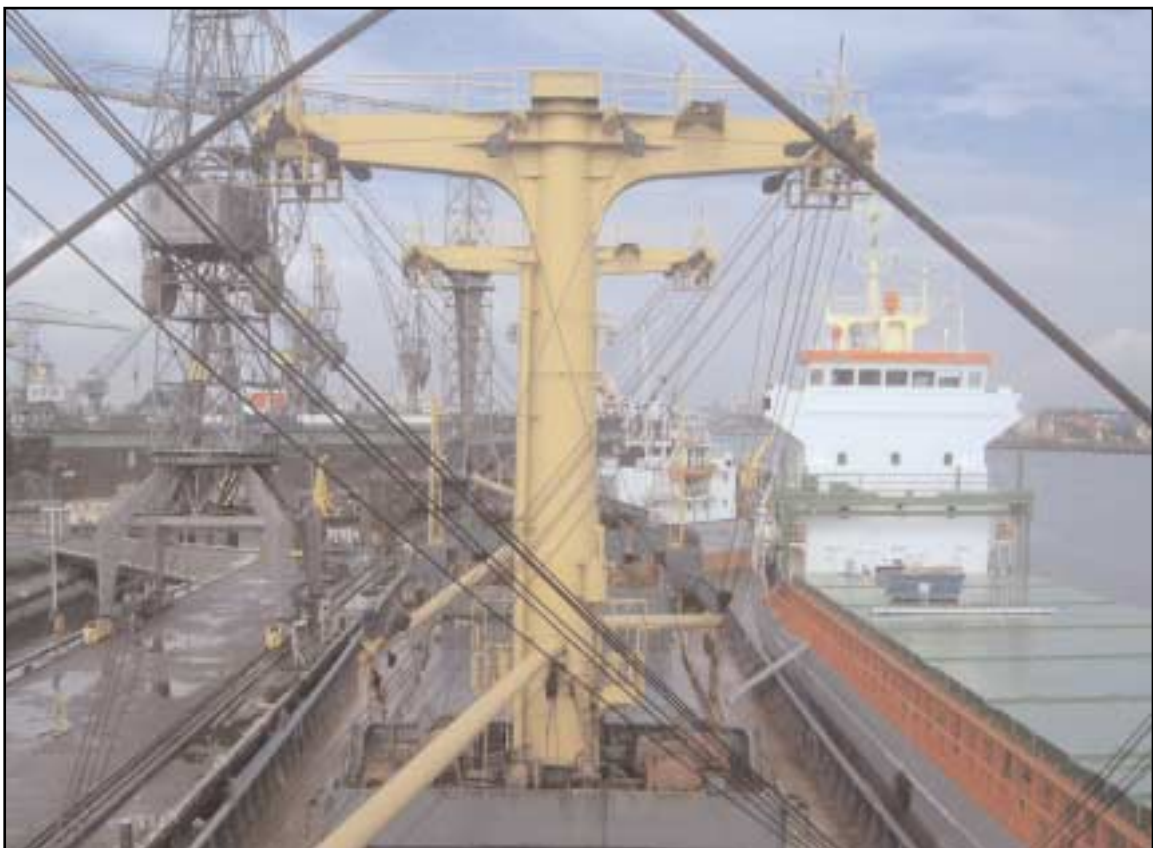
Photograph 7

At 0500, *Eastfern* and *Kinsale* were on slightly different but converging courses. On board *Kinsale*, the computer and the coffee making equipment were on the port side of the bridge. It is possible that on the occasions the chief officer looked forward from the port side, the forward cargo masts obscured *Eastfern*, which was very fine on his starboard bow (**see photograph 7 opposite**). However, *Eastfern* was crossing slowly from *Kinsale's* starboard to port bow.

At about 0524, *Eastfern* was right ahead of *Kinsale*. When the chief officer emerged from behind the curtain he saw *Eastfern* which, from his perspective on the port side of the bridge, had emerged from behind the mast on to the port bow. He tried to avoid the collision, but it was too late.

A view forward from *Kinsale's* bridge
