**Report on the investigation  
of three persons falling overboard  
from a rigid inflatable boat  
in the River Test  
during the Southampton International Boat Show  
on 22 September 2000  
with one fatality**

Marine Accident Investigation Branch  
First Floor, Carlton House  
Carlton Place  
Southampton  
SO15 2DZ

**Report No 28/2001  
August 2001**

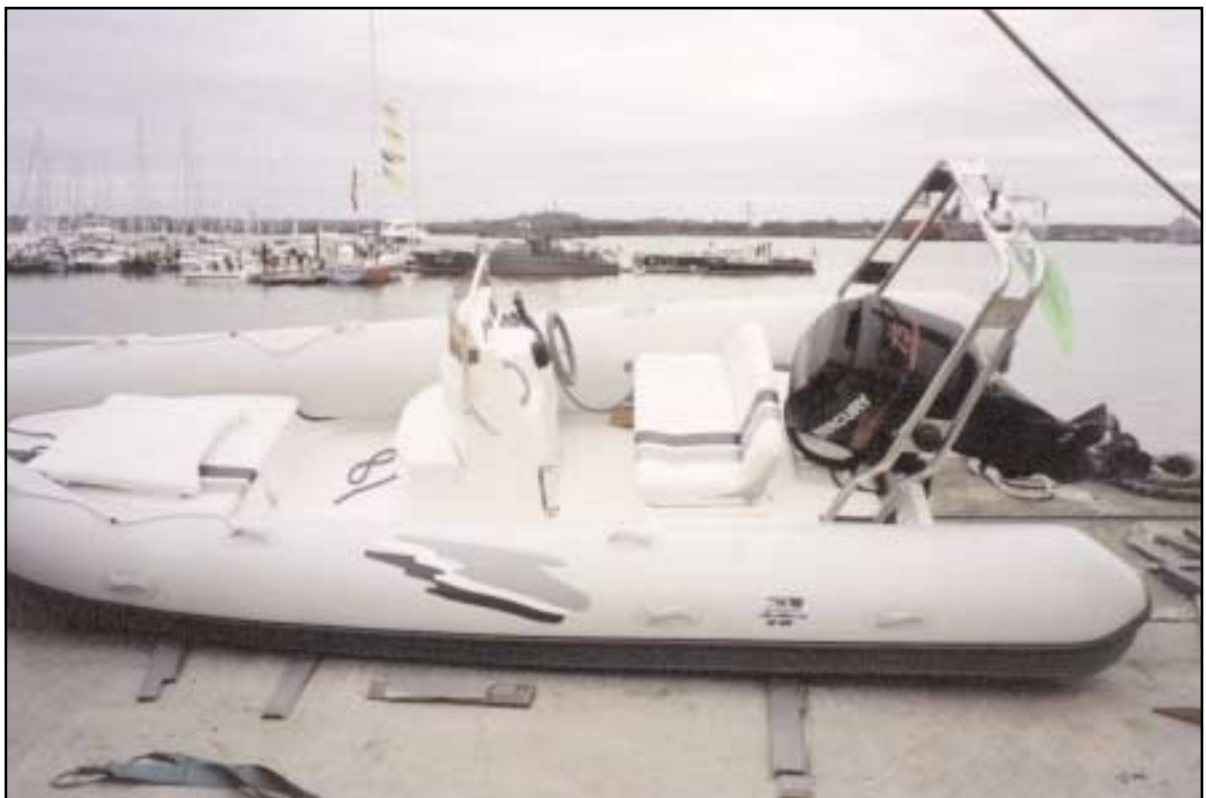
Figure 1

#### 1.4 GENERAL ARRANGEMENT OF THE ARIMAR RIB (Figure 1)

The Arimar RIB is a rigid inflatable boat, with a glass reinforced plastic (GRP) 'vee' hull with a five compartment pneumatic buoyancy tube all around, bar the stern.

Amidships is a control console with steering wheel, engine/gearbox controls, instruments and light switches. A metal grab rail, which passes over the top of the console, is secured on either side. A grab handle is at the left of the console, into which is built a small locker.

Just aft of this is a transverse bench seat for the helmsman and one other. The cushion is level with the top of the buoyancy tubes. Under the seat's cushion is a large locker space for loose gear. It also houses the battery and electric bilge pump.

Behind this seat is an 'A' frame carrying the navigation lights. This is fitted just forward of the transom on which is mounted the outboard engine, a 55kW (75hp) Mercury 4-stroke.

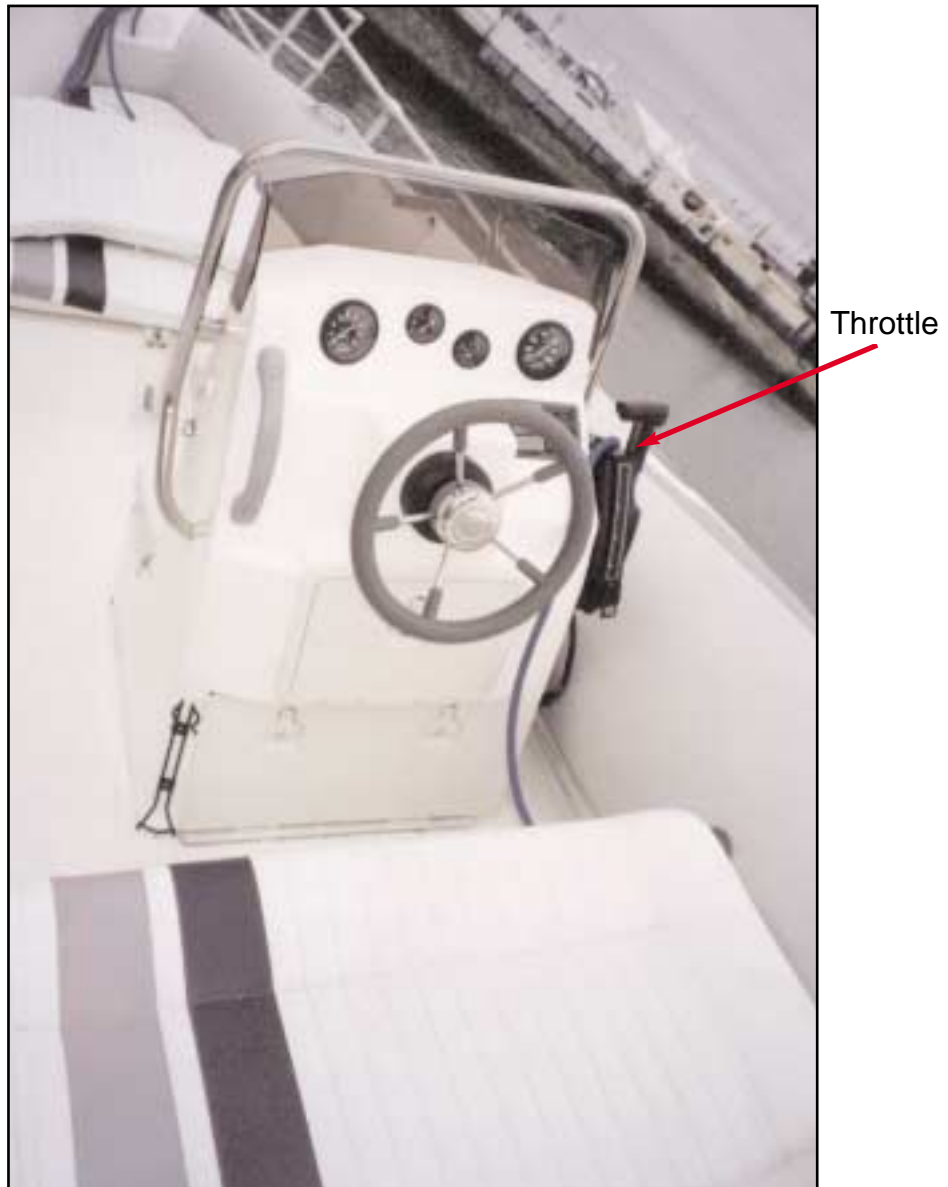
Figure 2

A brief initial inspection of the RIB was made after its recovery from the water to a quay, adjacent to the Southampton International Boat Show site, on the afternoon of the accident (**Figures 1 and 2**). The engine had already been fully tilted, and both the engine's kill-cord and ignition key had been removed. The engine/gearbox control lever was in the position corresponding to full ahead. No major hull damage was found at that time, but some damage was noticed on the tips of the propeller. A painter/bowline was secured forward.

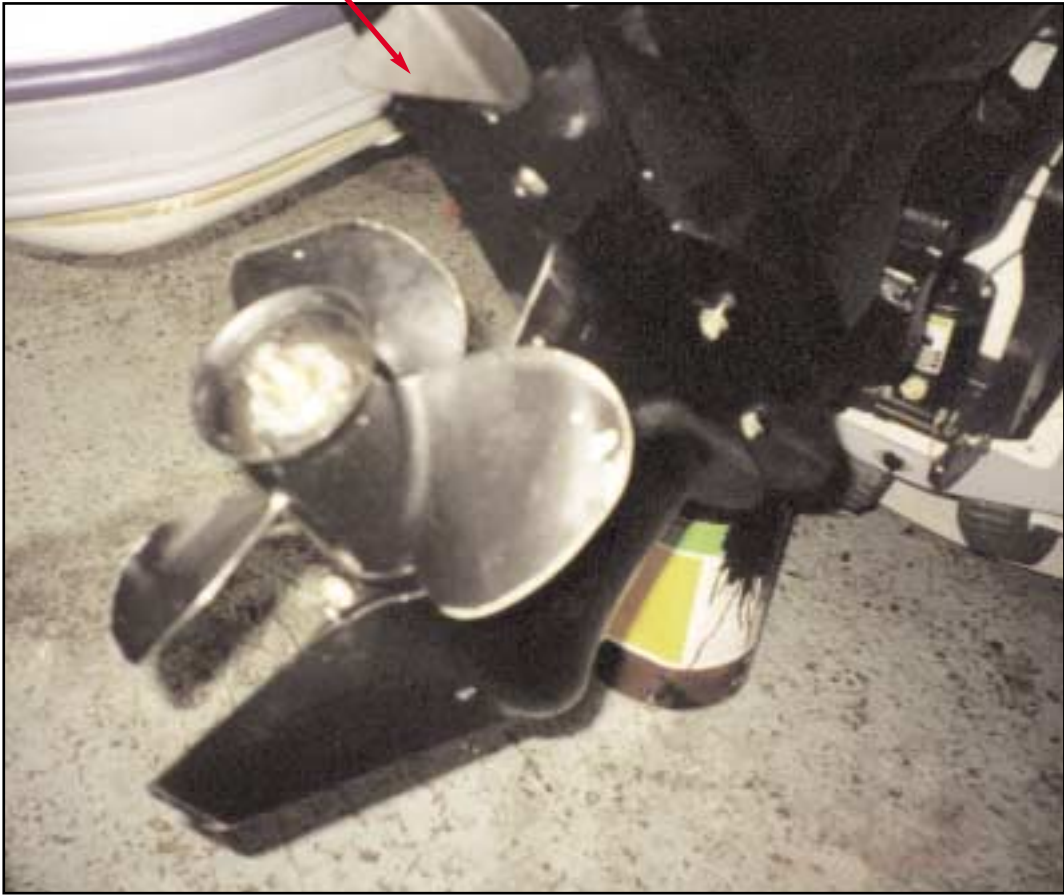
Figure 3

In addition to the propeller-tip damage recorded at the earlier inspection, it was noted that the engine's torque tab (see Section 2.9) was offset about 10° from straight-ahead, with its leading edge towards starboard (**Figure 3**). The torque tab showed no signs of damage, and was securely fitted.

Following the accident, the Mercury 75 engine on the RIB was found to have its torque tab set at 10° to starboard. This setting would be expected to generate a starboard transverse thrust on the engine. The force it generates would be added to any propeller-induced forces acting to starboard.

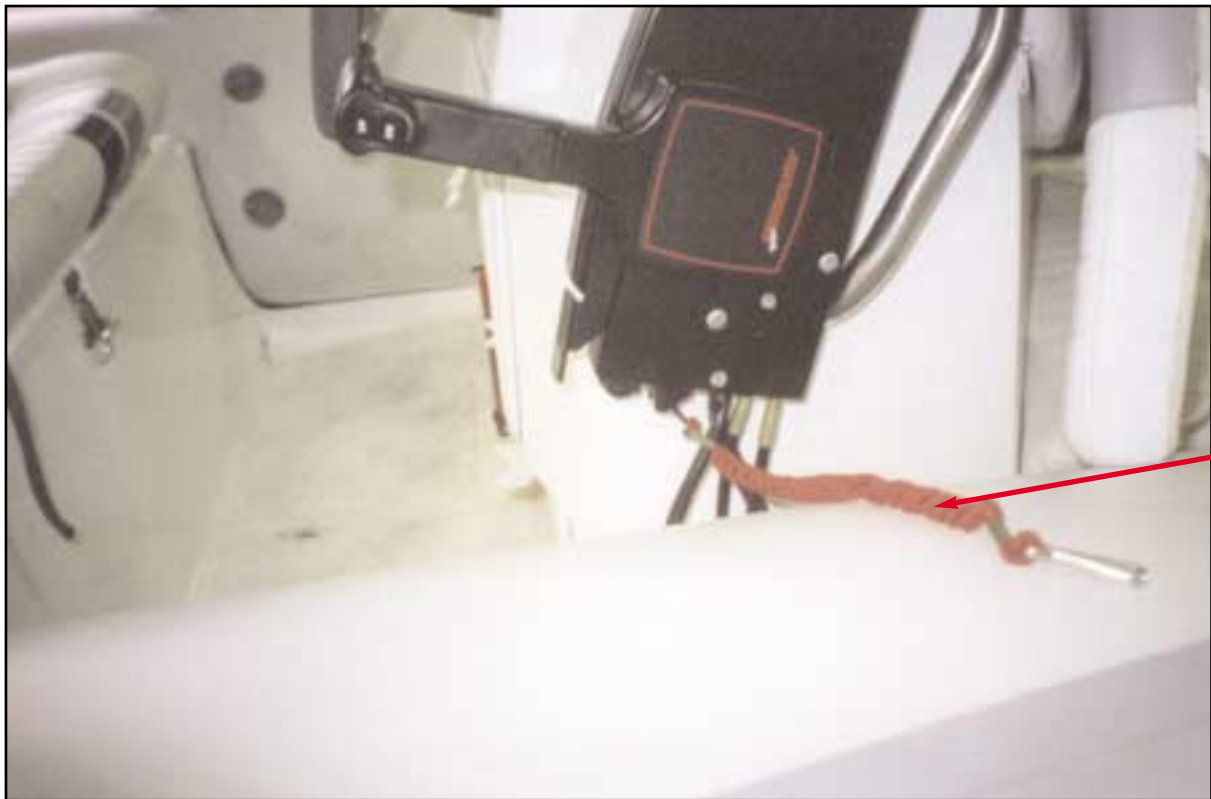
Figure 4

In addition to a key-operated ignition switch, on the lower edge of the control box there is a toggle switch which can shut off the engine (**Figure 4**). The plastic end-loop of an elastic cord can be passed over the toggle, which then retains it in place if it is switched to the 'engine run' position. A pull on the cord causes the toggle to move to the stop position, allowing the loop to fall clear. This cord is the safety device known as the 'kill-cord'. The toggle switch can be placed in the 'engine run' position without the cord's plastic end-loop being in place.

This kill-cord system was tested and, mechanically, found to function as intended. The switch was not tested electrically. However, it was reported to have been tested immediately after the boat returned to the boat show marina, while the boat was still waterborne.

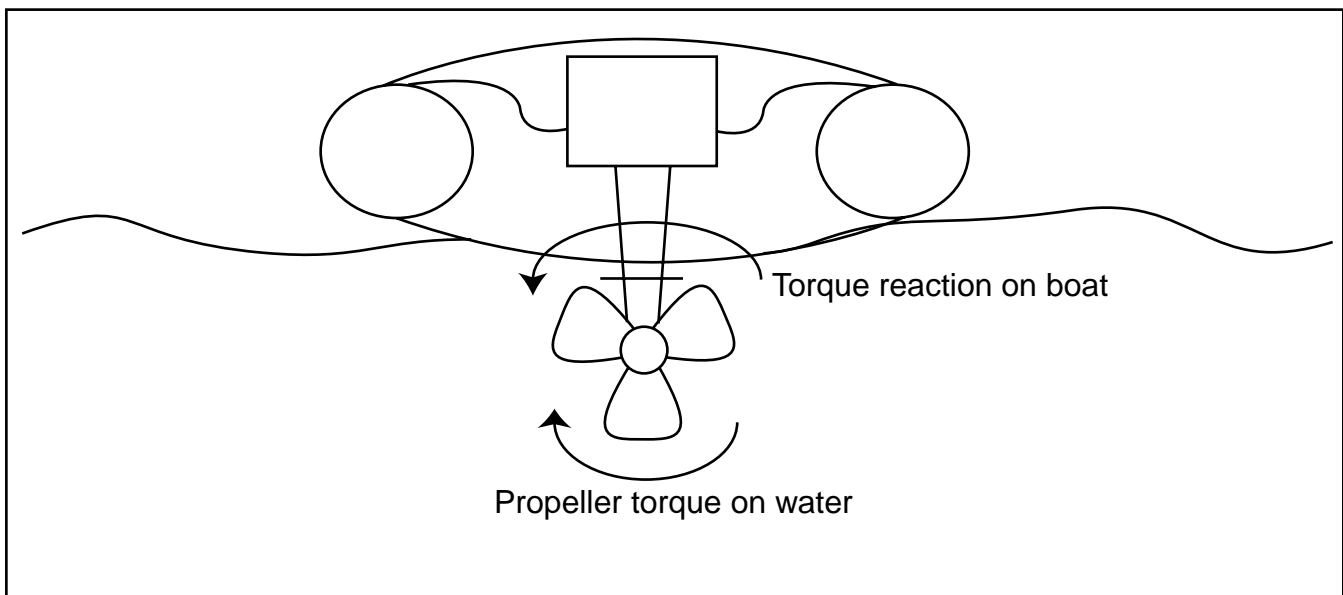
Figure 5

If uncorrected, the greater immersion of the boat's hull on the port side can result in increased drag on the port side, and a corresponding tendency for the boat to steer to port.

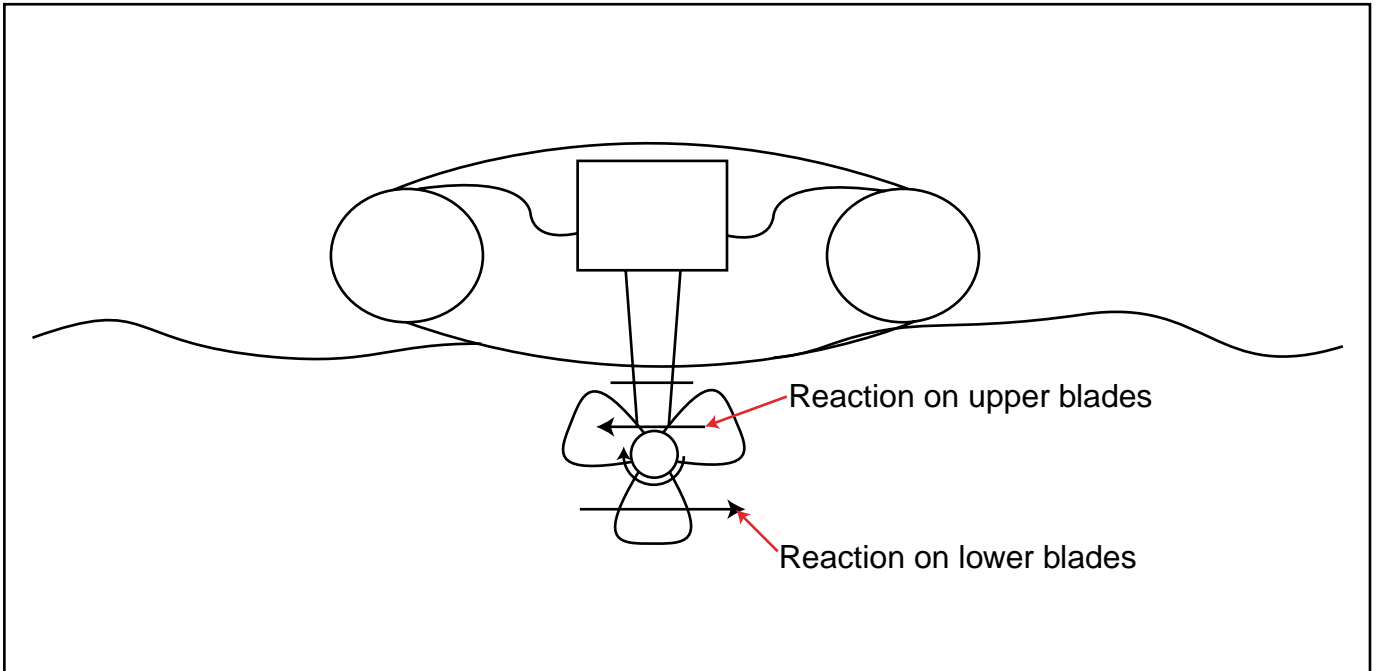
Figure 6

Thus, even when the propeller is fully immersed, the transverse force generated by the lower blades is not matched by that from the upper blades (**Figure 6**). The nett effect is that the propeller still attempts to move or 'walk' to starboard.

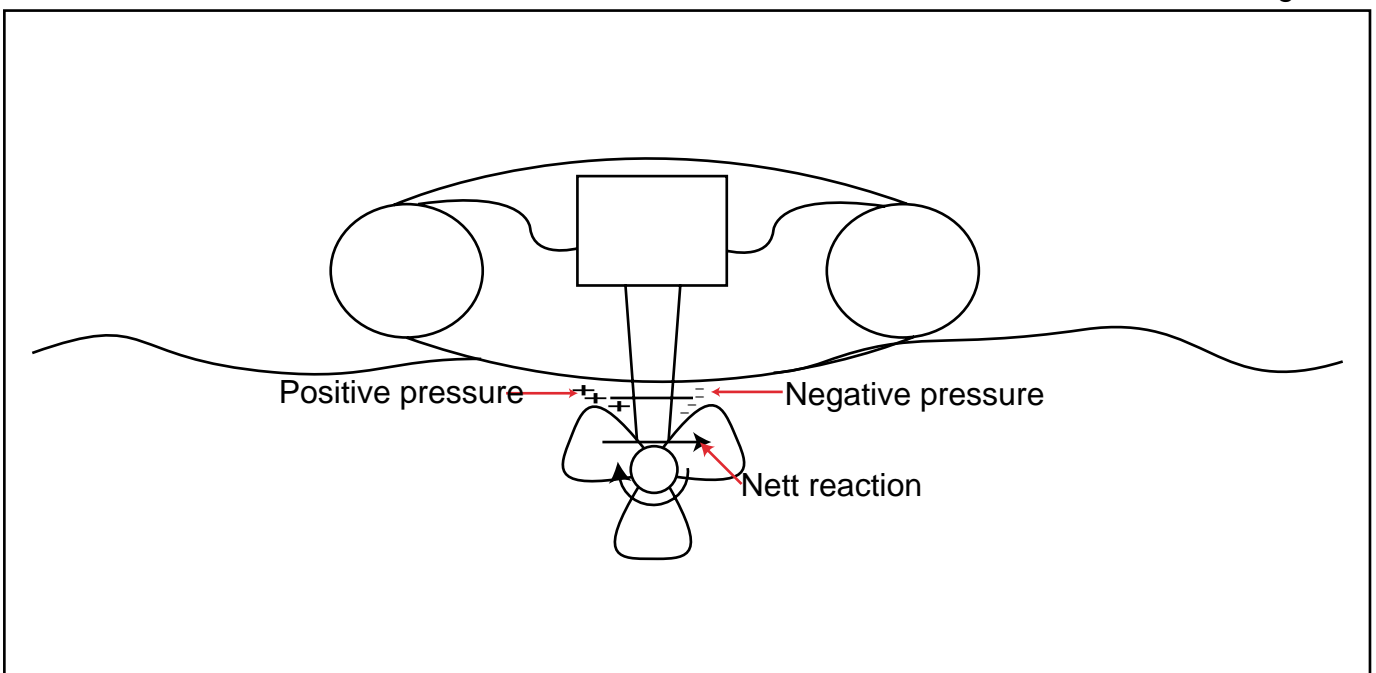
Figure 7

This effect may be in addition to the results of pressure differences acting on the engine's skeg, drive and gear casing (**Figure 7**). Both effects will, for a clockwise rotating propeller, tend to move the propeller and outboard engine to starboard.

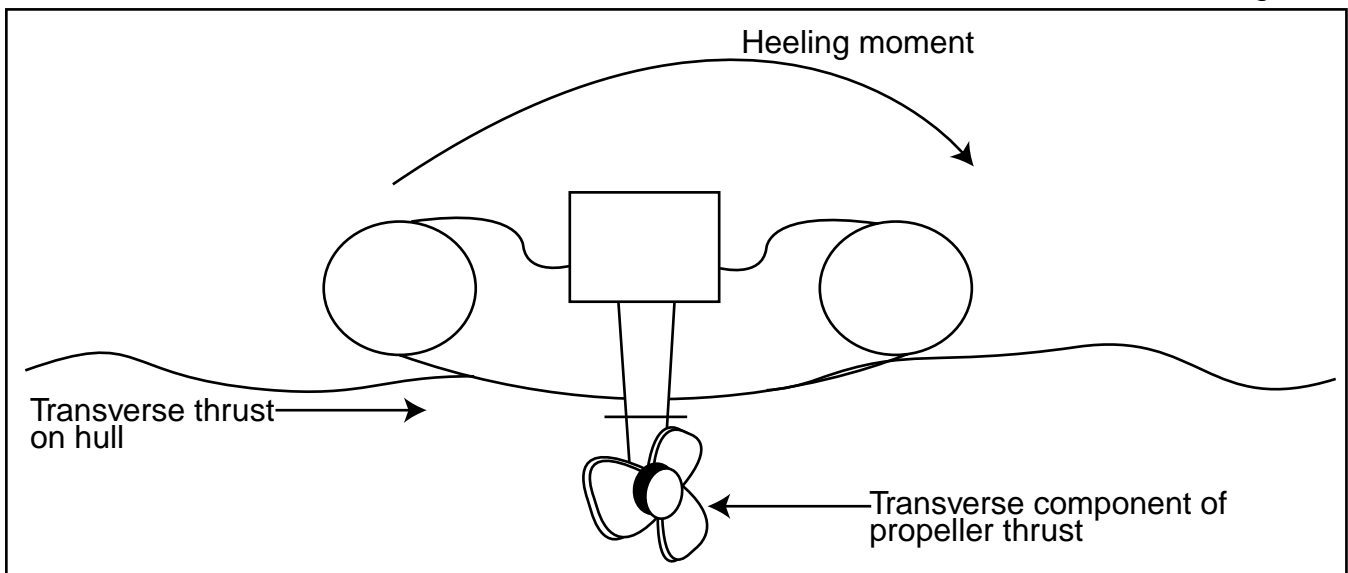
Figure 8

When turning to starboard, under power, the boat will heel to starboard, and vice versa.

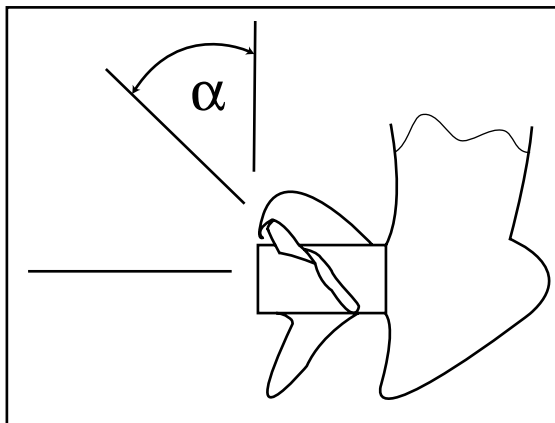
Figure 9a

Provided a propeller's axis of rotation is parallel with the surface of the water, there will be no significant offset of thrust in the horizontal plane. This will be a desirable condition if efficiency is important (**Figure 9a**).

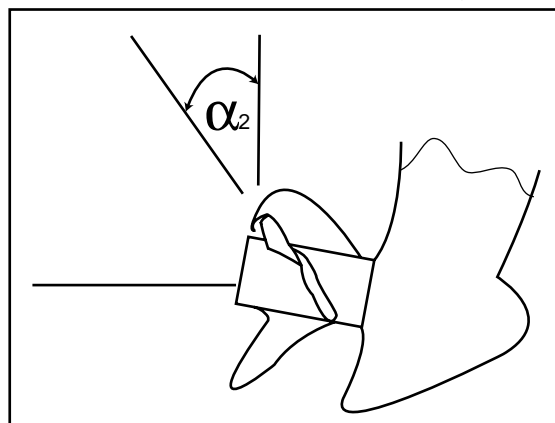
Figure 9c

With the engine and propeller trimmed out, and the propeller's axis sloping down from aft to forward, the effect is reversed and nett thrust is offset to port (**Figure 9c**).
