Report on the investigation
of the engine room fire on

RMS St Helena

25 August 2000

Report No 19/2001

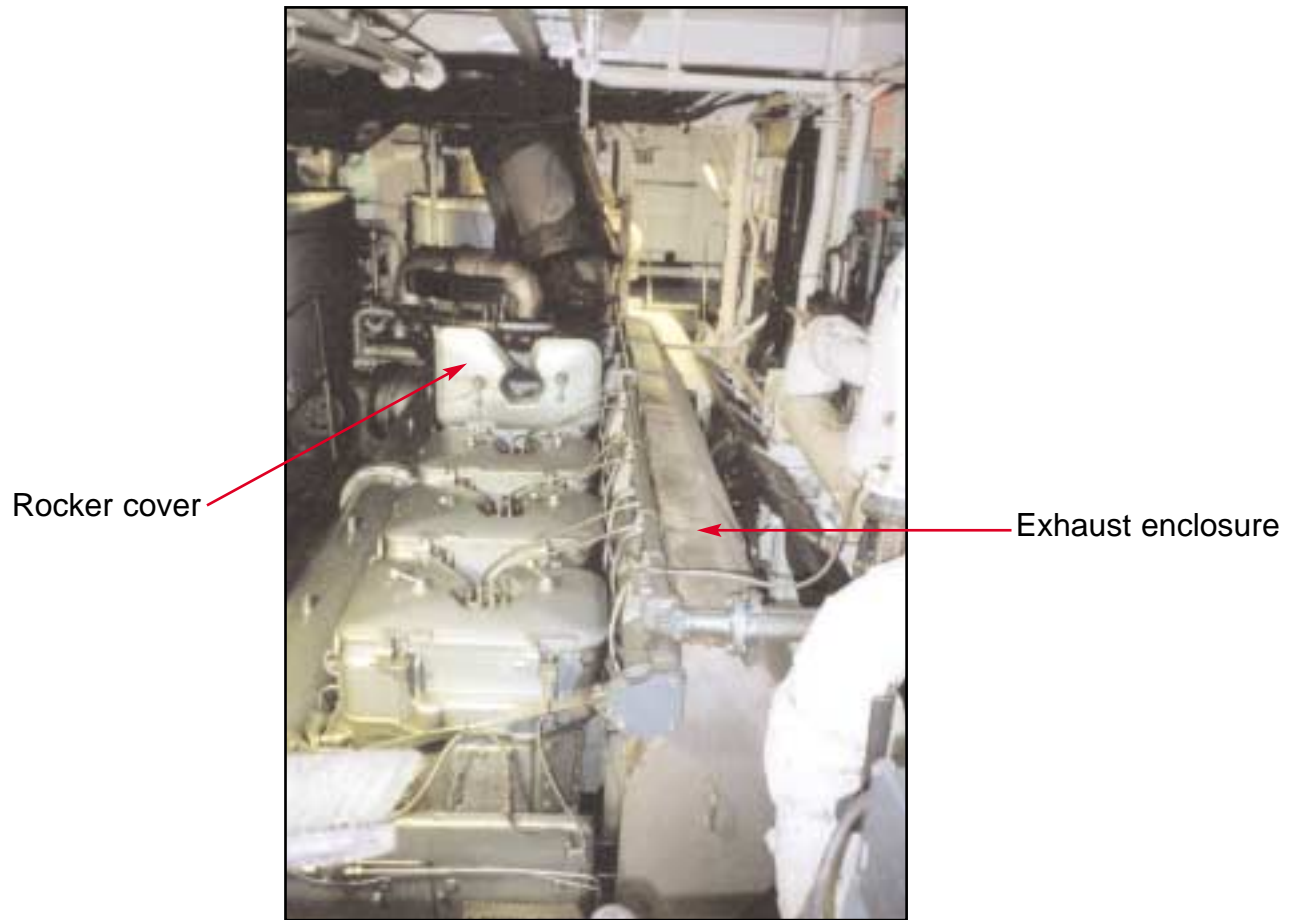
Figure 2

The third engineer slackened the securing screws on No 4 rocker box cover to ensure there was no overpressure. He then completely undid the screws and lifted the cover slightly, hingeing it about its aft edge. As he did so, a fan of oil sprayed from the rocker box on to the adjacent enclosure for the exhaust manifold, where it ignited.

Hinged covers enclose the valve rocker gear of the main engines. One cover per cylinder. The top of the enclosure of the exhaust manifold is level with the top of these rocker covers. The exhaust's enclosure consists of a series of metal covers which are not gas tight (**see Figure 2**).

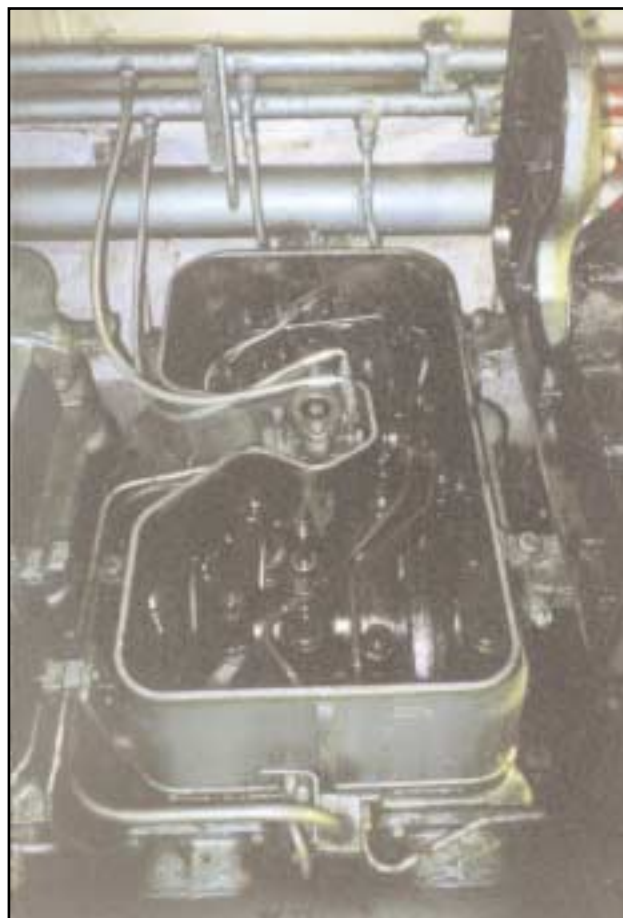
Figure 3

A leaking flexible lubricating oil pipe was found in No 4 rocker box. This was considered to have caused the oil to spray from the rocker box when the cover was lifted. After repairs, the engine was restarted and returned to service at 1405.

The fuel valves are positioned in a small cut-out area of the rocker boxes. Both these and the exhaust valves are liquid cooled. The coolant pipes for the exhaust valves pass into the rocker boxes and then to the valve cages by pipes which include short flexible sections. Some lengths of lubricating oil pipes within the rocker boxes are also flexible (**see Figure 3**).

Rocker box with cover raised

1. The fire was caused by oil issuing from a leaking flexible hose in No 4 rocker box of the starboard main engine, and igniting after making contact with the exhaust duct. [2.1]

2. Consider making it a requirement that, when the vessel is at sea, there is at least a second person present in the engine room during the opening of any enclosure from which flammable gas, vapour or liquid can escape.
