Report on the investigation of
the collision and subsequent foundering of
Global Mariner
at Matanzas, Orinoco River, Venezuela
on 2 August 2000

Marine Accident Investigation Branch
First Floor
Carlton House
Carlton Place
Southampton
United Kingdom
SO15 2DZ

**Report No 35/2002
November 2002**

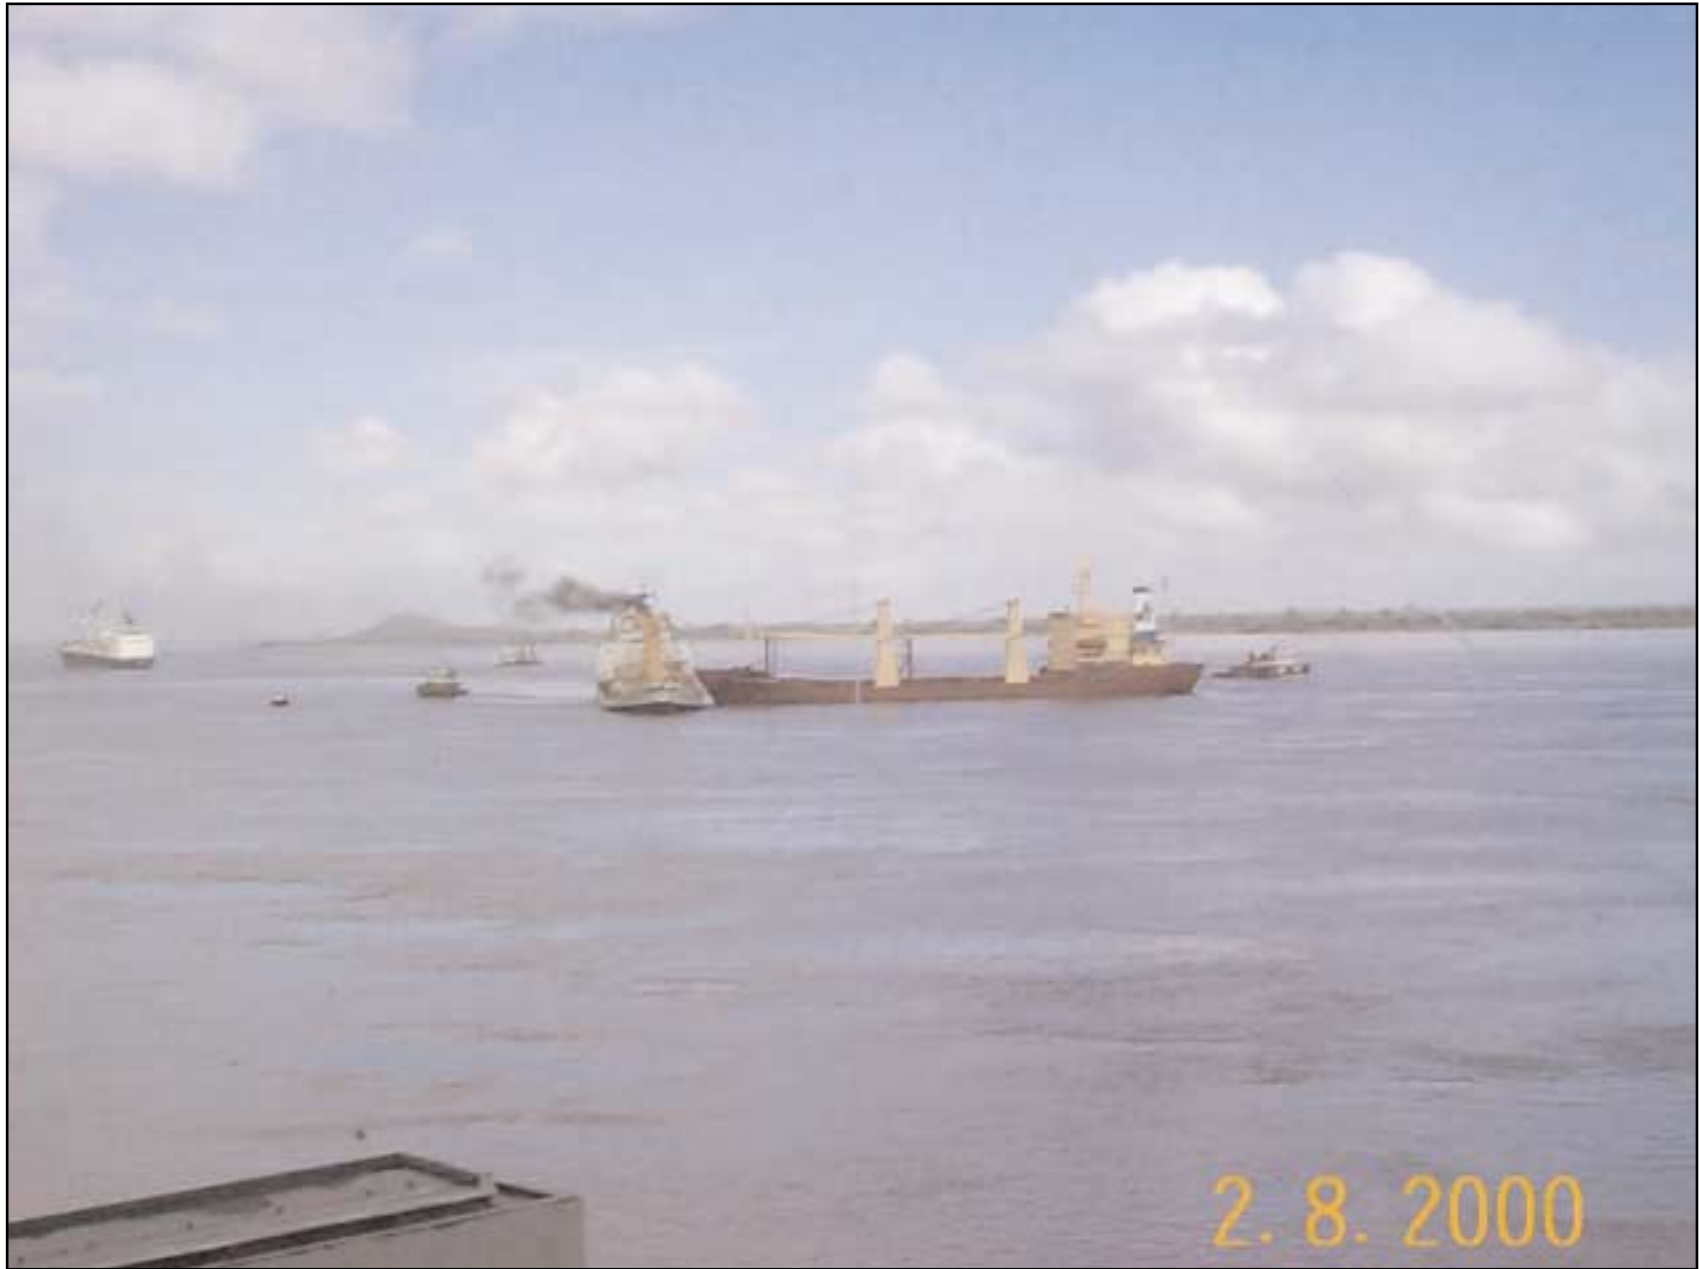
Figure 2

The master then moved to the port wing, and saw *Atlantic Crusader's* starboard anchor cable leading abeam on a short stay. A mixture of air and spray was seen emitting from No 1 and 2 hold vents; *Global Mariner* quickly trimmed by the head. She then turned to port and drifted downstream (**Figure 2**).

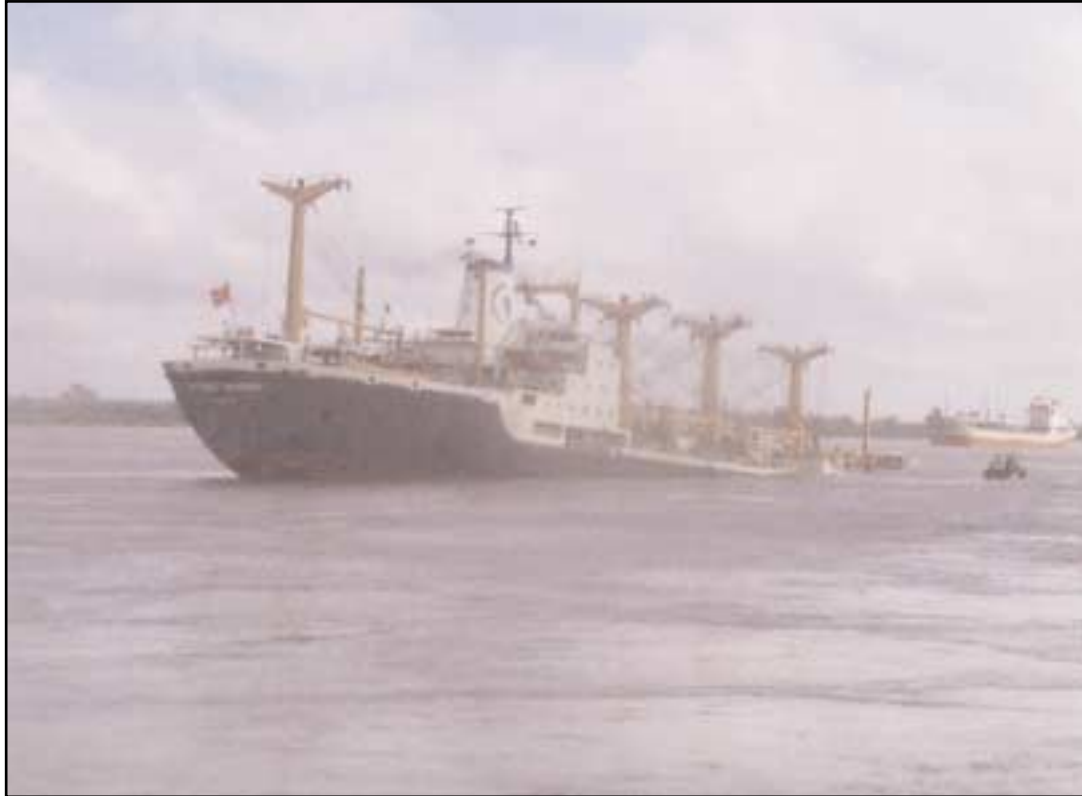
Figure 3

Flooding of *Global Mariner* following the collision

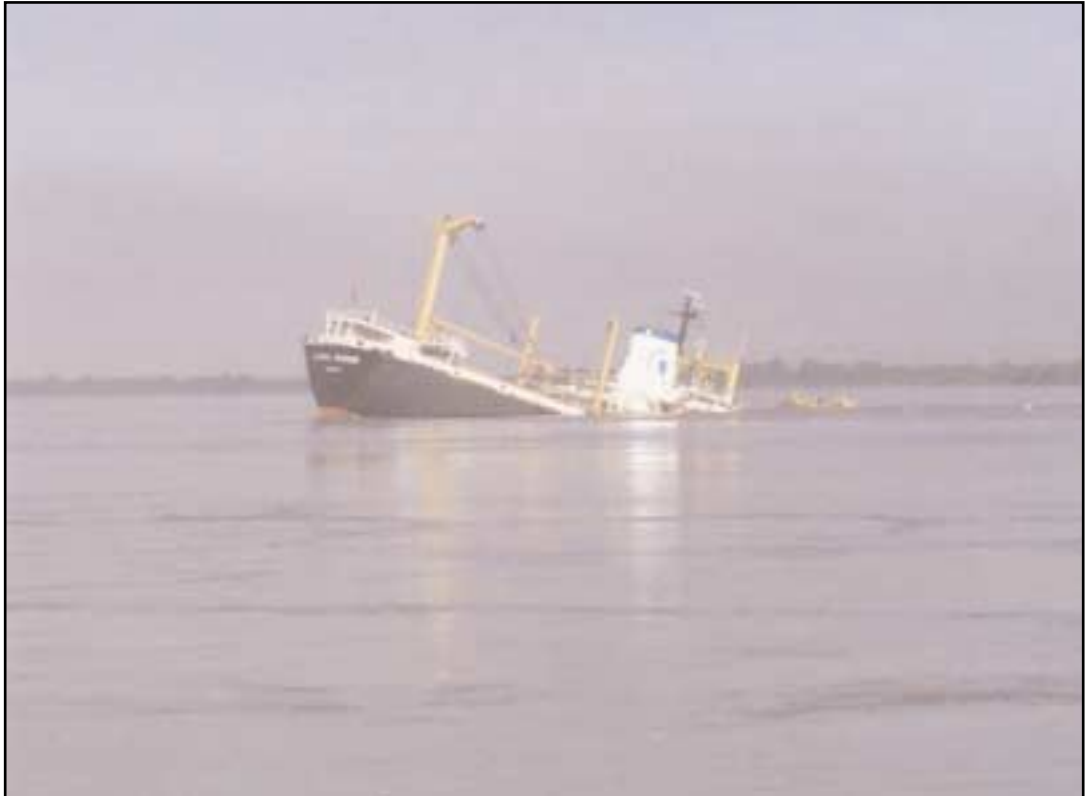
Figure 4

Global Mariner finally grounded on the south side of the river in position Latitude 08°18.2'N, Longitude 062°49.7'W.

Global Mariner aground following the accident

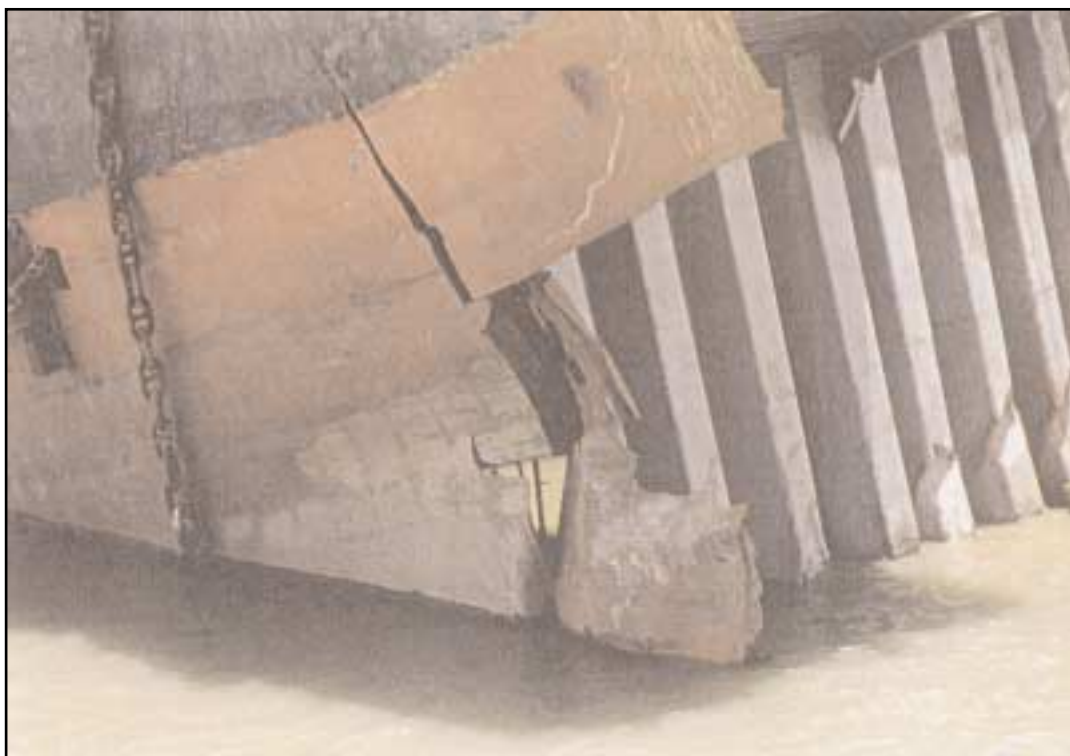
Figure 5

Atlantic Crusader's bulbous bow penetrated *Global Mariner's* hull on the port side, in way of the bulkhead between No 2 and 2A holds and, in her nearly fully loaded condition, the resulting damage to *Global Mariner* was sufficient to cause her to flood rapidly and founder.

Cut section showing bulb penetration and bulkhead between No 2 and 2a holds

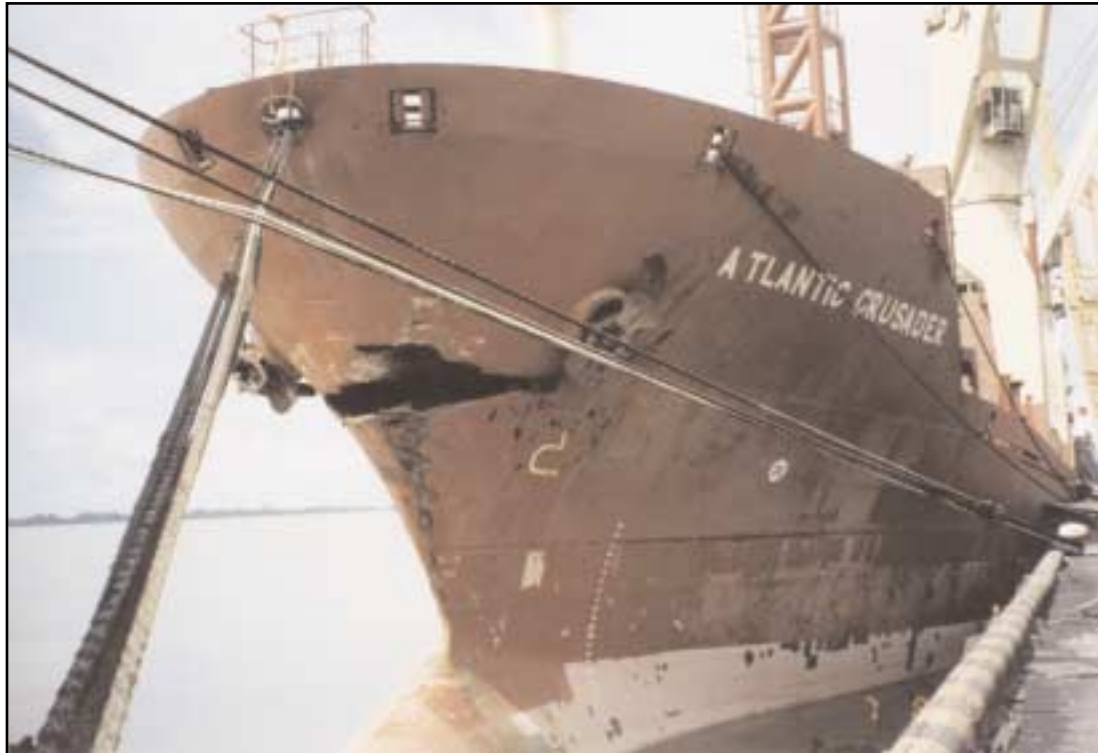
Figure 6

Atlantic Crusader's stem was penetrated in way of her forecastle store as a result of contact with the port side deck edge of *Global Mariner*. She incurred no apparent damage to her bulbous bow or other underwater areas.

Damage to stem of *Atlantic Crusader*

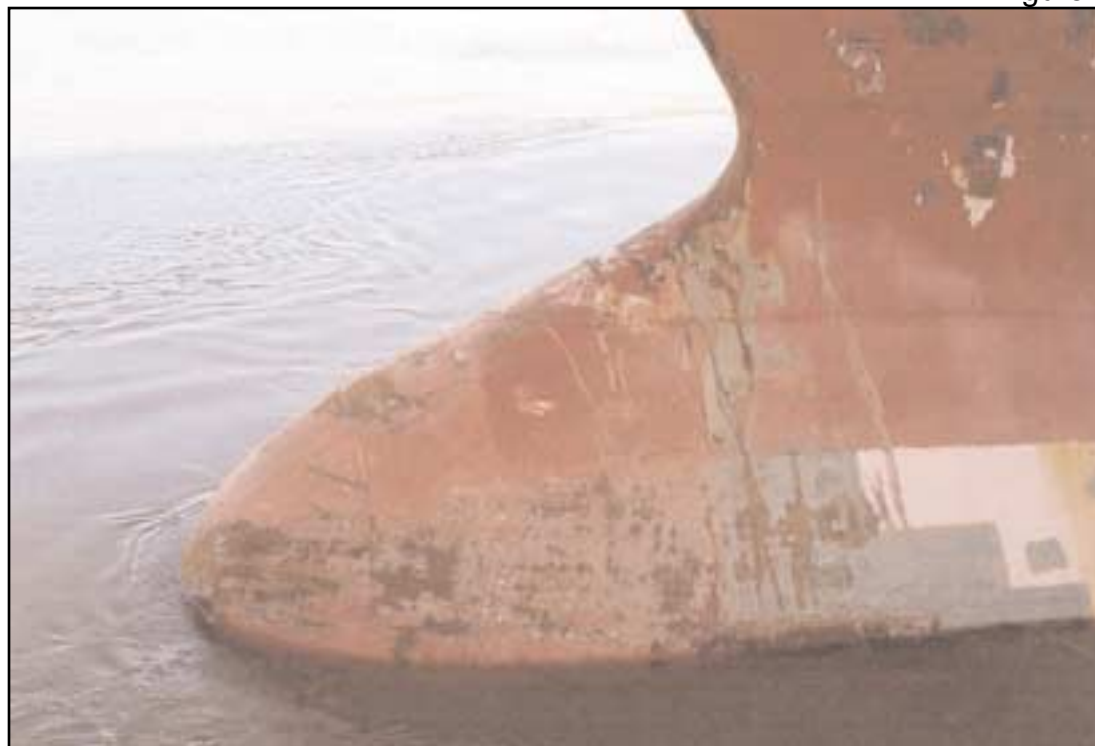
Figure 7

Bulbous bow of *Atlantic Crusader* after the incident

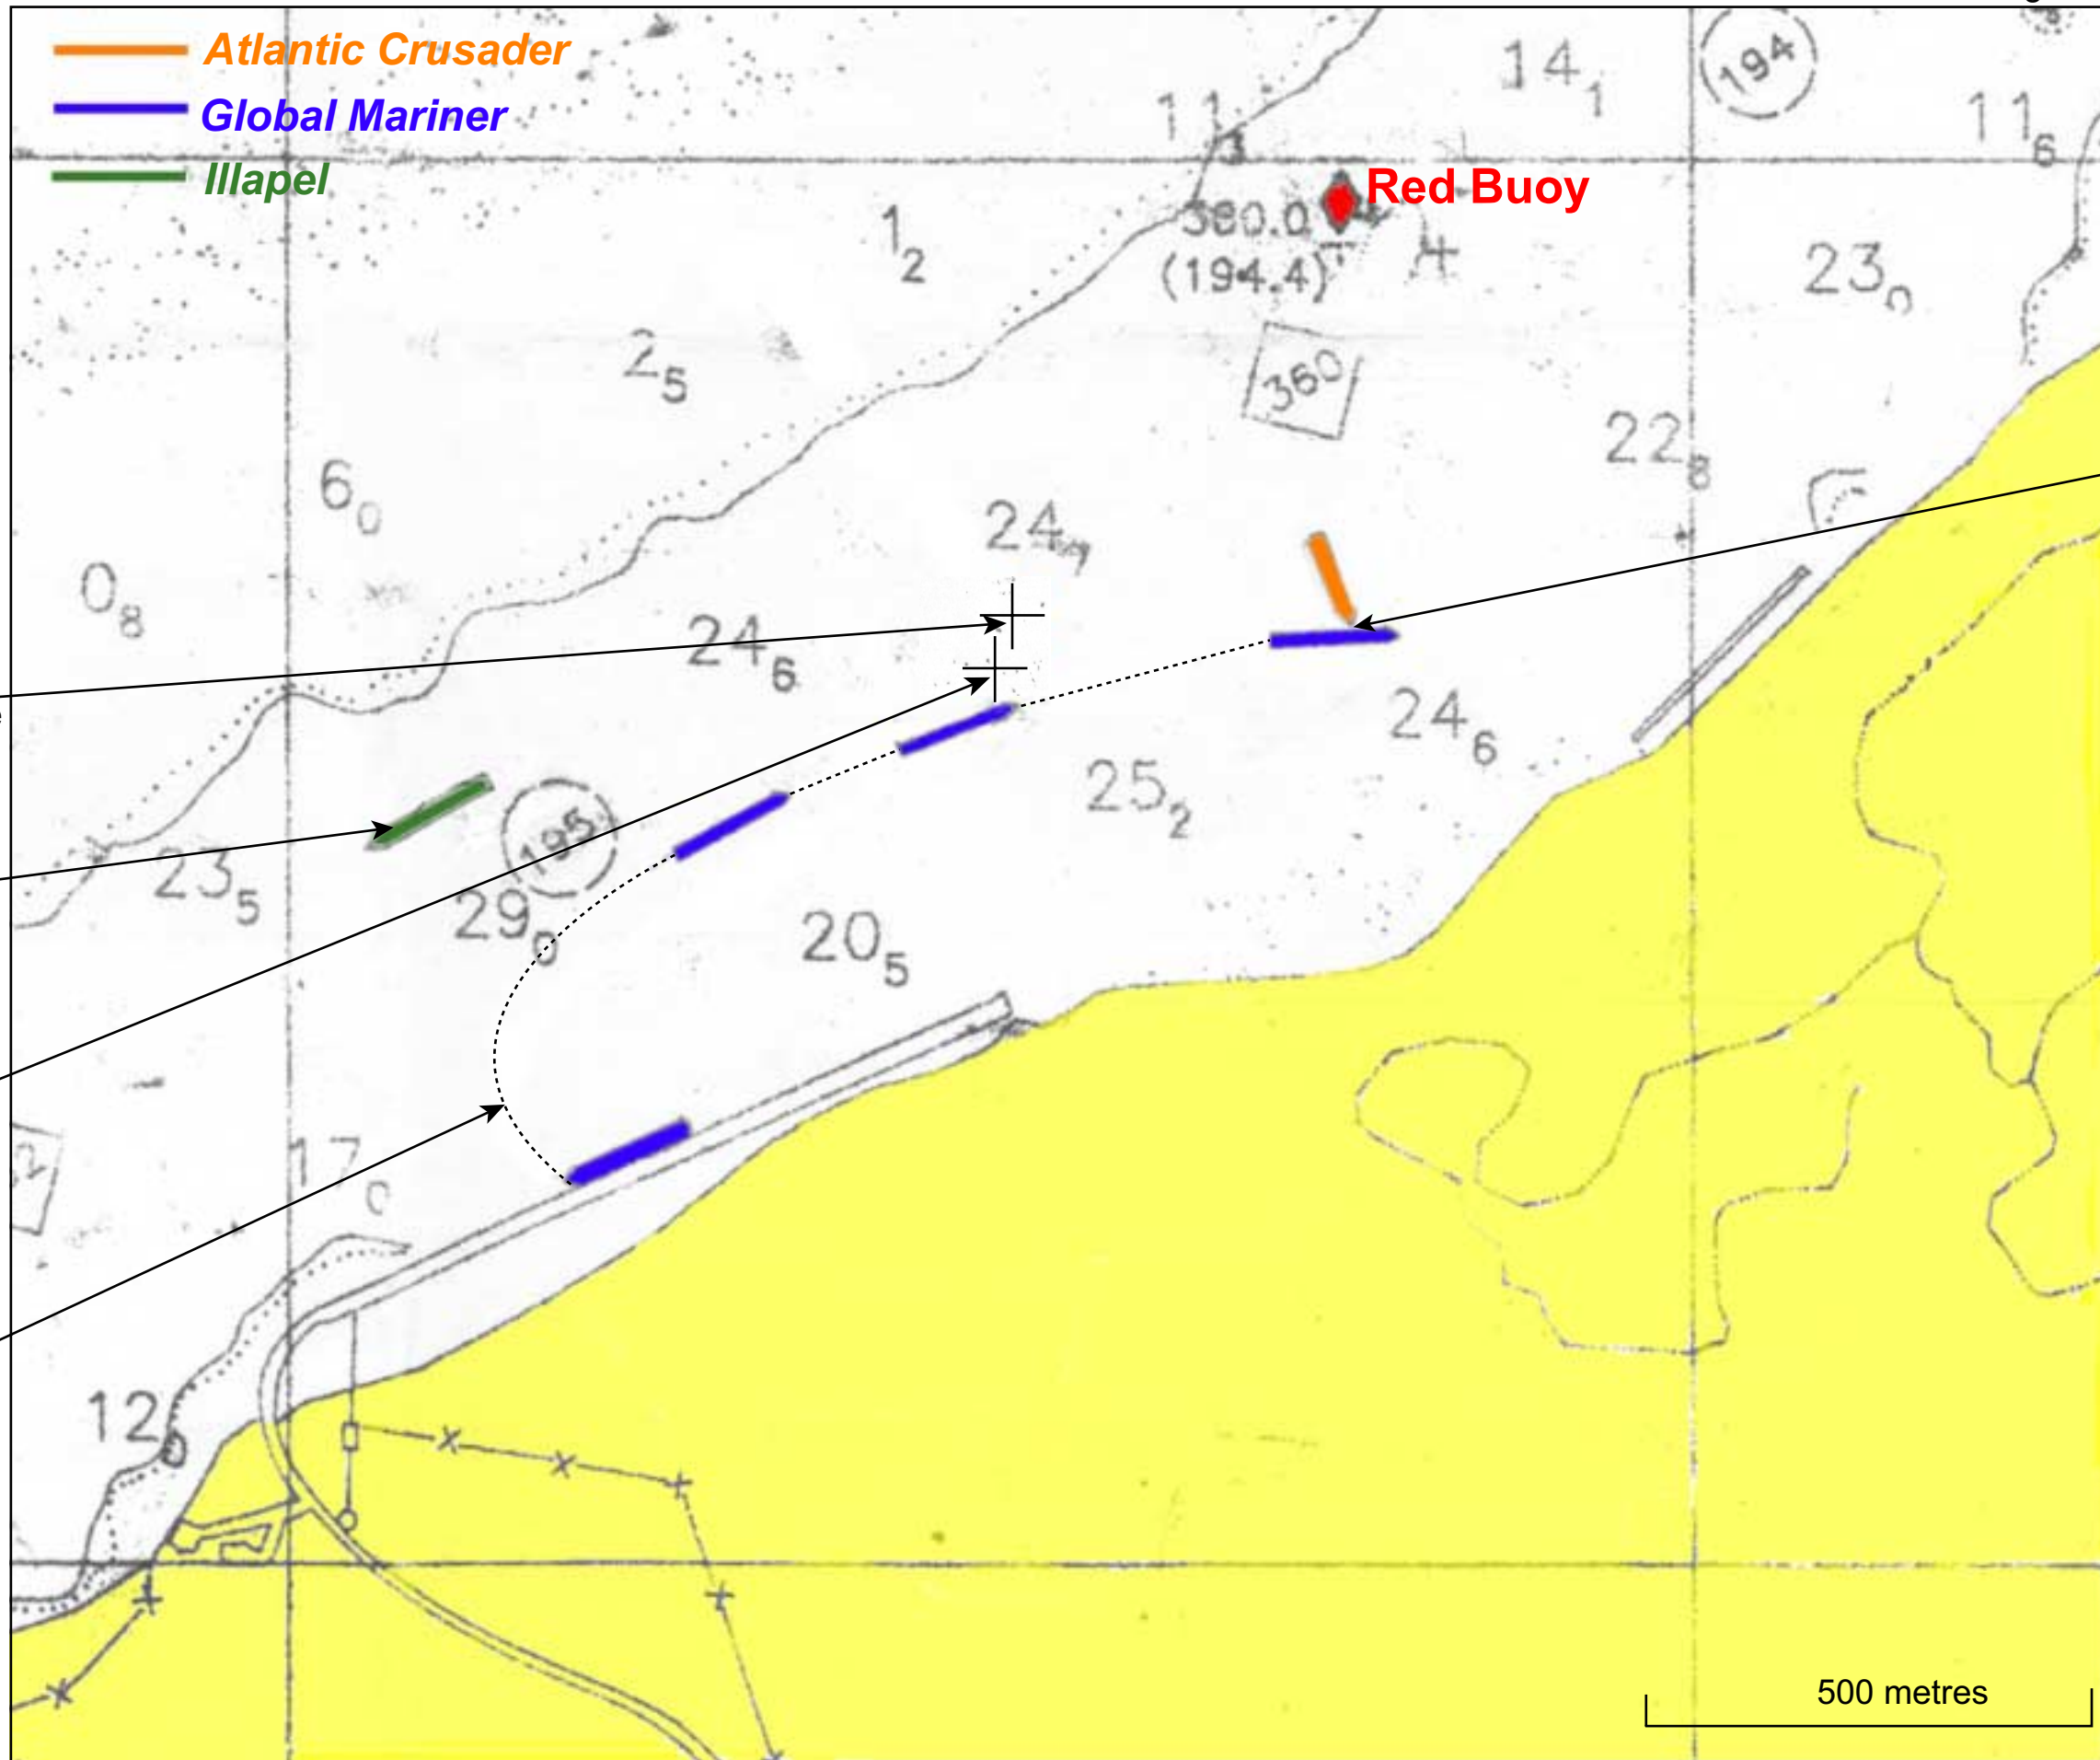
There is conflict between *Atlantic Crusader's* recorded anchorage position, her recorded collision position, and the collision position generally estimated by eyewitnesses. It is possible that the collision caused *Atlantic Crusader* to move from her anchorage position. Alternatively, she could have already started to drag her anchor before the collision, which is plausible given the frequency with which she had previously dragged her anchor, and had continued to do so in her revised anchorage position. Eyewitness accounts support the latter.

Eyewitness estimated collision position
