**Report on the investigation of
the grounding of
mv Coastal Bay
Church Bay, Anglesey
on 21 July 2000**

Marine Accident Investigation Branch
First Floor
Carlton House
Carlton Place
Southampton
United Kingdom
SO15 2DZ

Report No 8/2001

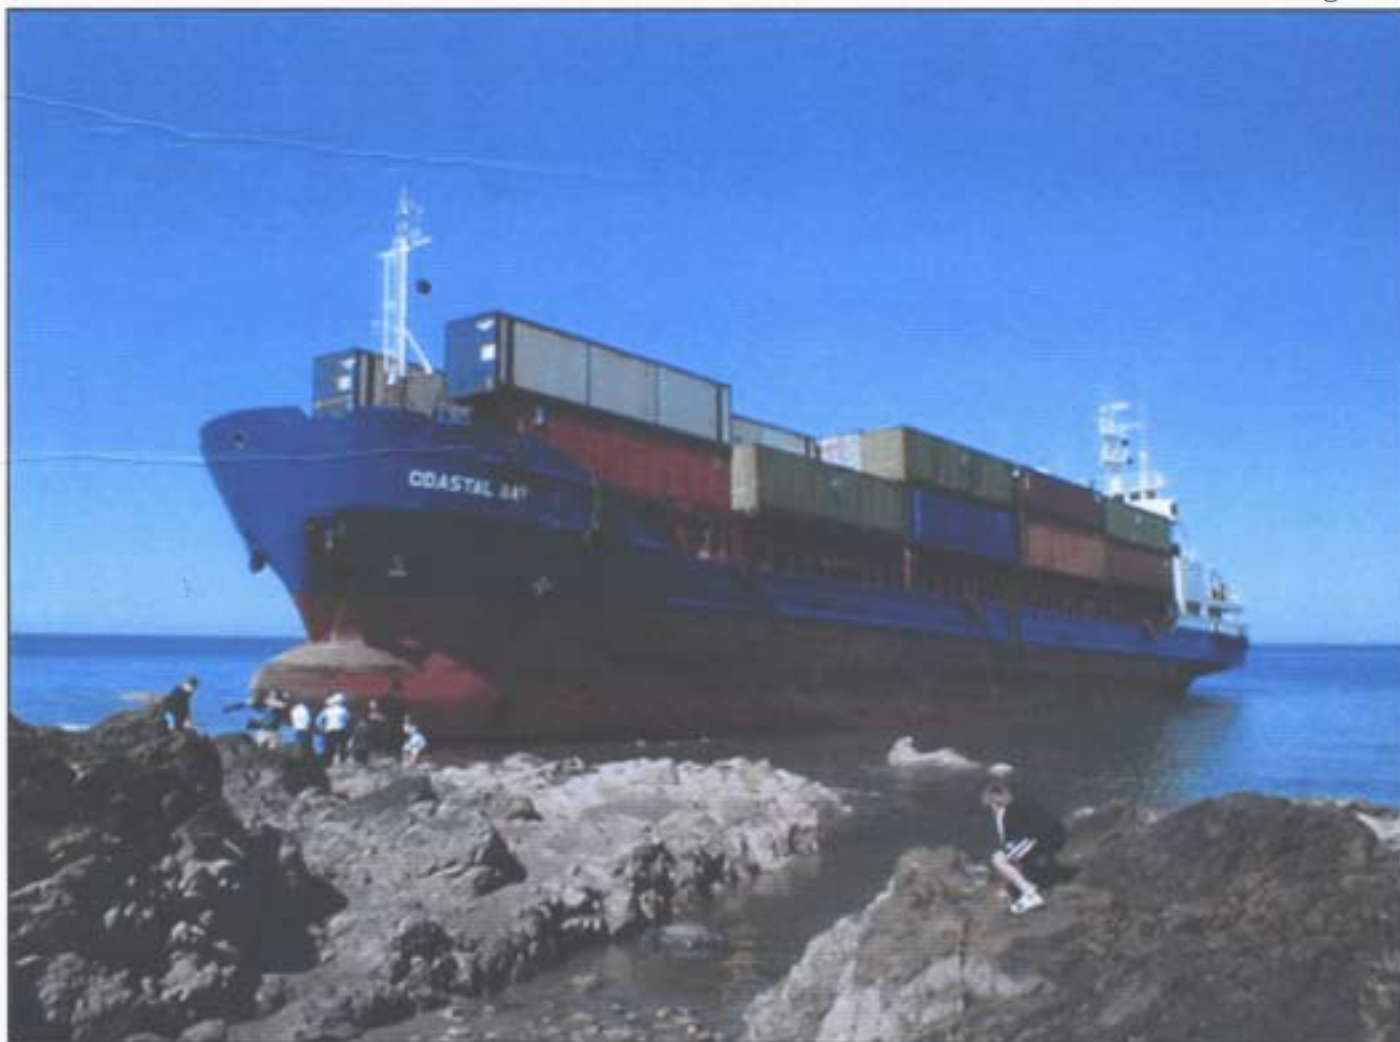
Figure 1

Damage : Buckled and indented plating, split in ballast
tank, distorted propeller blades, indentations in
skeg and rudder.

Coastal Bay aground in Church Bay

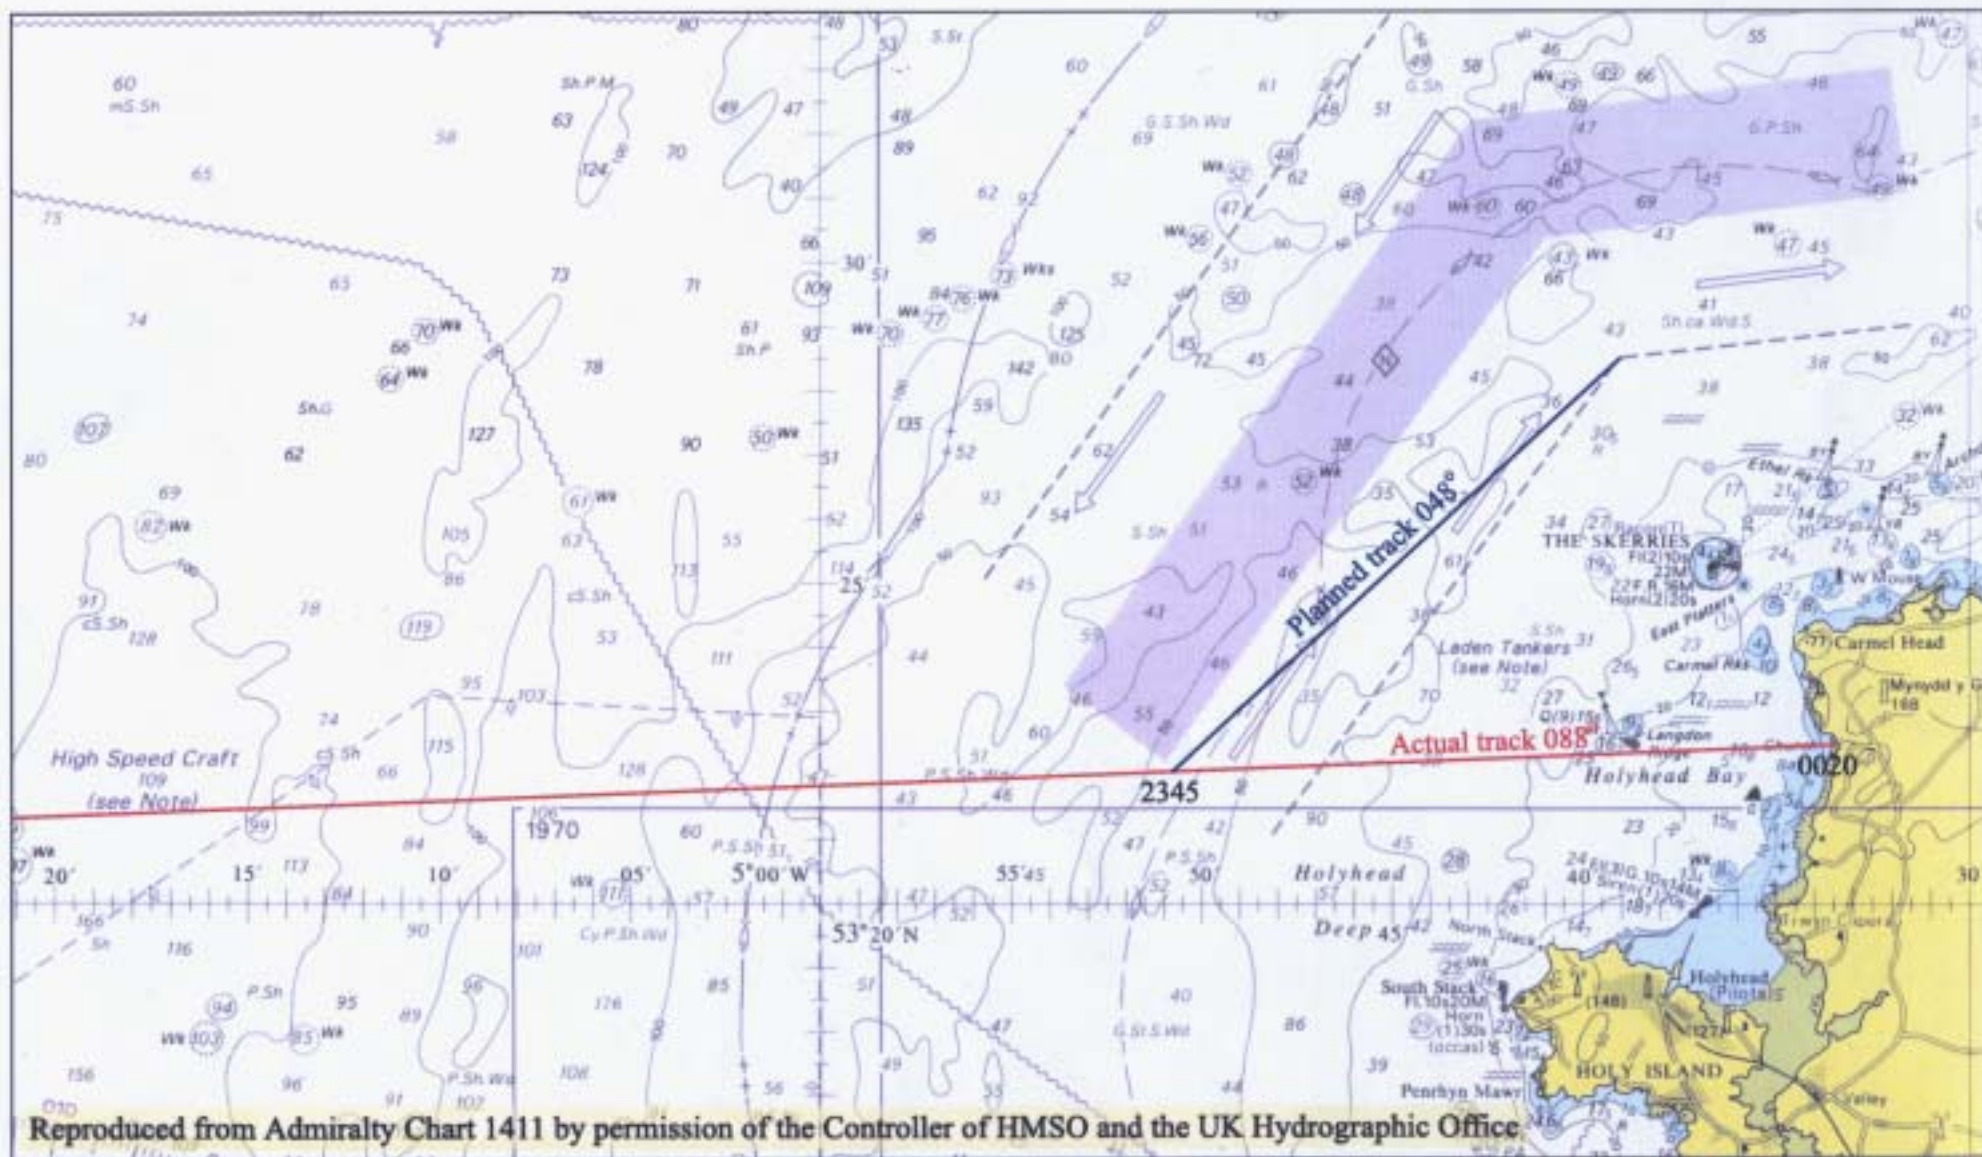
Figure 2

Planned and actual track

13. The chief officer probably slept between 2325 and 0020. [1.6]
14. A course alteration to 048° due at about 2345 was missed; the ship remained on a course of 098° and made good a course of 088°. **(Figure 2)**

1. The chief officer fell asleep and the planned course alteration was missed. [1.5,2.1]
