Report on the investigation of the
death of an engineer on board
Fivla
in the Bluemull Sound, Shetland
on 16 July 2000

Marine Accident Investigation Branch
First Floor
Carlton House
Carlton Place
Southampton
United Kingdom
SO15 2DZ

Report No 11/2001

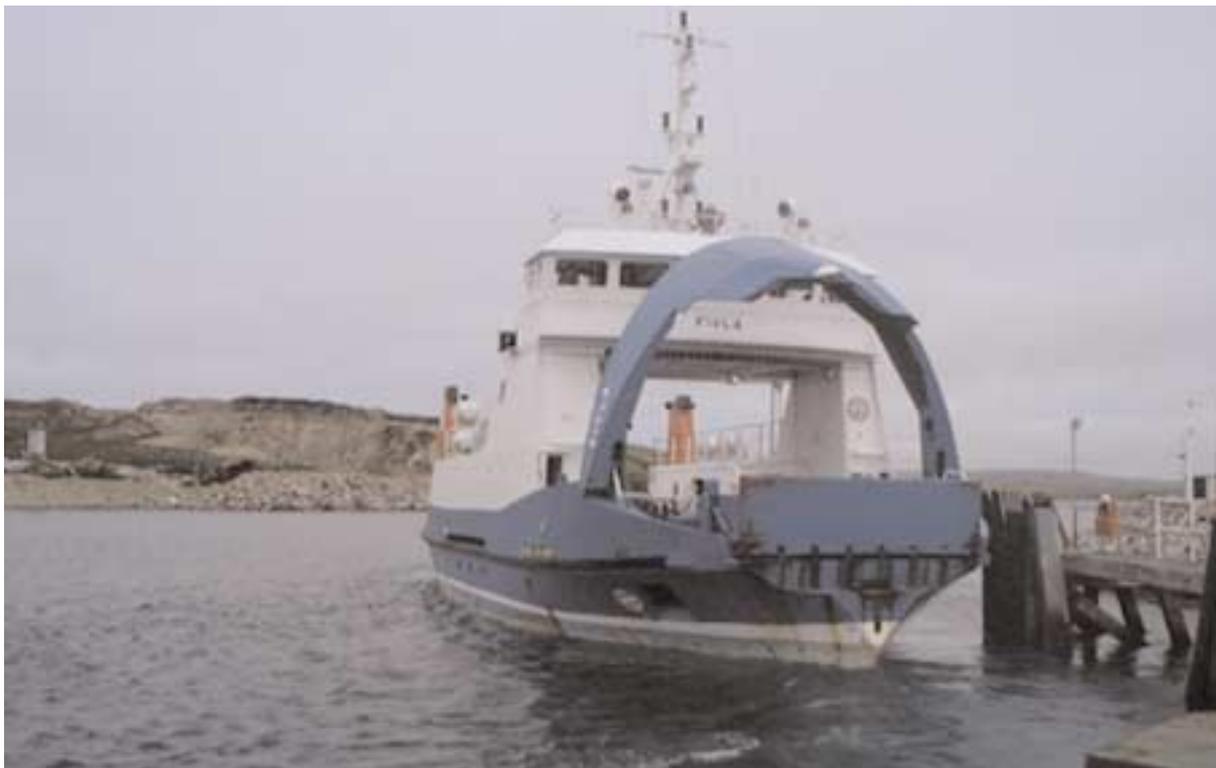
Figure 2

On departure Gutcher *Fivla* was moved astern off the berth with the visor still open (**Figure 2**). Once clear of the berth, the master activated the pre-recorded safety announcement and closed the visor from the console on the bridge. It normally reached the fully closed position about 2 minutes after sailing. The vessel then proceeded on passage. The master remained alone on the bridge until the mate and/or the deckhand arrived.

Fivla moving astern off the berth in Gutcher

It was the practice on *Fivla* and other ferries run by the Shetland Islands Council for the master to lower the bow visor from the bridge after moving the vessel astern and clear of the berth. At this time the master was often the only person on the bridge, while the deckhand collected fares, and the mate made his way from the deck. The master would not have the time to monitor the closing of the visor from start to finish, even with the provision of closed circuit television, without interfering with his shiphandling and navigation duties. To view the fore deck, the master had to stand at the front of the bridge. From all other parts of the bridge the fore deck could not be seen. The mate was often still on the deck when the visor was being lowered, and sometimes waited until it was secure before leaving the deck, especially if passengers were on the deck. The visor was, however, on occasions lowered without any continuous visual monitoring.

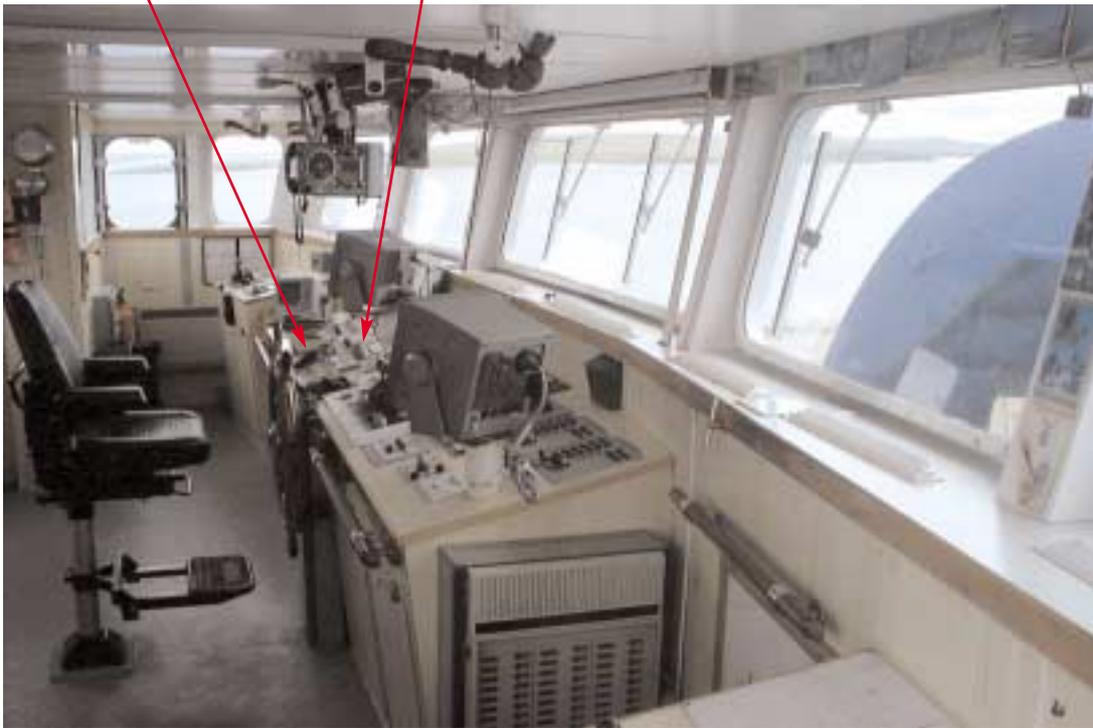
Figure 3

Although the visor was visible from the bridge, it could only be seen by someone standing at the front and looking down. There was no alarm system, and the visor could only be operated from the bridge console. It took approximately 35-40 seconds to close the visor. There were no written operating procedures, but there was a manufacturer's notice on the bridge console by the operating controls (**Figures 3 and 4**), which instructed the operator to check the area was clear before lowering. The controls consisted of "raise" and "lower" buttons and two lights which indicated if the visor was being raised or lowered. There was an emergency stop button on the bridge console. There were also controls for the hydraulic pumps used to operate the visor. There were no other controls for the bow visor on the vessel.

Bow visor control panel

Bow visor operating instructions notice

Fivla - view of wheelhouse

No other controls existed for the operation of the bow visor, and therefore it could only be raised or lowered from the bridge. Also, it could only be stopped from the bridge, as this was the location of the one emergency stop. If the mate on deck was monitoring the closing, and realised there could be a potential obstruction, he had to contact the bridge to inform the master to stop the visor, as well as trying to remove the obstruction himself. The provision of, at least, an emergency stop in the local position could allow the mate, or whoever was monitoring from the deck, to stop the operation immediately in the event of possible obstruction.

Installed audible and visual alarms to indicate the bow visor is being raised/lowered.

Installed emergency stops in a position local to the bow visor.

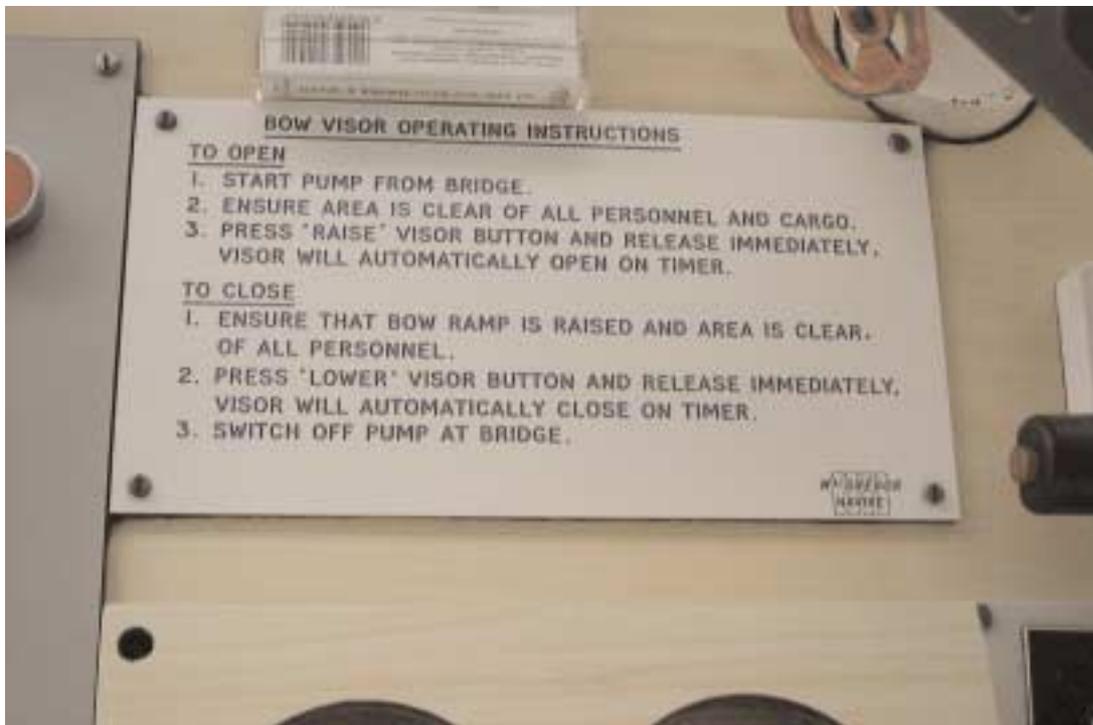
Figure 4

Bow visor operating instructions on bridge console

The council had not given the master and crew any written instructions for operating the bow visor. The only instructions were those provided by the manufacturer in the notice on the bridge console.

Issued a memo to all masters on 6 September 2000 regarding operating the bow visor, and instructing masters to develop appropriate operational procedures.

1. Introduce into its safety management system, guidelines and procedures, including training, for the operation of bow visors, throughout its fleet.
