**Report on the investigation of
the grounding and subsequent loss of**

mfv Betty James

Isle of Rhum

Report No 34/2000

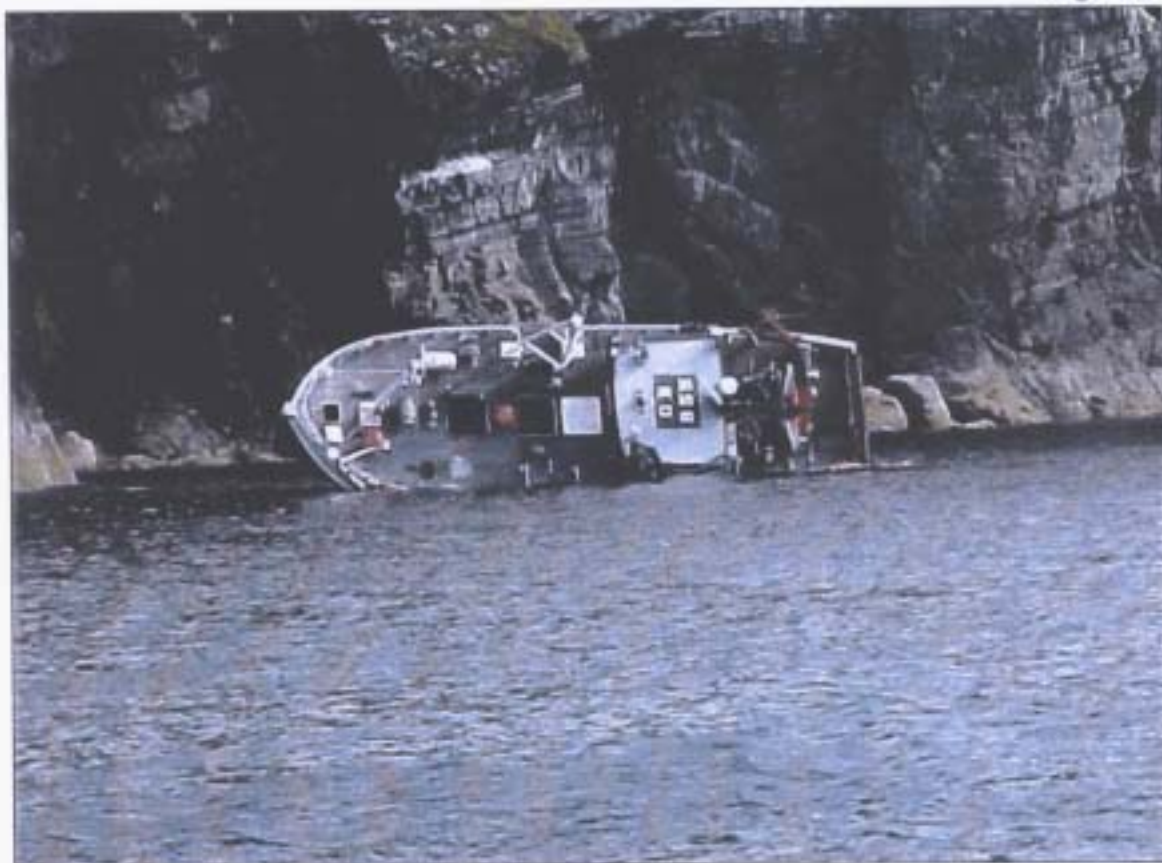
Figure 1

Subsequent movement on the rocks caused by the tide and wind, together with unsuccessful attempts to refloat the vessel, caused the vessel's watertight integrity to be breached and she was eventually lost.

Betty James aground

3. The grounding occurred within an hour of high water and she could not be refloated. [1.3,1.4]
4. The vessel was not holed at the time of grounding but subsequent movement and attempts to refloat the vessel resulted in breaches in her watertight integrity and loss of the vessel. [1.3]

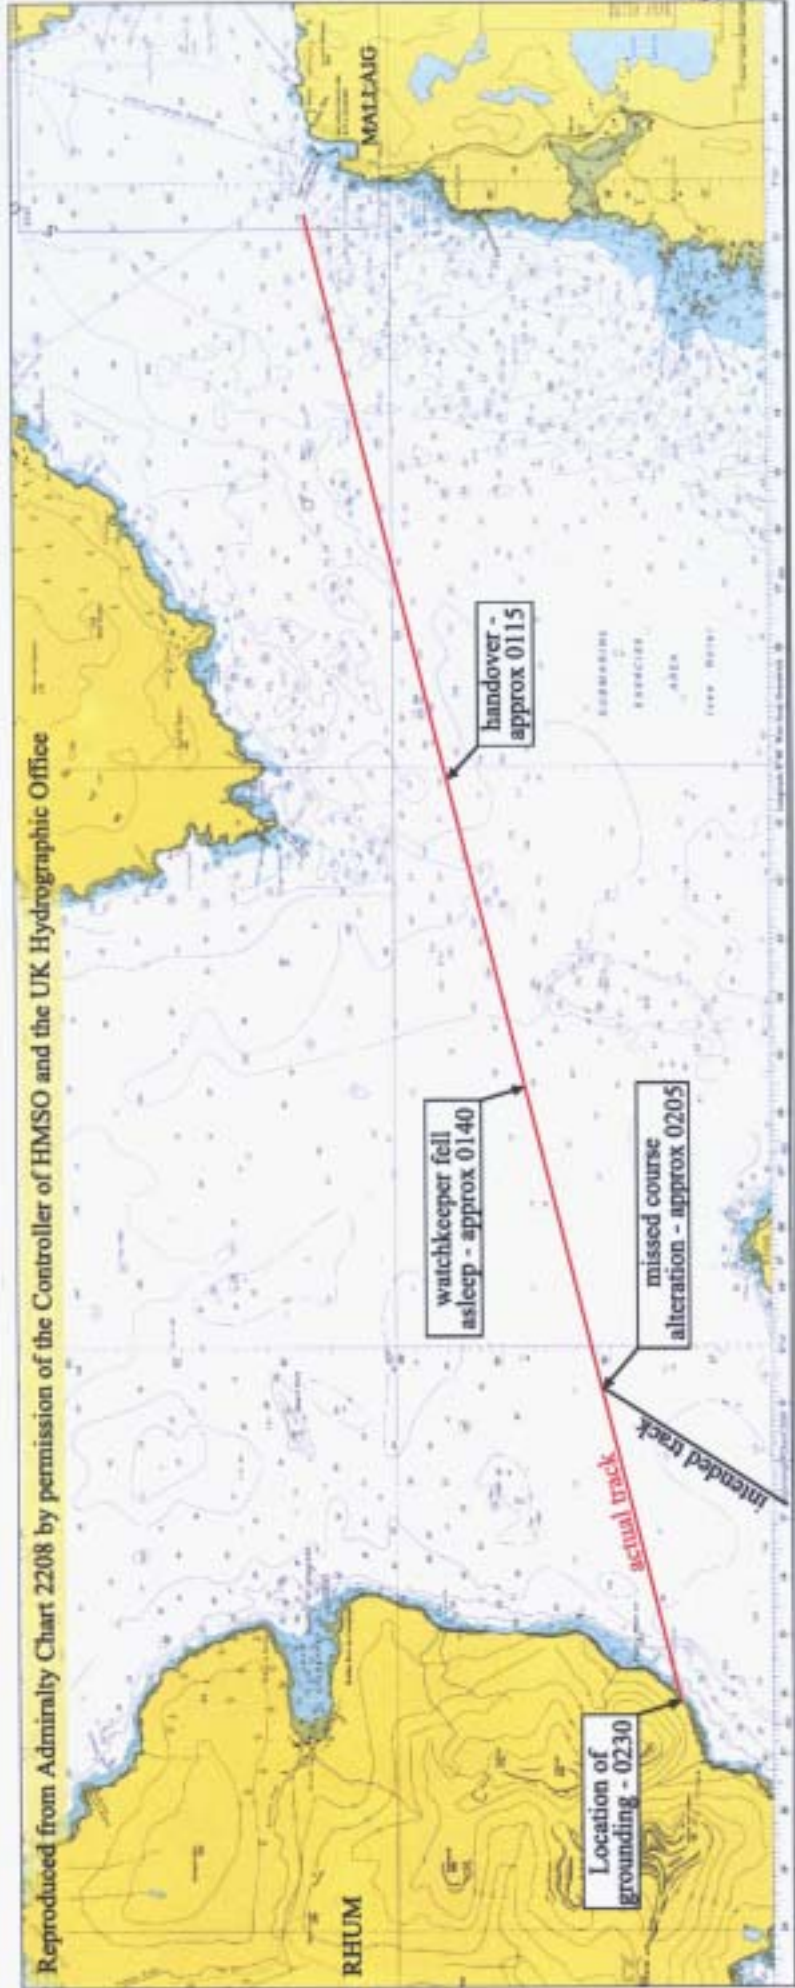
Figure 2

The passage from Mallaig to the Hillies Edge fishing grounds had been drawn on a chart and was shown on the Decca video plotter. The first track of approximately 250° was from a position half a mile west of Mallaig towards Rhum Sound. From a position to the north-west of Eigg the track then ran south-westerly through the centre of the channel between Rhum and Eigg. An approximation of the intended track is shown at **Figure 2**.

15. The planned alteration of course to take the vessel between Rhum and Eigg, which should have occurred at 0205, was missed and the vessel continued on her 250° heading. [1.3]
16. The person on watch did not awake until the vessel grounded. [1.3]
17. The crew did not make full use of the survival equipment available when abandoning ship:
 - a. Only three members of the crew possessed survival suits and only two of these donned them prior to getting into the liferaft. [1.12]
 - b. Seven lifejackets were carried but only the skipper put one on before getting into the liferaft. [1.12]
18. One of the crew had not completed the mandatory sea survival course. He was not wearing a survival suit or a lifejacket when he abandoned ship. [1.2, 1.12]
