Report on the investigation of
the death of a crewmember after falling
down a pumproom hatch on the
motor tanker

INGA

at Pembroke on 7 July 2000

Report No 10/2001

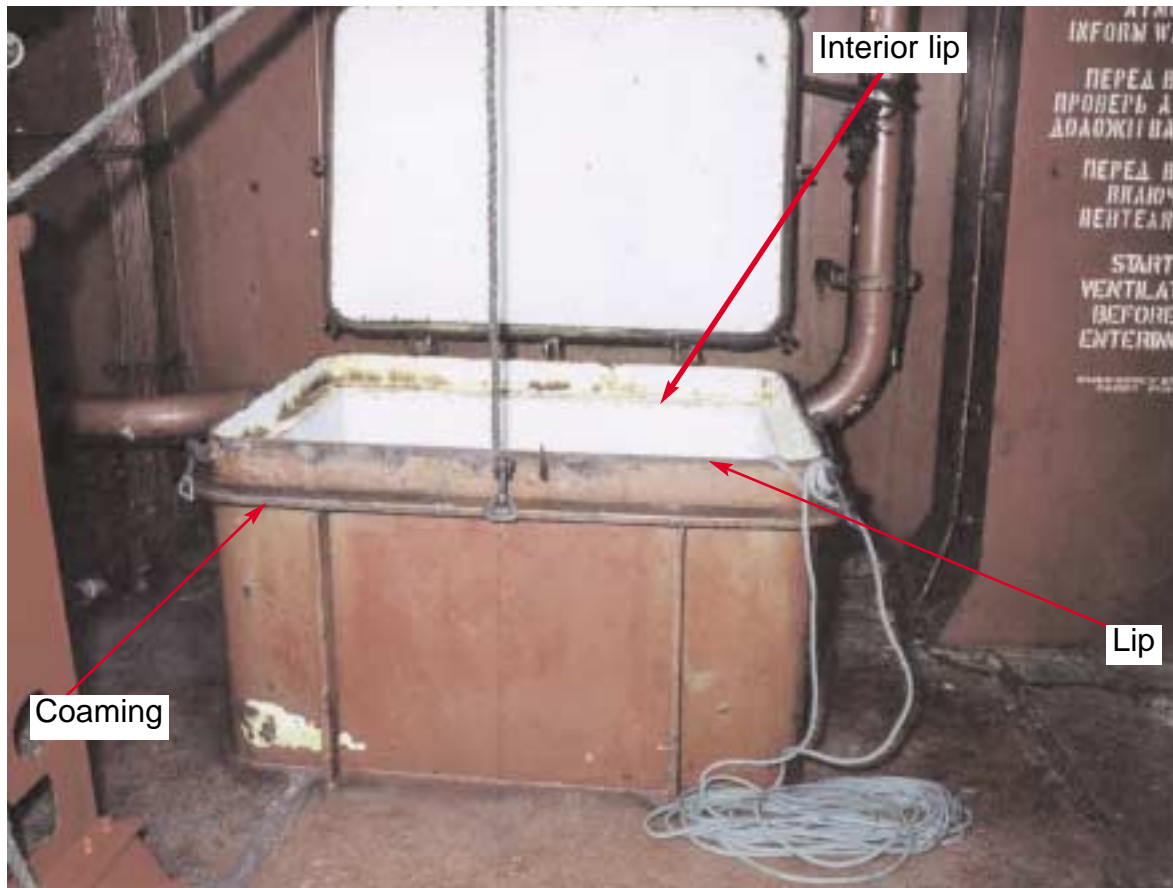
The pumproom hatch was just to port of the centreline, and immediately forward of the accommodation. It measured 1.0m x 1.4m and was designed for raising and lowering machinery and equipment to and from the pumproom. A small davit was located on the deck by the forward starboard side of the hatch, for use in lowering and raising equipment, and also for opening and closing the hatch lid. A rope was used to keep the hatch lashed open. The hatch had no ladder fitted, but did have a small lip, 7cm wide and 11cm below the lip on top of the coaming, running around the interior. The distance from the main deck to the pumproom bottom plates was 13.7m. It was a straight drop with no obstructions.

Pumpproom hatch looking from forward

None of the crew can recall there ever having been a cover plate fitted, despite the presence of the lip running around the hatch interior.

He had recently complained about having a blister on the base of his left foot, and his left boot and both gloves were found on the deck by the hatch. It is therefore likely that he had sat on the lip or the coaming of the hatch, and taken his boot off to examine his blister. His left sock had not been removed when the body was discovered. If he had sat directly on the lip of the hatch, and not the coaming, a small shift in balance of his body weight would have been enough to have caused him to fall into the hatch. Had he sat on the hatch coaming, then the base of his back would have been resting against the vertical part of the hatch between the coaming and the top. Overbalancing and falling into the hatch from this position would have been more difficult and unlikely.

1. Ensure the pumproom hatch on board *Inga* is guarded when open. A simple grating/cover plate on the interior lip would suffice.
2. Review and implement onboard procedures to remove the necessity for this hatch to be opened except for the purpose for which it was designed.

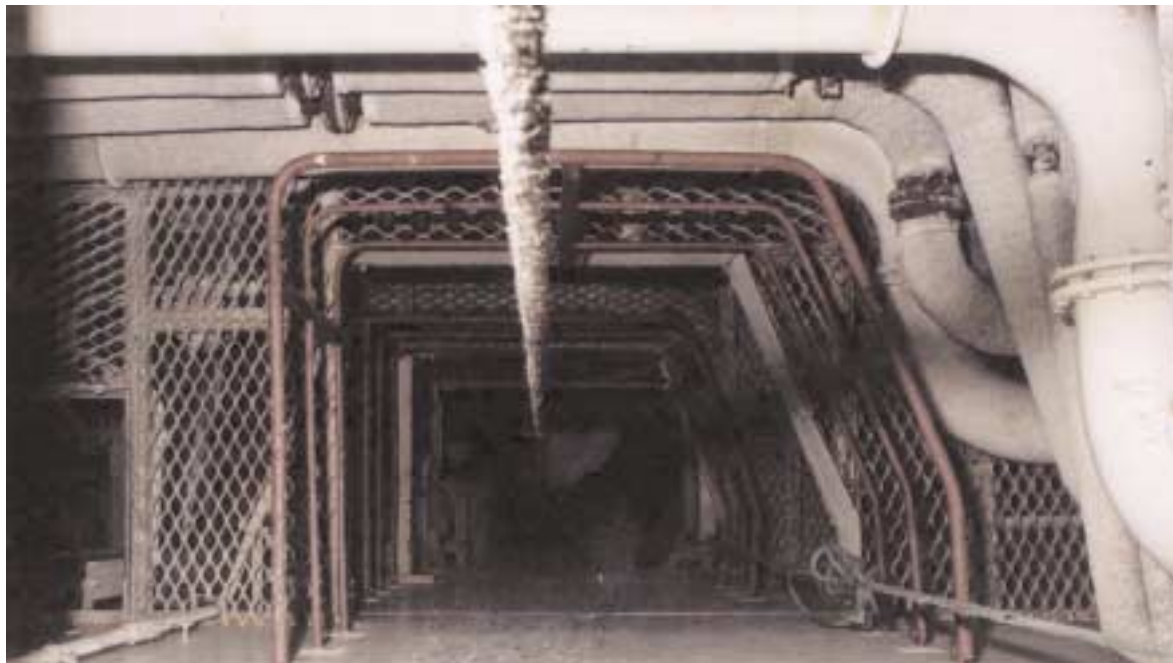
View down pumpproom hatch looking from forward side

the pumproom through the hatch and saw the senior pumpman's body lying on the bottom plates. This was at the all-fast time of 1420.
