**Report on the investigation
of a rescue boat falling from
Pride of Bilbao
into Cherbourg Harbour
injuring two people
on 1 July 2000**

Marine Accident Investigation Branch
First Floor, Carlton House
Carlton Place
Southampton
SO15 2DZ

Report No 4/2001

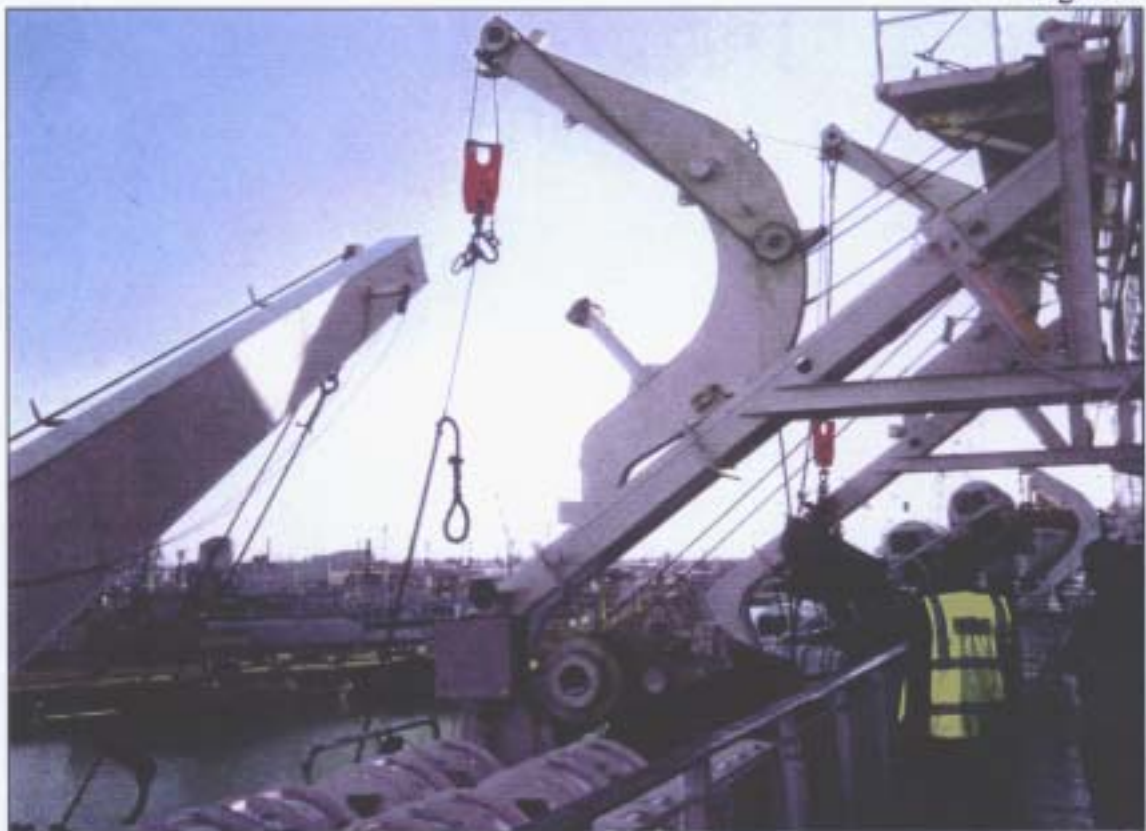
Figure 2

No damage was apparent on the davit's arms or any part of its fixed structure.

Starboard rescue boat davits after accident

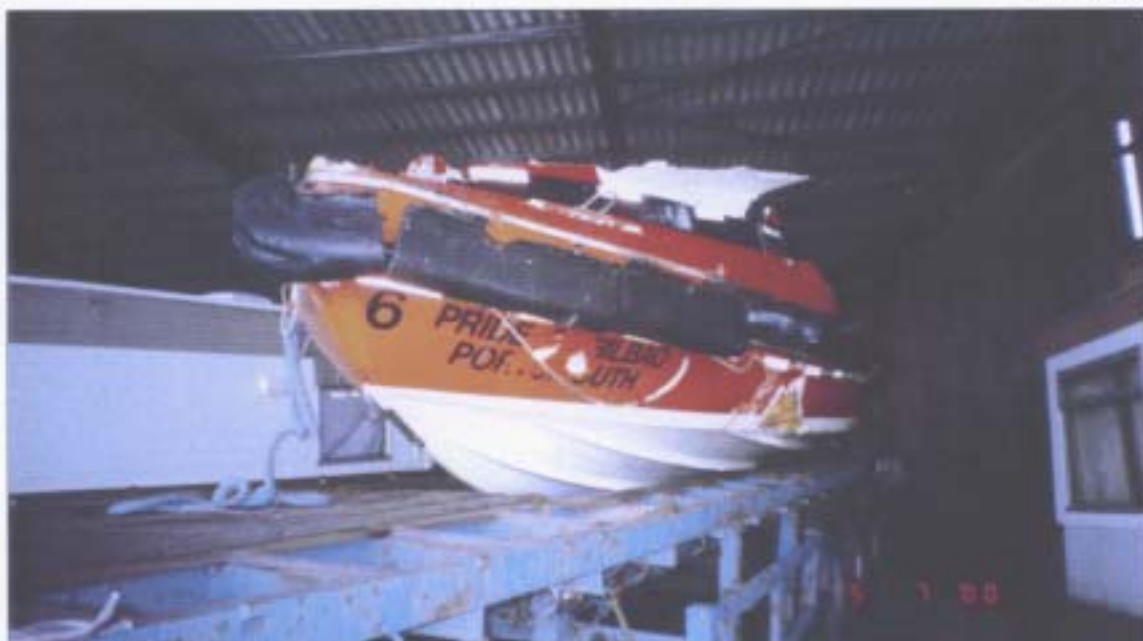
Figure 3

The boat's structure had suffered serious damage (**Figure 3**). The port side of the hull was damaged, with an area of the outer skin missing; exposing foam buoyancy material. The starboard side rubbing strip was missing; that on the port side was damaged, particularly towards the forward end.

The aft suspension hook and the boat's transom were missing and most of the cuddy top and coxswain's control position were seriously damaged and displaced. The forward hook was in place, with its column set aft by about 45°. Mounting of the column on the inner skin showed no signs of damage. The outer skin was cracked either side of the stem plate. This plate and a mounting bolt, displayed signs of external impact.

The forward cuddy structure was seriously damaged. The forward part, to which the painter hook had been attached, was torn away.

Damaged boat after recovery to Portsmouth

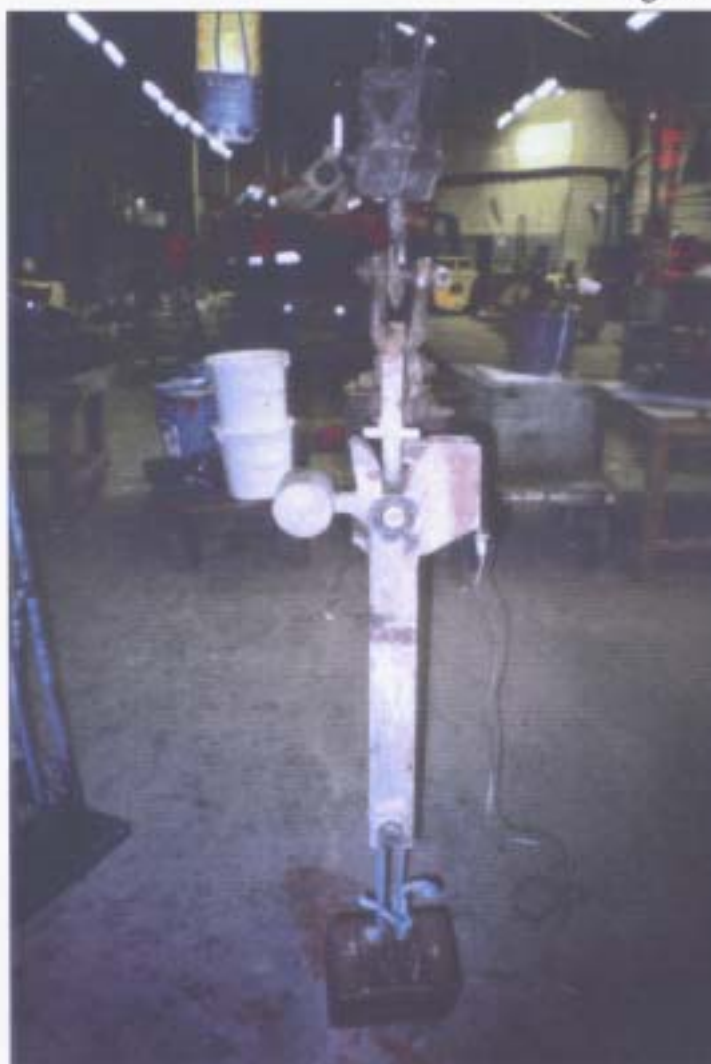
Figure 4

This was repeated with the hook only partially closed around the suspension ring (**Figure 4**). Again these attempts were unsuccessful. Several lateral shocks were then applied to the assembly. Again the hook failed to release.

Testing of forward suspension hook with 25kg load

During these trials it was noted that the bulldog clip securing the release cable to the hook was able to foul against one cheek plate. This clip was not original specification.

Bulldog clips are not the specified fitting for this application. Therefore, in spite of the above conclusion, the owners should advise the service staff they employ, that replacement parts should comply with manufacturer's specifications.

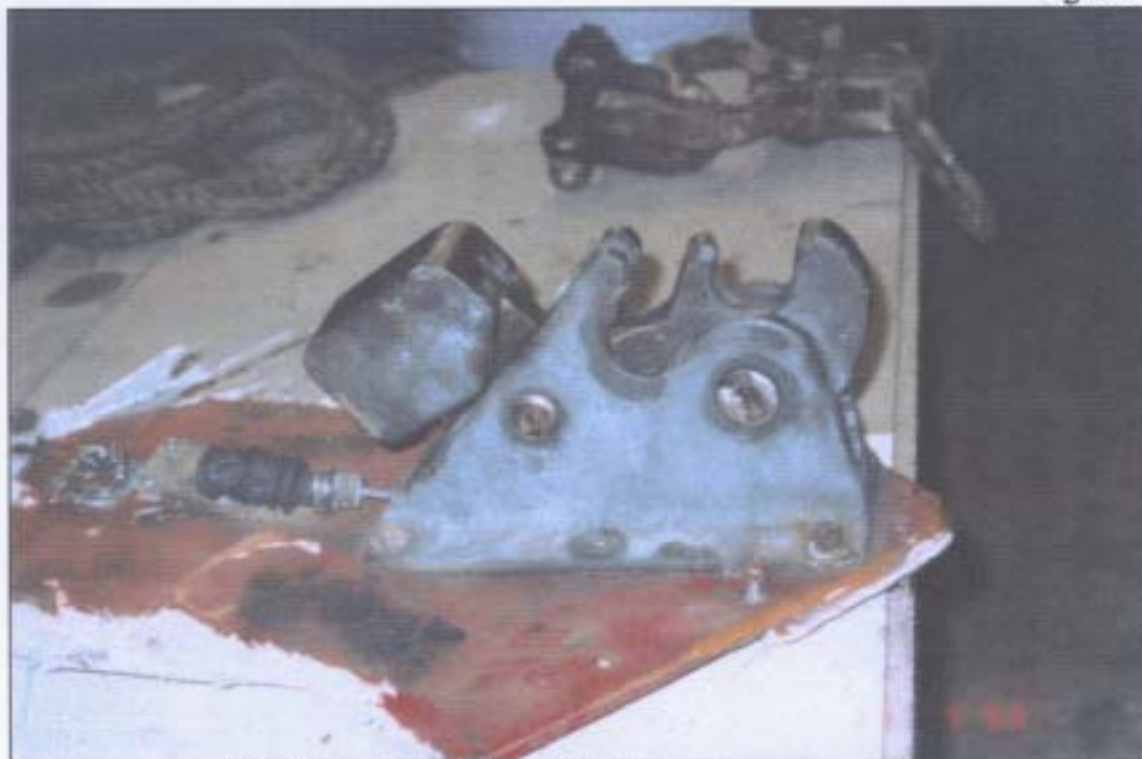
Figure 5

The hook assembly remains attached to a small piece of the GRP laminate that had been the foremost part of the cuddy top (**Figure 5**). Along two edges of this piece of GRP are several of the self-tapping screws that had previously secured it to the boat's hull (**Figure 6**). The third edge is fractured and very rough. The hook's release cable remains attached to the mechanism and release lever.

Painter hook and attached GRP from damaged cuddy

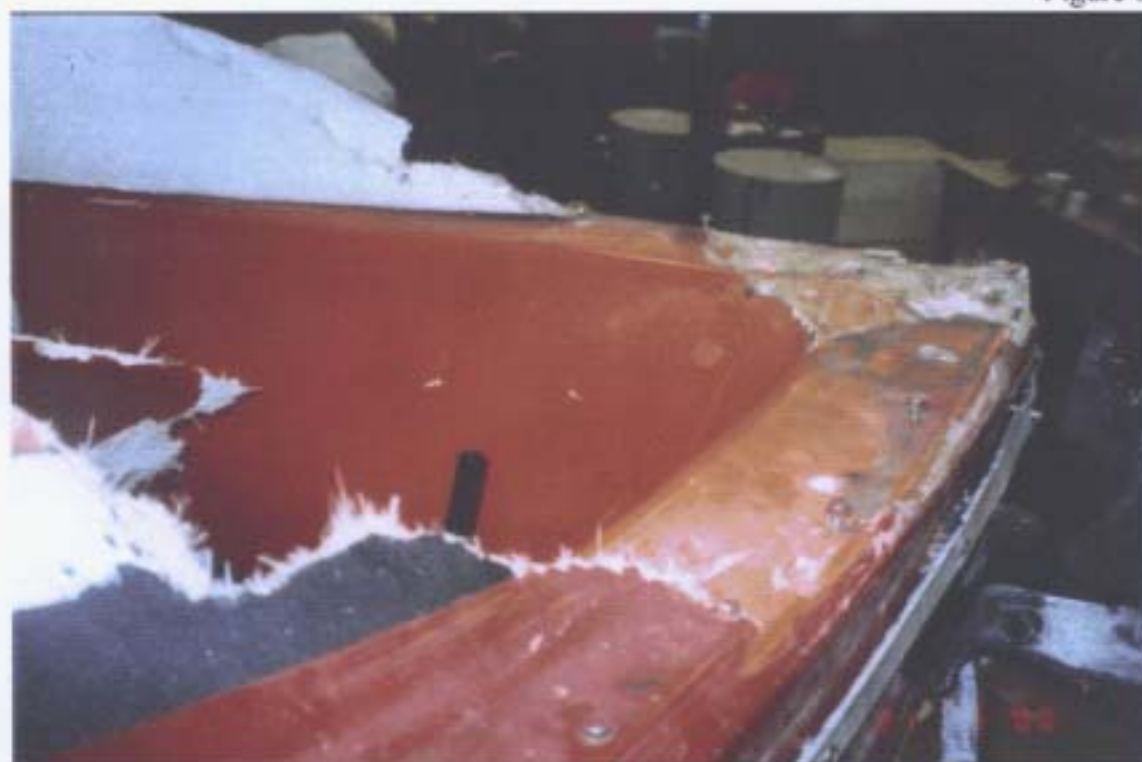
Figure 6

Forward part of boat from where painter hook was torn

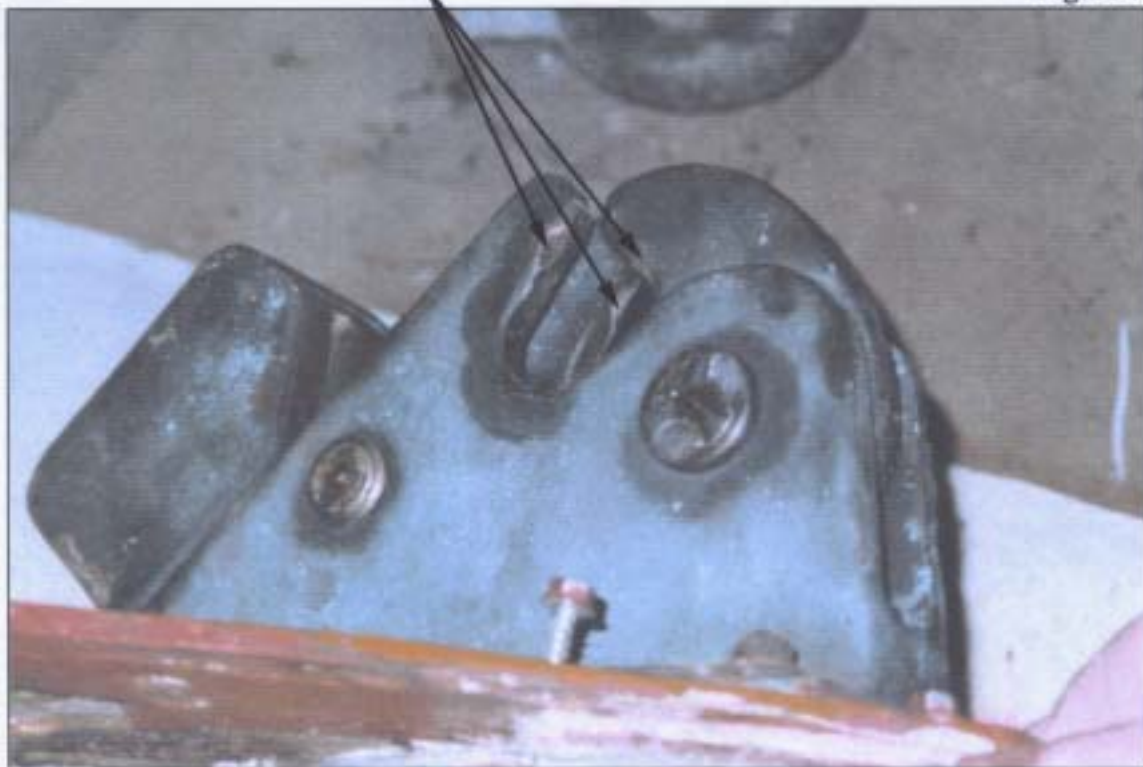
Figure 7

The outer edges of both cheek plates shows localised crushing damage, and the cheek plates are slightly closed in; by approximately 3mm (**Figure 7**).

Painter hook, showing crushing

However, to remove totally the potential for a similar accident occurring, hook dimensions should be altered. One way would be to fit a smaller painter hook which will not accept a suspension ring. The owners are recommended to consider this alteration.

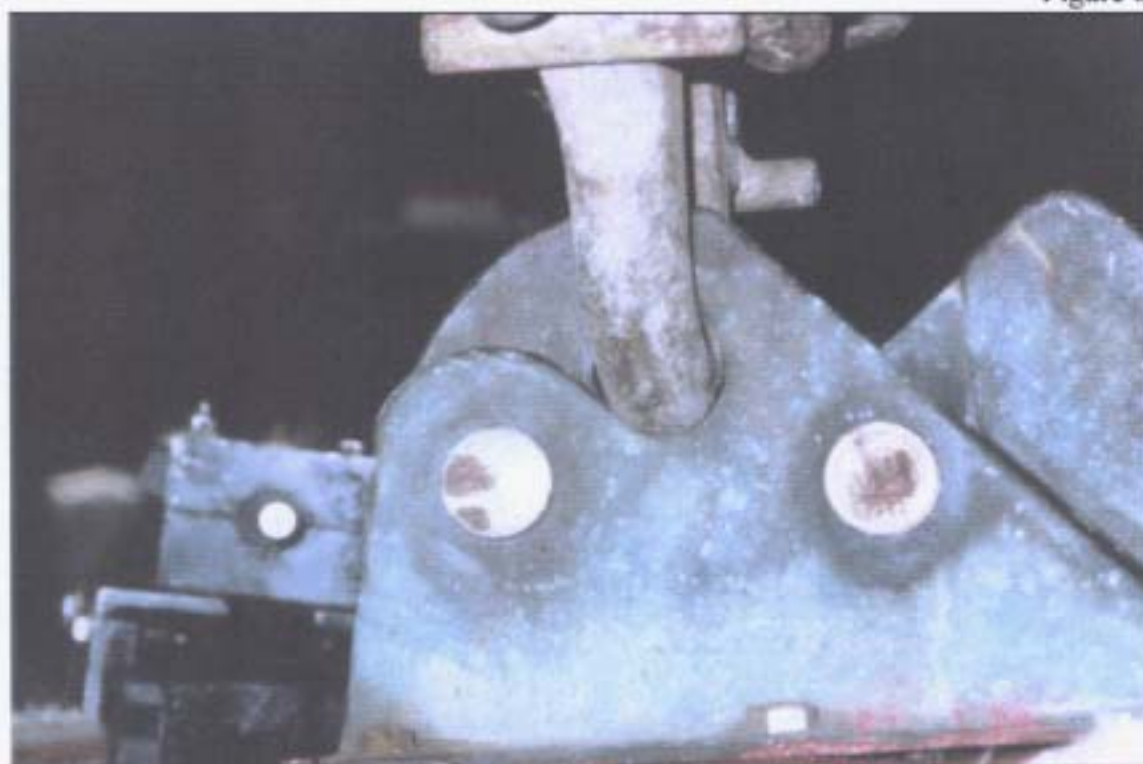
Figure 8

With the hook in its normal attitude, the boat's forward suspension ring was placed in the hook, which was then closed. When the ring was lifted slightly, sufficient only to remove slack, the crushing damage, mentioned above, coincided exactly with the points of contact with the ring (**Figure 8**).

Forward lifting ring fitted in painter hook

The immediate error leading to the accident was the fitting of the forward suspension ring to the painter hook. Neither the suspension hooks, nor the painter hook, appear to be in any way defective or unsuitable for their purpose.

However, their dimensions corresponded exactly, in as much as the suspension ring was a perfect fit in the painter hook; a condition that contributed to the error of connecting the suspension ring to the painter hook.

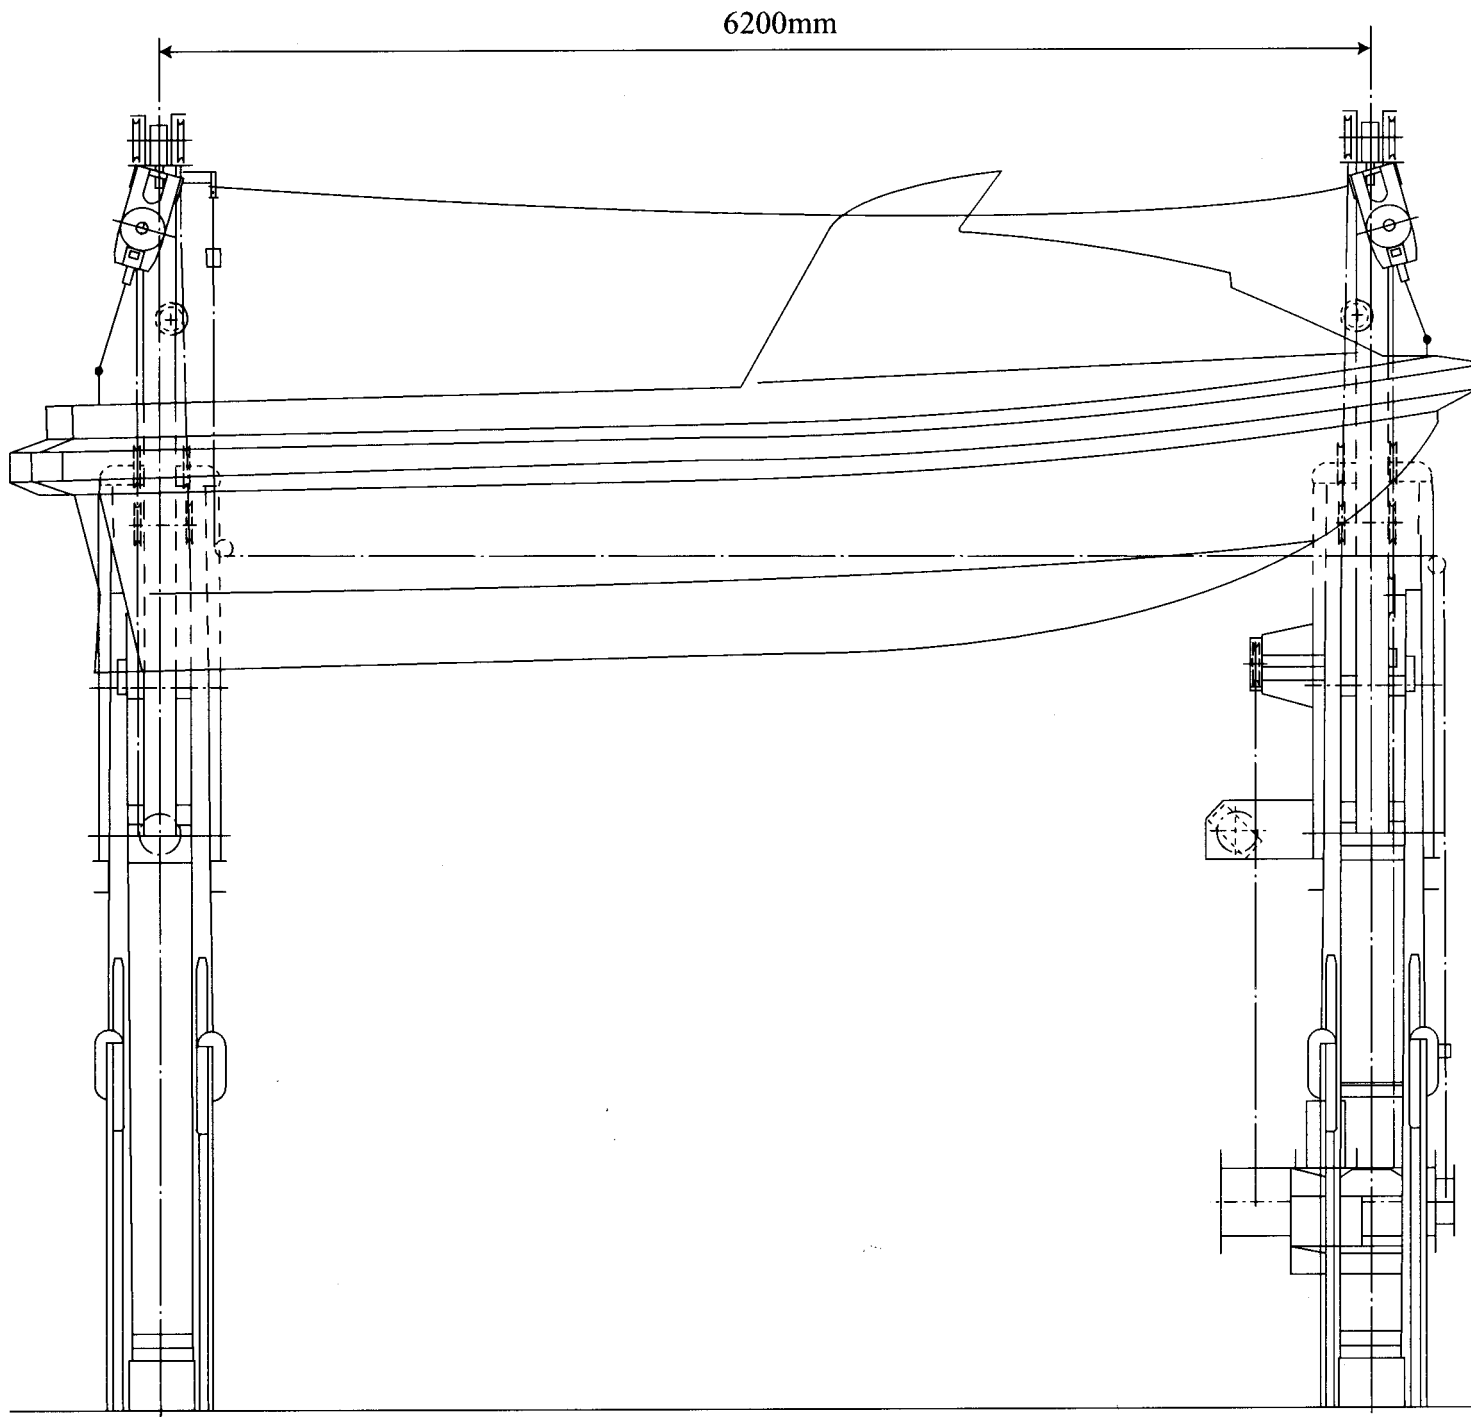
Heavy marks at the forward edge of the horn aperture in the block are consistent with it making heavy contact with the horn, without entering the aperture. Inadequate alignment between the lower blocks and the horns is indicated.

These features suggest that the aft block did not take to its horn, slipped down as the arm was rising, and that this movement was the first to be detected by witnesses. It

Rescue boat davits with boat stowed on lifting points 6.8m apart showing lower block misalignment (not to scale)

Normally the difference between the boat's weight, and the fall wire load, is taken by the davit horns. It has been concluded that the lower blocks did not properly take to their horns. An indeterminate friction force between the nose of the horns and the blocks then probably supplied the normal horn load. The indications of hard points of contact on the blocks support this suggestion.
