MAIB SAFETY BULLETIN 4/2000

Launching and recovery of rescue boats

Pride of Bilbao

on 1 July 2000

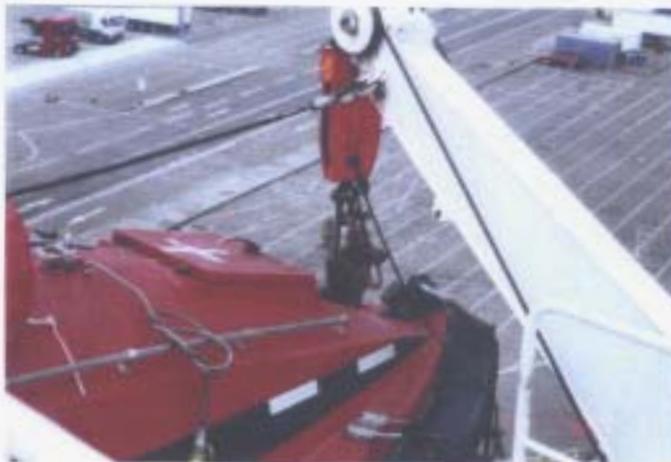
The precise cause of the accident is still being investigated, but the initial findings show that the forward lifting ring was capable of being attached to the painter release hook rather than the lifting hook.

No matter whether this happened during this accident, there is a risk that such a connection can be made. Not only were the two hooks very close together, but the size of the painter hook was compatible with the lifting rings. It was therefore possible for the lifting rings to be placed under the painter release hook which was not intended to support the boat's weight.

1. Check whether boat lifting rings are able to fit the painter release hooks. If the painter release hooks can be closed with the lifting rings fitted, then immediate precautions and procedures should be taken to prevent this Connection being made.
2. Crew members should be given training in such procedures which should be practised at drills
