Report of the investigation of a fatal accident to a

crew member on board

***Solstice II (BF 56)***

**Report No 22/2001**

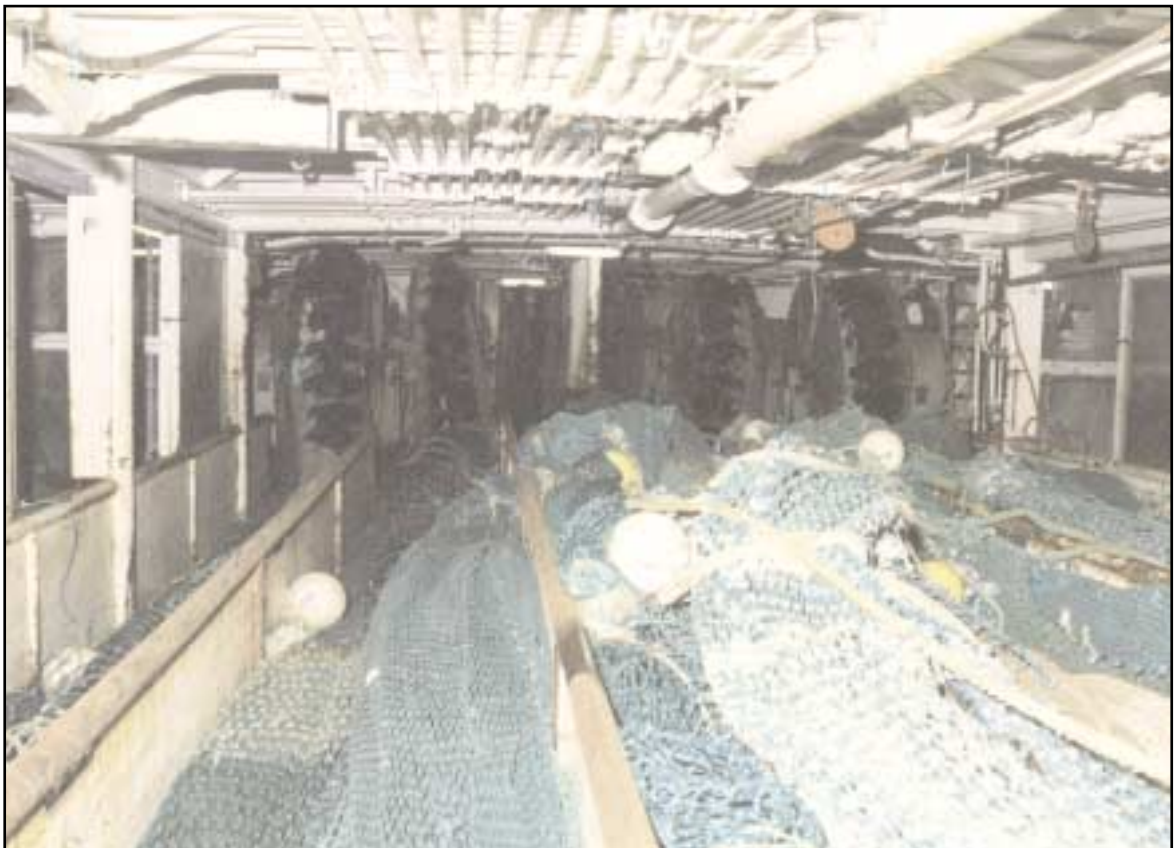
Figure 3

Upper deck

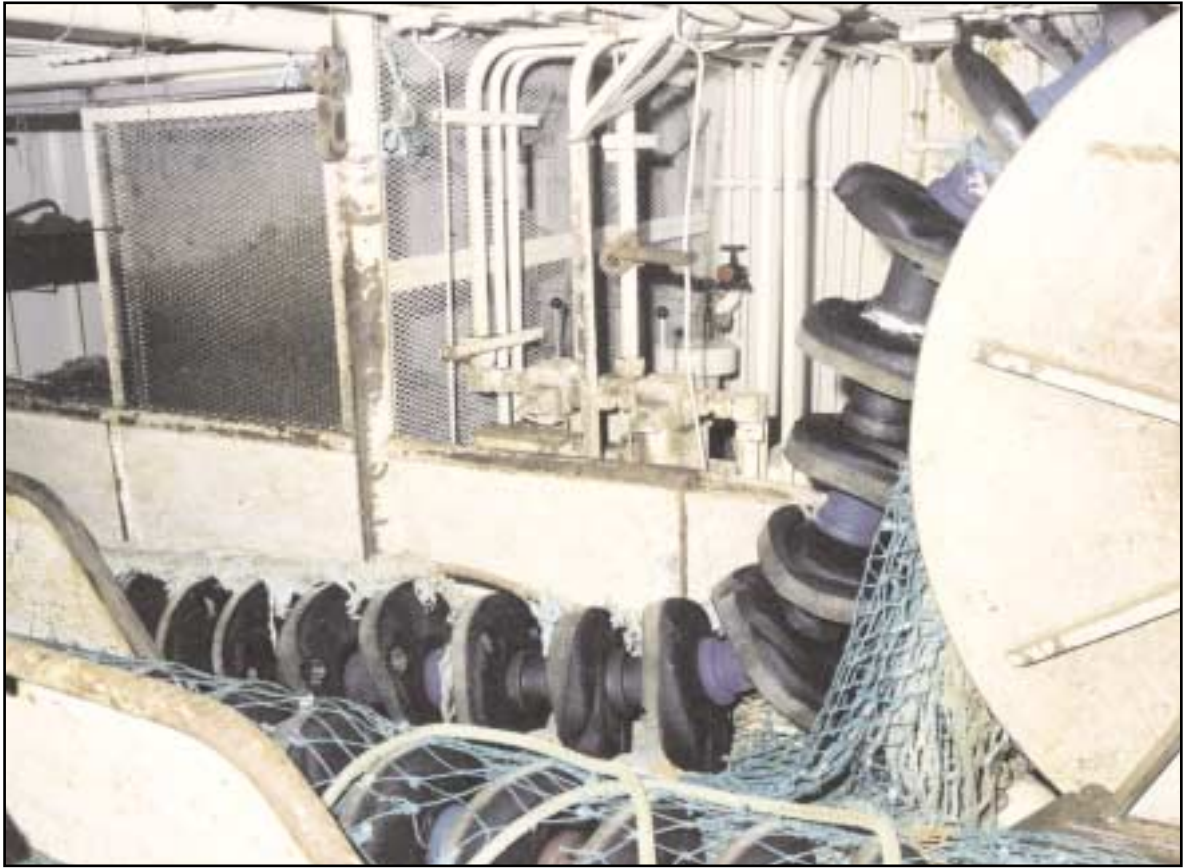
Figure 4

Port side operating position

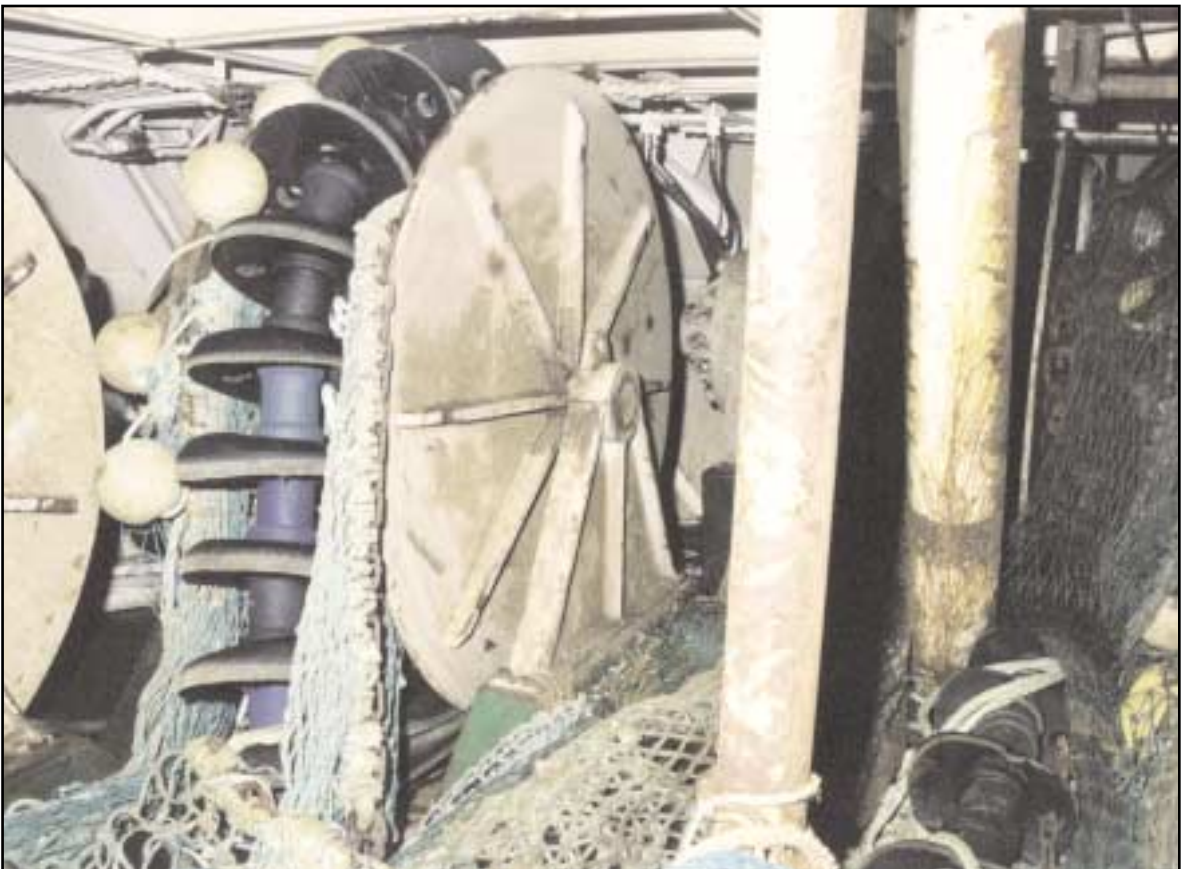
Figure 5

As he did so, he noticed someone's boots lying on the deck at the base of the inner port side winch. He called out, but got no reply. Realising there was something very wrong, he rushed to the wheelhouse and informed the skipper.

It soon became apparent that the crewman who had been working the port winches had been fatally injured. The nature of his injuries were synonymous with his arm being caught in the space between the supporting upright and the flange of the rotating drum and being dragged into the winch.

Inner port side sweep line winch
