Report of the investigation
of a carbon monoxide poisoning on
fv *Mariama K (FR242)*
in Douarnenez, France
on 10 June 2000
One fatality

Marine Accident Investigation Branch
First Floor, Carlton House
Carlton Place
Southampton
SO15 2DZ

Report No 12/2001

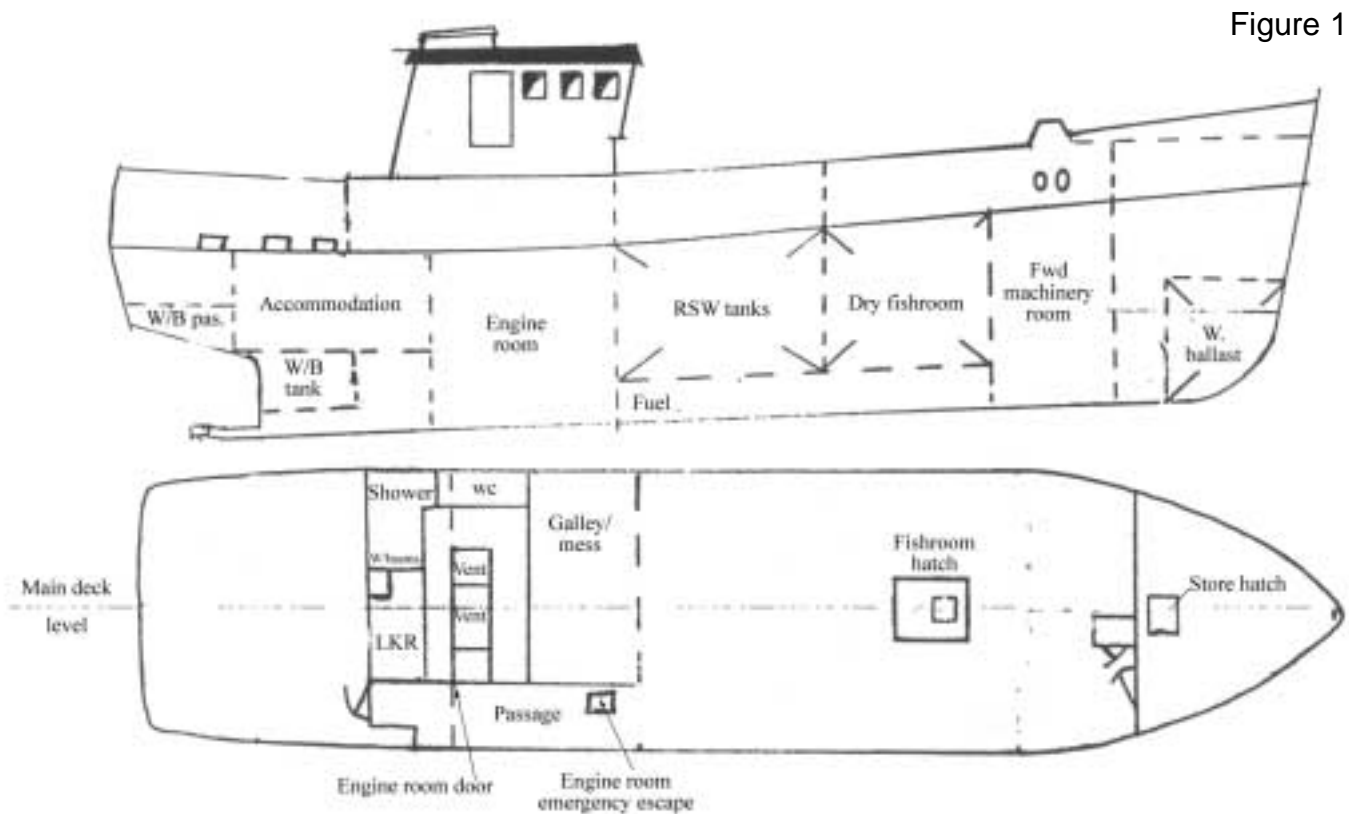
Figure 1

Below working deck level the hull is divided into five main compartments. From forward to aft, these are: forward store, forward machinery space, fishroom/refrigerated sea water (RSW) space; engine room; cabin (see Figure 1).

Mariama K - General Arrangement

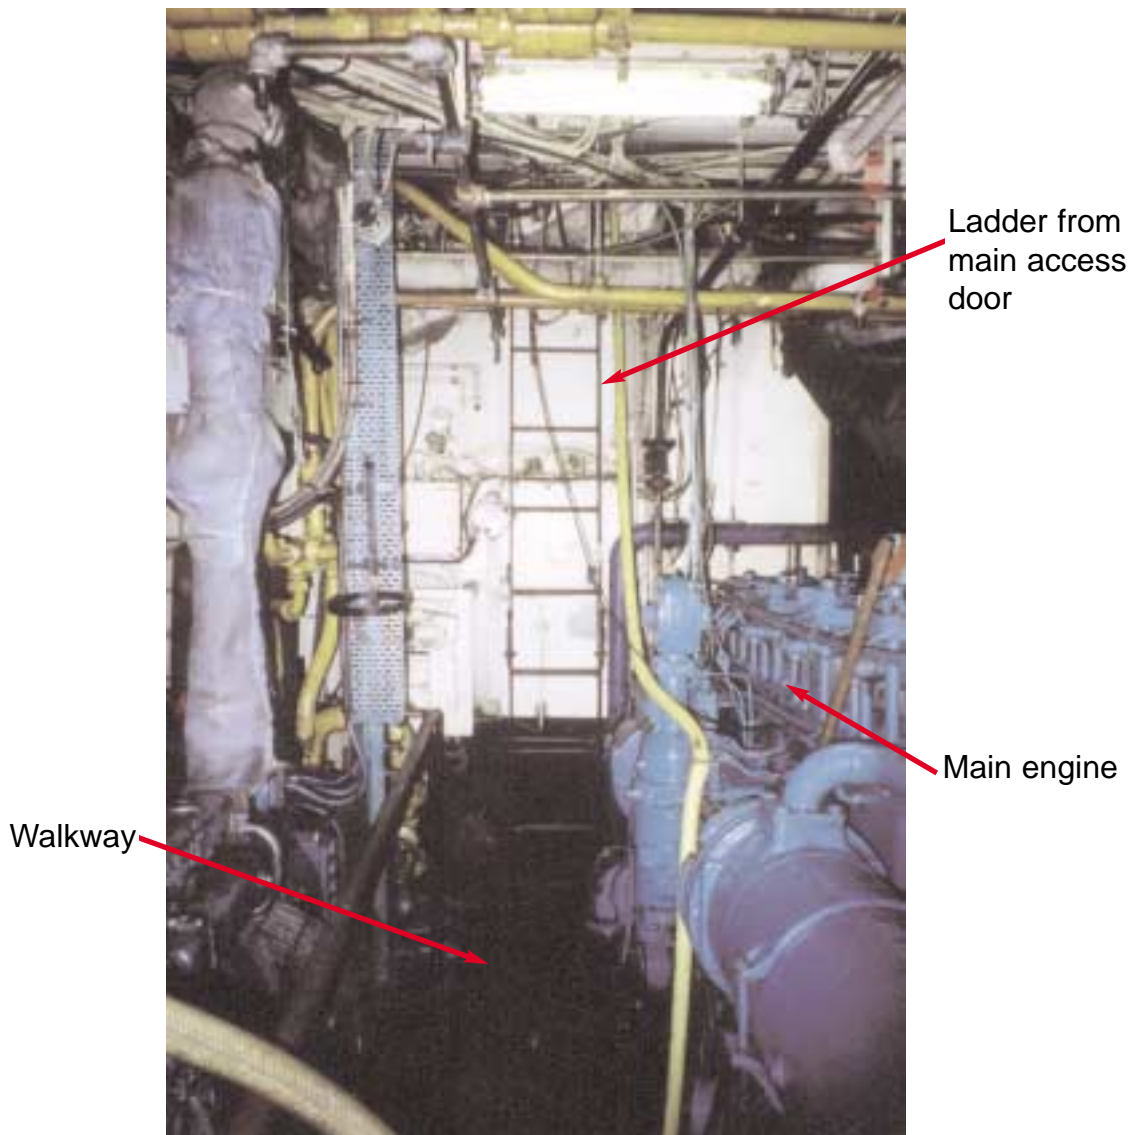
Figure 2

The main engine room door leads into a vertical trunk, with a ladder leading down to a fore and aft walkway to the starboard side of the main engine. On the starboard side of this walkway is an auxiliary engine with another narrow length of walkway at its starboard side (see **Figure 2**).

At the forward end of the narrow walkway by this auxiliary engine is a ladder leading up to the engine room emergency escape hatch at main deck level.

The portable pump used to pump bilges was positioned at the forward end of this narrow walkway, beneath the emergency escape hatch.

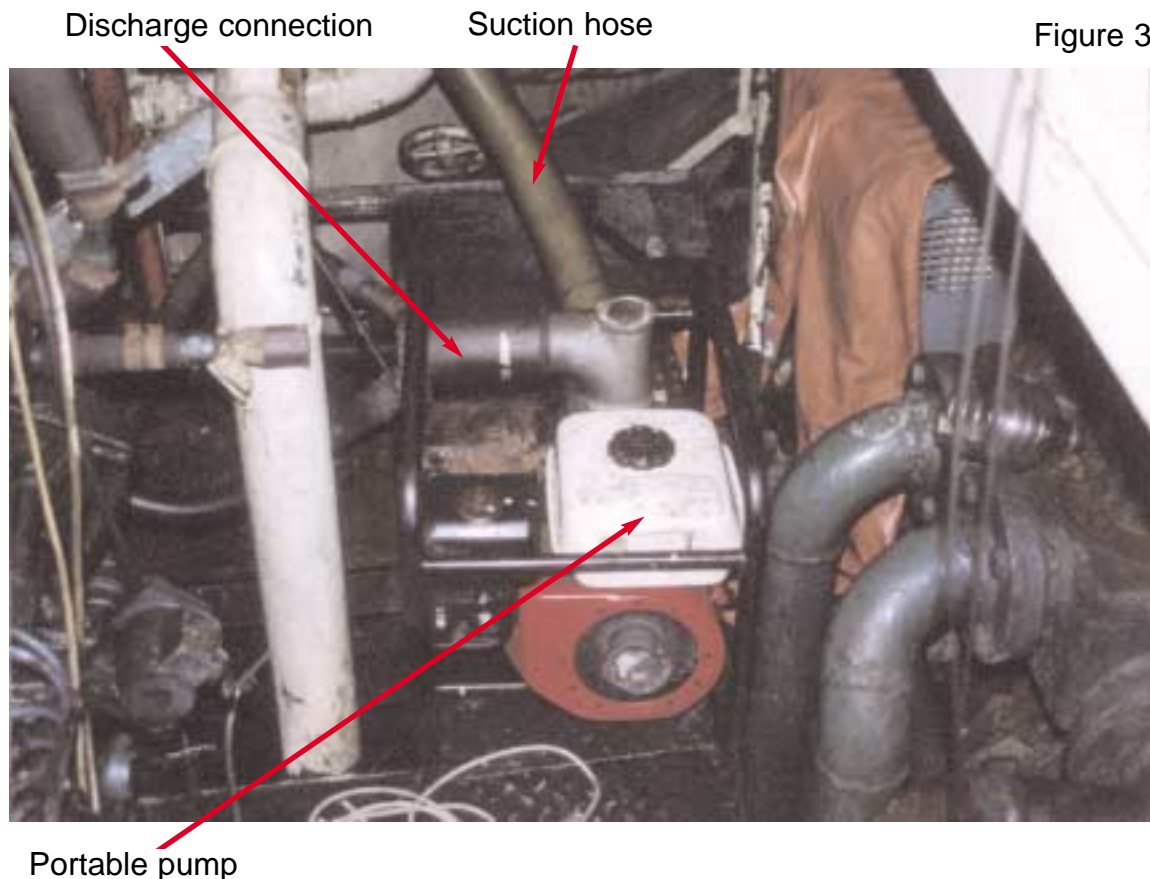
During the voyage to Europe, the engine room bilges were routinely pumped out using the portable pump. Initially this was placed on the working deck, with a suction hose leading into the engine room bilges. The pump did not perform well in this arrangement, so it was decided to reduce the suction lift by lowering the pump into the engine room (**see Figure 3**). This configuration performed satisfactorily.

The portable pump, positioned at the starboard side of the main engine, was used to pump the bilge water into a slush well on the starboard side of the working deck. Two hoses, passing from the pump through the engine room's emergency escape hatch, connected the pump to the slush well. An electric pump, permanently installed in the slush well, then transferred the bilge water overboard.

Running time on 10 June was between 1 and 1½ hours. Pumping rate was restricted, probably by some partial obstruction of the pump, resulting in an estimated flow rate of about one third of maximum. Despite this poor performance, it was decided to leave the pump running in this state. This made it necessary to extend the running time required to clear the bilges.

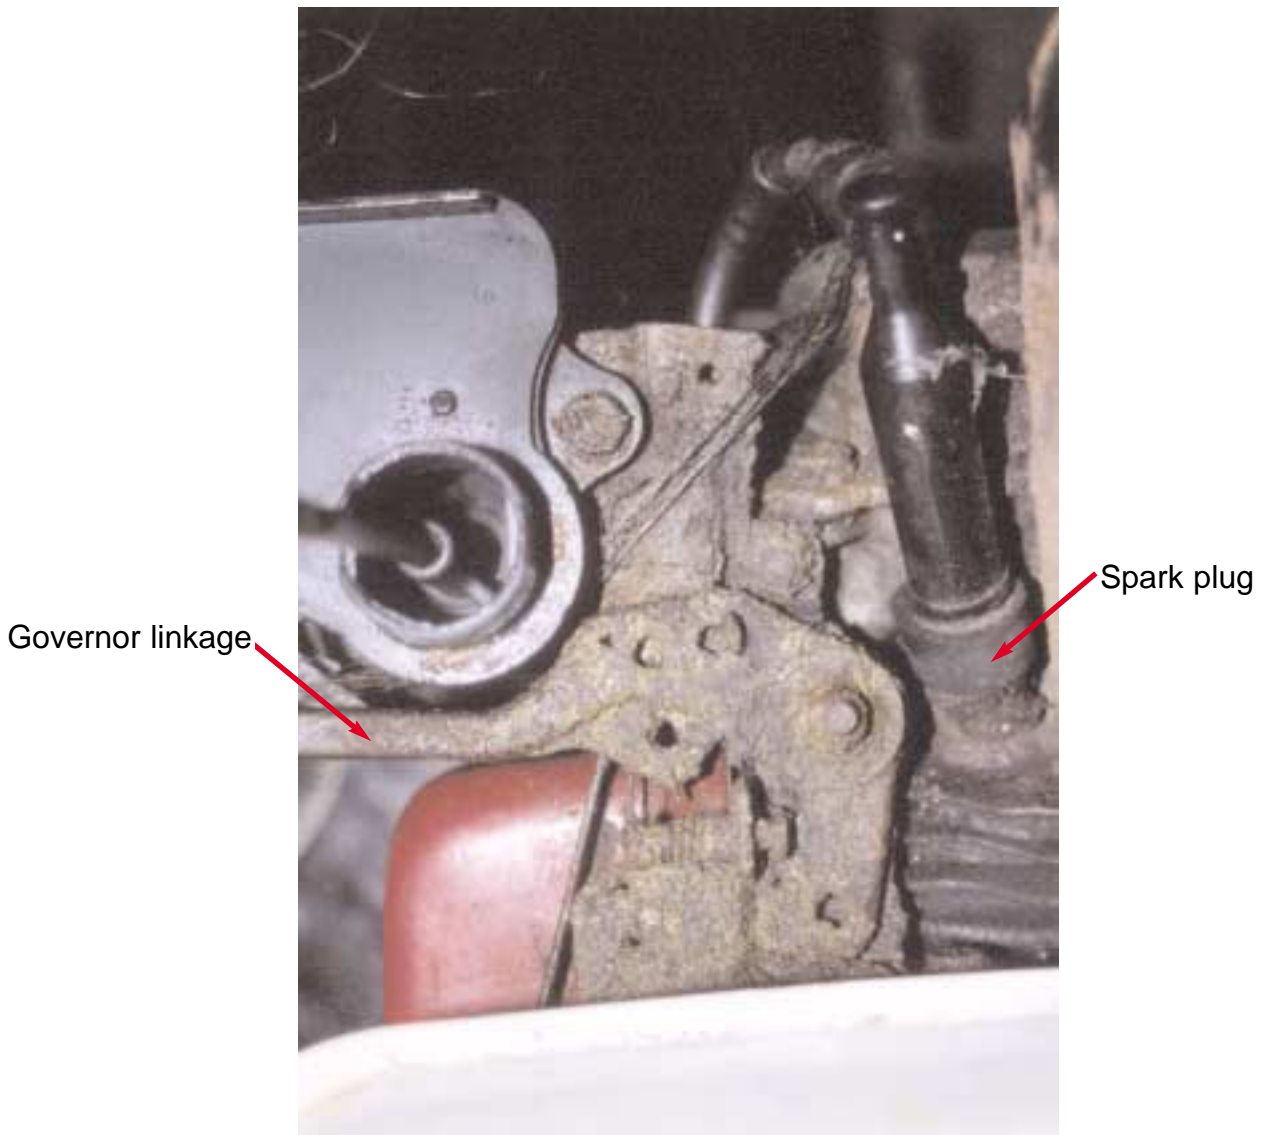
Figure 4

No other substance capable of producing a noxious vapour was found in the engine room. However, the portable petrol-powered pump, at the starboard forward end of the engine room was examined.

Apart from noting that the engine of this pump exhausted into the engine room, details of manufacturer, its type and capacity were recorded. These have been stated in Section 1.6. Also noted was the poor condition of several parts of the engine, in particular the governor linkage and sparking plug were very heavily corroded (**see Figure 4**). Although the governor linkage was free to move by hand, it was not established whether its range of movement was to specification. The engine and pump were not test run as part of this inspection.
