Report on the investigation of the
impact with the quay by
the passenger ro-ro ferry
P&OSL Aquitaine
at Calais
on 27 April 2000

Marine Accident Investigation Branch
First Floor, Carlton House
Carlton Place
Southampton
United Kingdom
SO15 2DZ

Report No 27/2001
July 2001

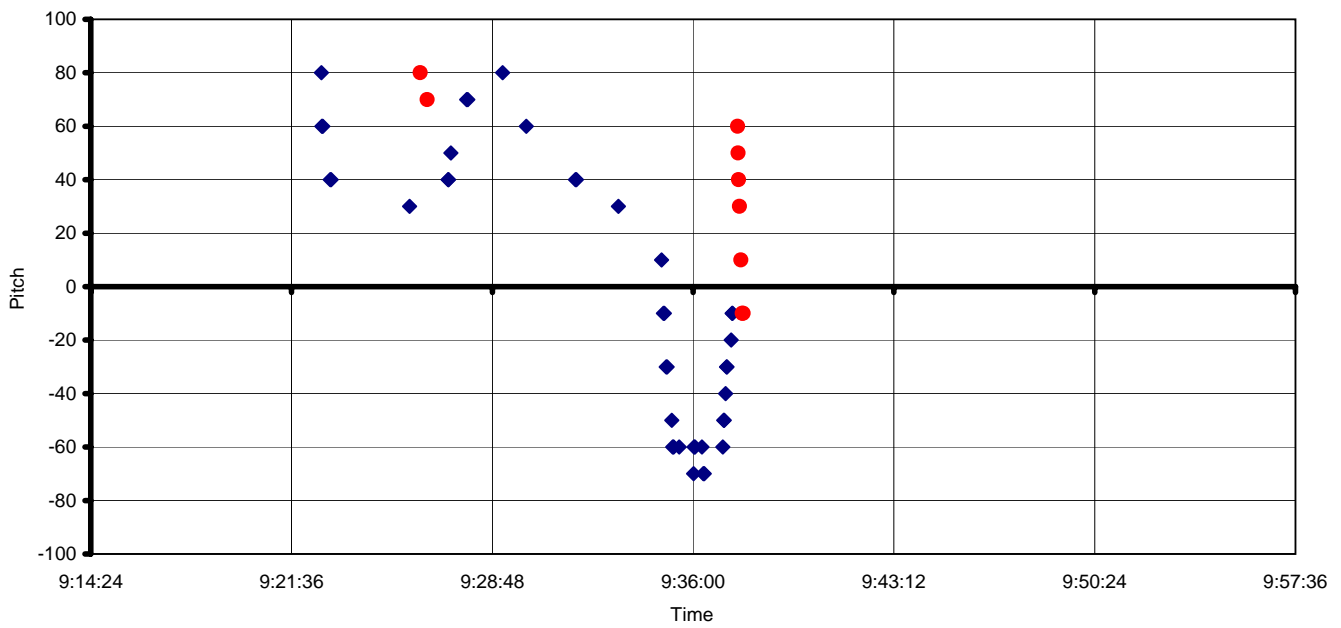
Port Pitch

When approaching the harbour entrance, neither the master, nor the first officer, noticed that the port propeller pitch remained fixed at 70%, despite changes in demand. Given these conditions, manoeuvring within the harbour was bound to be precarious. Despite this, however, when dangerous situations arose with the vessel sheering towards *P&OSL Kent*, and subsequently towards the knuckle at

The pump was unable to produce sufficient pressure in the high pressure side of the CPP system to cause the blade pitch to change in response to movement of the pitch control combinator levers. Consequently the blades locked into the position achieved, that is 70% ahead pitch.

1. Since the accident, and before the production of this report and recommendations, P&O Stena Line has taken the following action:
2. A follow-up alarm has been fitted to both port and starboard CPP systems giving audible and visual alarms on the bridge centre console. The alarms activate when 20% difference between demanded and achieved pitch occurs.

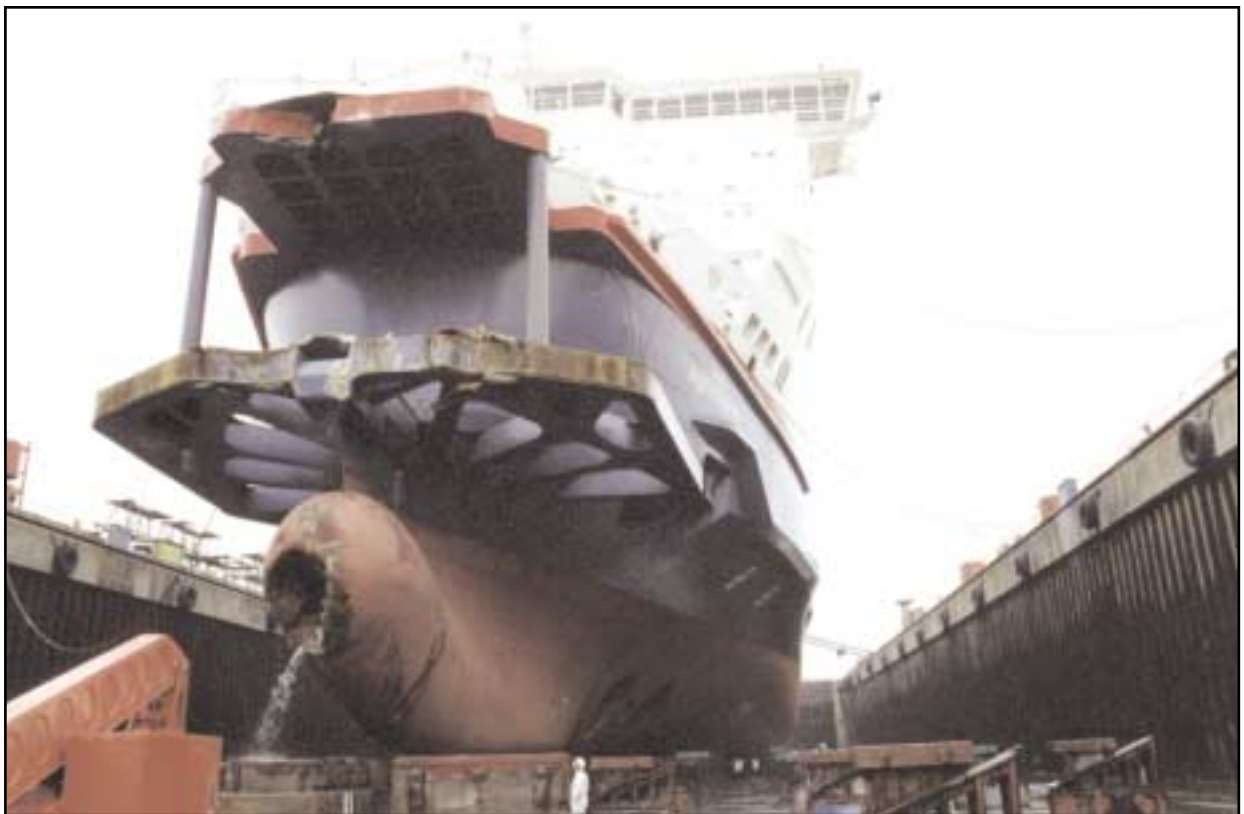
Figure 4

The vessel sustained damage to her bulbous bow, forward upper and lower fixed fenders, fore peak and forward clam door. About 200 vehicles on the car decks were damaged. There was also damage to various fittings, furniture and crockery. The vessel received temporary repairs in Dunkirk. Repairs were completed in Falmouth. She resumed full service in early June 2000. Calais No 7 berth was badly damaged and was out of use for several months.

Damage to bow

5. No 7 berth was badly damaged, and was out of use for several months. [1.9]
6. The vessel suffered damage to her bulbous bow and bow apron. Some vehicles on the car decks were also damaged. [1.9]

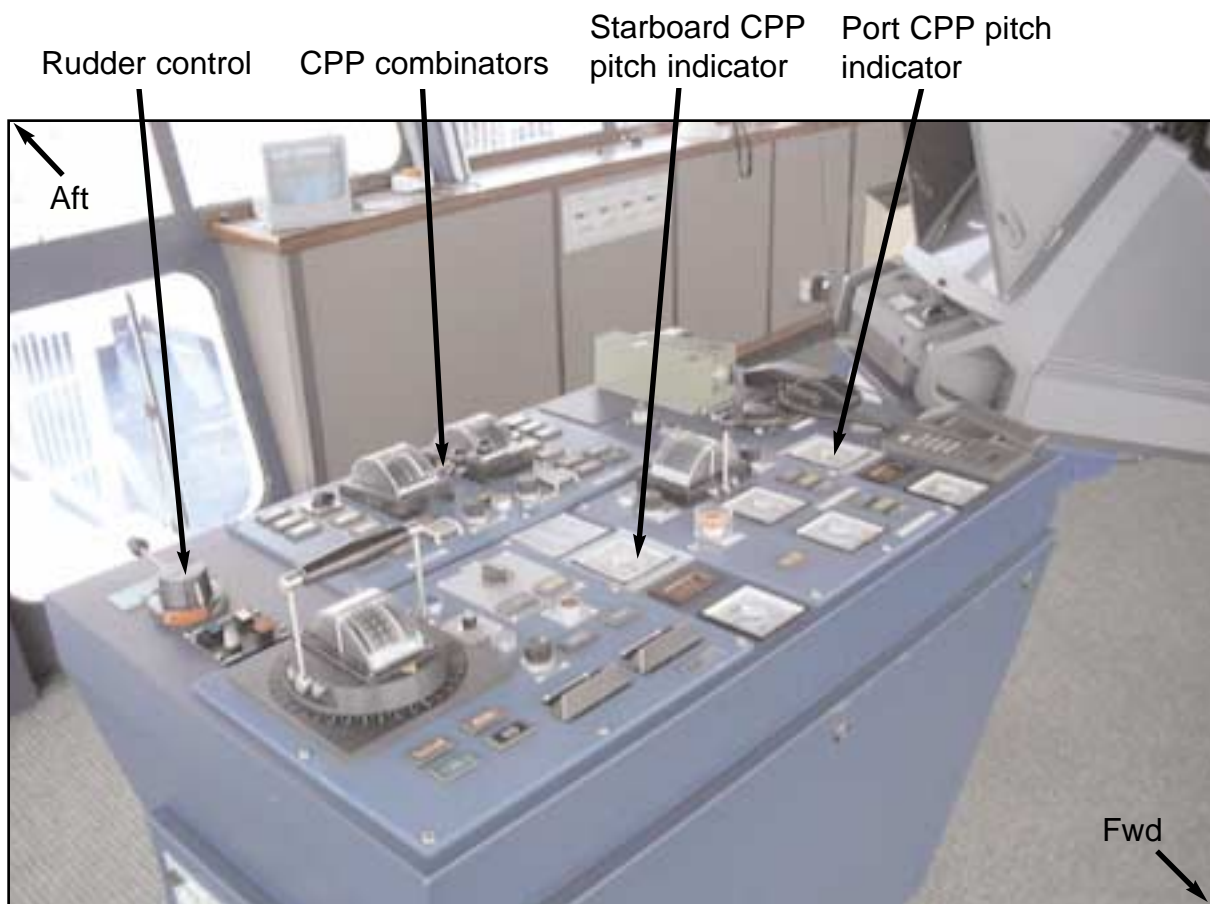
Figure 5

Starboard bridge wing console

The port CPP pitch indicator was not checked at all by the master or the OOW. Had they observed the console instrumentation during the manoeuvre into the port, they would have realised that something was wrong with the controls.
