Report on the investigation of
an explosion on board
fv Fleur de Lys
which then foundered
18 miles south-east of Portland Bill
on 16 April 2000

Marine Accident Investigation Branch
First Floor, Carlton House
Carlton Place
Southampton
United Kingdom
SO15 2DZ
Report No 36/2001
October 2001

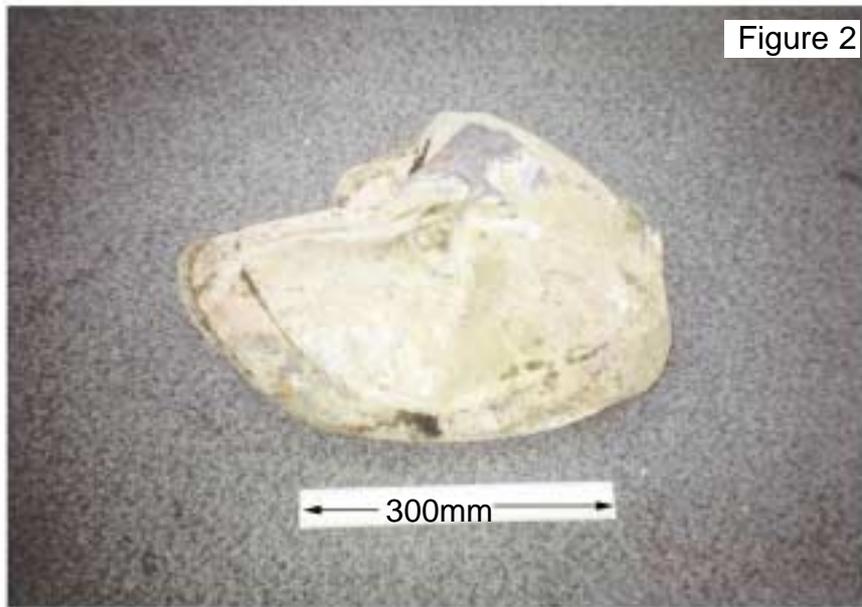
Figure 2

During the late morning of the second day of this work, the base of the hot water cylinder was found. This was at the port side of the engine room, level with the floor plates, about 400mm forward of the aft engine room/cabin division. Shortly afterwards, the top of the cylinder, complete with immersion heater element, was found slightly forward of this position.

These three items were all seriously distorted, and no thermal insulation remained on their surfaces. The cylinder bottom showed signs of failure of the circumferential brazed joint to the wrapper plate. Many other failure surfaces were of virgin material some distance from any brazed or welded seam.

Base of hot water cylinder

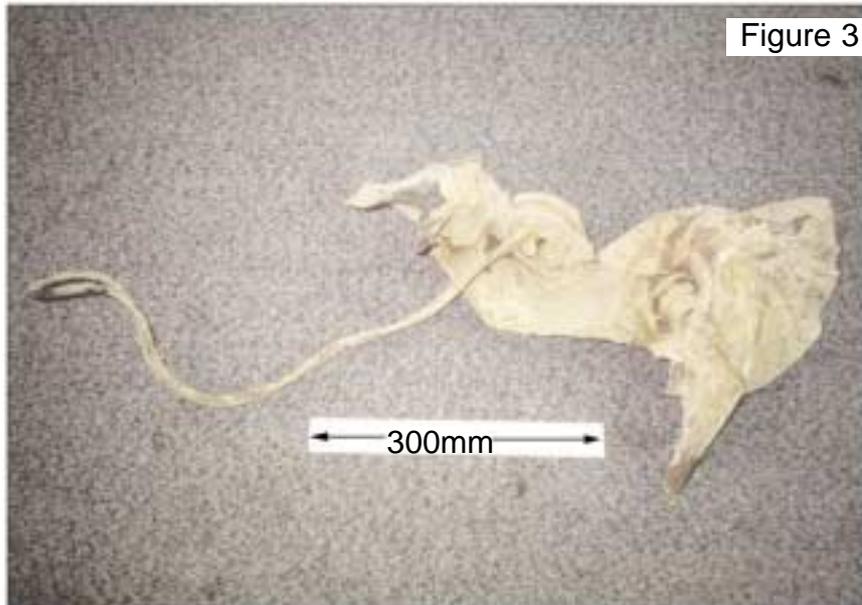
Figure 3

Cylinder top, with element of immersion heater

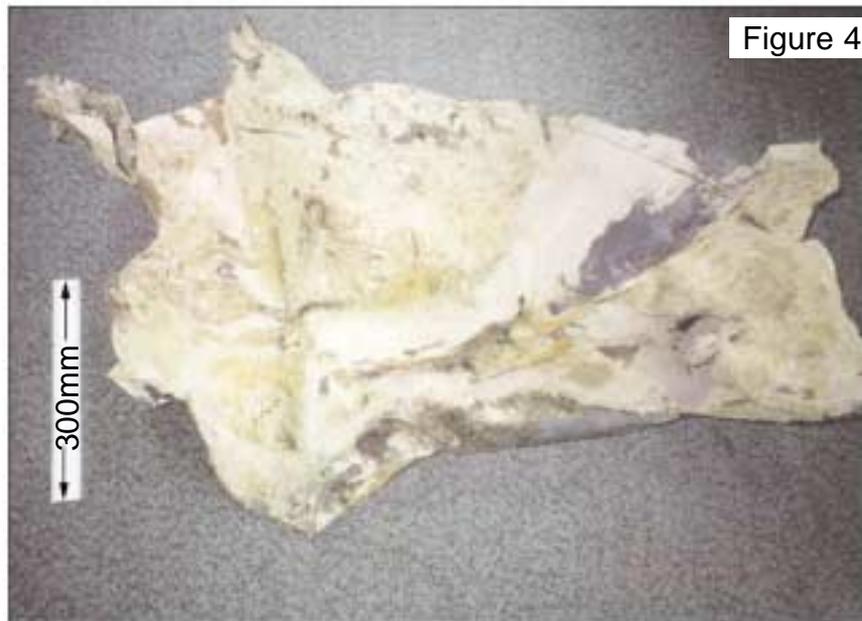
Figure 4

Further searching resulted in the cylinder's cylindrical wrapper plate being found beside the starboard side of the main engine, partially below floor plate level, and about 2m forward of the engine room/cabin division. A smaller piece was close by. The wrapper plate was noted to be embossed with the manufacturer's mark, M4469 (**Figures 2, 3 & 4**).

Wrapper plate of cylinder

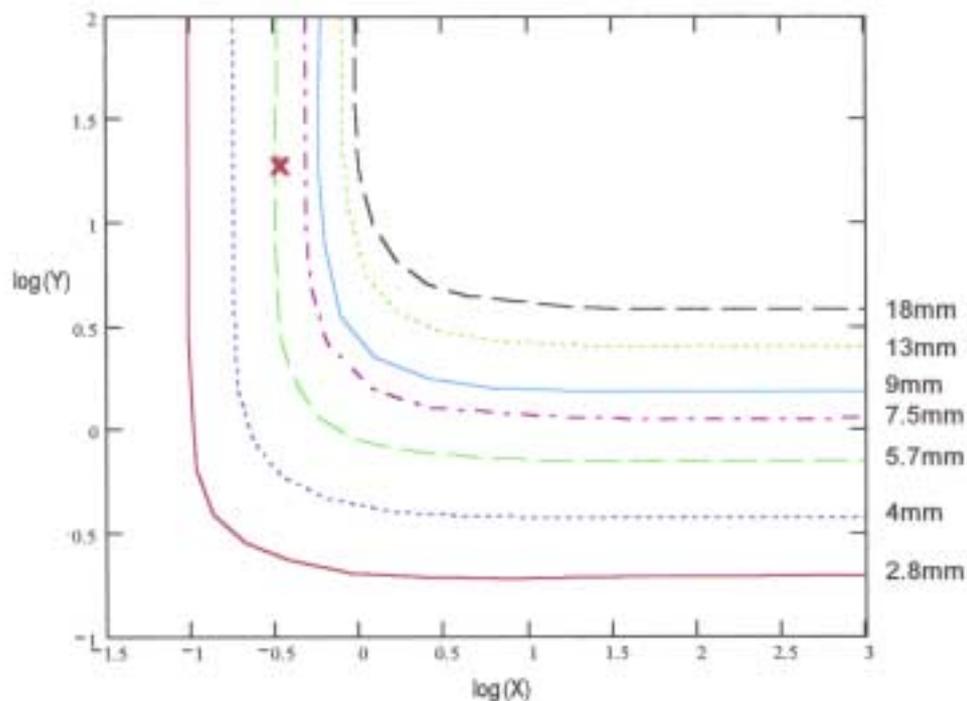
The PI chart for beams has been reproduced from the figure in Ref.2 and is shown below. The X-axis represents the resistance to peak overpressure and the Y-axis represents the resistance to impulse. The X and Y values for the peak overpressure of 2.12 bar and the impulse of 0.0215 bar s and for the hull plank defined earlier are 0.336 and 19.5 respectively and these figures are represented by the point X on the chart.

This result shows that the blast load would expect to deflect a hull plank by up to 6mm between the frames. This would apply to all the planks in similar locations.

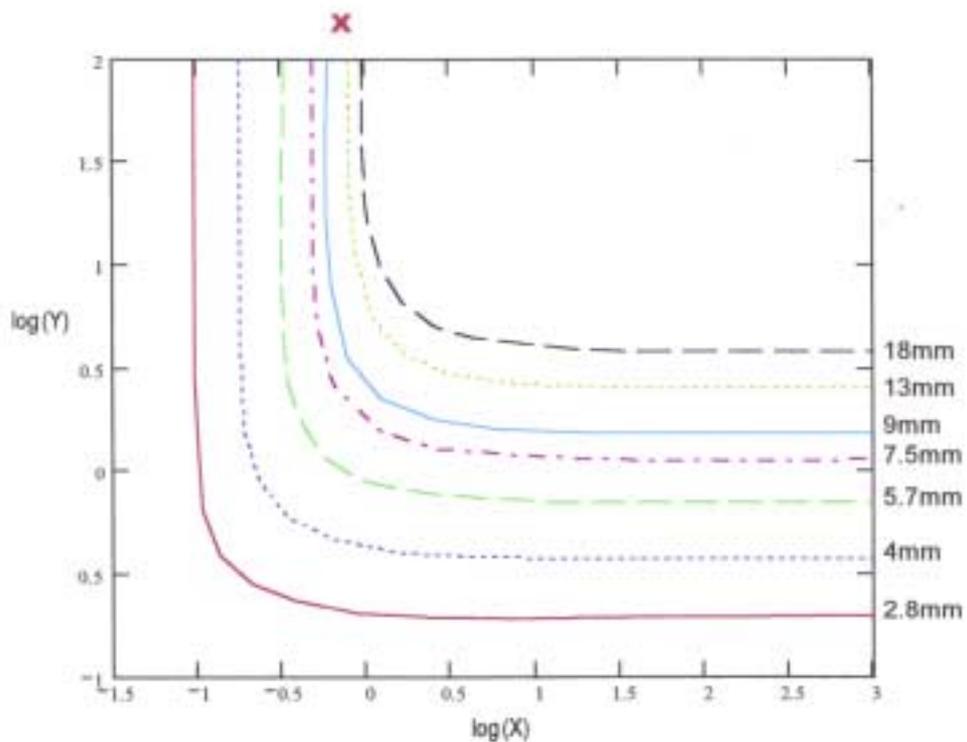
The PI chart for beams has been reproduced from the figure in Ref.2 and is shown below. The Y-axis represents the resistance to peak overpressure and the X-axis represents the resistance to impulse. The X and Y values for the peak overpressure of 4.44 bar and the impulse of 0.155 bar s and for the hull plank defined earlier are 0.705 and 141 respectively and these figures fall outside the chart as shown in the figure on the next page.

This result shows that the blast load would expect to deflect a hull plank by up to 11mm between the frames. This would apply to all the planks in similar locations.
