**Report of the investigation
of an accident on the bulk carrier
mv *Diamond Bulker*
with the loss of two lives
when at anchor in Lough Foyle,
Londonderry, Northern Ireland
on 5 April 2000**

Marine Accident Investigation Branch
First Floor, Carlton House
Carlton Place
Southampton
SO15 2DZ

Report No 9/2001

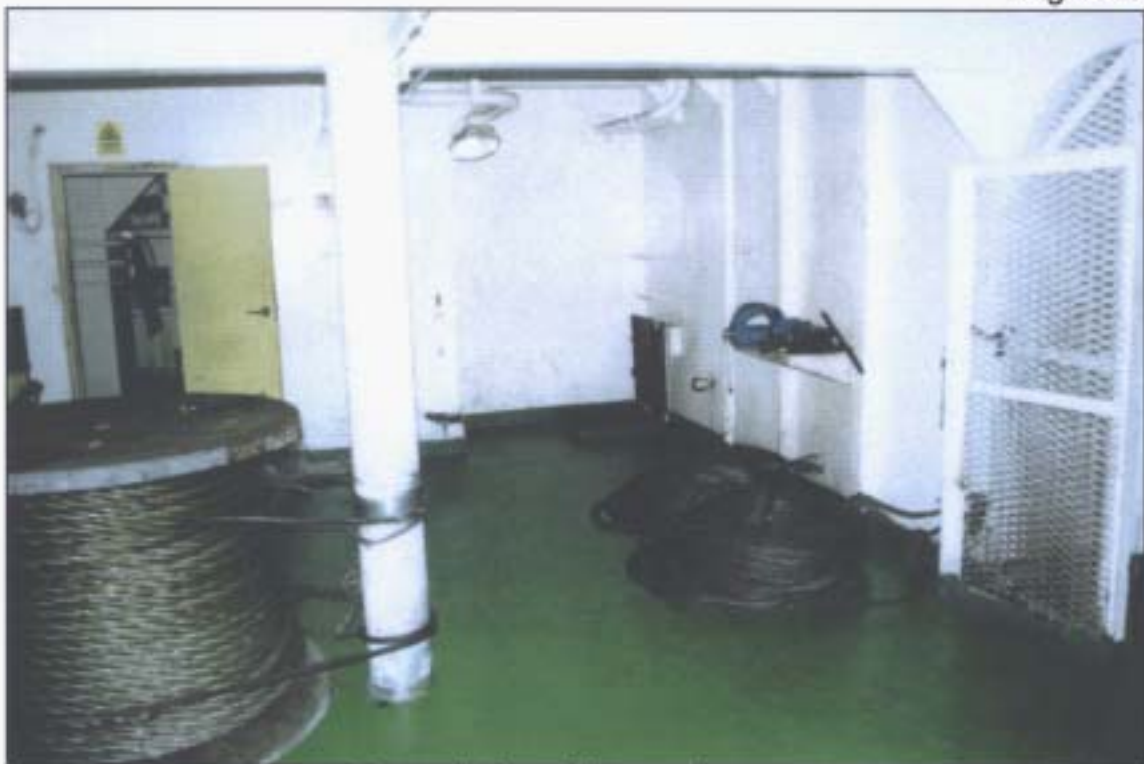
Figure 2

General view of forecastle store
Note open hatch in corner leading down into N°1 hold

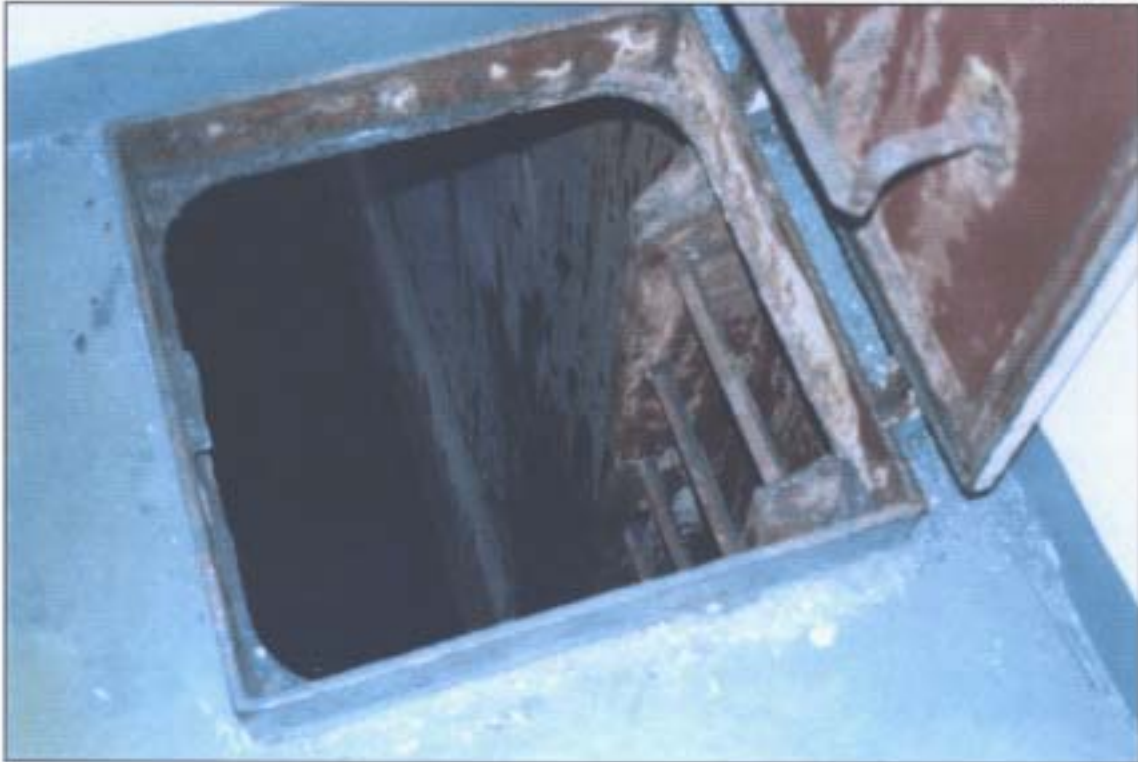
Figure 3

View of entry hatch showing vertical ladder and first platform

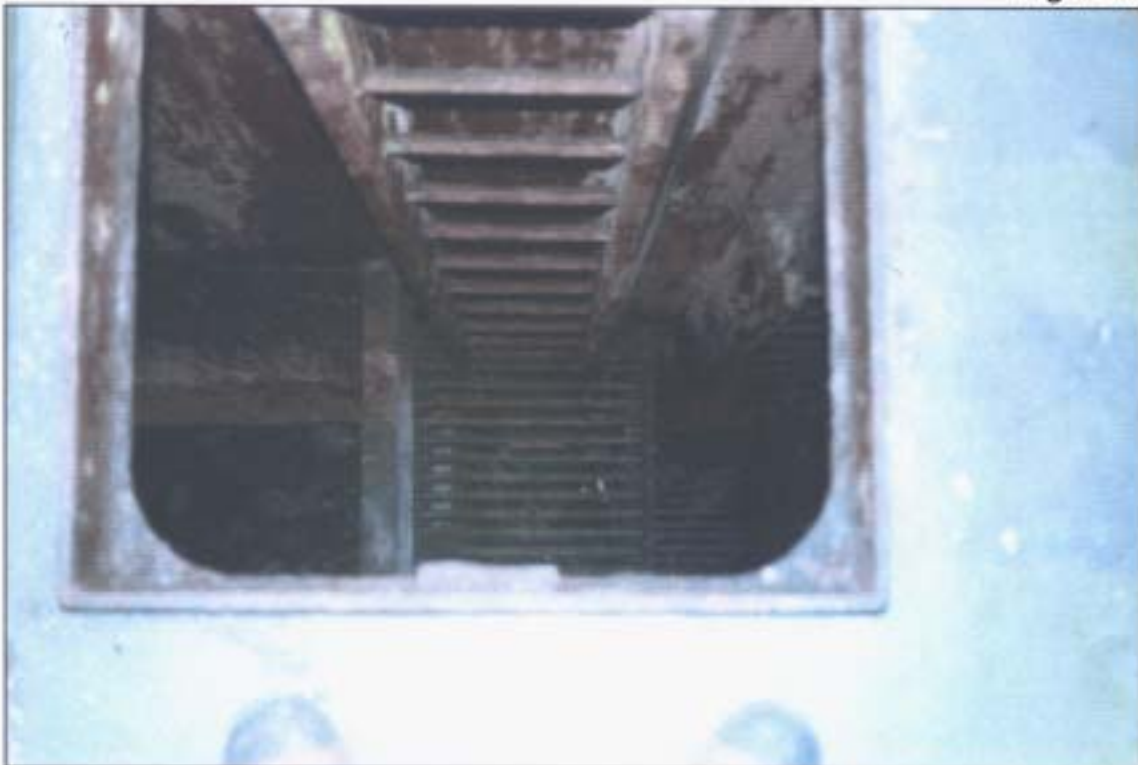
Figure 4

Close up of entry hatch to N°1 hold

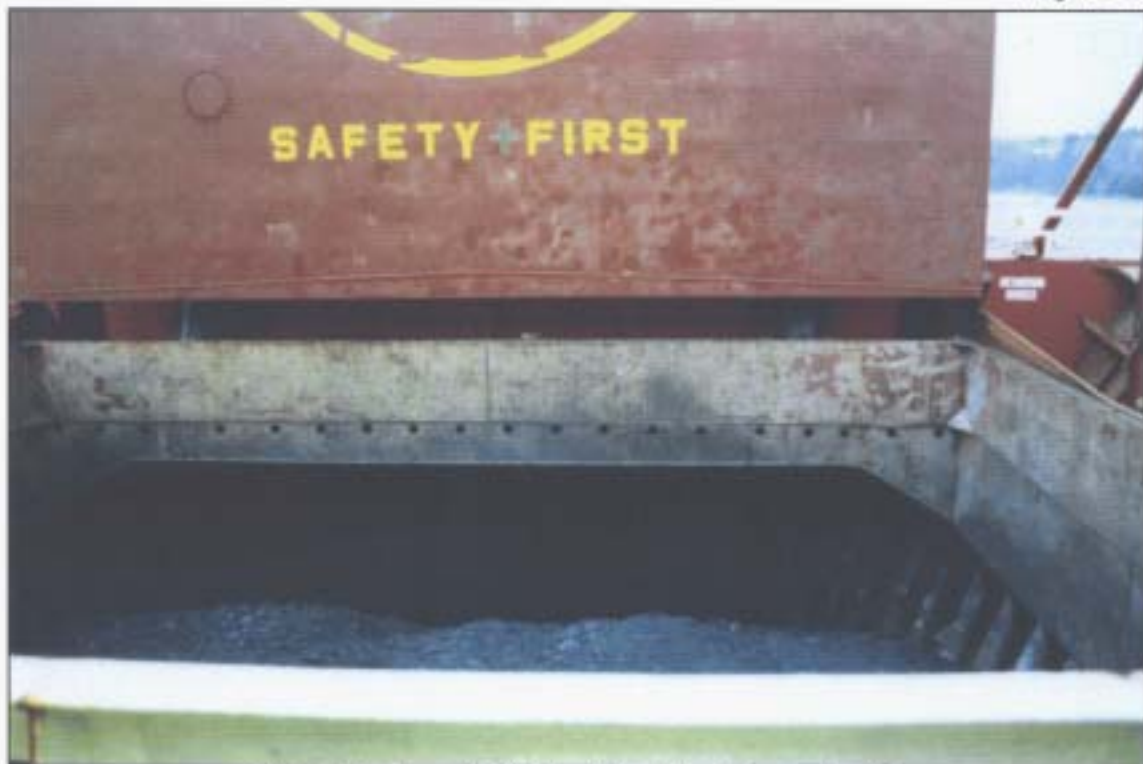
Figure 5

General view of N°1 hold looking forward with forward part of hatch cover in raised position

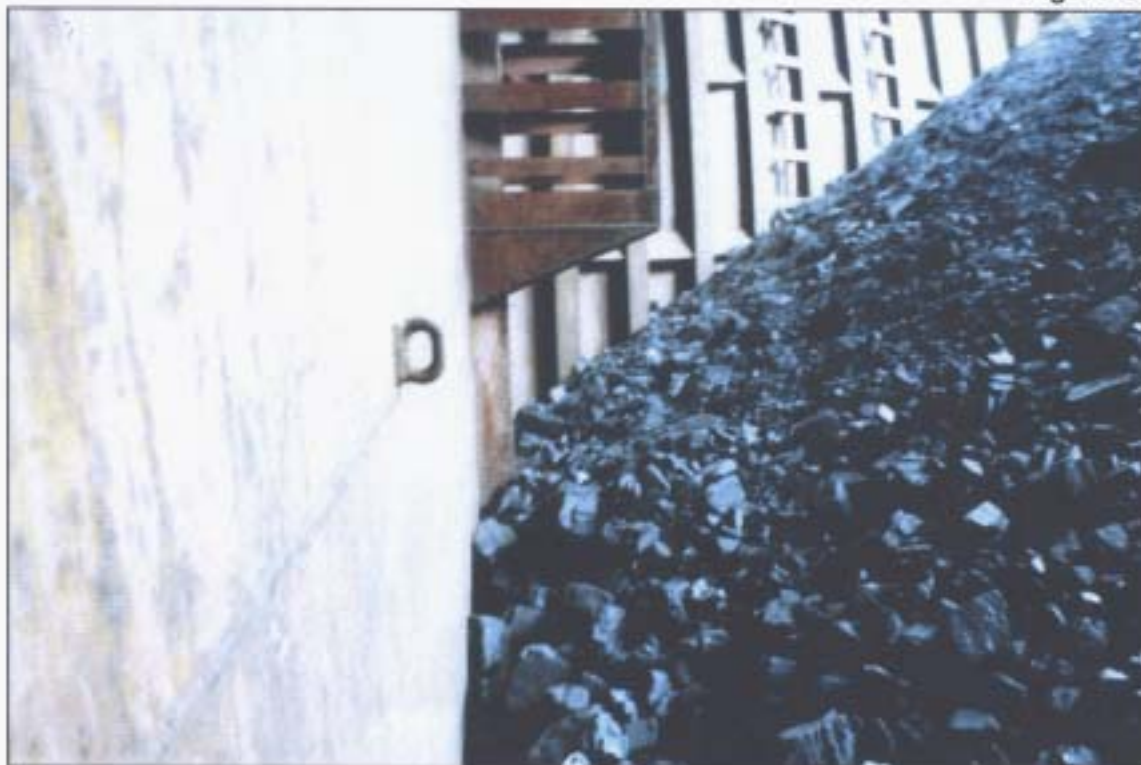
Figure 6

View inside N°1 hold looking from port to starboard at forward bulkhead
Note bottom of second platform

The cause of the accident was low oxygen and increased carbon dioxide levels present in No 1 hold due to an ongoing oxidation process in the cargo of coal.
