**Report on the investigation of  
the collision between the  
United Kingdom registered feeder container ship  
*Celtic King*  
and the Belgian registered fishing vessel  
*De Bounty*  
to the south of The Smalls traffic separation scheme  
off the south-west coast of Wales  
on 19 March 2000**

**Report No 2/2001**

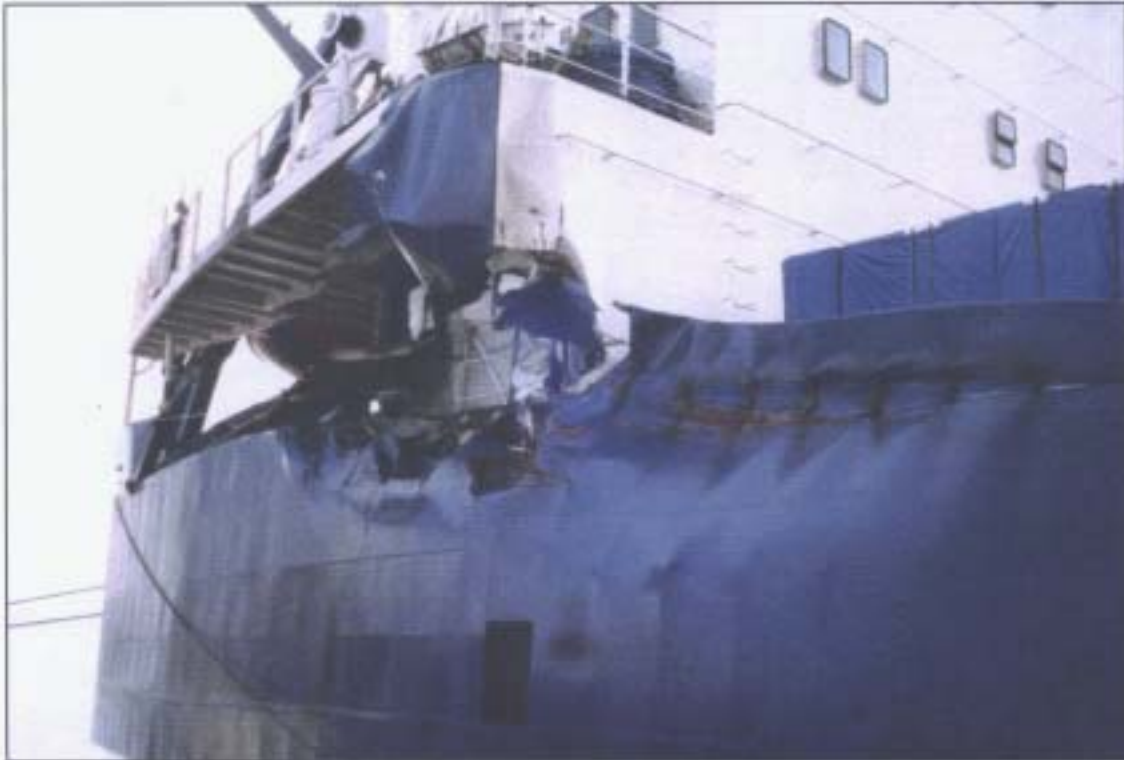
### **1.3.4 Damage (see photograph 3)**

The bulwark from the main deck to the forward starboard side of the accommodation superstructure was severely indented and scraped. The gangway stored aft of this was distorted. The fairing between the poop deck and the boat deck was distorted and ripped. The compartment below the poop deck was severely indented at the forward corner.

Damage to *Celtic King*

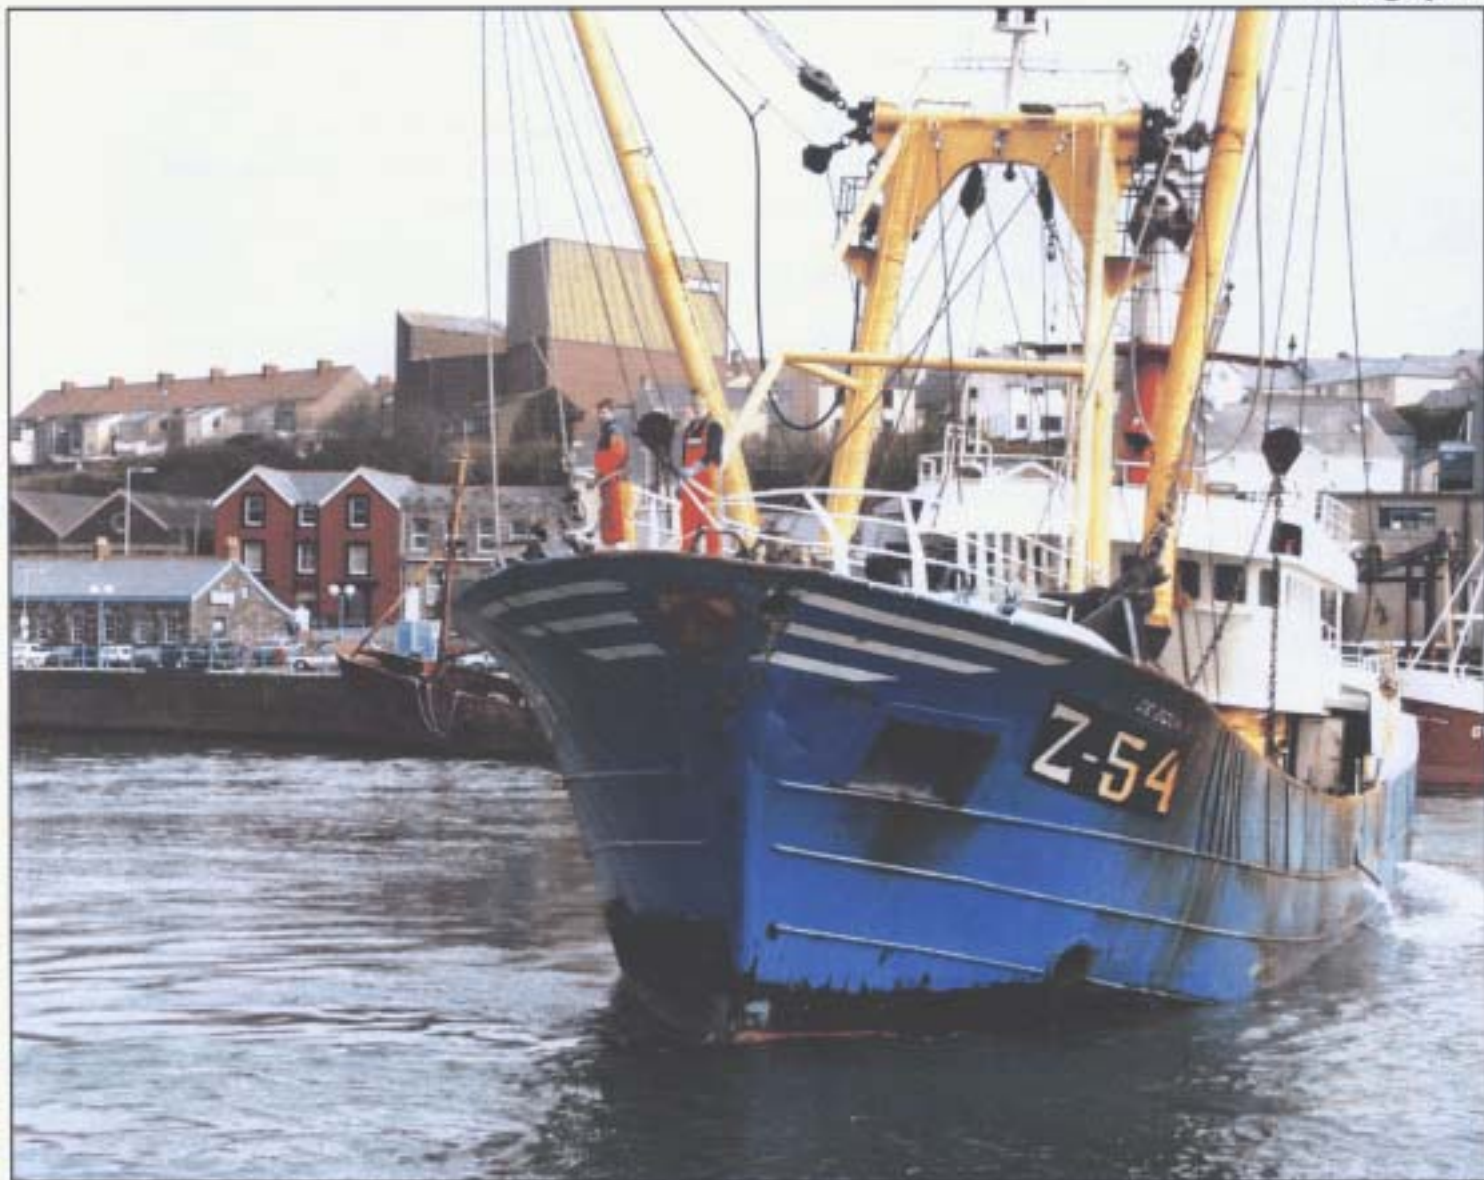
#### **1.4.4 Damage (see photograph 4)**

There were scrape and indentations on either side of the stem between the main deck and the top of the whaleback. There was one small hole to port of the stem bar just beneath the whaleback deck edge.

Damage to *De Bounty* confined to the upper part of the stem

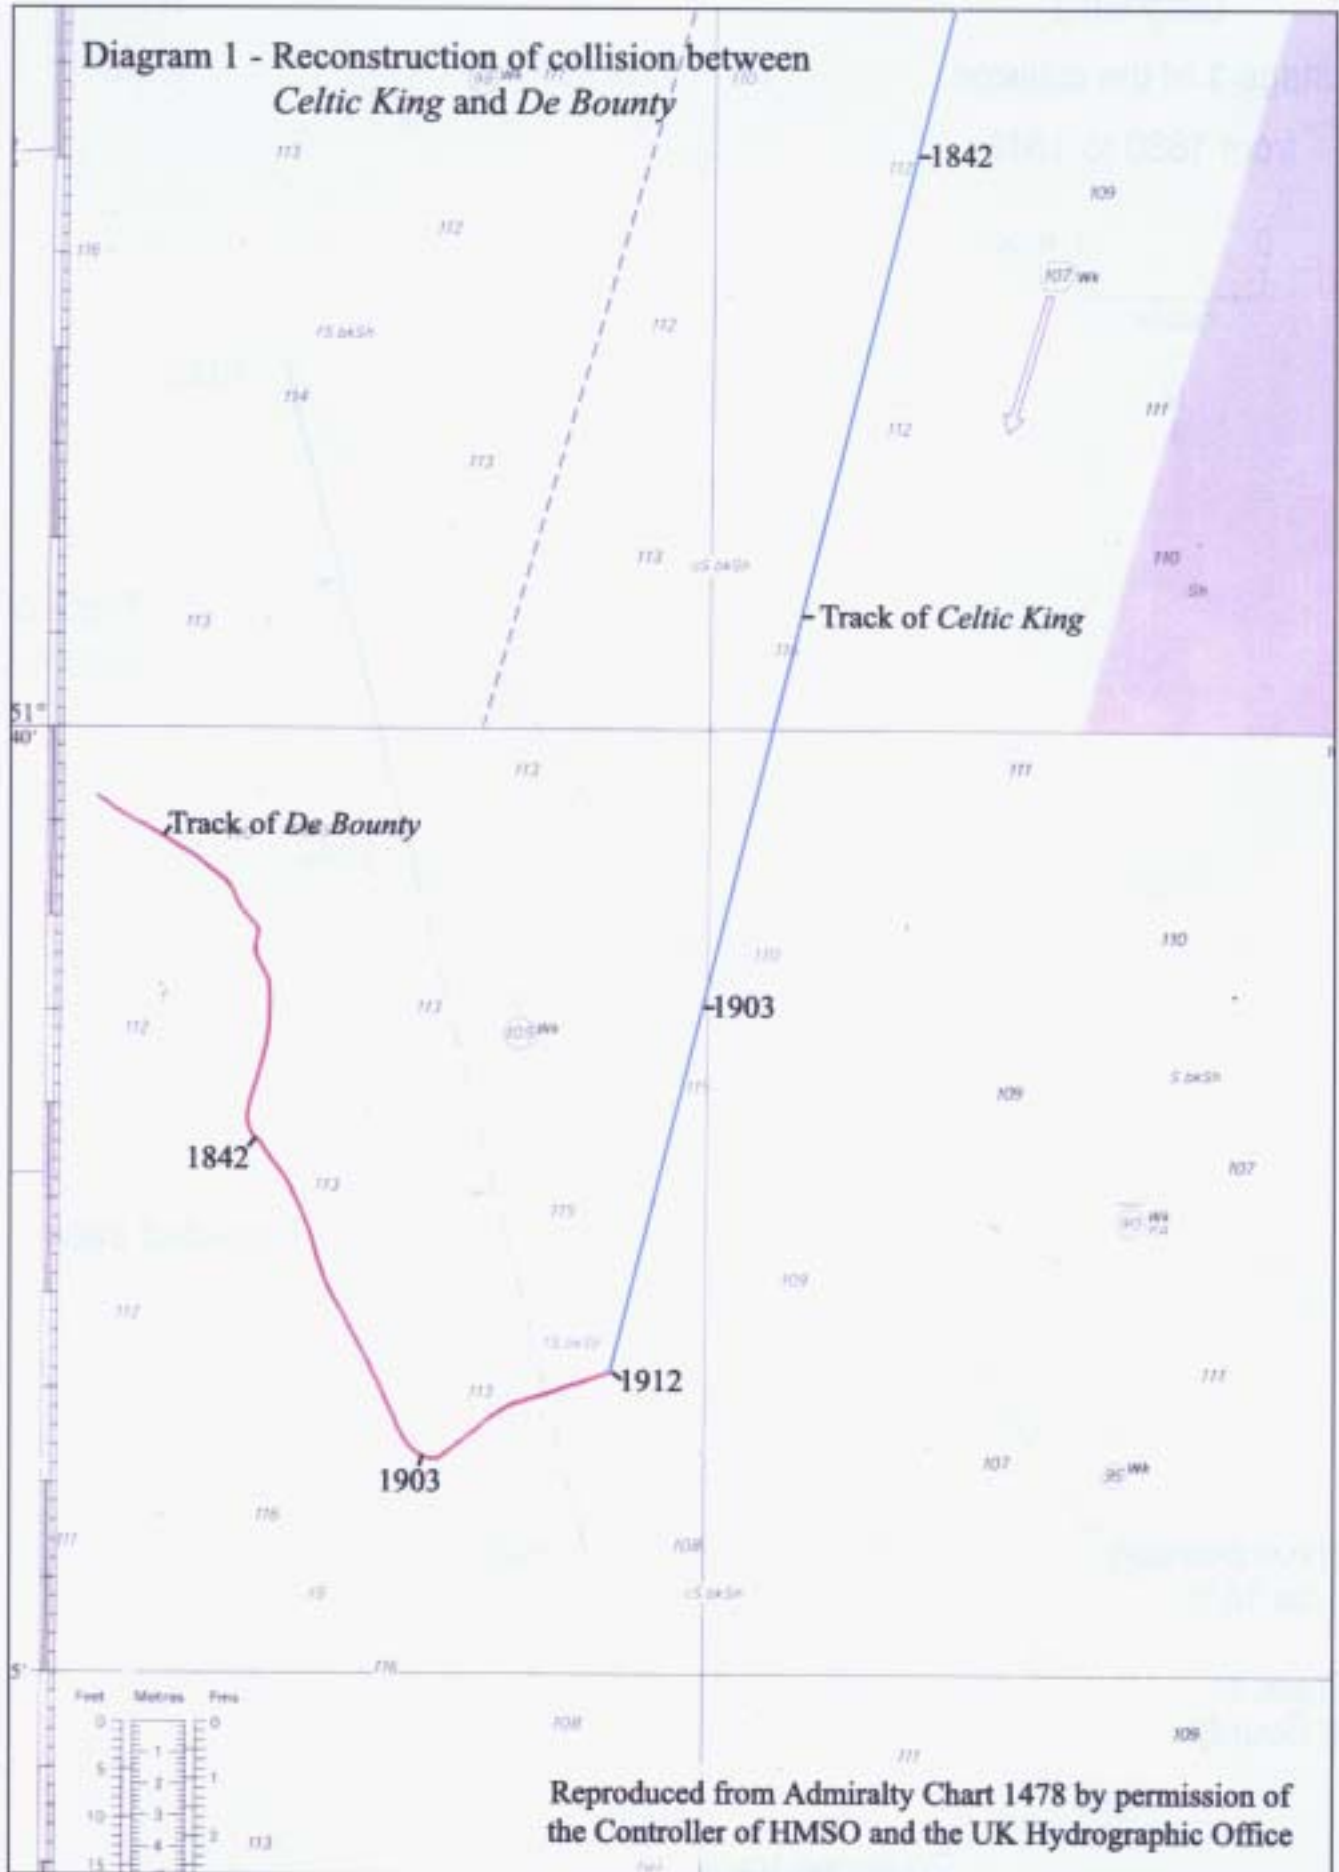
Diagram 1 - Reconstruction of collision between *Celtic King* and *De Bounty*

The track of the fishing vessel was being recorded on her electronic chart system, from which data were taken at sample points (latitude, longitude, time, distance and course made good since last sample point). A hard copy of the track was printed off and has been reproduced in **diagram 1**.

*De Bounty* made good a steady course of about 120° until just after 1830, which was the approximate time that *Celtic King*'s radar predicted *De Bounty*'s CPA ahead was about 2 miles. If the fishing vessel's track line is projected from the 1830 position to cross ahead of *Celtic King*, it is found that this would have occurred at about 1900 at a distance of about 1.4 mile. However, from about 1830, *De Bounty*'s track followed a more southerly route.

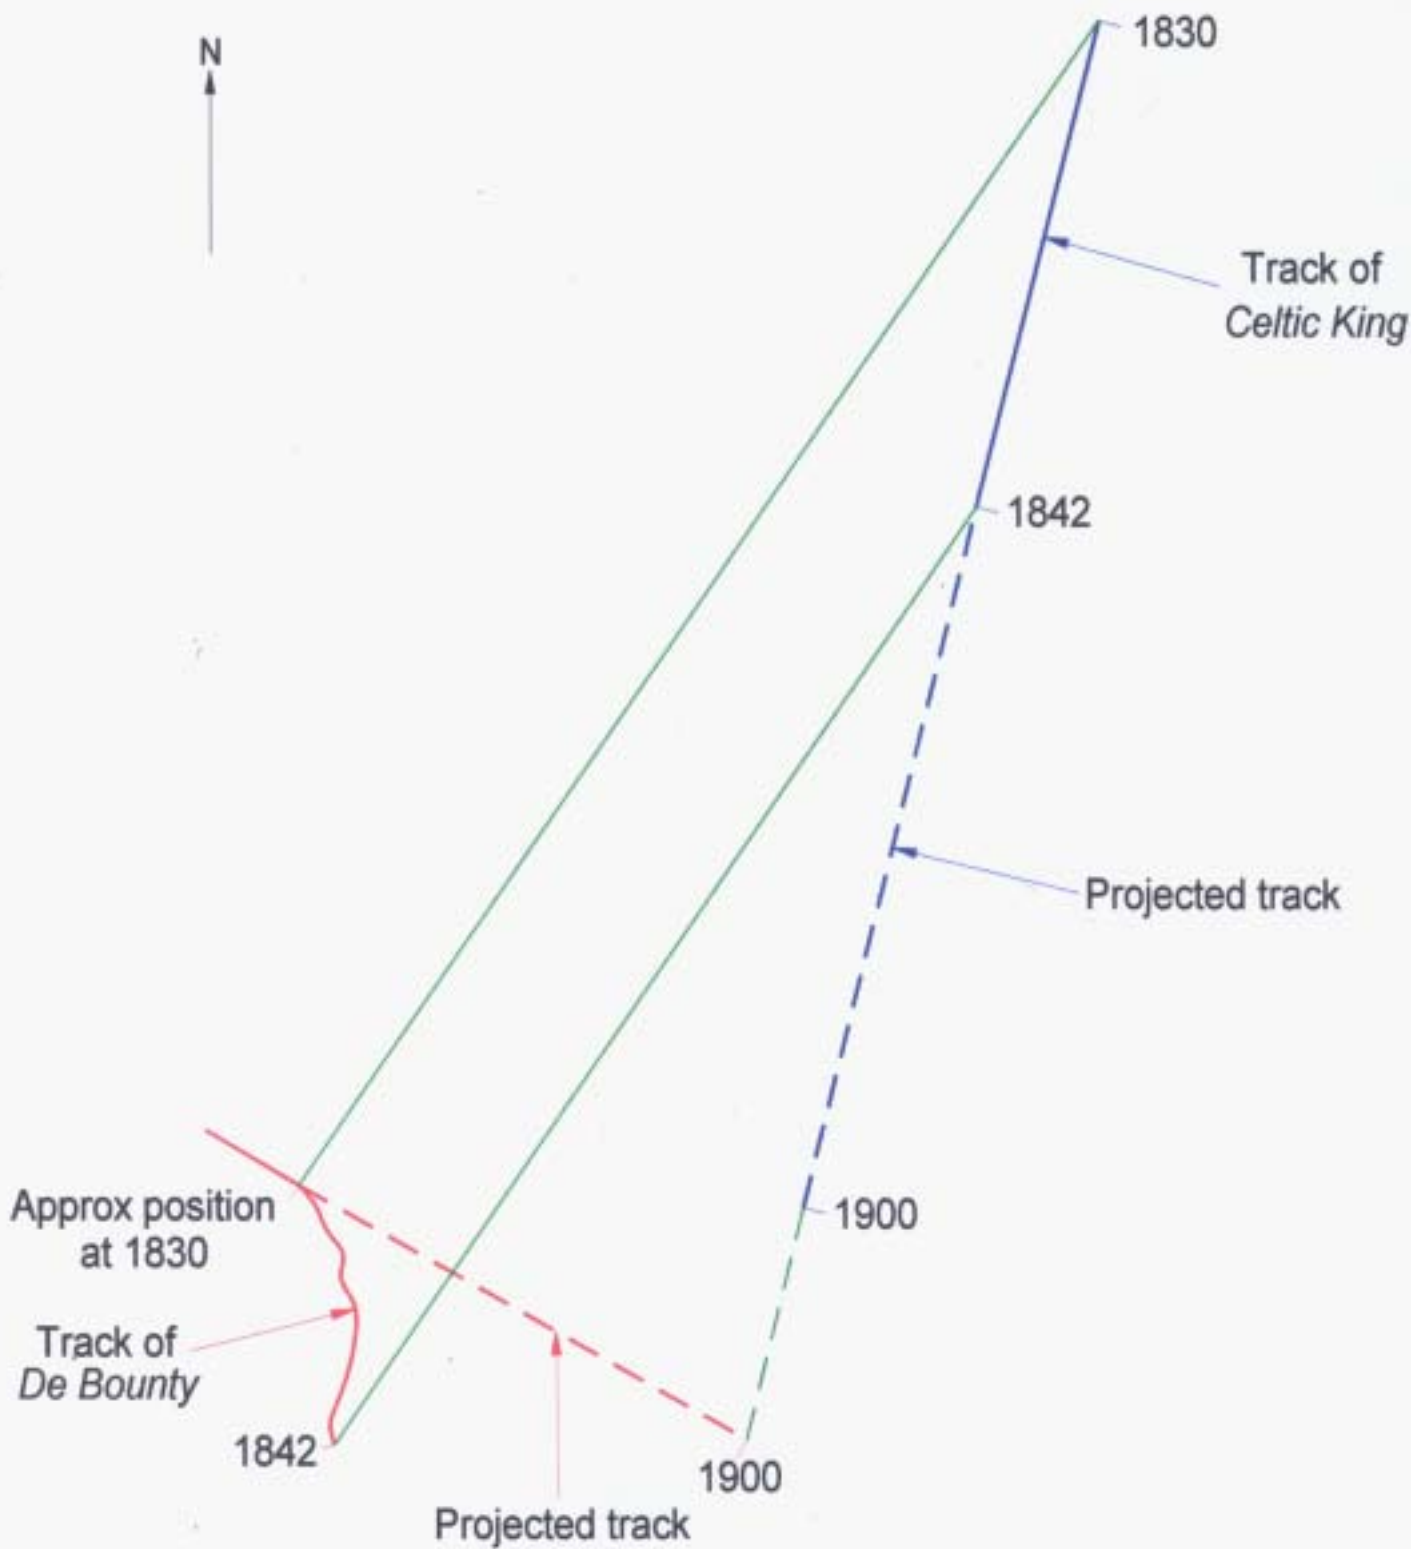
Diagram 2

Stage 1 of the collision  
from 1830 to 1842

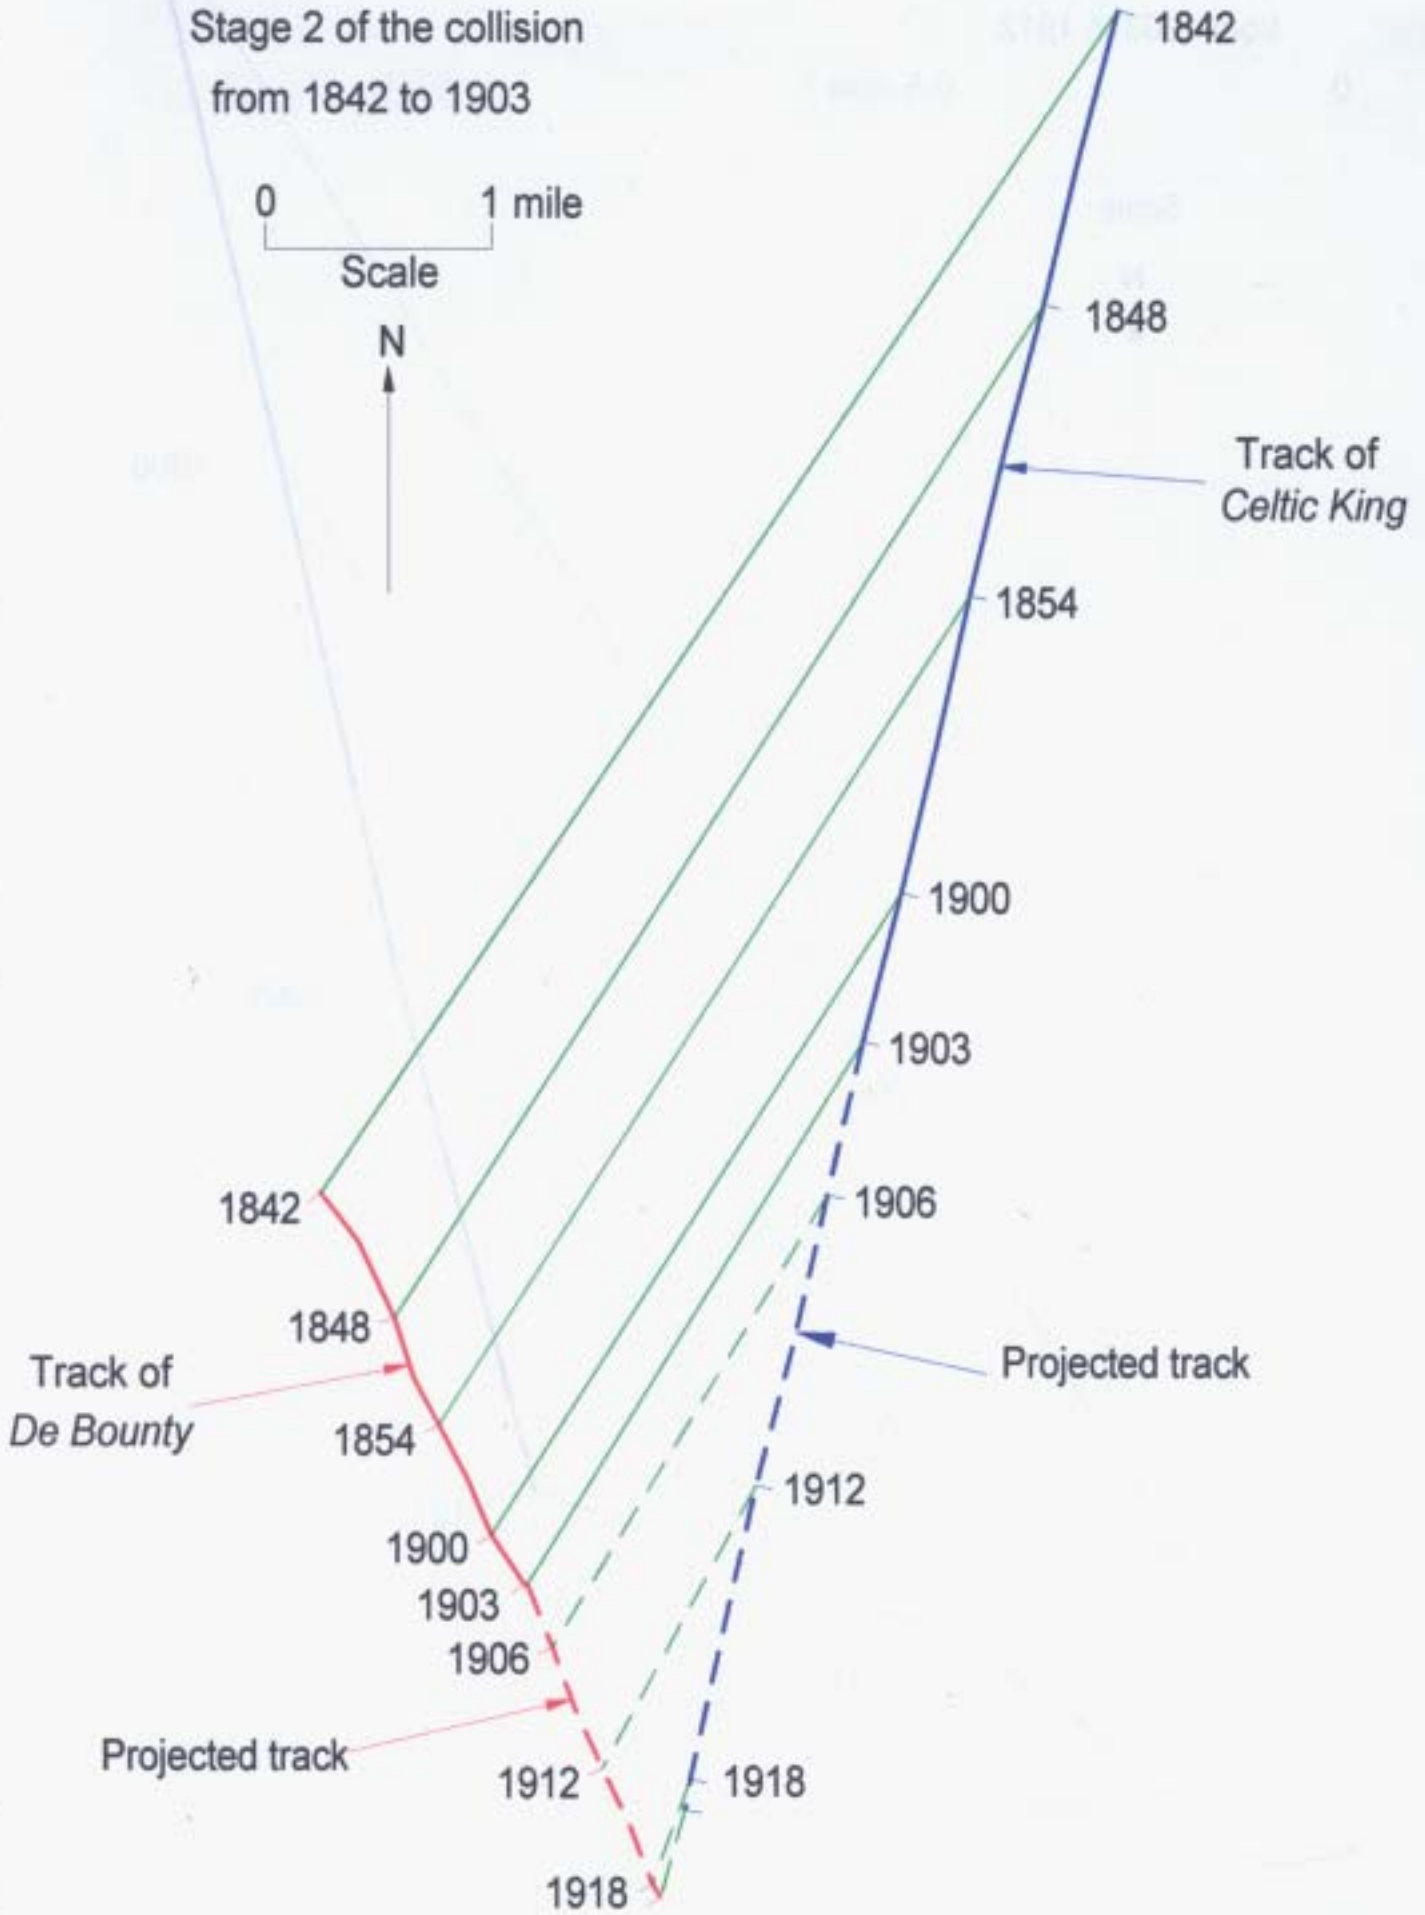
Diagram 3

Stage 2 of the collision  
from 1842 to 1903

From 1842 *De Bounty* made good a relatively steady track of about 154° (see **diagram 3**). At 1842, *Celtic King* was just over 6 miles away, and the mate would not have seen her echo on the radar until a few minutes later. When the echo appeared on the edge of the screen at 6 miles, it had a relative bearing of about 240° or nearly 3 points abaft the port beam.

The fishing vessel's speed was variable but, between 1842 and 1903 she had travelled 1.95 miles, which gave an average speed made good of about 5.6 knots. If the fishing vessel had continued on her course at that speed instead of turning on to an easterly heading, she would have crossed about 4 cables ahead of the ship (see **diagram 3**). However, the fishing vessel's speed increased after 1903, which increased the crossing distance.

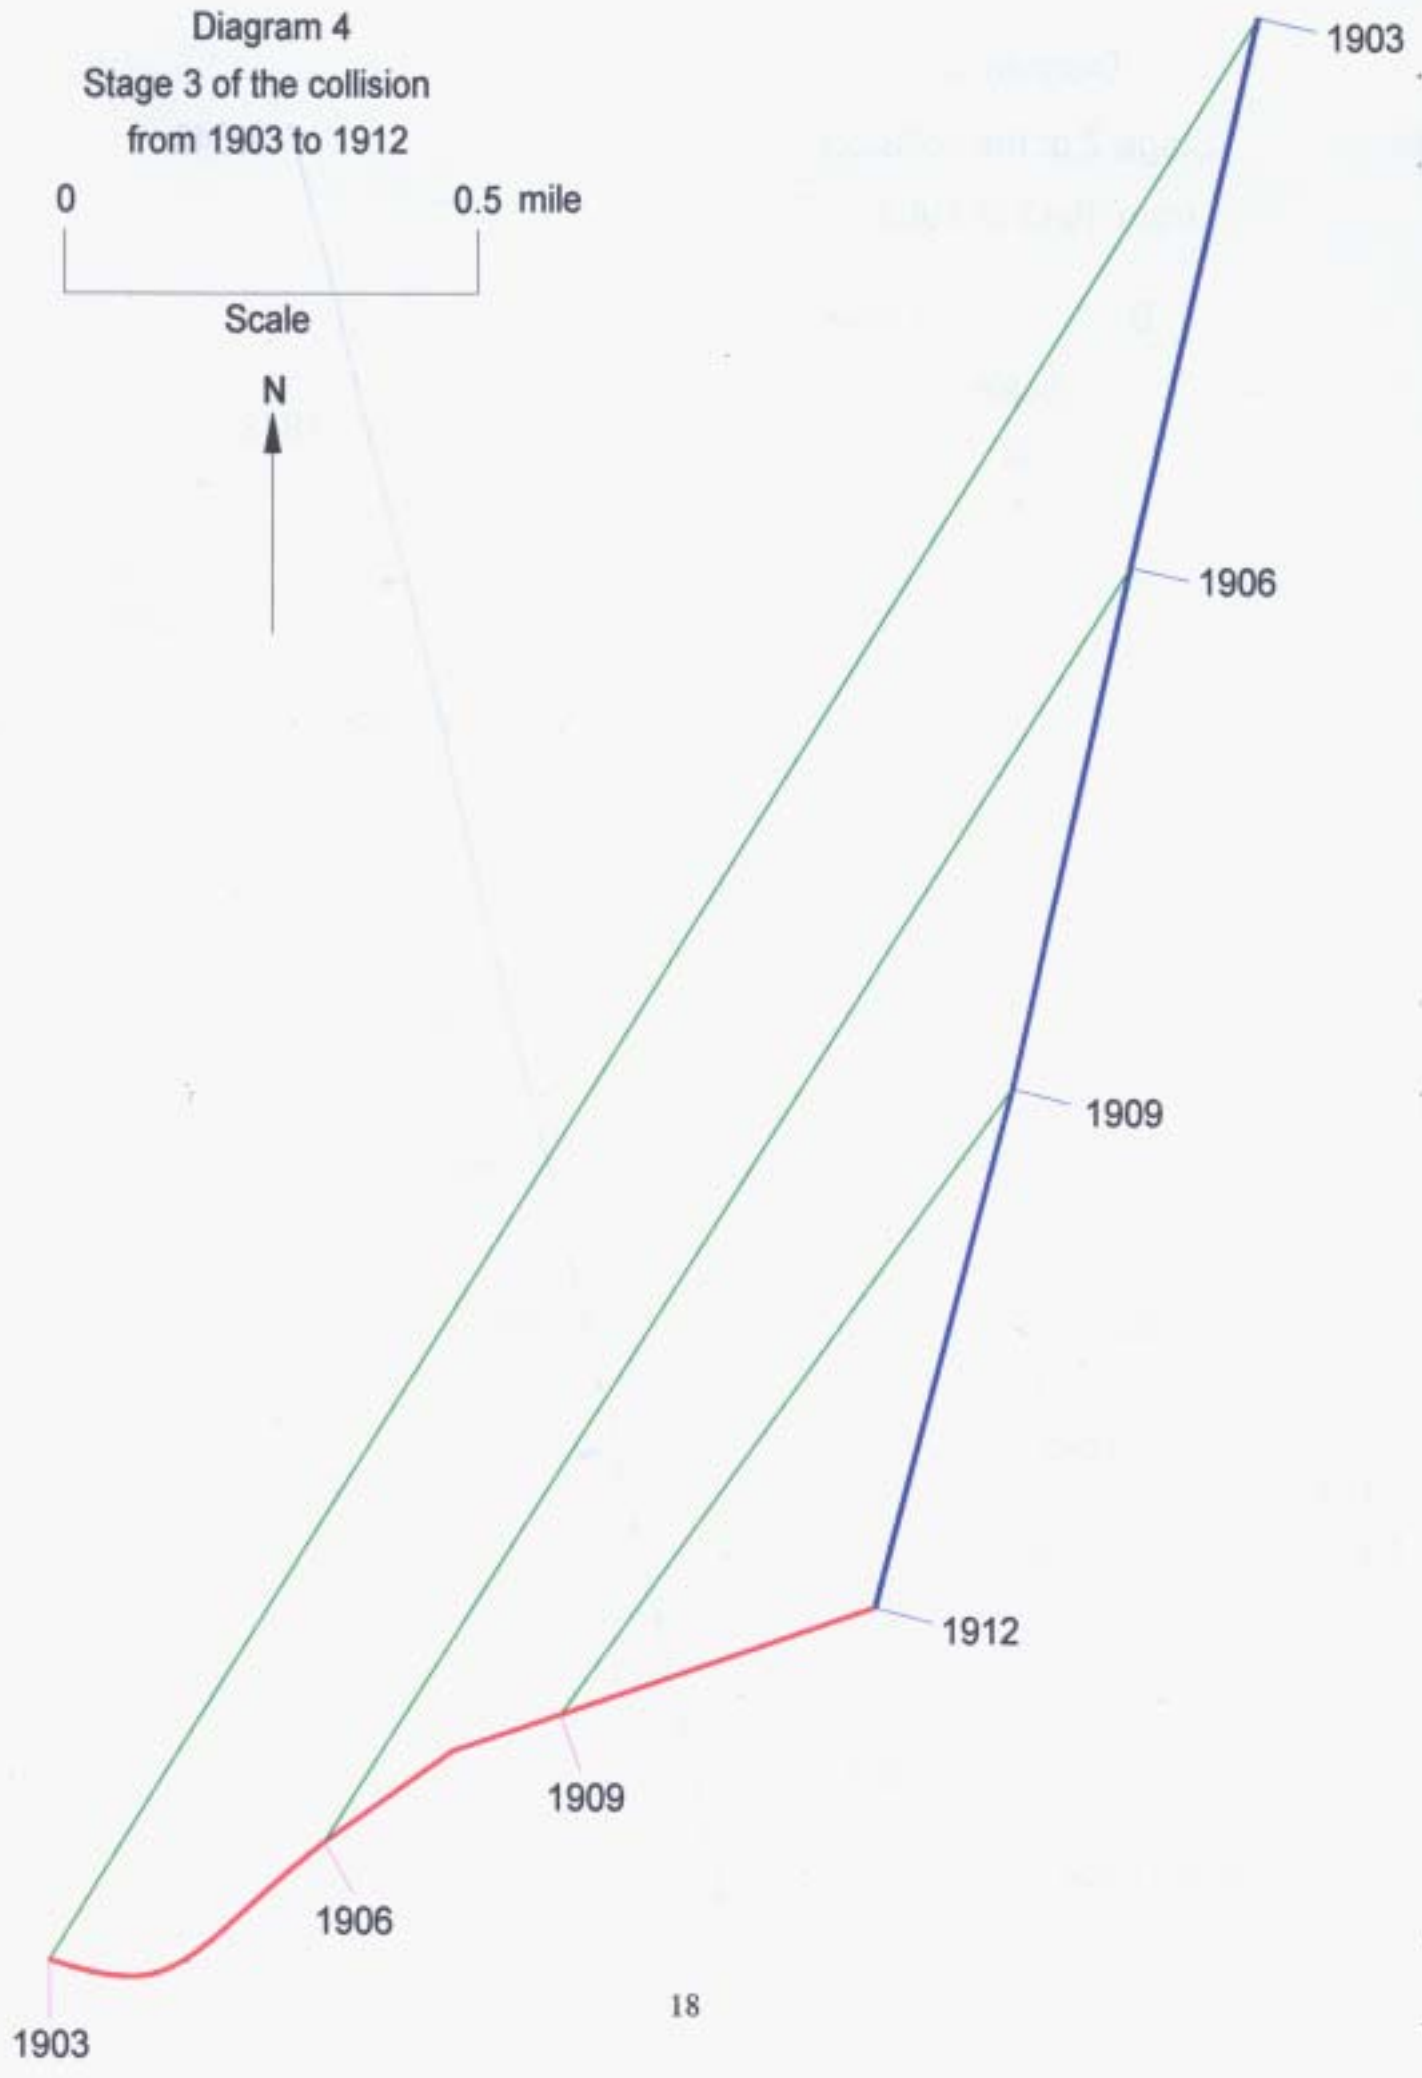
Diagram 4  
Stage 3 of the collision  
from 1903 to 1912

At 1903, the mate turned the fishing vessel to port, making good a course of about 050° until a little after 1907. At that time the vessel altered course to starboard and made good a course of about 072° until the collision. Had she continued on the 050° course, *De Bounty* would have crossed about 7 cables astern of *Celtic King*.

The mate on the fishing vessel made no systematic plots of the movement of the radar echo of *Celtic King* when on these various courses (see **Rule 7 (a) and (b) - section 1.5**). He did not make any sound signals, until the later stages of the incident (see **Rule 35(c) - section 1.5**). However, when he knew instinctively that a ship was bearing down on him rapidly, he should have called for assistance from the skipper. As the two vessels approached each other, the mate kept to the skipper's planned track, which took the vessel between 3 and 4 miles to the south of the termination of the south-west bound traffic separation lane; an area where particular caution was needed (see **Rule 10(f) – section 1.5**). Under Rule 19, both vessels had the responsibility to keep out of the way of the other. At 1903, the mate of the fishing vessel altered course towards the ship, which was abaft his port beam, and was in contravention of Rule 19. Although the initial new heading would have resulted in the fishing vessel passing astern of the ship, he made a further alteration of course (to starboard and only about 4 to 5 minutes before contact) which brought about the collision.
