Report of the Investigation
of a man overboard fatality from
mfv Opportune (WK171)
35 miles east of Wick
on 23 February 2000

Marine Accident Investigation Branch
First Floor Carlton House
Carlton Place
Southampton
SO15 2DZ

Report No 33/2000

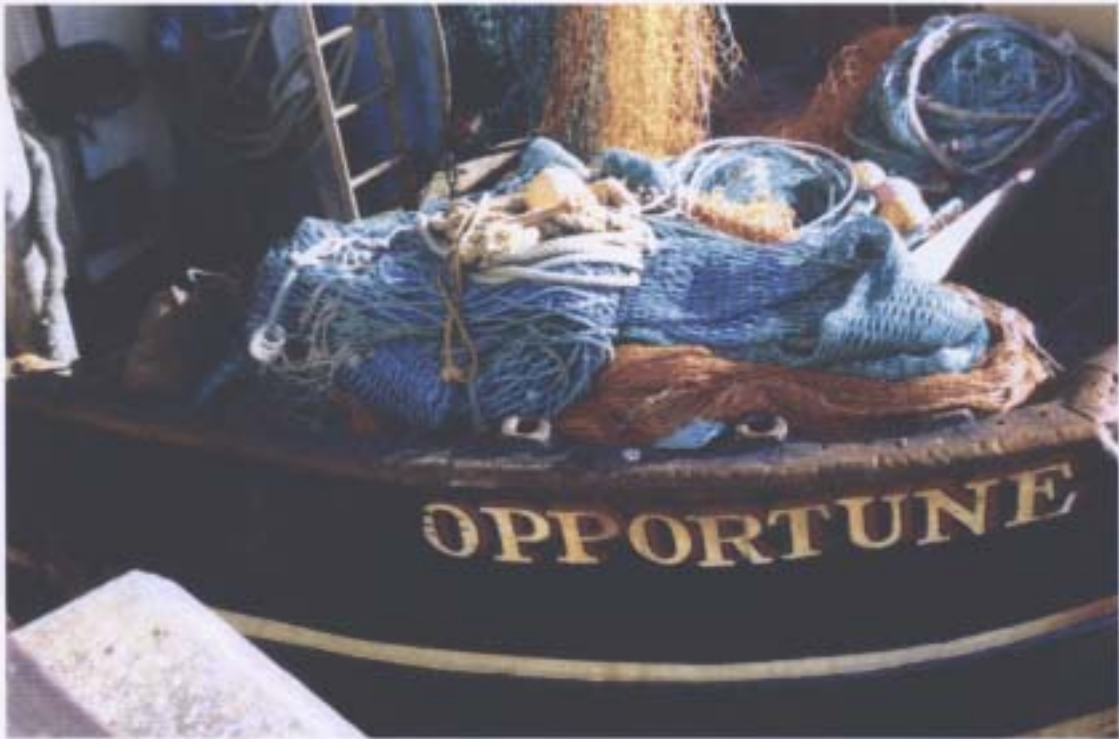
Figure 3

Part of the seine net in use at the time of the accident was stored in the port side bin at the aft end of the vessel. This section was stored with the cod end on top ready for shooting. The first wing of the net to be shot was laid on the deck of the centre bin. The remaining part of the net was wound on to the net drum.

To prevent the net spilling out of the bin when the vessel rolled it was lashed down with two ropes. The crew untied these ropes in preparation for shooting the net when one coil of rope was left on the reel.

Opportune - net secured in bin
