Report on the investigation of
the collision between
the offshore supply vessel
Highland Pioneer
and the *DA* jack-up rig
of the *Douglas* offshore installation
in Liverpool Bay
on 27 January 2000

Marine Accident Investigation Branch
First Floor, Carlton House
Carlton Place
Southampton
United Kingdom
SO15 2DZ

Report No 15/2001

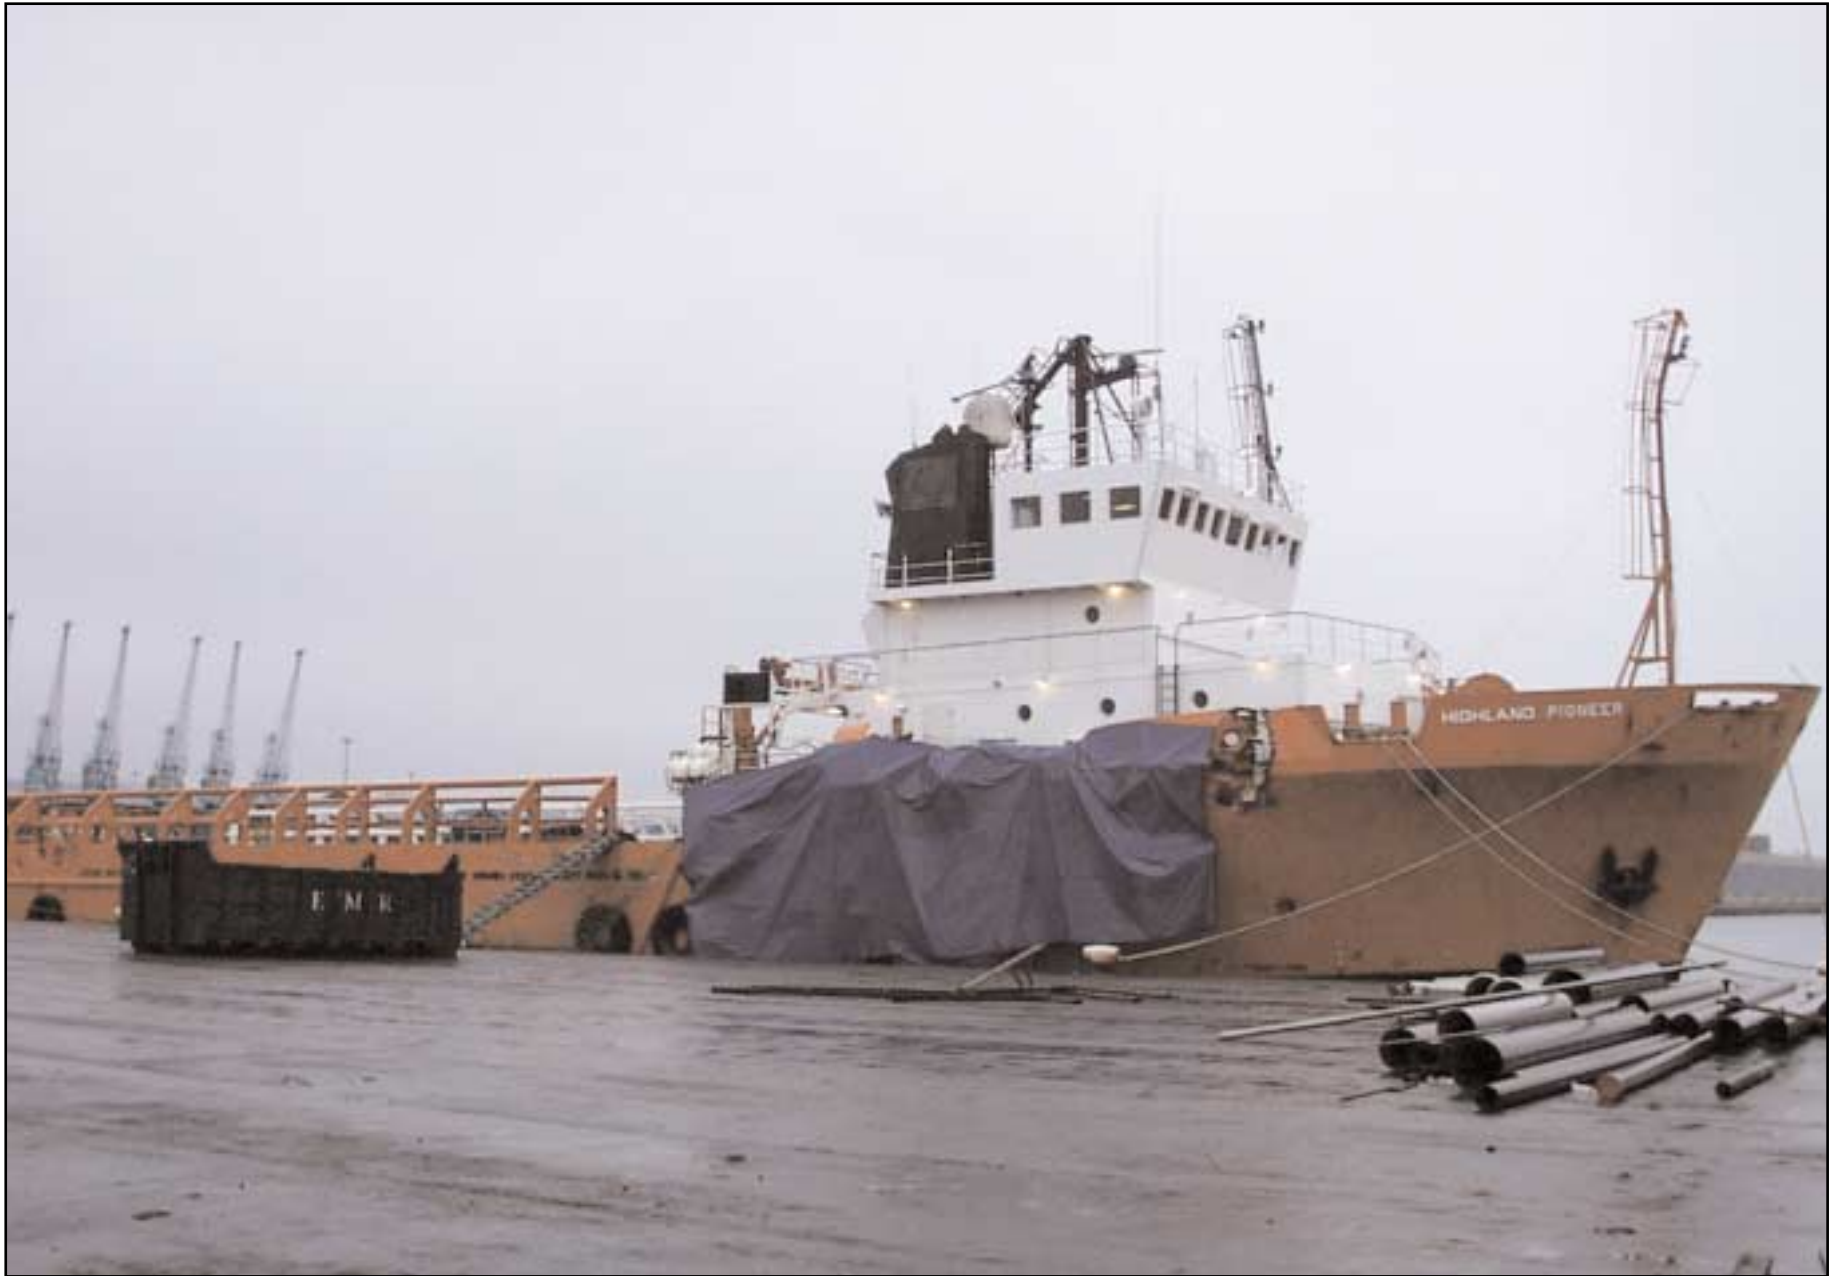
Photograph 1

Highland Pioneer alongside in Liverpool Docks

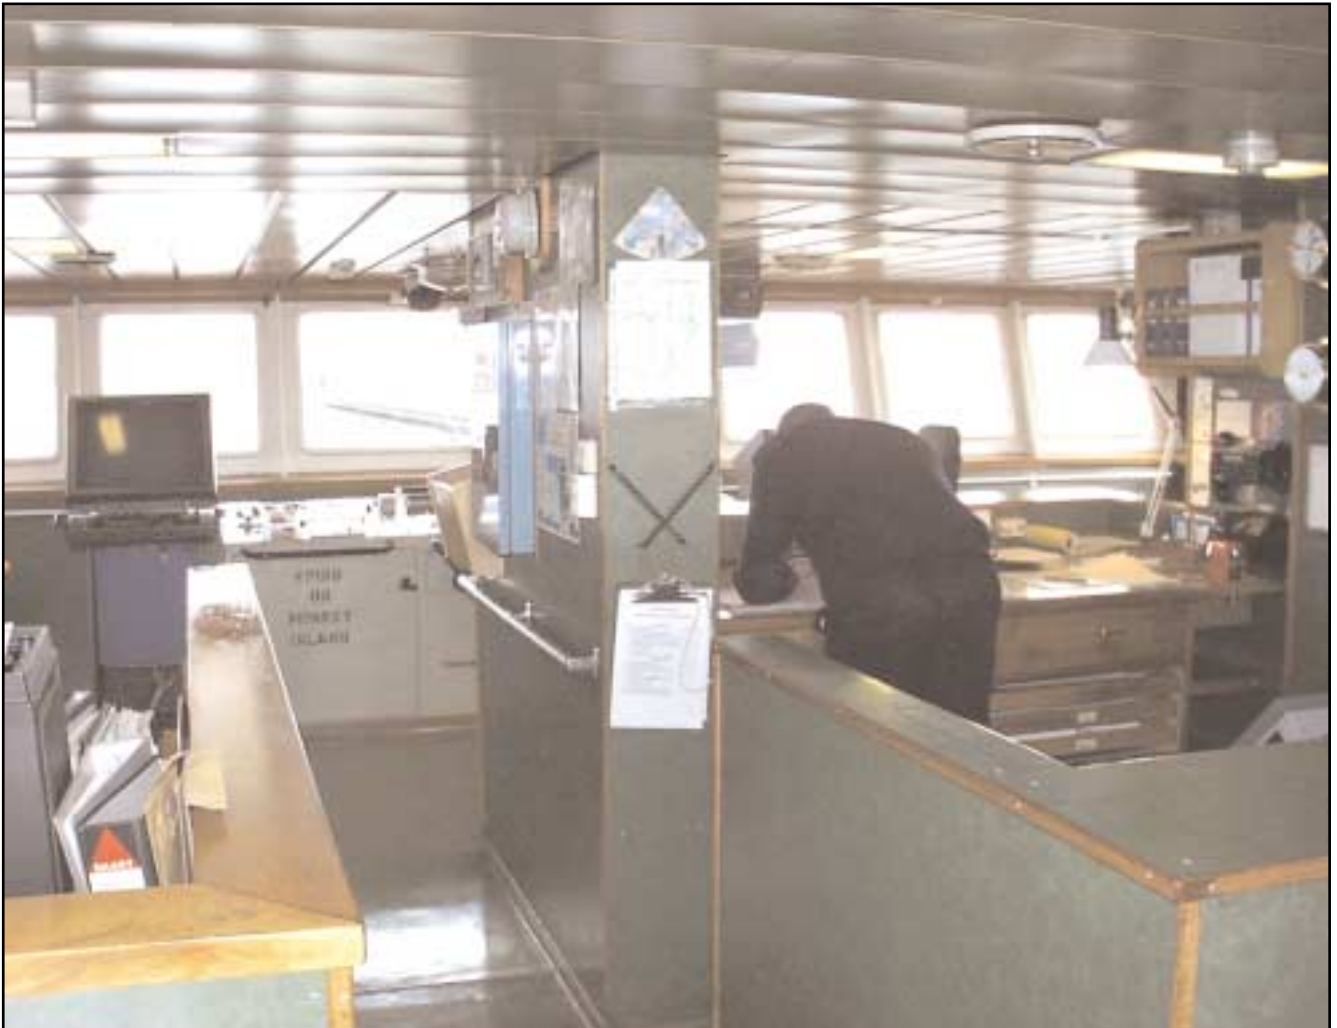
Photograph 2

Because the vessel was about 4 miles from the installation, she was ahead of the required time for cargo working, and the master was of the opinion that he reduced speed by moving the propeller pitch control to 60%. The automatic helm was in operation and the radar was on the six-mile range scale. At this time the master set a one-mile radar variable range marker on the installation echo to mark the point at which he required the vessel to stand-by and to be ready for cargo work. He then worked briefly at the ballast control panel at the after end of the bridge, before moving to the chart table to make tidal stream computations for the period which would be spent at the *Douglas* installation. From this position, he had full view of both the brightly-lit installation and the radar (**see photograph 2**).

The master at the chart table

Working at the chart table, the master had a clear view of the radar and of the brightly lit installation. The radar had a zone alarm facility, but it was not used. The master did not check the doppler log, the speed reading on the GPS set, or the radar, or look at the installation during this time. Had he done so at any time, he would have been alerted that the vessel was fast approaching the installation. He should not have worked at the chart table unless there was another person on the bridge. Instead he should have monitored the vessel's progress towards the installation. He could have arranged for the tidal stream computations to have been made prior to arrival, or suspended progress and stopped the lookout from leaving the bridge until he had completed them.

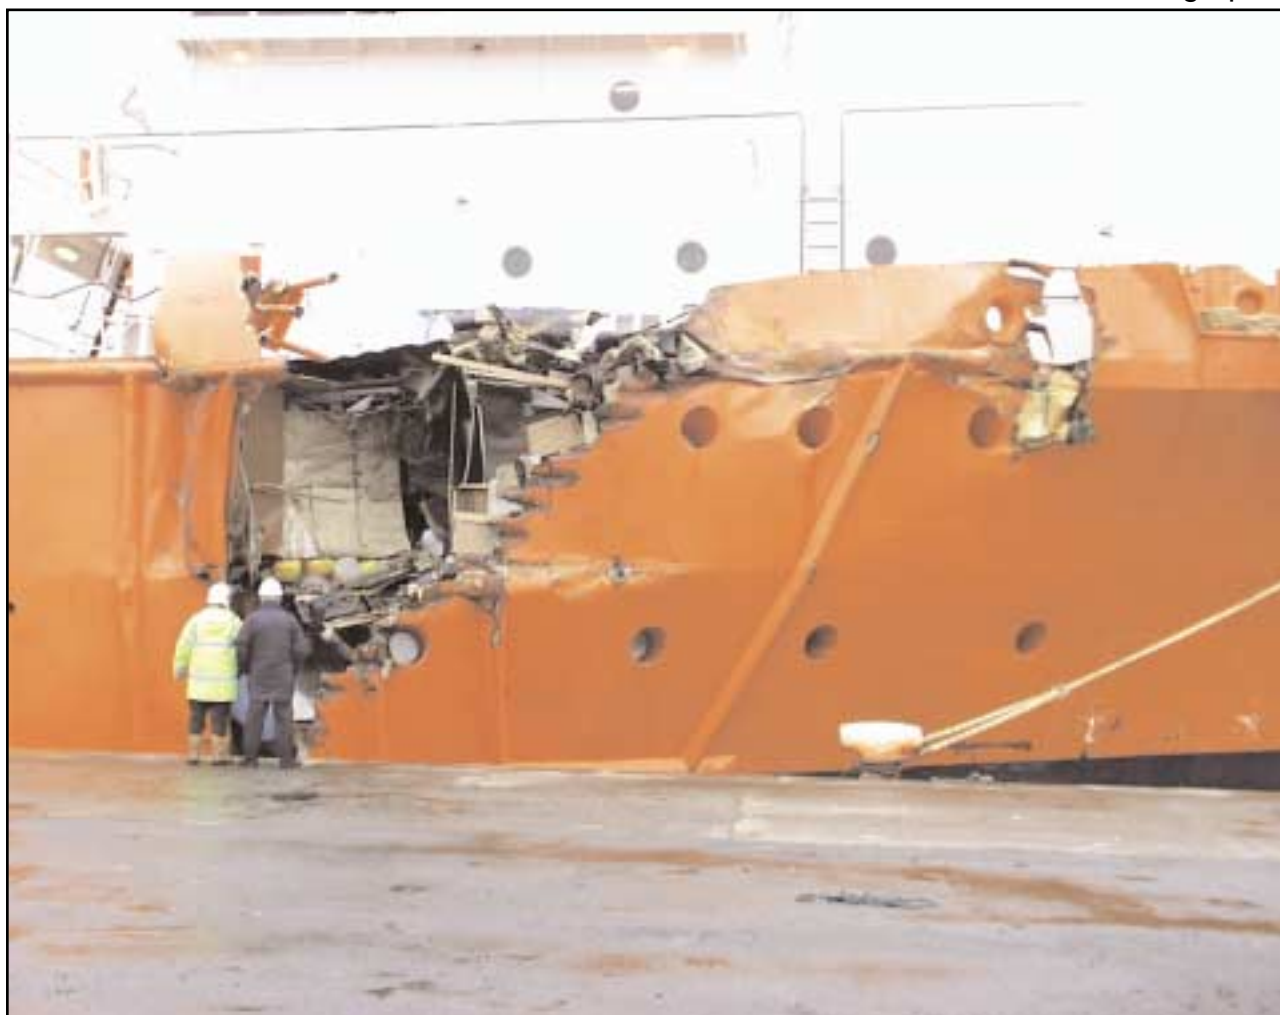
Photograph 3

The foremast was bent and misshapen. The top section of mainmast, sited on top of the monkey island, collapsed aft on to the satellite communications antenna dome. At the starboard side forward shoulder, the side shell was missing over a “V” shaped area from deck edge to the waterline. There was a smaller indentation through the bulwark just aft of the starboard forward mooring fairleads (see photographs 1 and 3).

Starboard side forward. Side shell missing over a “V” shaped area from deck to waterline. Small opening in bulwark just aft of fairlead.

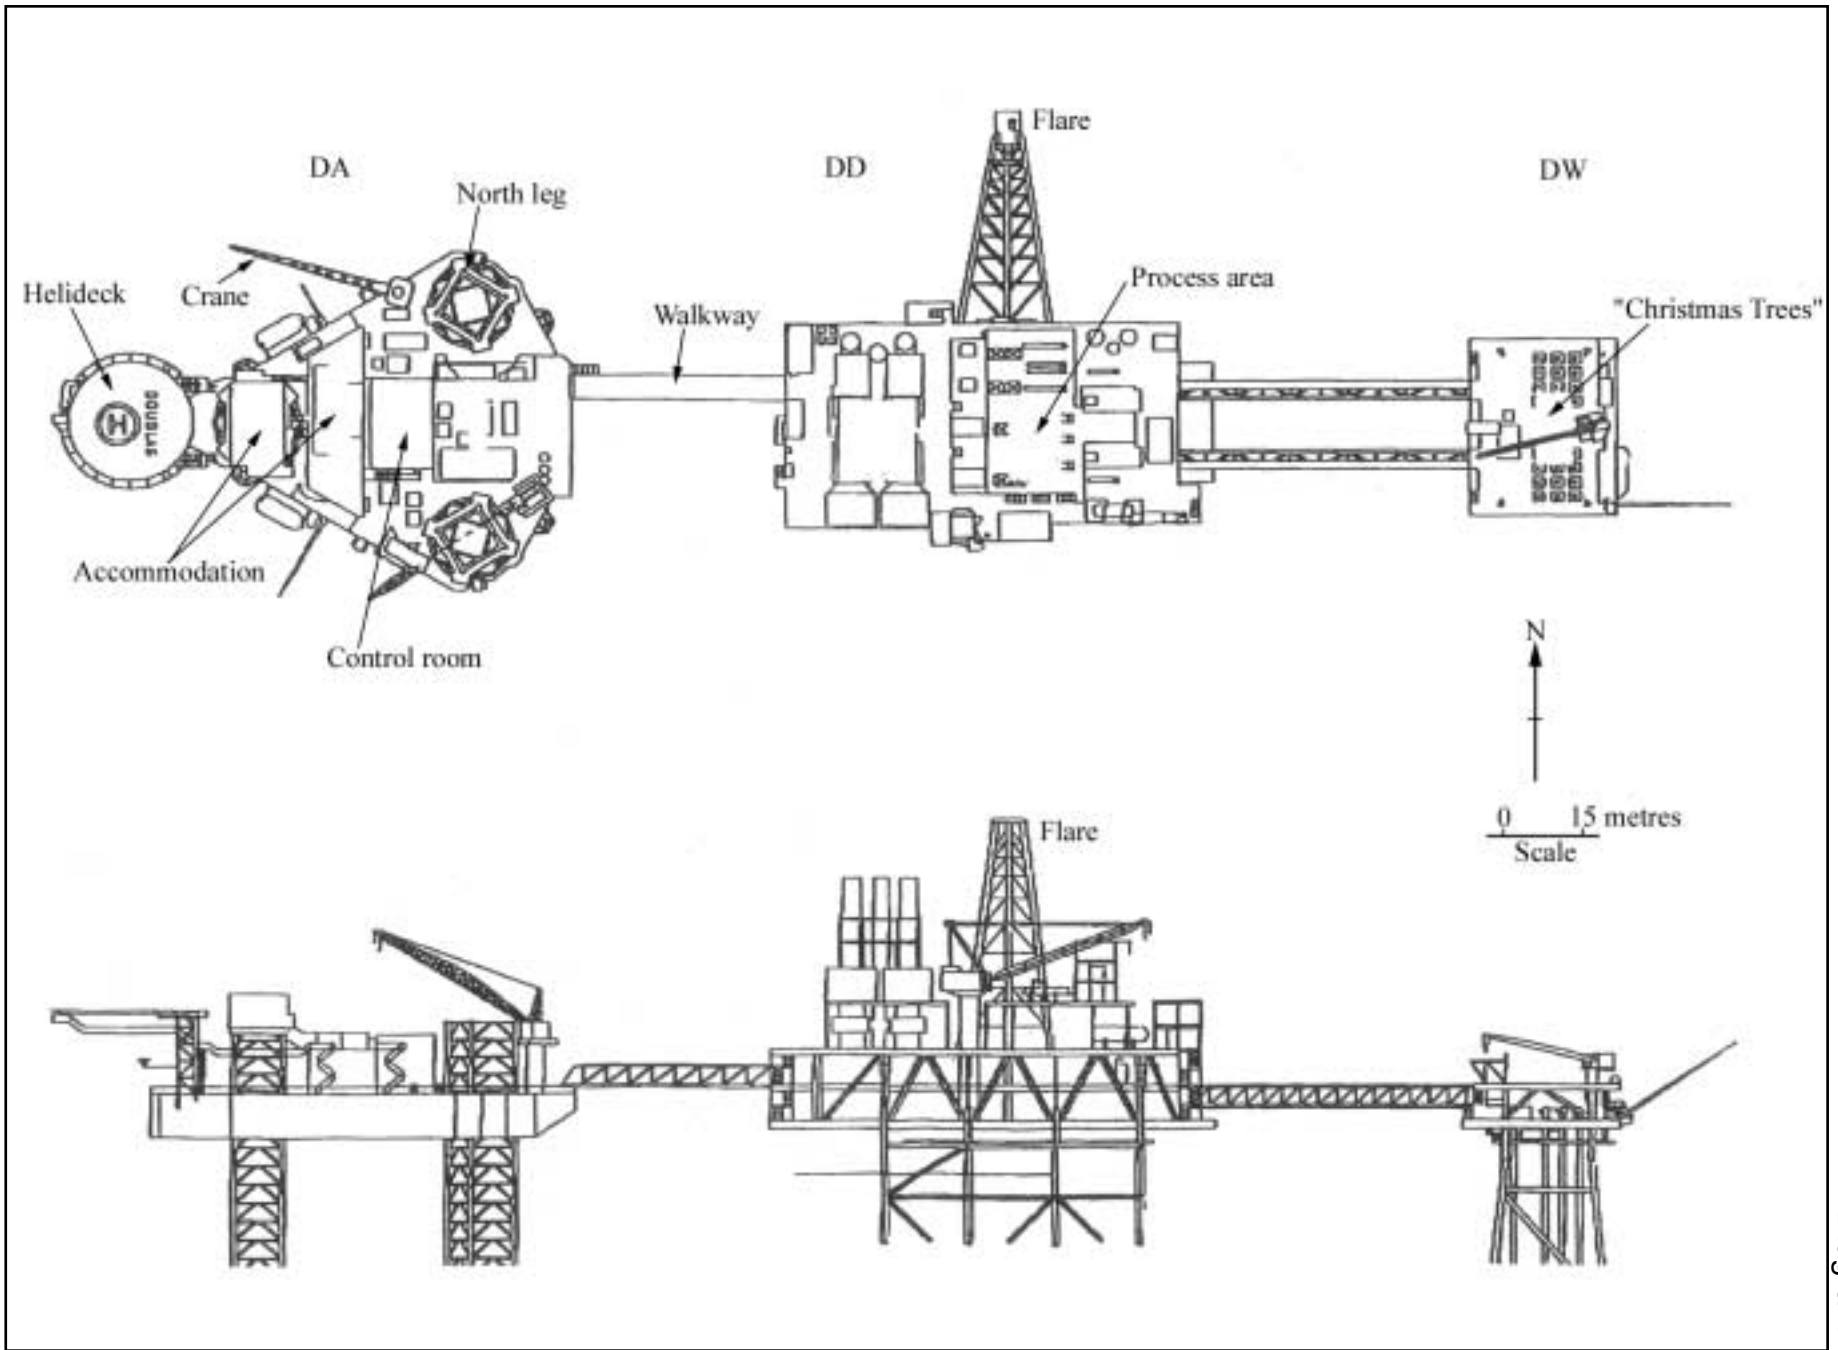
Diagram 1

At about 0622, the master looked up and, through the front bridge windows, saw that the north end of the *DA* jack-up rig (**see diagram 1 at section 1.5**) was in close proximity. He immediately went to the forward control console and moved the pitch propeller control levers to full astern. At the same time, he switched the automatic steering to manual and placed the tiller to hard-to-starboard. He

The *Douglas* Complex

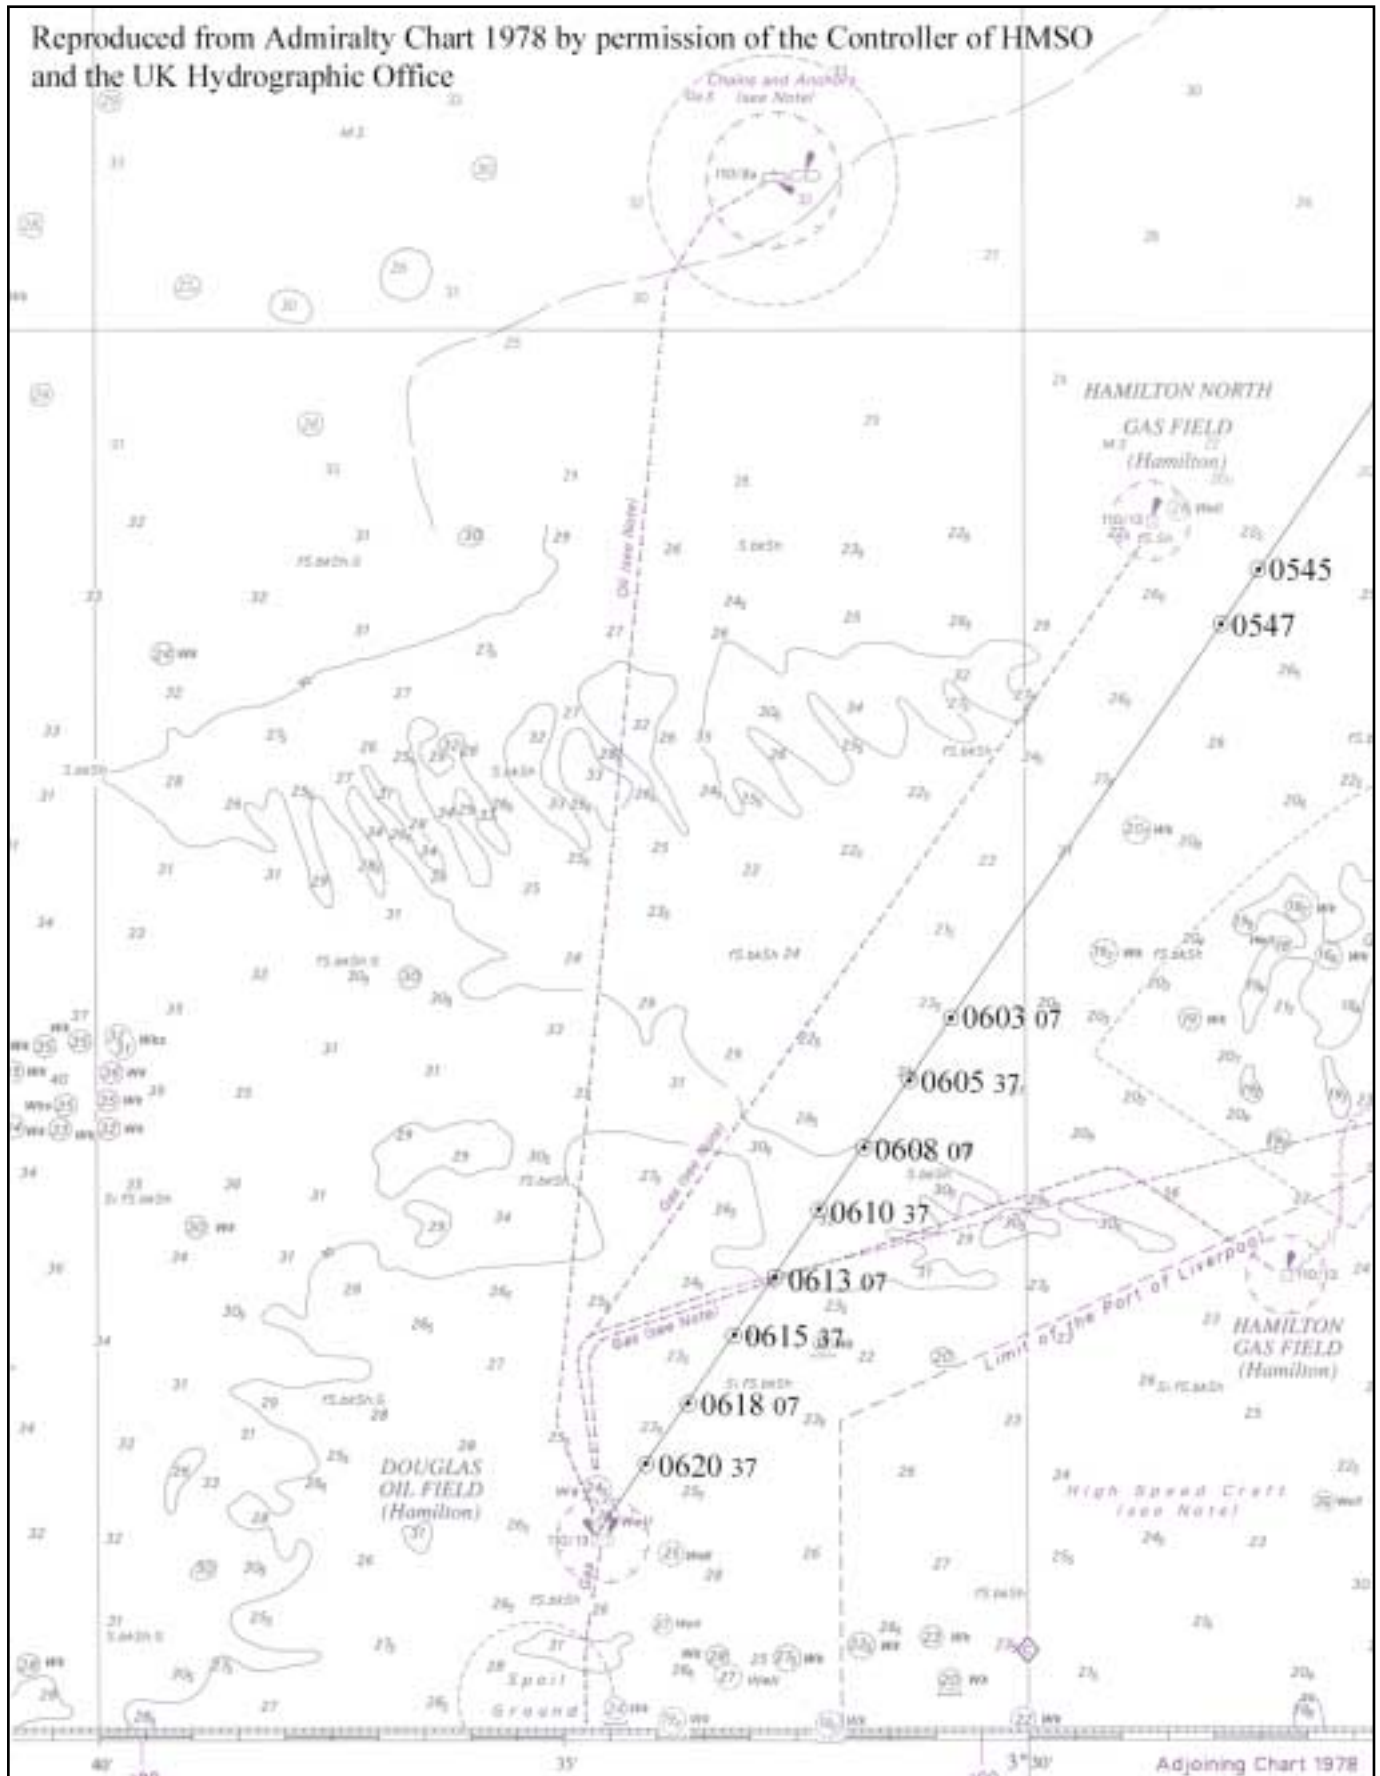
After the accident the REWS database was downloaded, the plot from which is shown in **diagram 2 opposite**. The positions and times are from DGPS, and have a high degree of accuracy.

- 0545 the vessel was abeam of the *Hamilton* platform and was **7.53** miles away from the *Douglas* installation;
- 0603, she was **4.05** miles away from the installation, (confirming the master's estimation);
- 0621 she was **5.8** cables away from the installation; and
- collision occurred at 0623.

The distances between 0545 and 0603 and between 0603 and 0621 (18-minute intervals) were the same at **3.48** miles, giving a speed of 11.8 knots.

From 0603 to the impact, the vessel covered the distance in 20 minutes, which gave a speed of 12.15 knots.

Plot derived from REWS database

Therefore, from the above, it is concluded that the speed before and after 0603 did not change until just before the impact, when the master took action to prevent the collision.
