Report on the investigation of
the collision between
the offshore supply vessel
Highland Pioneer
and the *DA* jack-up rig
of the *Douglas* offshore installation
in Liverpool Bay
on 27 January 2000

Marine Accident Investigation Branch
First Floor, Carlton House
Carlton Place
Southampton
United Kingdom
SO15 2DZ

Report No 15/2001

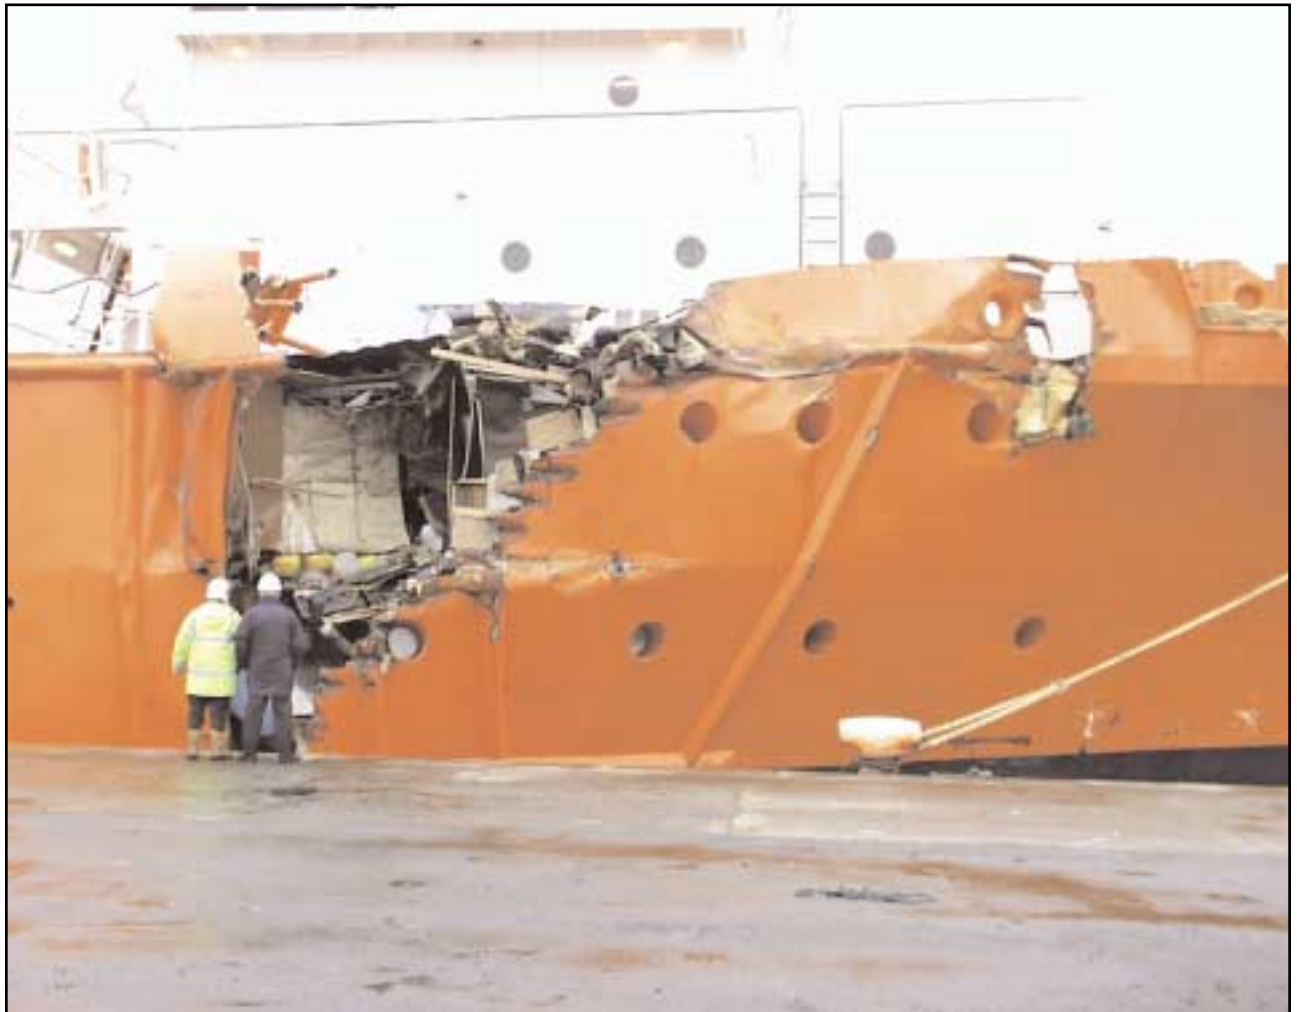
Photograph 3

The foremast was bent and misshapen. The top section of mainmast, sited on top of the monkey island, collapsed aft on to the satellite communications antenna dome. At the starboard side forward shoulder, the side shell was missing over a “V” shaped area from deck edge to the waterline. There was a smaller indentation through the bulwark just aft of the starboard forward mooring fairleads (see photographs 1 and 3).

Starboard side forward. Side shell missing over a “V” shaped area from deck to waterline.
Small opening in bulwark just aft of fairlead.

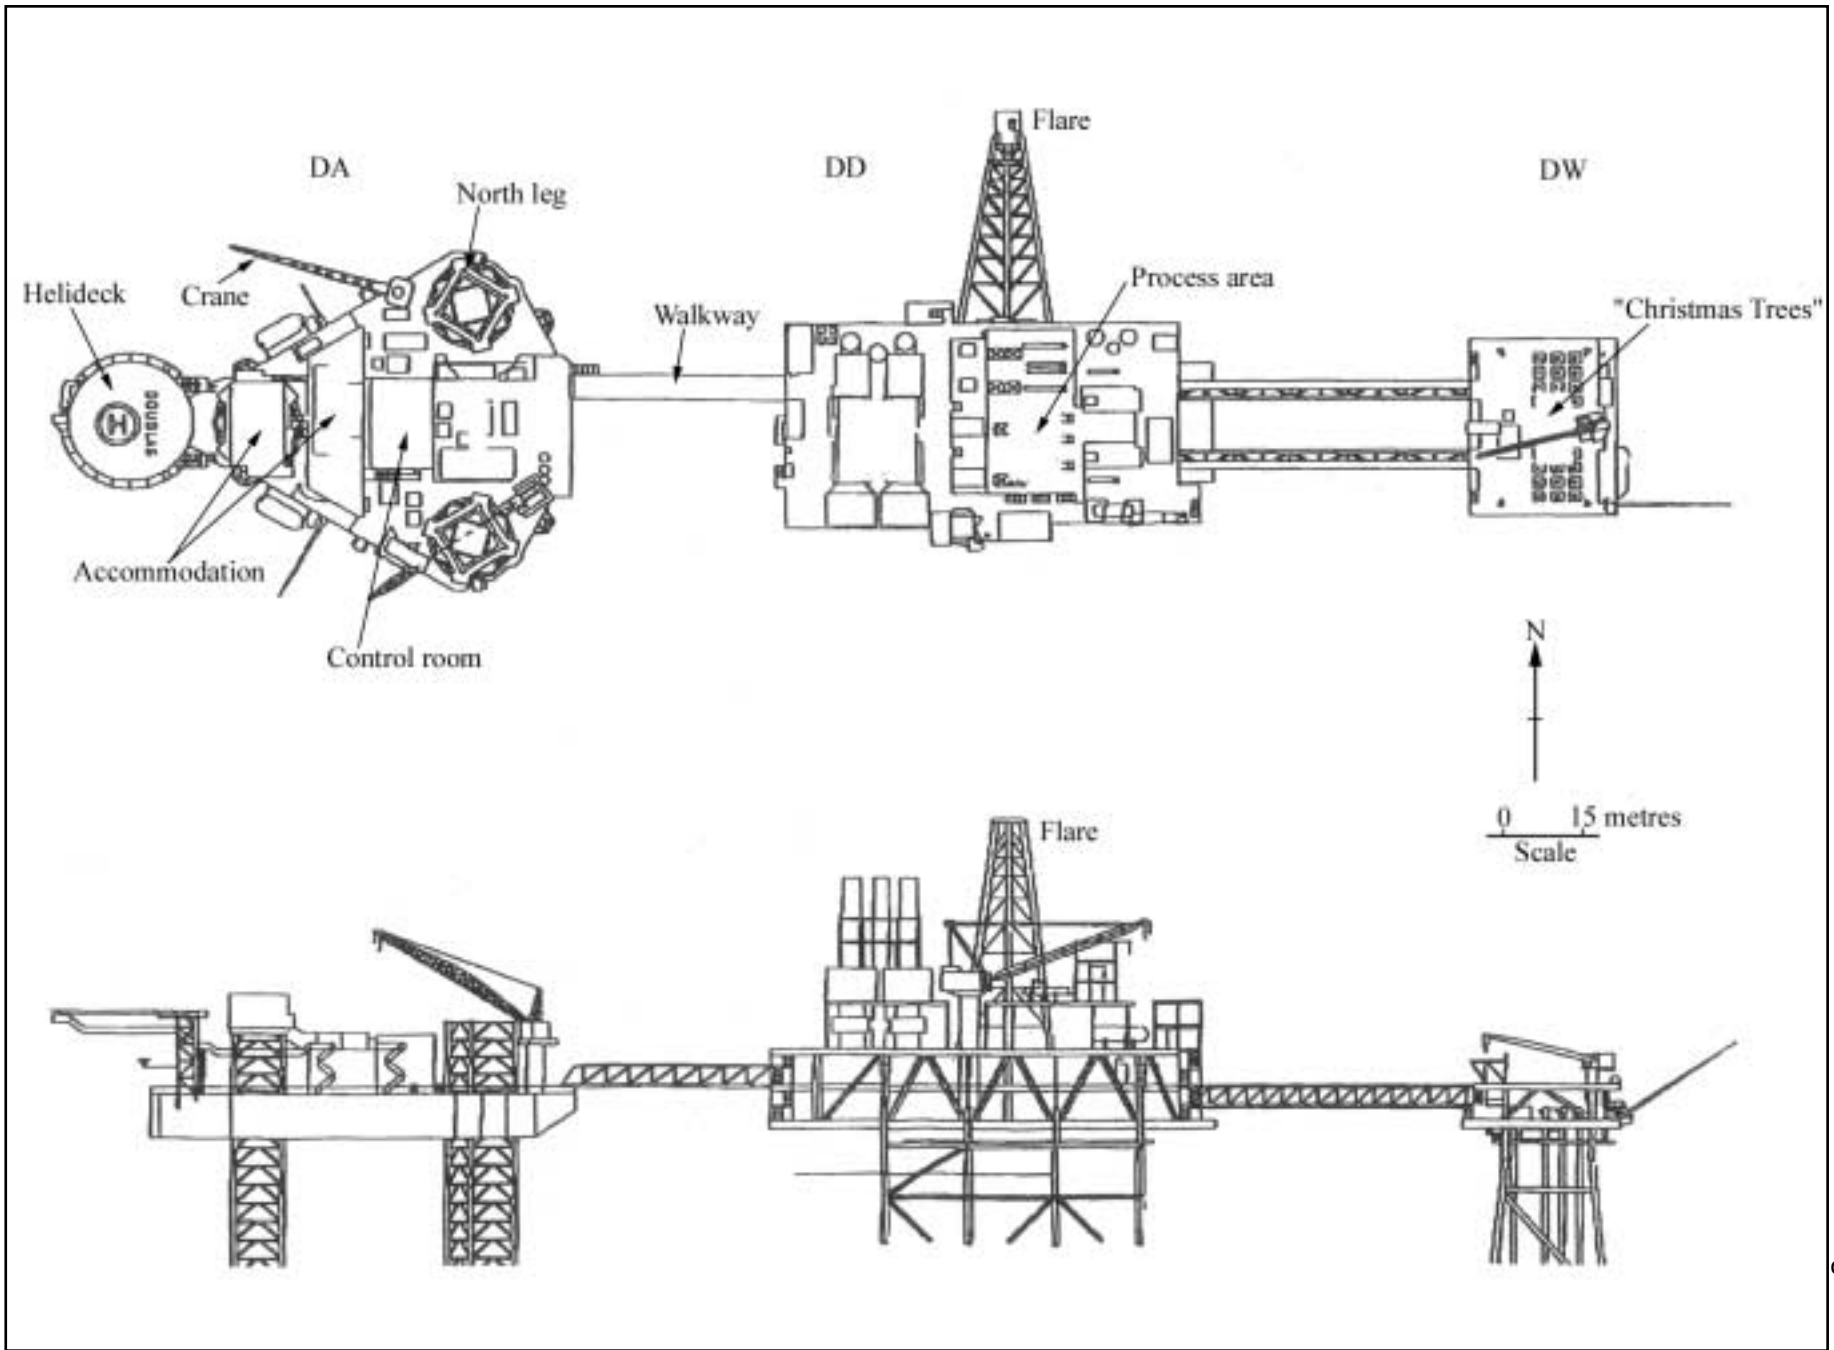
Diagram 1

At about 0622, the master looked up and, through the front bridge windows, saw that the north end of the *DA* jack-up rig (**see diagram 1 at section 1.5**) was in close proximity. He immediately went to the forward control console and moved the pitch propeller control levers to full astern. At the same time, he switched the automatic steering to manual and placed the tiller to hard-to-starboard. He

The Douglas Complex

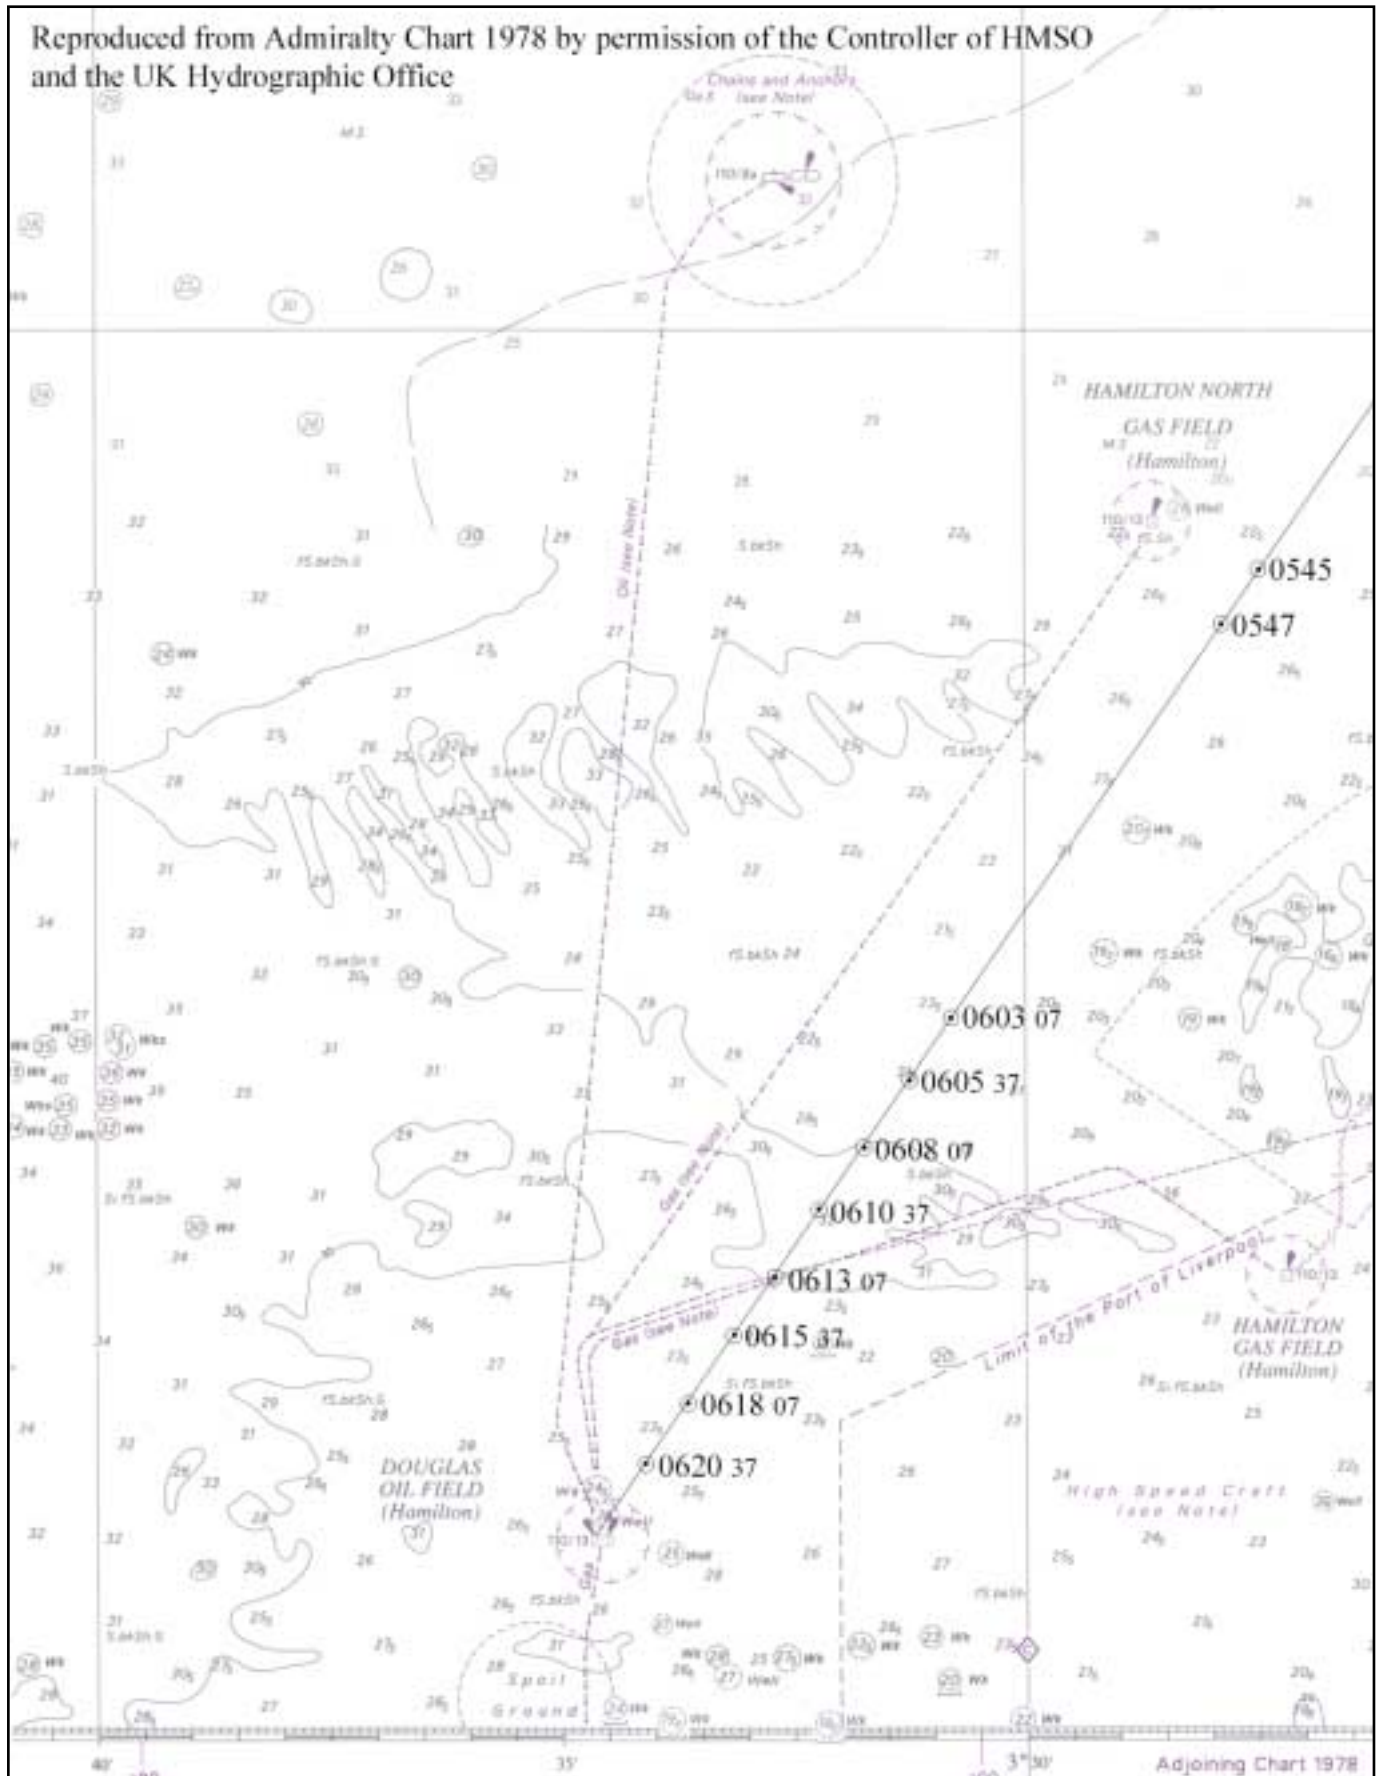
After the accident the REWS database was downloaded, the plot from which is shown in **diagram 2 opposite**. The positions and times are from DGPS, and have a high degree of accuracy.

The plot shows that:

- 0545 the vessel was abeam of the *Hamilton* platform and was **7.53** miles away from the *Douglas* installation;
- 0603, she was **4.05** miles away from the installation, (confirming the master's estimation);
- 0621 she was **5.8** cables away from the installation; and
- collision occurred at 0623.

The distances between 0545 and 0603 and between 0603 and 0621 (18-minute intervals) were the same at **3.48** miles, giving a speed of 11.8 knots.

From 0603 to the impact, the vessel covered the distance in 20 minutes, which gave a speed of 12.15 knots.

Plot derived from REWS database

Therefore, from the above, it is concluded that the speed before and after 0603 did not change until just before the impact, when the master took action to prevent the collision.
