Report on the investigation of
the collision between the
Cayman Islands registered reefer
Pasadena Universal
and the Cyprus registered bulk carrier
Nordheim
in the Dover Strait
on 12 January 2000

Marine Accident Investigation Branch
First Floor Carlton House
Carlton Place
Southampton
United Kingdom
SO15 2DZ

Report No 35/2000

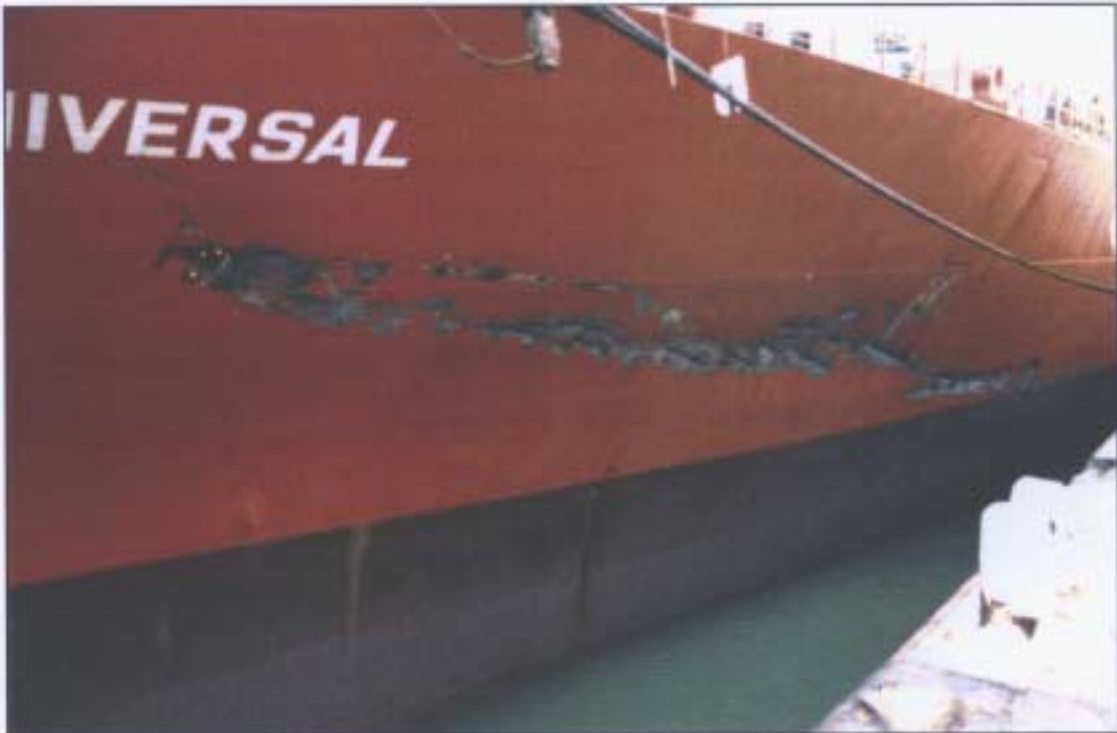
Photograph 3

On the port bow, there was a 15m long gash in the hull, which had a hole at the fore end. There was a series of scrape marks and gashes in the hull in way of the port quarter.

The damage to the port bow of *Pasadena Universal*

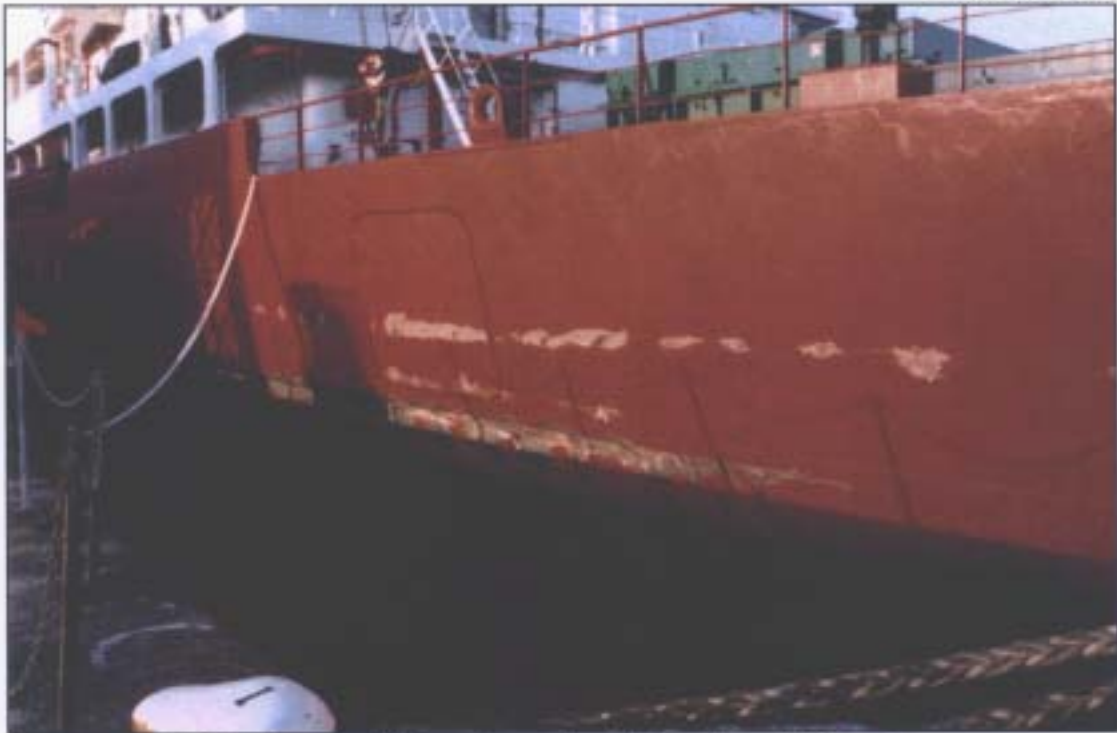
Photograph 4

The damage to the port quarter of *Pasadena Universal*

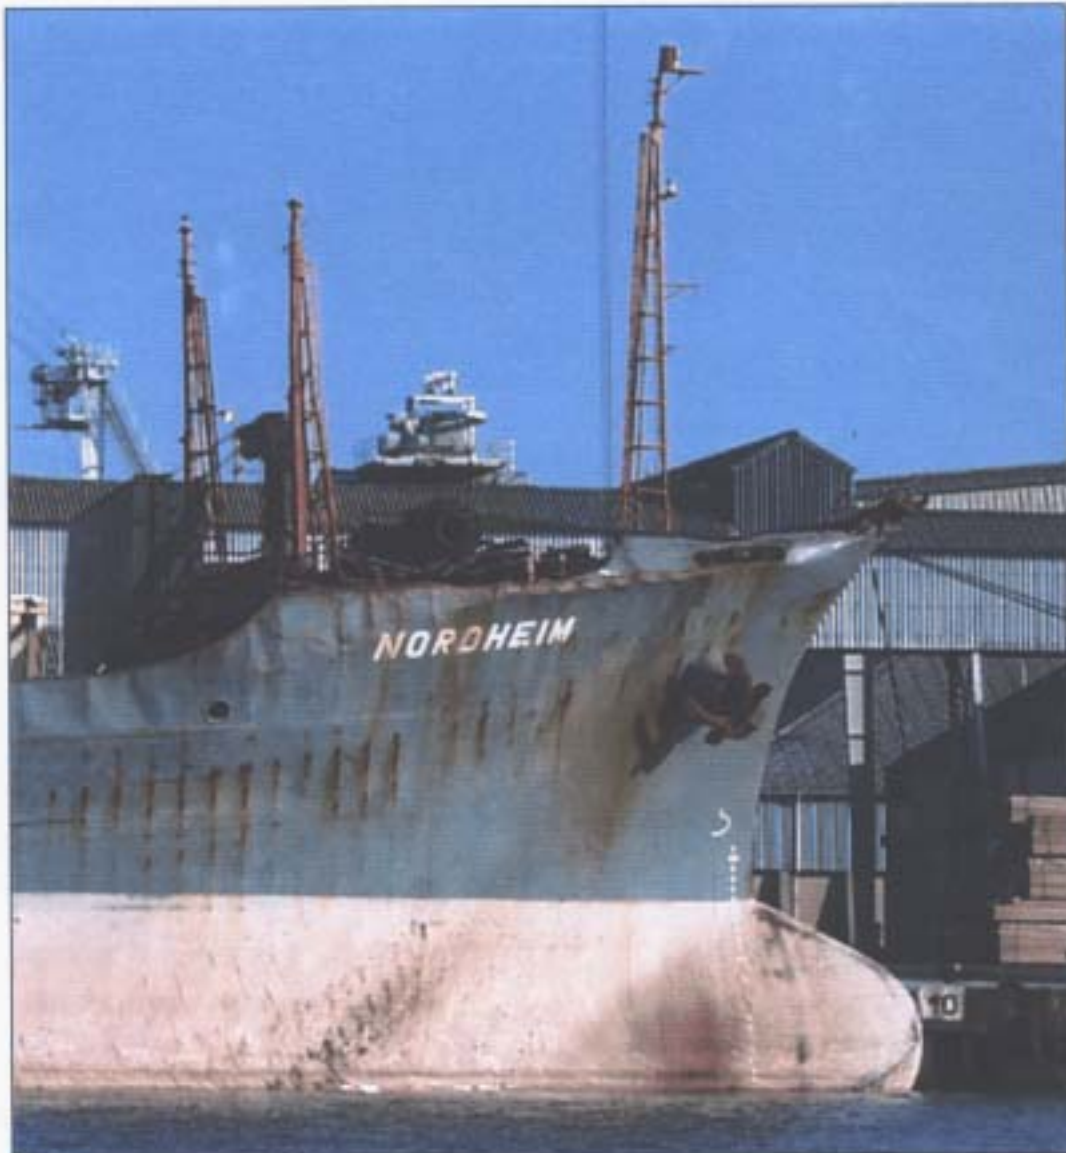
Photograph 5

The forecastle starboard bulwark was crumpled inboard. The shell plating at the break of the forecastle was indented. The bulwark on the main deck, in way of No 3 hold was indented. There was damage to a bulwark and deck edge on the starboard forward corner of the accommodation superstructure.

General view of *Nordheim's* starboard bow showing the damage

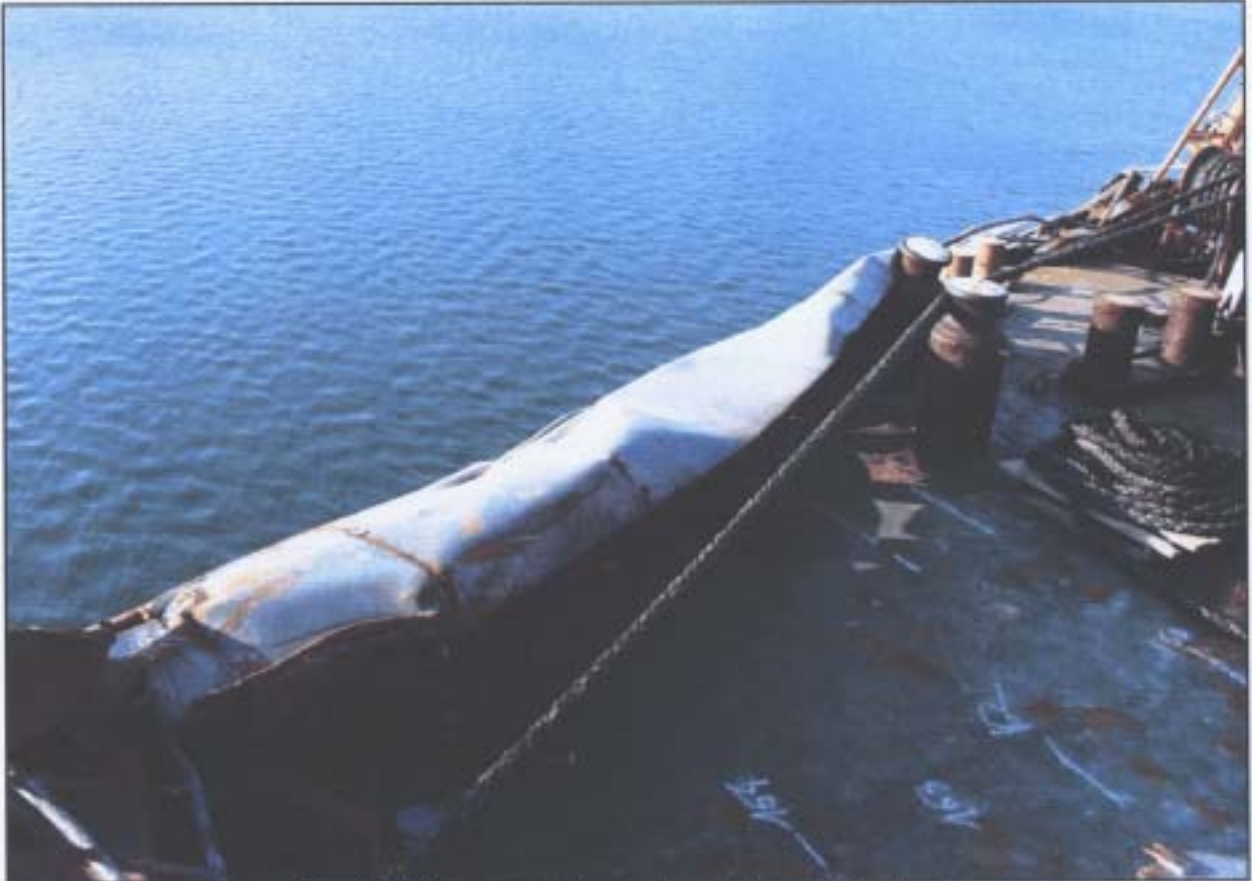
Photograph 6

Detail of damage to the starboard bow of *Nordheim*

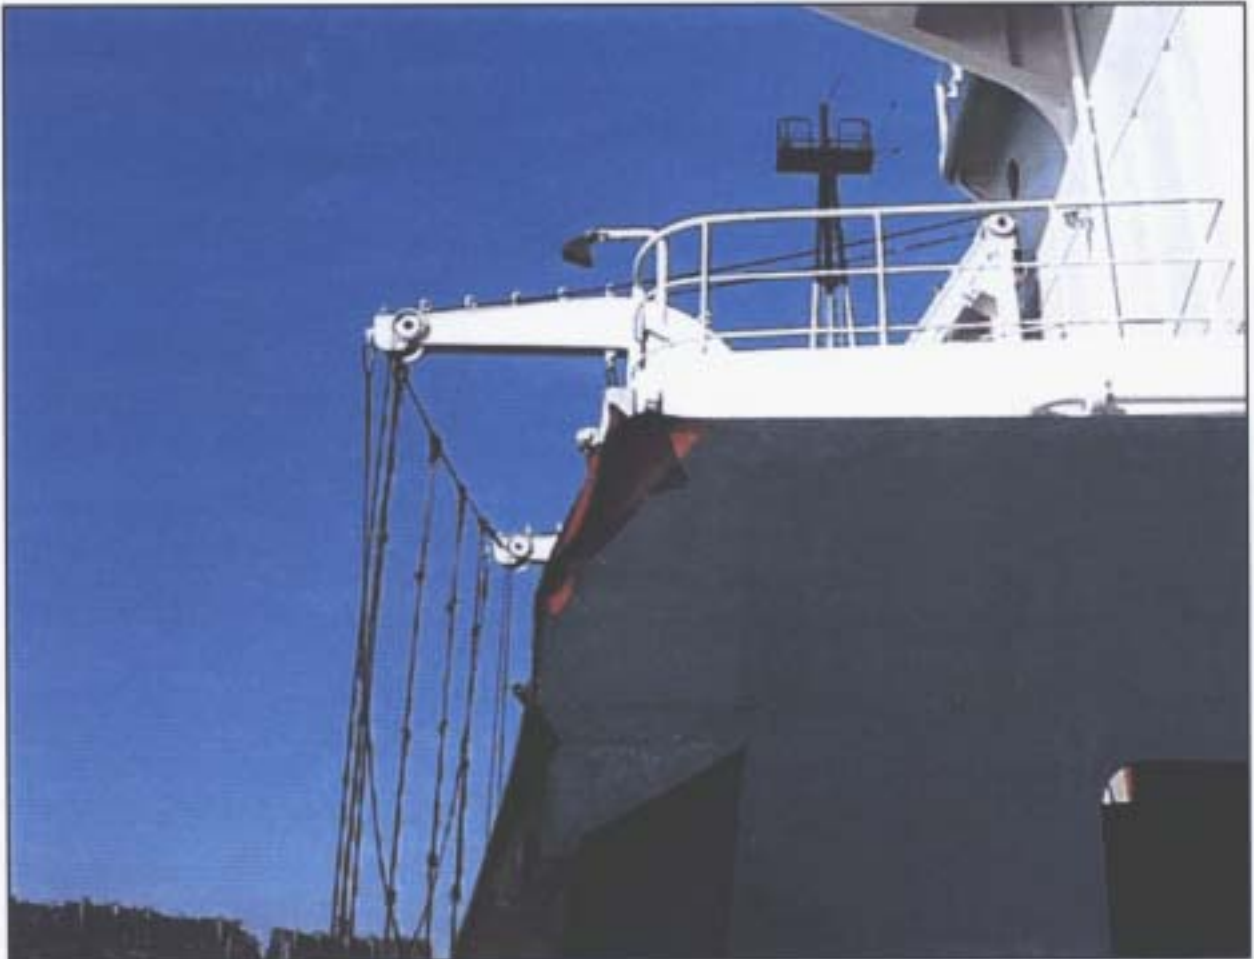
Photograph 7

Damage to the boat deck on the starboard side of *Nordheim*

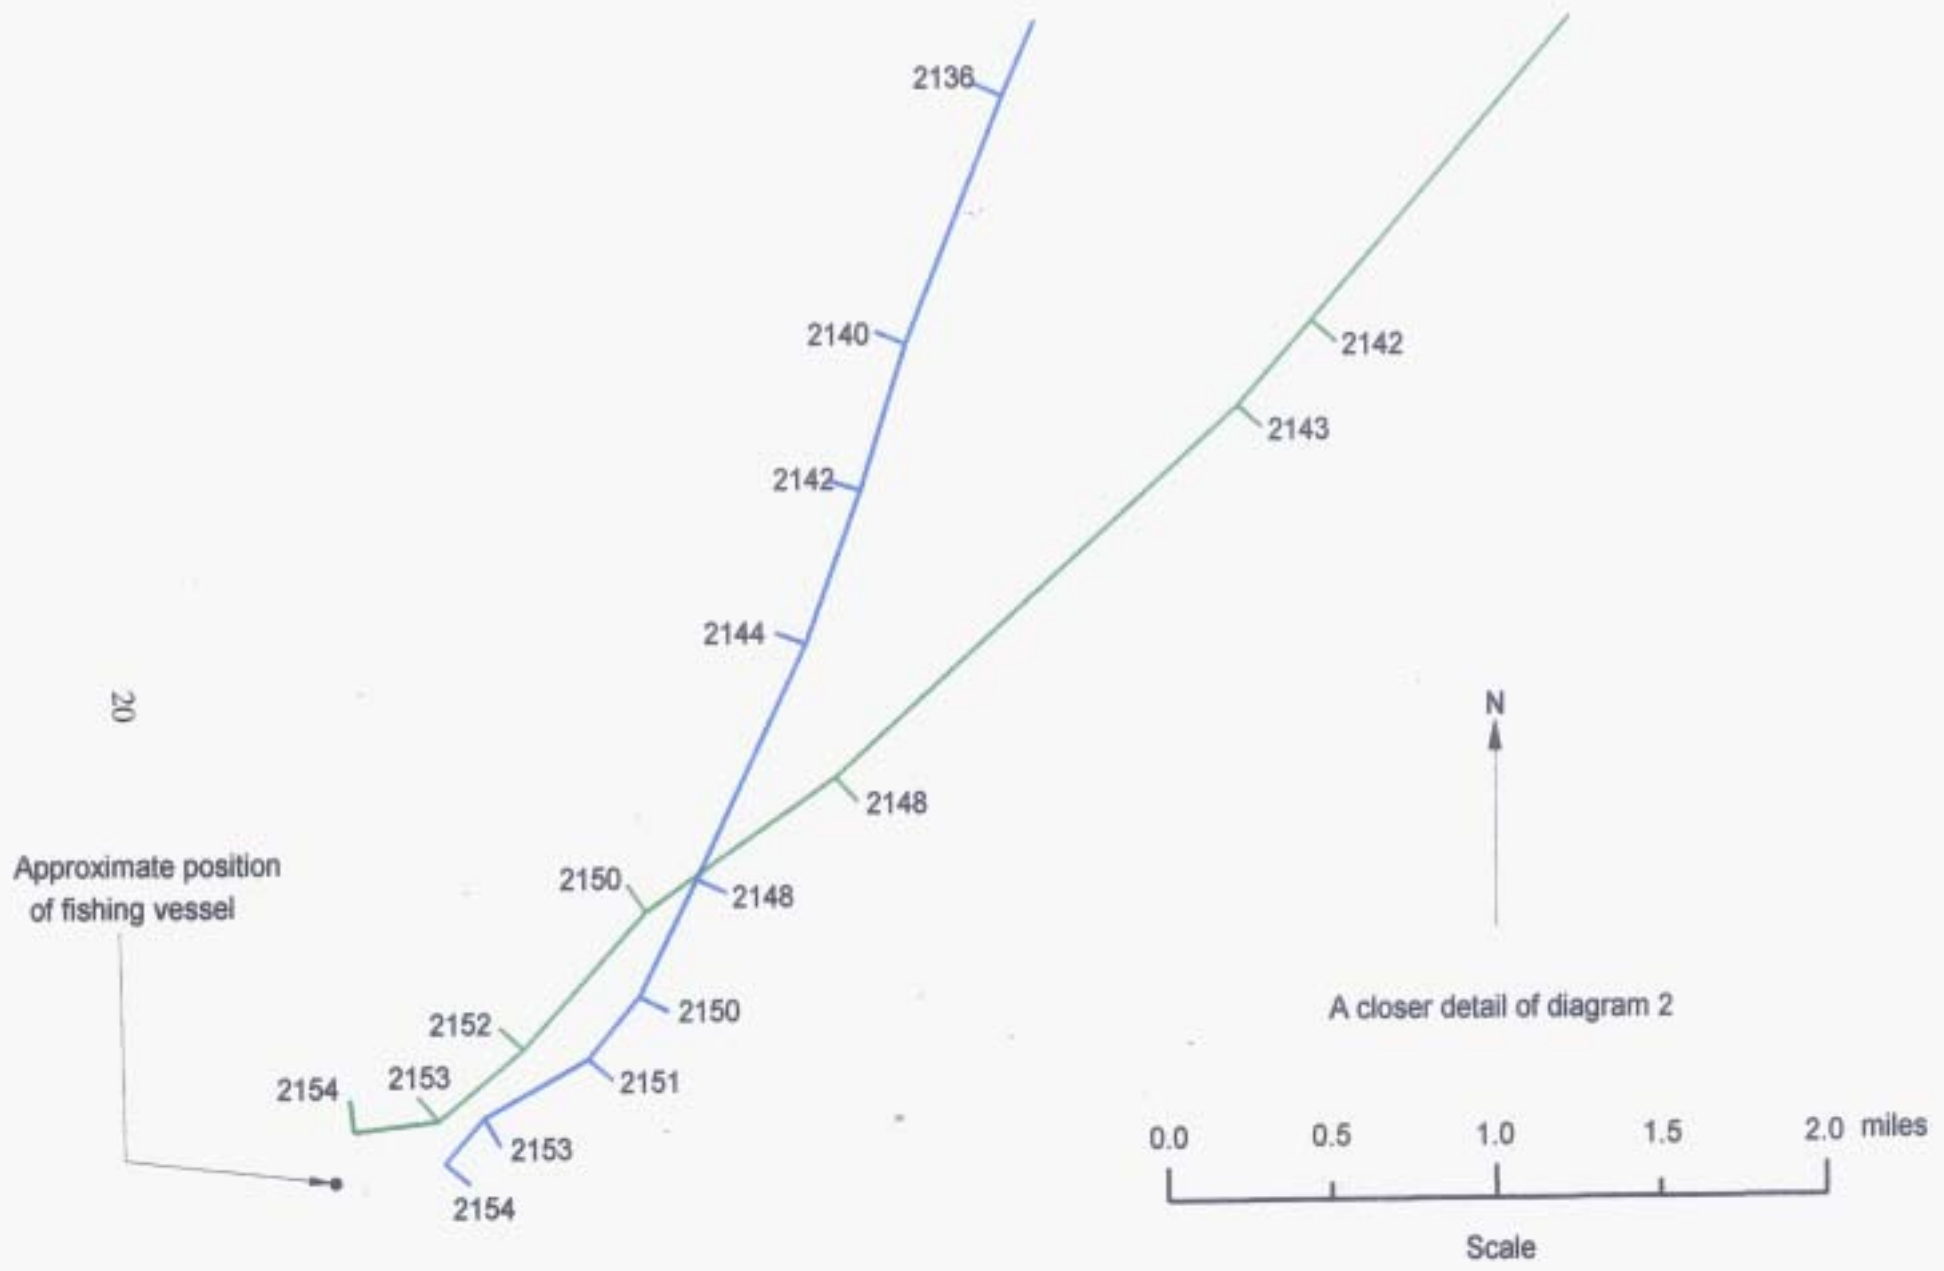
Diagram 2 - A reconstruction of the collision

By 2124, *Pasadena Universal* was making good a course of about 225° and she had *Nordheim* about 30° on the starboard bow by about 4.3 miles (see diagram 2). At 2130, the course recorder and the radar plot show that the ship altered course to port by 5°. From the latter time, the relative bearing of *Nordheim* began to slowly open to starboard as the range continued to decrease.

At 2143, again both the course recorder and the radar plot showed that there was alteration to starboard to 228° and then at 2148 there was another alteration of course to 234° (see diagram 3). At the latter time, *Nordheim* passed ahead of *Pasadena Universal* at about 5 cables. The master believed that the two ships were safe because they were on diverging courses, and he turned his attention to the fishing vessel (vessel 5).

The master had two options: either alter course to port and go between the fishing vessel and *Nordheim*, or pass to the west of the fishing vessel. He did not take the latter option as he feared that he might become too close to the South Falls sandbank. The master erroneously assumed that *Nordheim* would remain on her course during the time he would pass between the two vessels. He would have had the South Falls buoy ahead of him at this time, and the traffic lane was narrowing to a minimum width of 2 miles. Instead, he decided to take the first option, and at 2150 altered course to port to make 223° so that the fishing vessel would pass down his starboard side. *Pasadena Universal* was quickly passing *Nordheim*, but the master did not realise that the other ship was beginning to make a number of alterations of course to starboard towards his own ship. At 2152, the ship made an alteration of course to starboard, at which point *Nordheim* was just forward of *Pasadena Universal*'s port beam and closing rapidly. When the third officer alerted the master of the closeness of *Nordheim* it was too late to avoid a collision. The bows of both ships came in to contact and then further contact was made aft as the two ships swung away from each other.

By deciding to go between the fishing vessel and *Nordheim* the master left little margin for error if something unforeseen happened. Although the traffic lane was nearly two miles wide, he had enough sea room to the west (given the draught of the ship), in which to avoid both vessels. Therefore, the master may not have been fully aware of the ship's position in relation to areas of safe navigation. The chart was not marked with no-go areas. Perhaps the master was relying too much on the track lines and waypoints on the radar, and was not making regular referrals to the plotted positions on the chart. If he had been fully aware of the sea room to the west, he might have taken the safer action by leaving the fishing vessel and *Nordheim* well to port.
