Investigation of the capsized
and sinking of the
fishing vessel

***Solway Harvester* BA794**

11 miles east of the Isle of Man
on 11 January 2000
with the loss of 7 lives

**Report No 1/2006
20 January 2006**

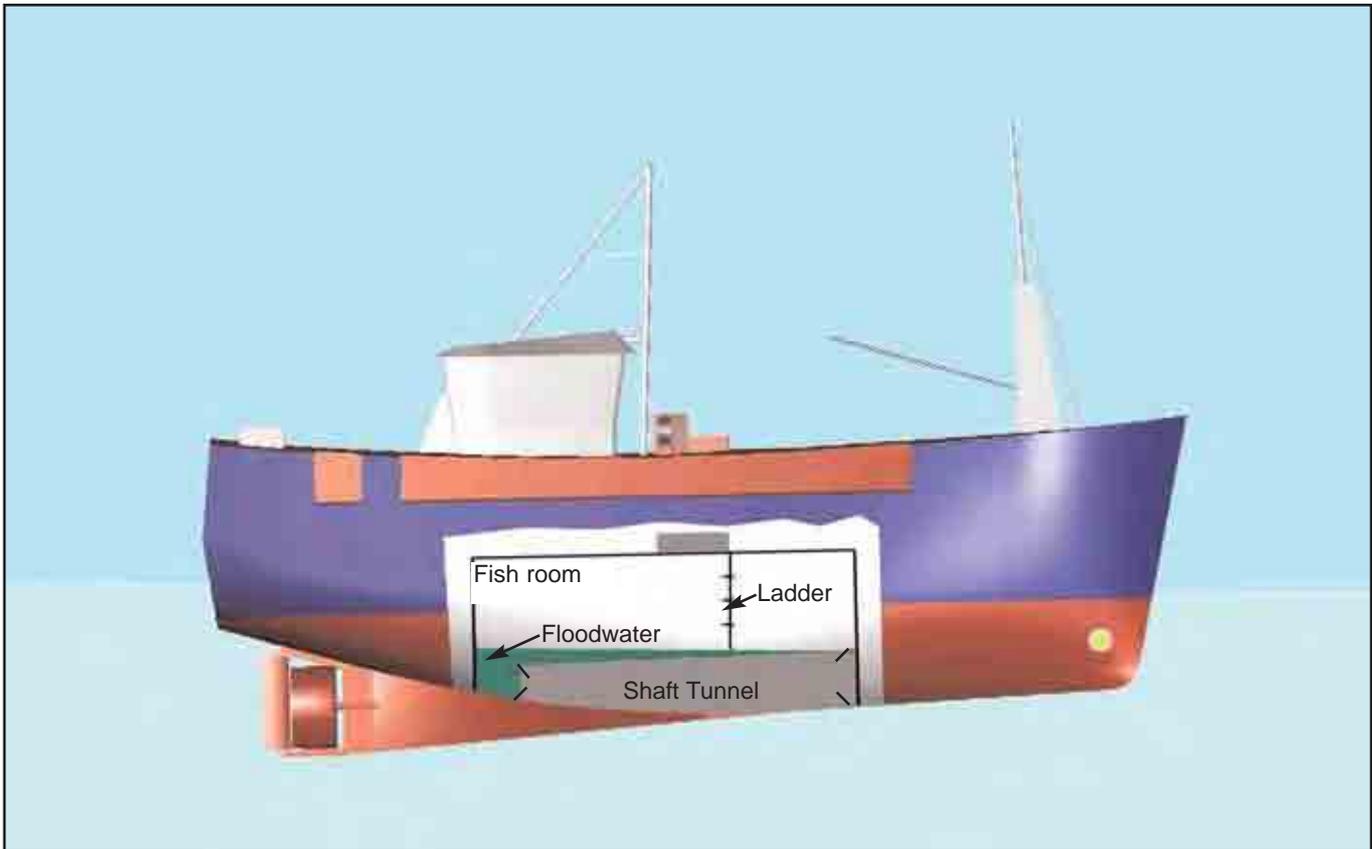
The water level on that occasion varied from about 0.3m deep at the aft end, to almost level with the bottom of the forward bulkhead (**Figure 4**). As the vessel rolled it surged from side to side, and was splashing up to the deckhead. At one stage a deckhand was swept off his feet and found himself having to swim for a moment or two.

A number of scallop bags slid back and forth across the deck, smashing into the wood panelling at the end of each roll and bursting. The lowest strake of panelling on the starboard side was badly damaged.

Eyewitnesses attributed the flooding to water draining off the main deck through the ice scuttles via the gaps under the flanges of the picking tray pipes. Melting ice and water seepage from the catch contributed a small amount.

Flooding of the fish room in early December 1999

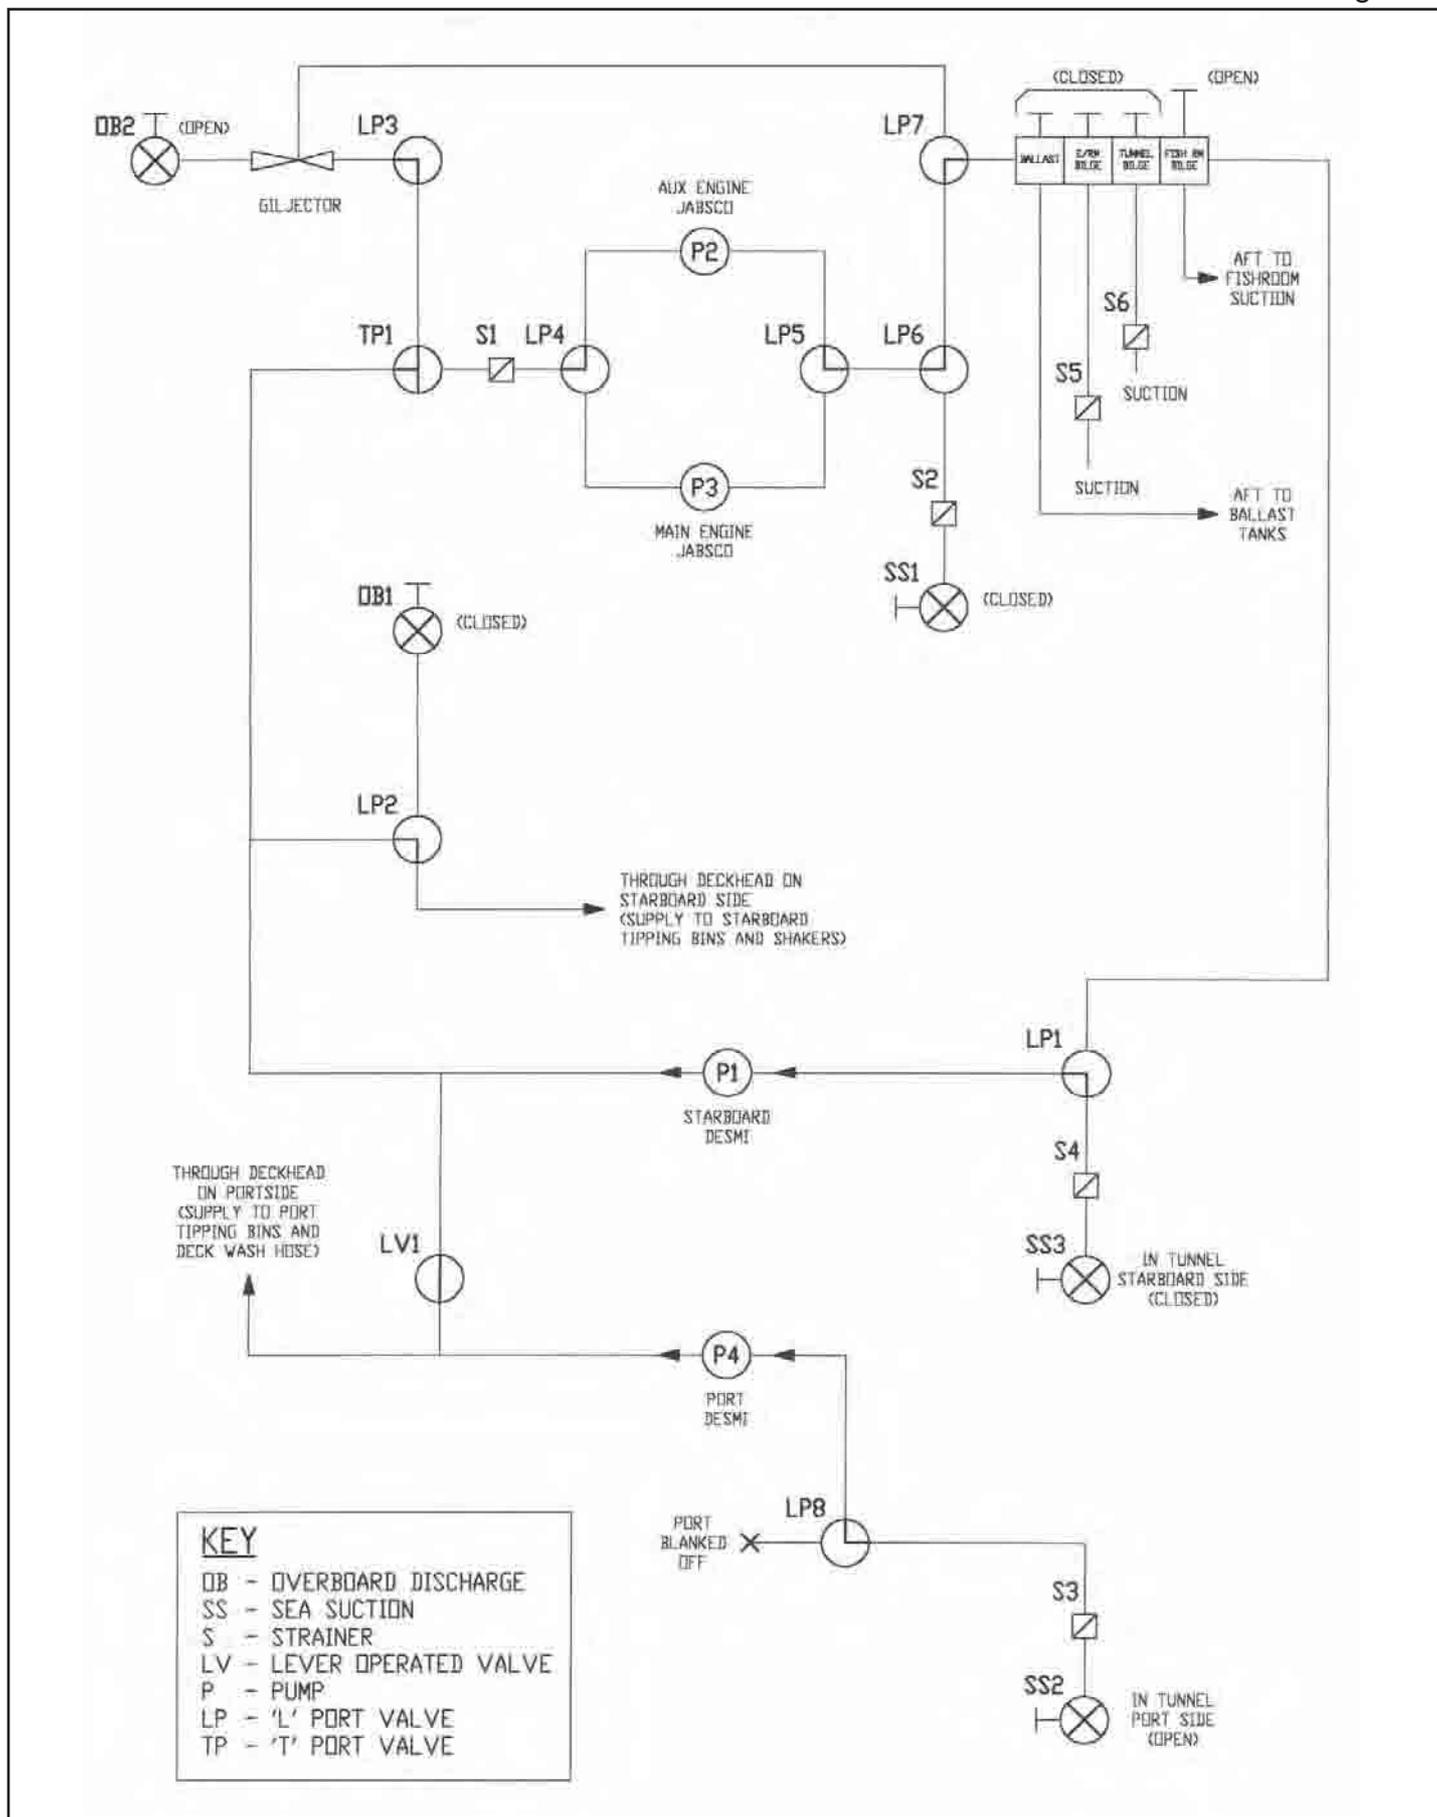
Bilge schematic "as found"

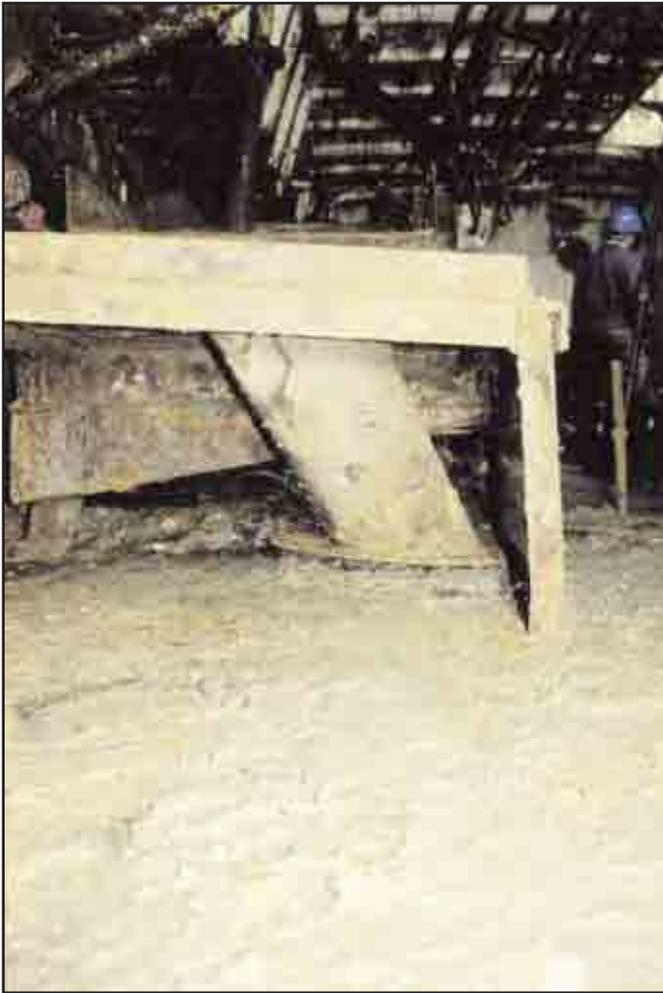
Figure 9b

Photographs showing the gap between the deck and the flange on the starboard picking tray

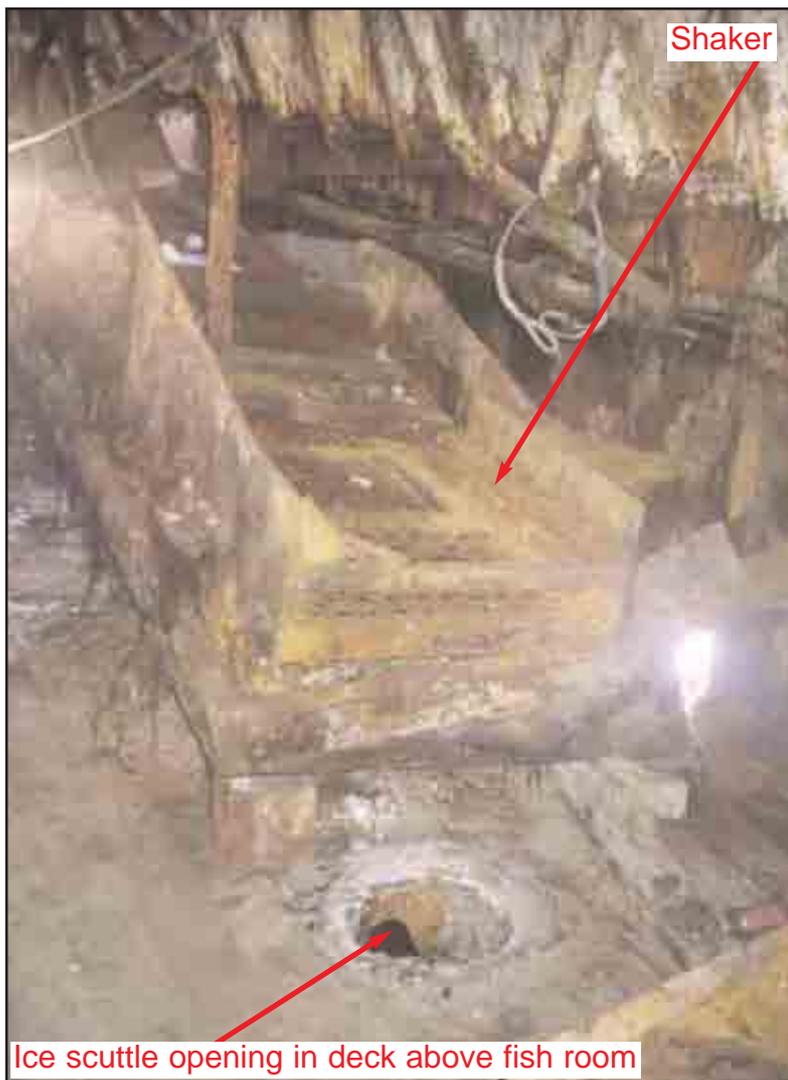
The port and starboard ice scuttles were open (**Figure 10 - port scuttle shown**). One of the watertight covers was found among the pile of loose gear on the starboard side, between the shaker and the wash room. The other was not found. Another securing key for the ice scuttles' covers was in the small wash room.

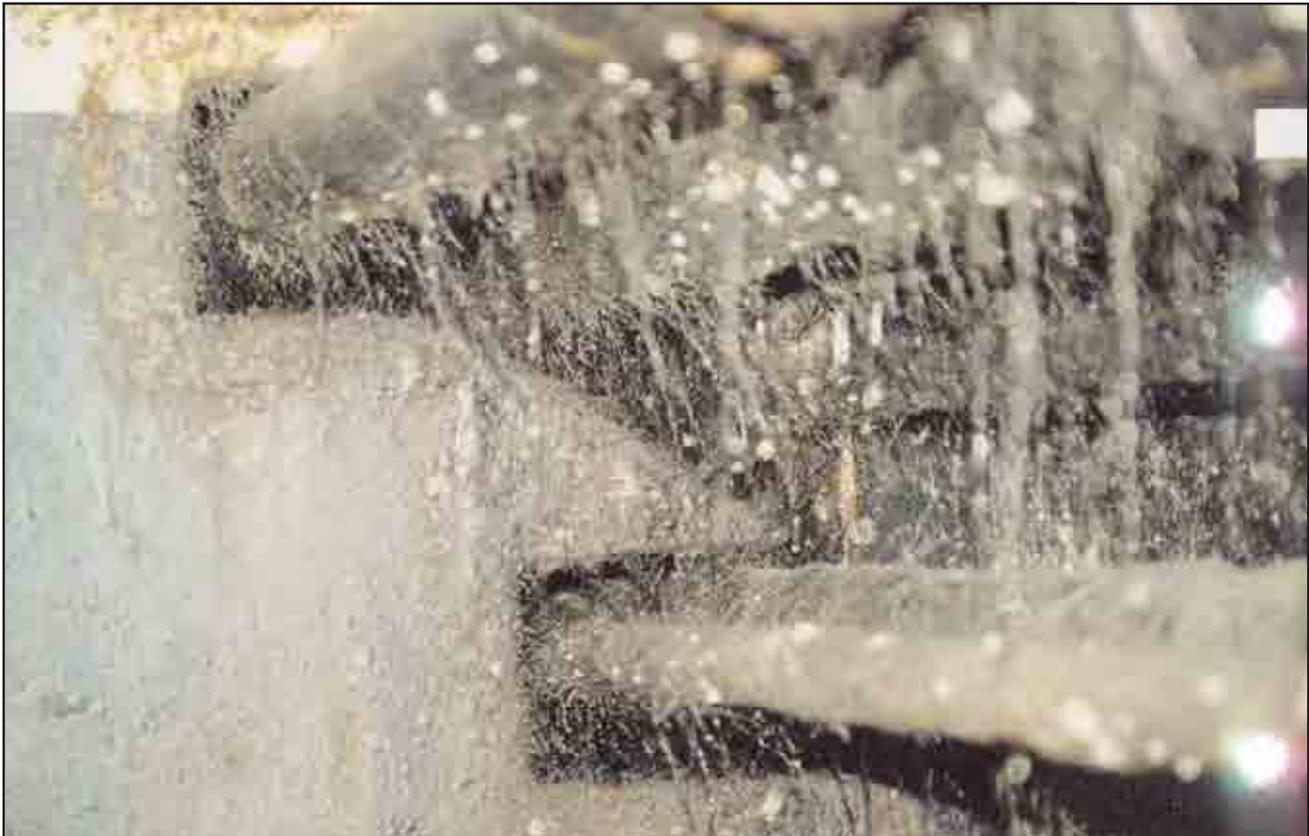
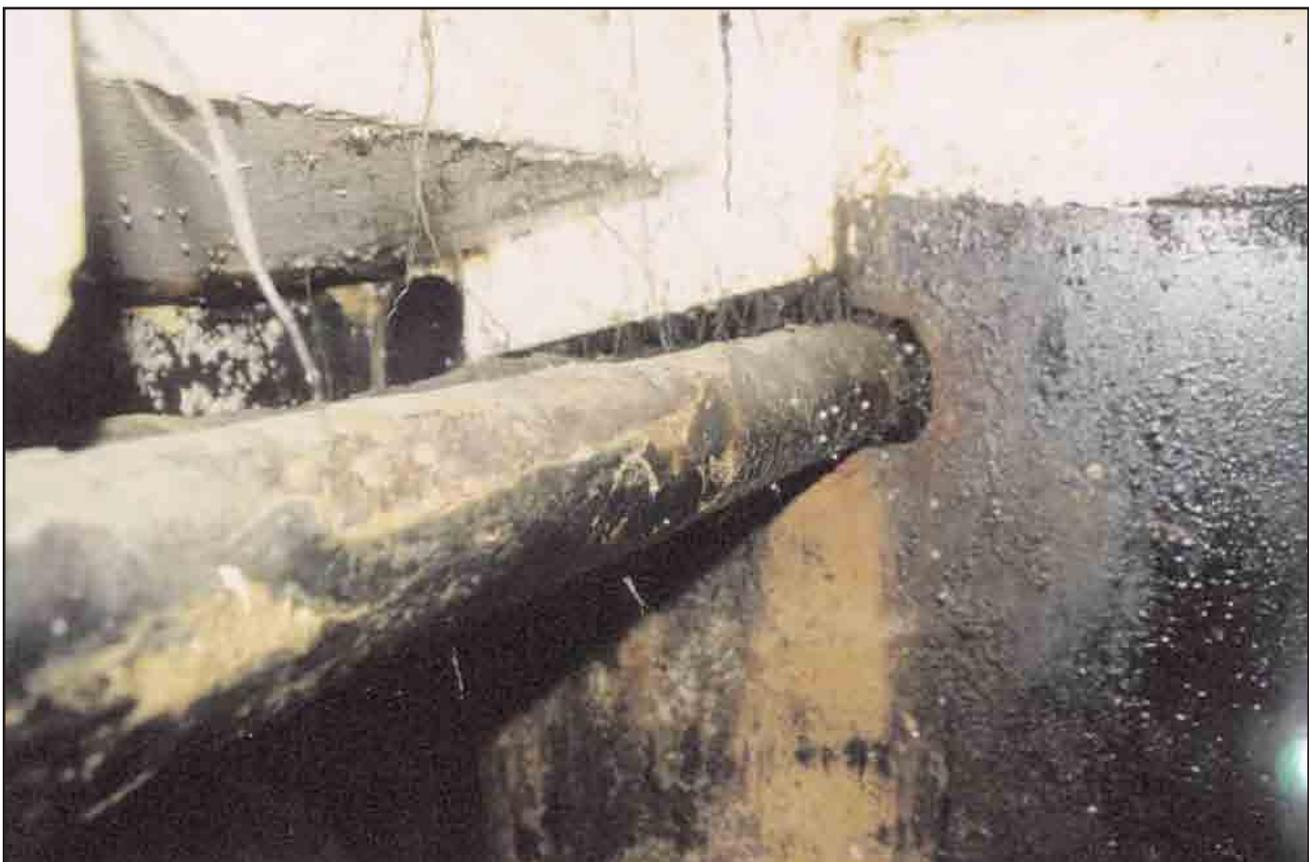
The “watertight” bulkheads showing gaps around pipe penetrations

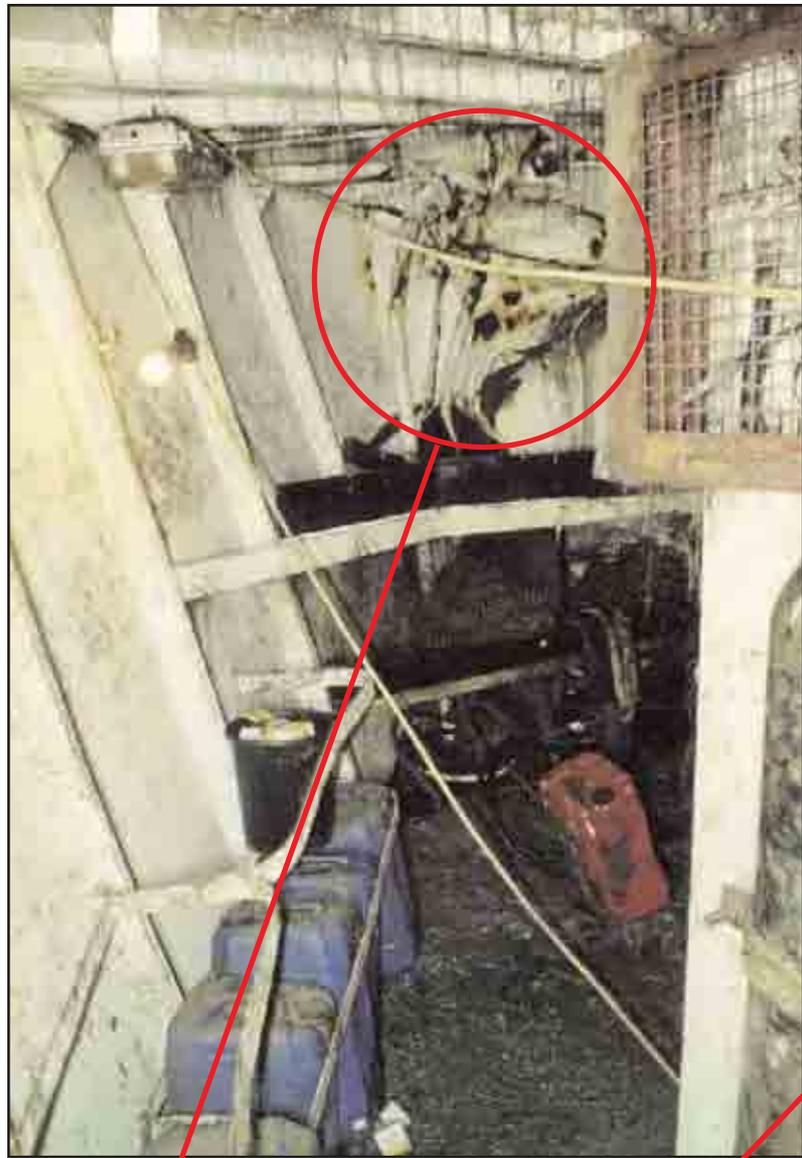
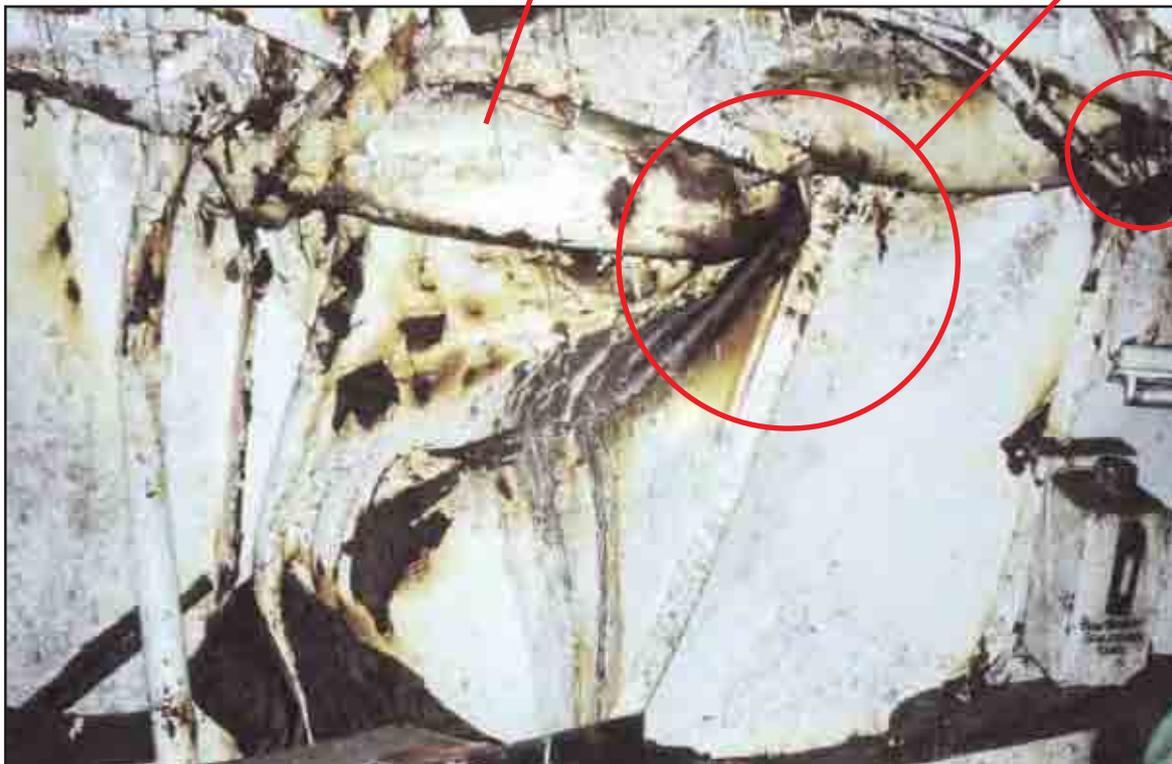
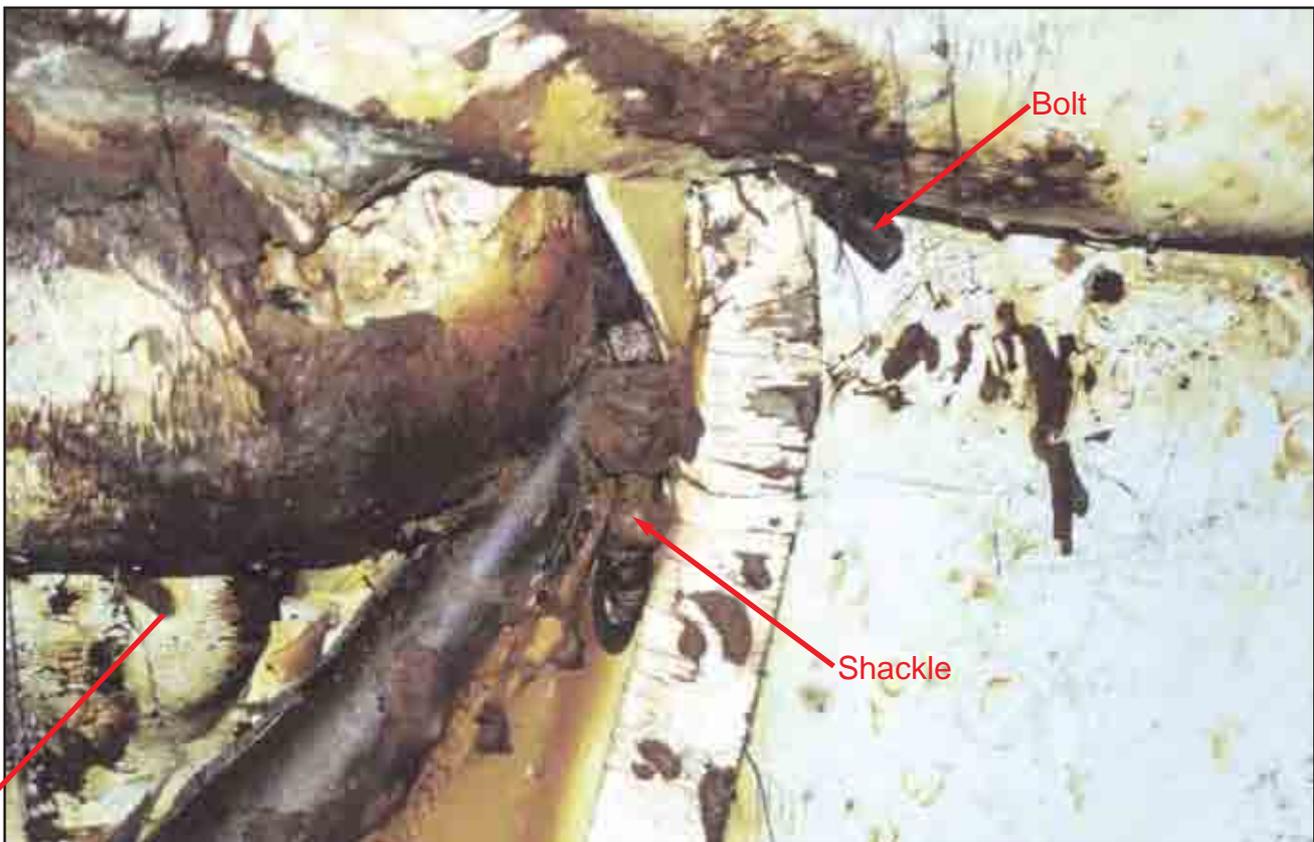
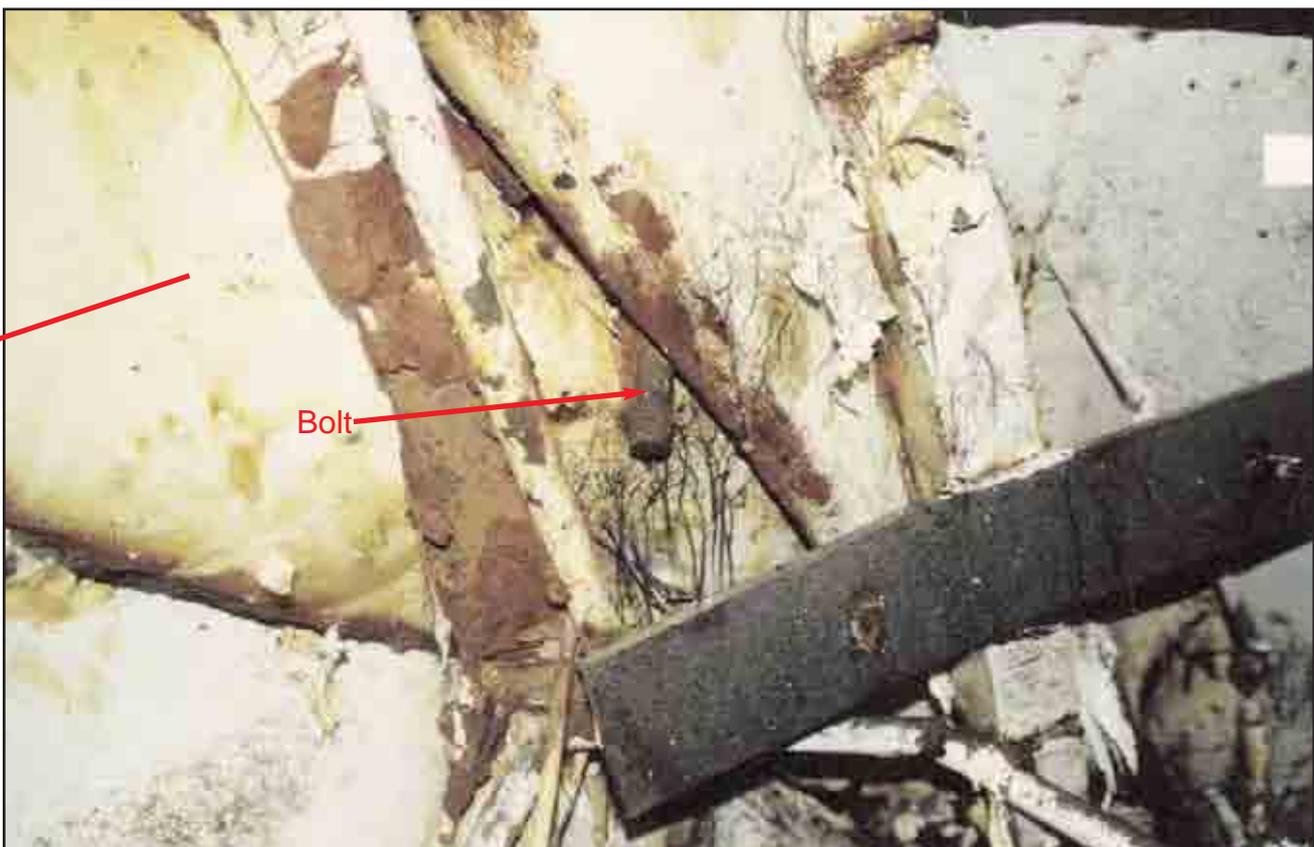
Figure 12a

The hull and deckhead plating was buckled on the starboard side of the stem. Shackles, nuts, bolts and springs were found compressed into the folded steel of the damaged deckhead and shell plating (**Figure 12**).

Photographs showing the bow damage from inside the forepeak space showing debris trapped in the buckled steel

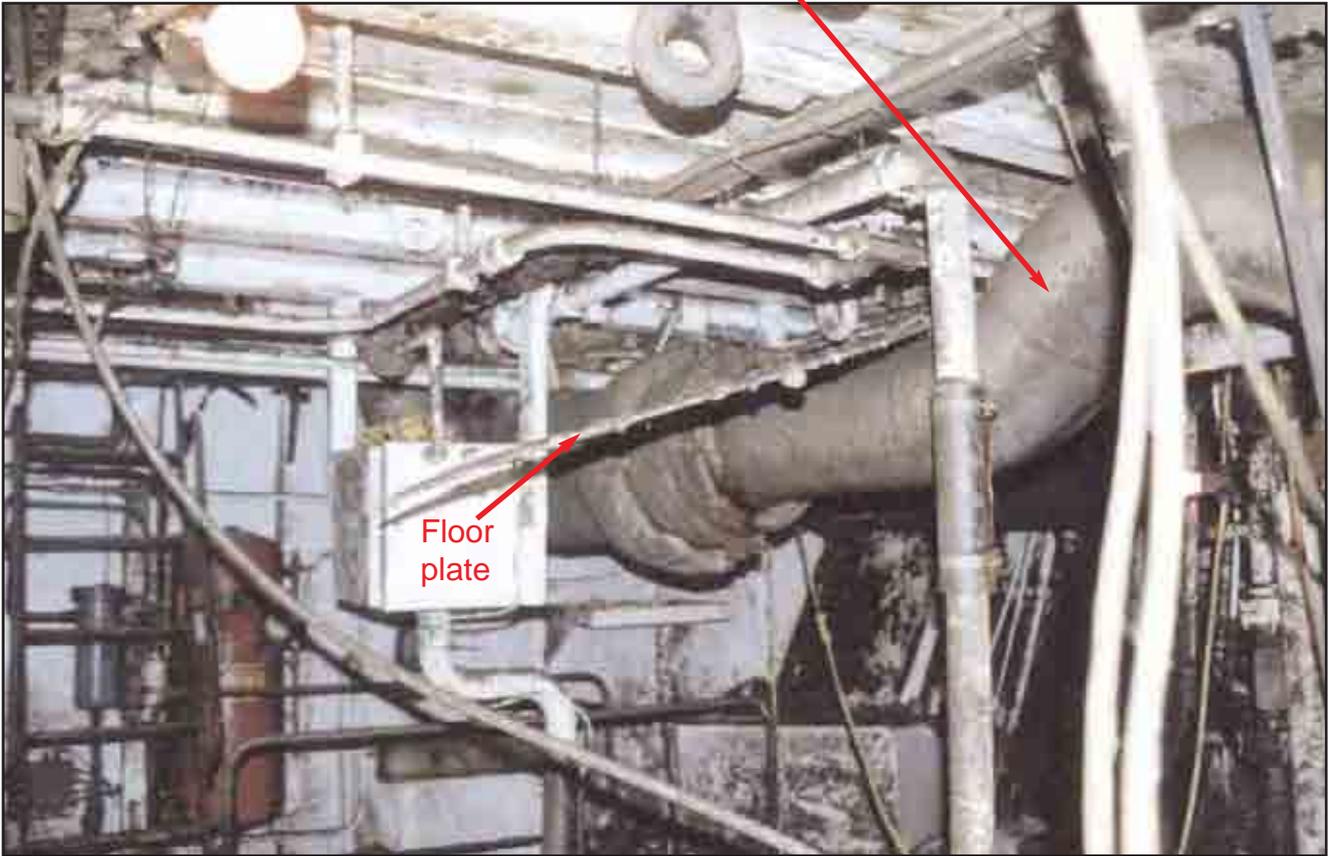
Figure 13

Floor plate found above exhaust pipe

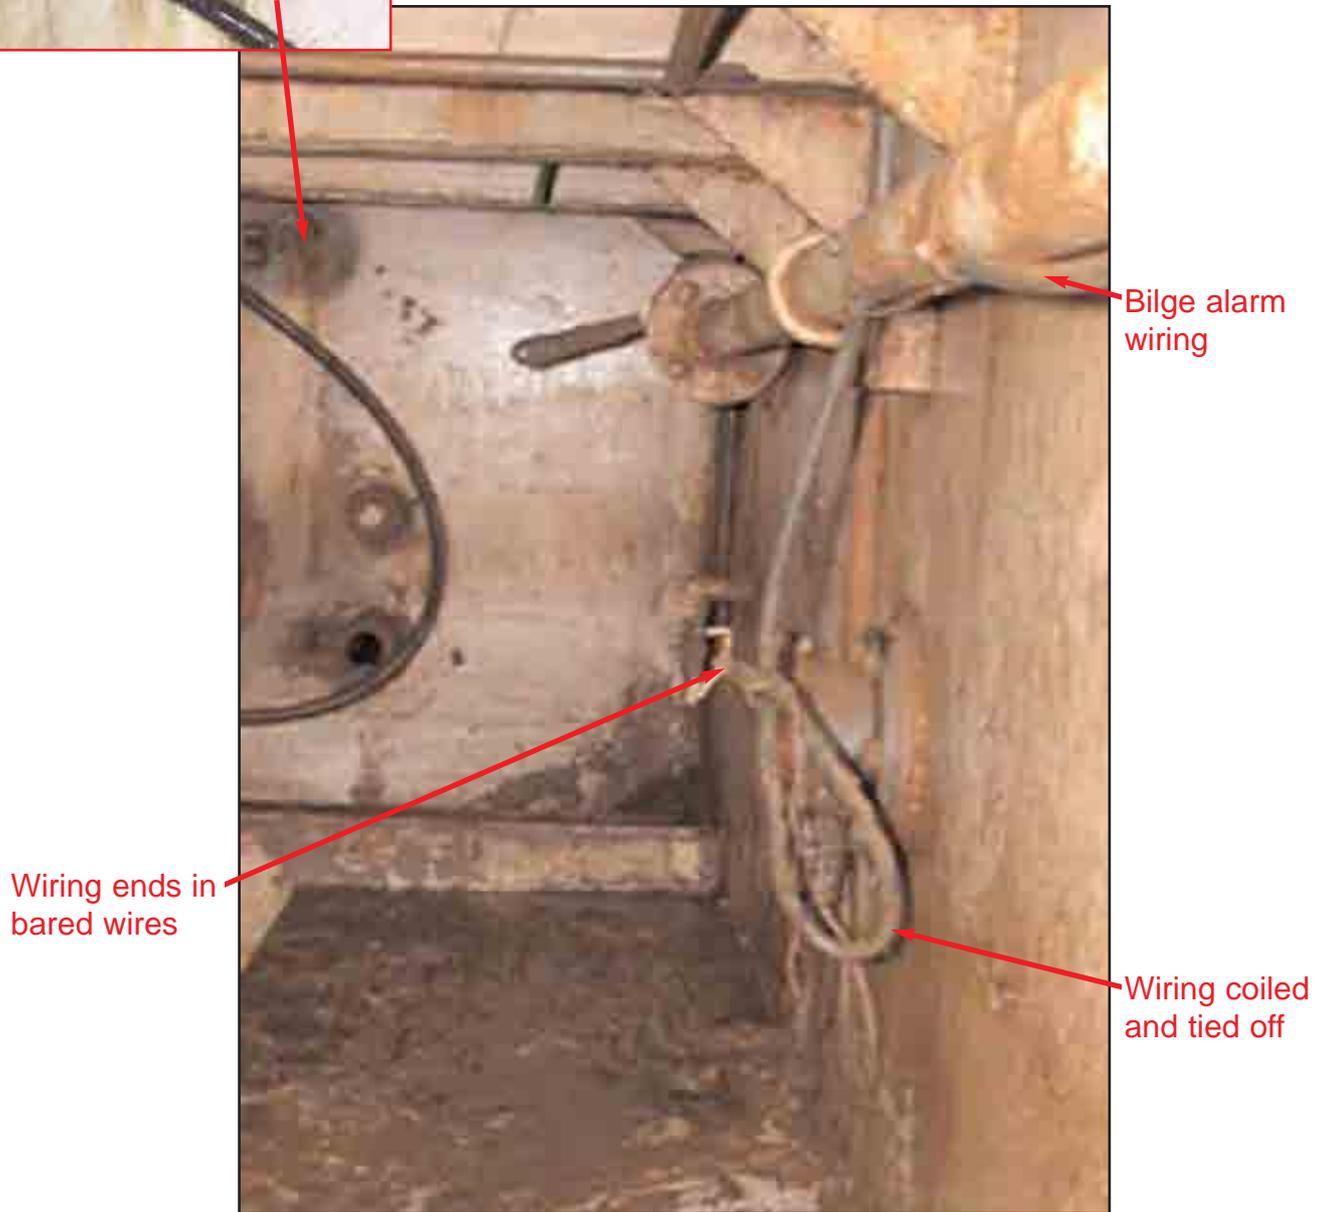
Figure 15

On 22 December 1999, *Solway Harvester* was lying alongside in Garlieston harbour. An electrician was on board repairing the radar when the skipper asked him to have a look at the bilge alarm float switch in the fish room because it was not working. The electrician did so and found the cable to the float switch broken in the shaft tunnel, apparently caused by a rope flailing

around the propeller shaft. It could not be repaired immediately because the break had occurred inside the watertight bulkhead gland between the slush well and the shaft tunnel. A new float switch, complete with moulded cable, was ordered.

She sailed with a fish room bilge alarm known, to the skipper, to be defective.

Bilge alarm wiring (disconnected) in the shaft tunnel

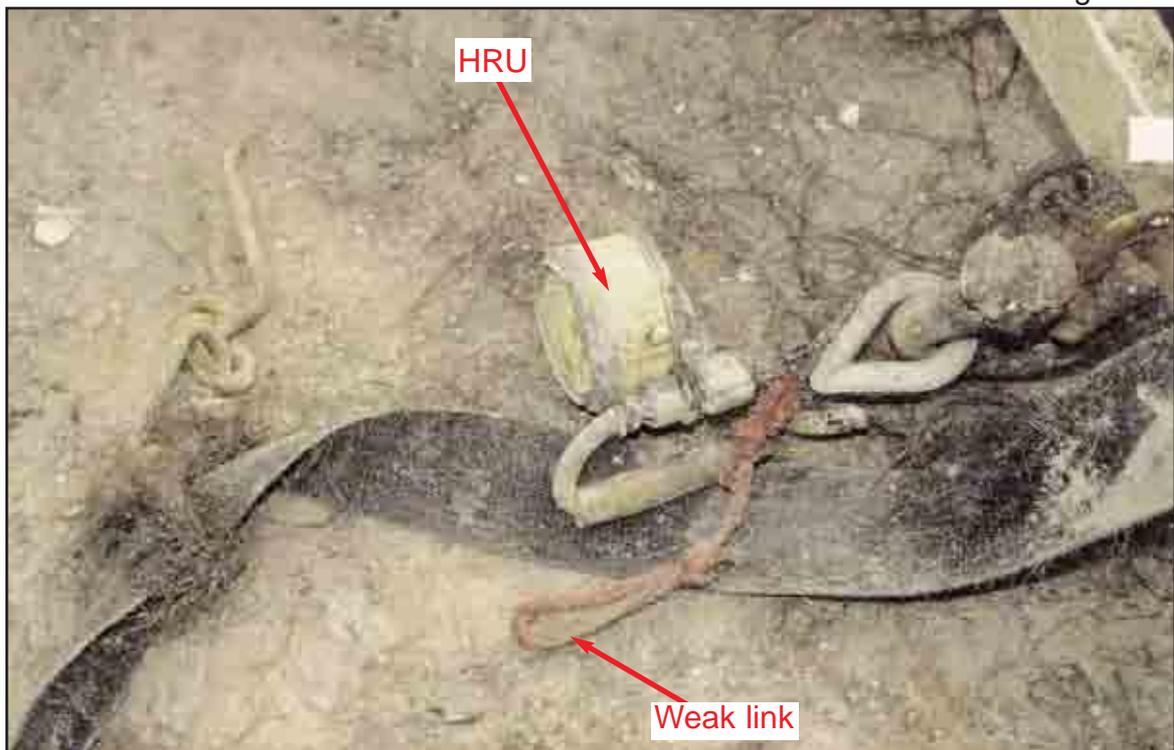
Figure 16

The lashings on the aft liferaft cradle were still fast and the HRU had not operated. The weak link was unbroken and its free eye empty (**Figure 16**). The expiry date on the unit was 9/98. The HRU on the forward liferaft cradle had operated and cut the lashings.

The aft liferaft securing straps and HRU

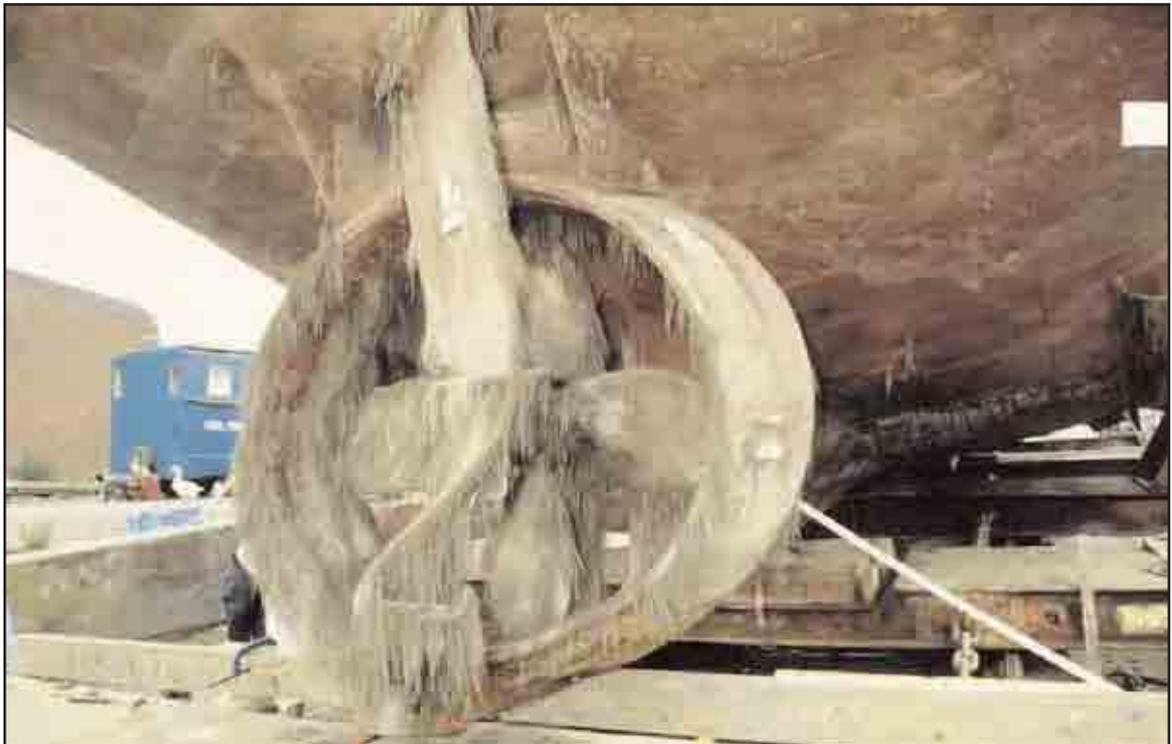
Figure 17

Salvage damage to kort nozzle and rudder

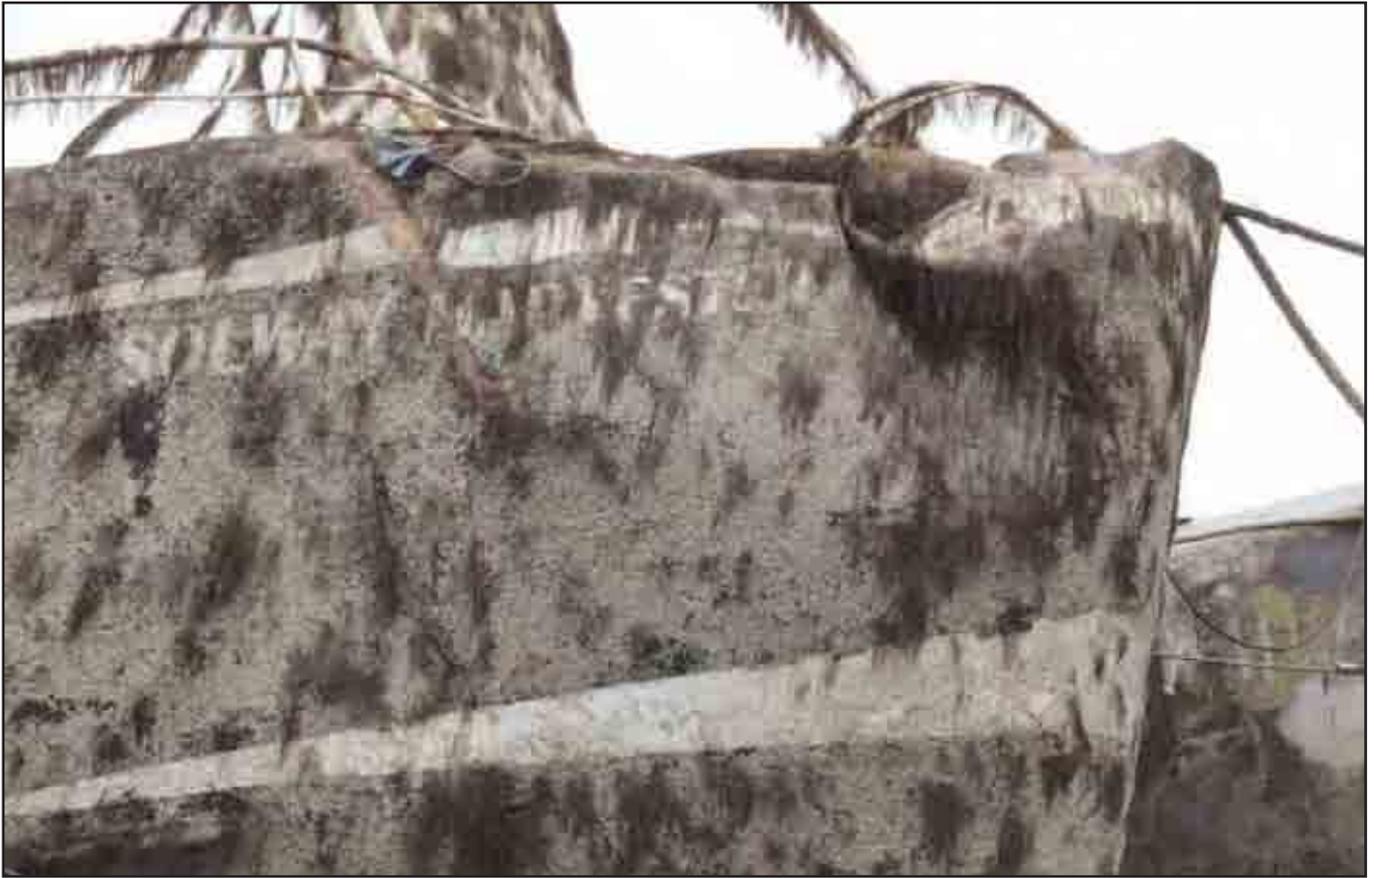
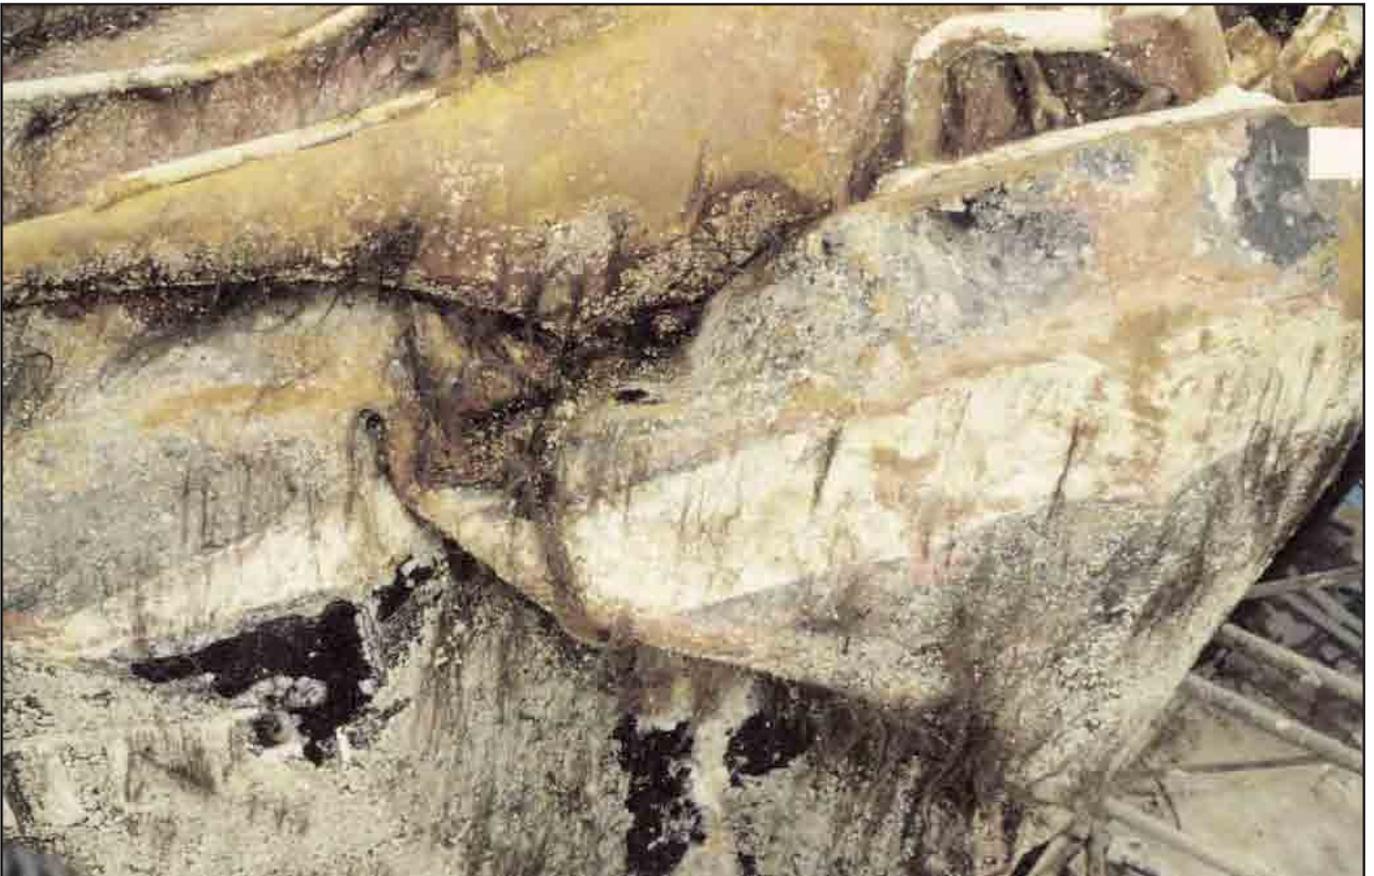
The bow damage was localised, and although the hull plating was folded, there was no hole (**Figure 18**). At the level of the shelter top, the damage began 300mm to port of the centre-line and extended 2900mm in a straight line across to the starboard side (**Figure 18 and 19**). The stemhead was set back 400mm folding the deck plating behind it.

Bow damage

The total damaged area was small. Examination of the hull in the immediate vicinity of the damage showed no “foreign” paint deposits.

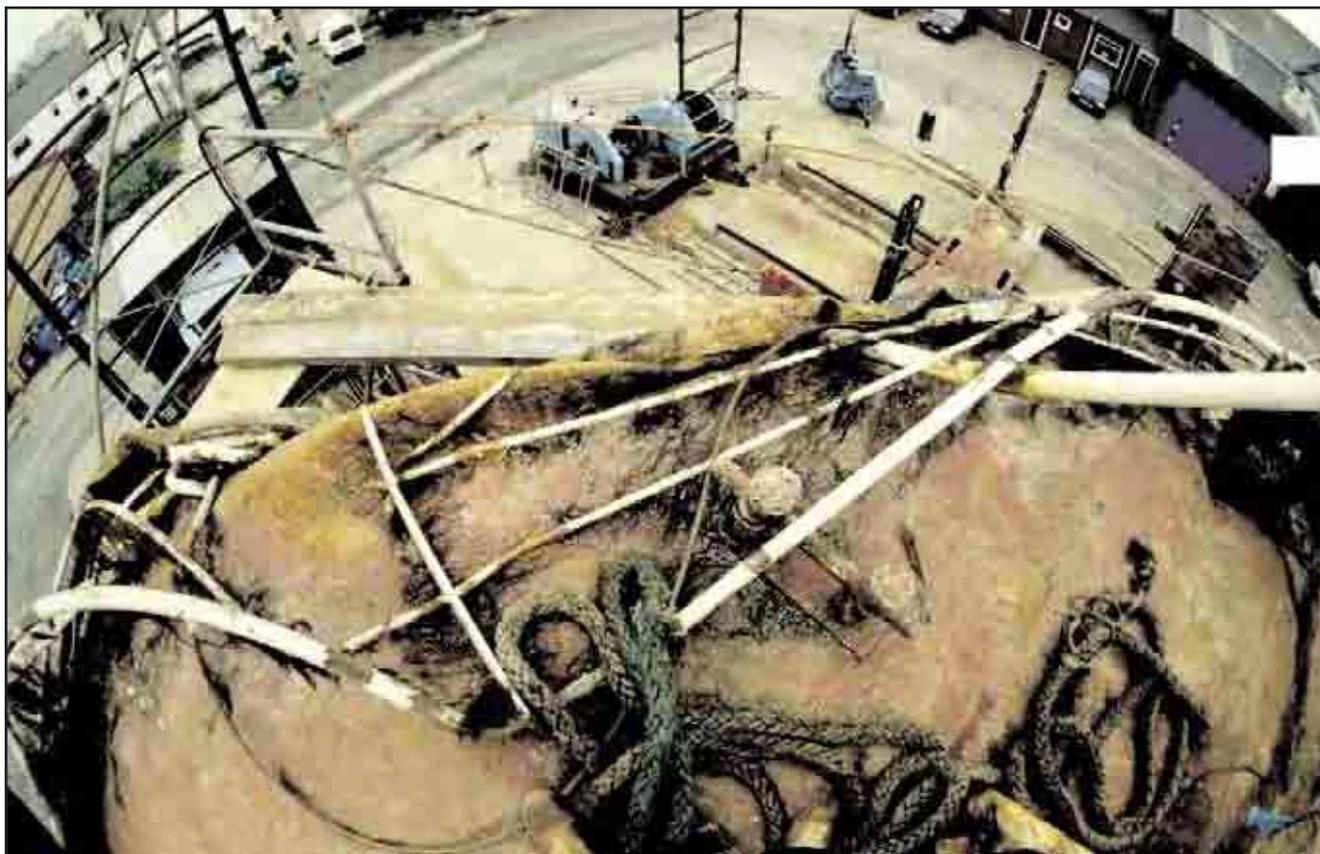
Bow damage viewed from the shelter top

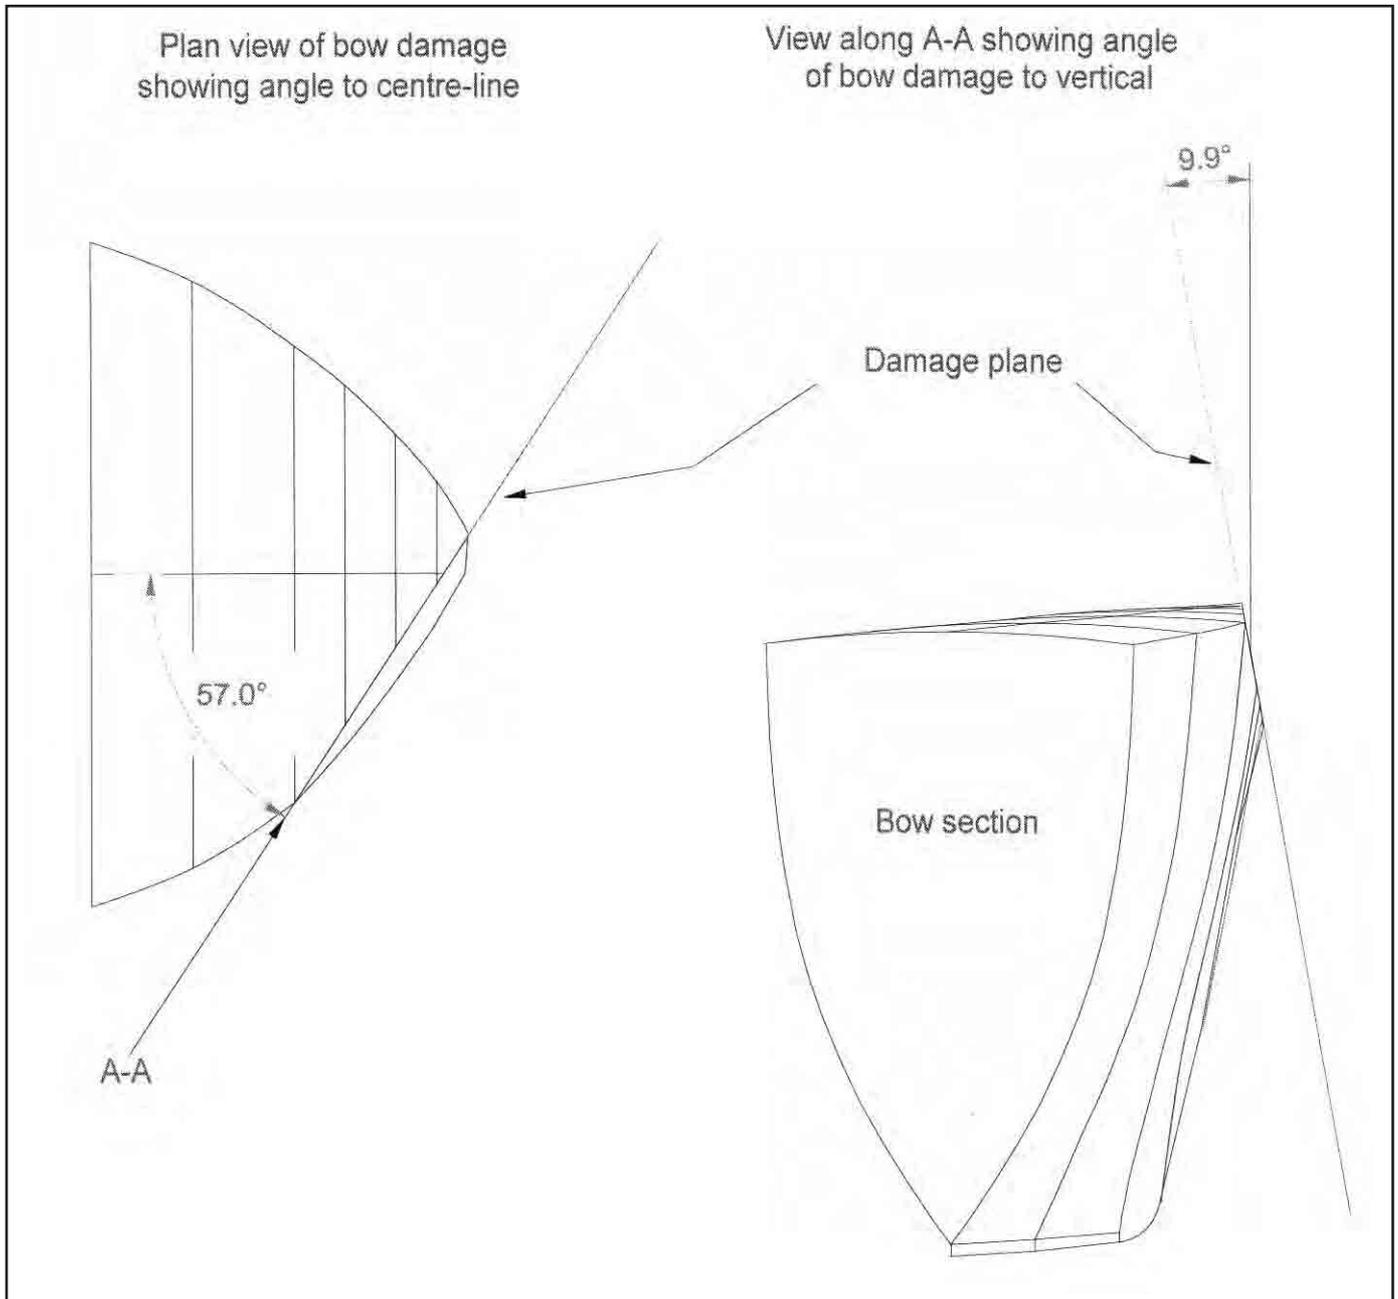
It was still necessary to determine what had caused the bow damage. Examination showed it was roughly a flat surface. Its orientation was about 57° to the wreck’s centre-line in plan and sloping about 10° past the vertical (**Figure 25**). Because the shaped steel of the bow had been flattened so conspicuously, the only viable explanation was that it had been caused by an impact with a flat surface. This, and knowing the damage had occurred after the vessel had

Orientation of the 'flat' bow damage

capsized, led the investigation to conclude that the only feature which could have caused it was the seabed, and that the damage occurred on impact, when *Solway Harvester* was in a near bow down attitude (**Figure 26**). Supporting this conclusion was the total lack of evidence of a contact with any other steel vessel or object.
