Report on the investigation of the collision of
Dole America
with the Nab Tower in the eastern approaches to The Solent
on 7 November 1999

Marine Accident Investigation Branch
First Floor, Carlton House
Carlton Place
Southampton
SO15 2DZ

Report No 32/2000

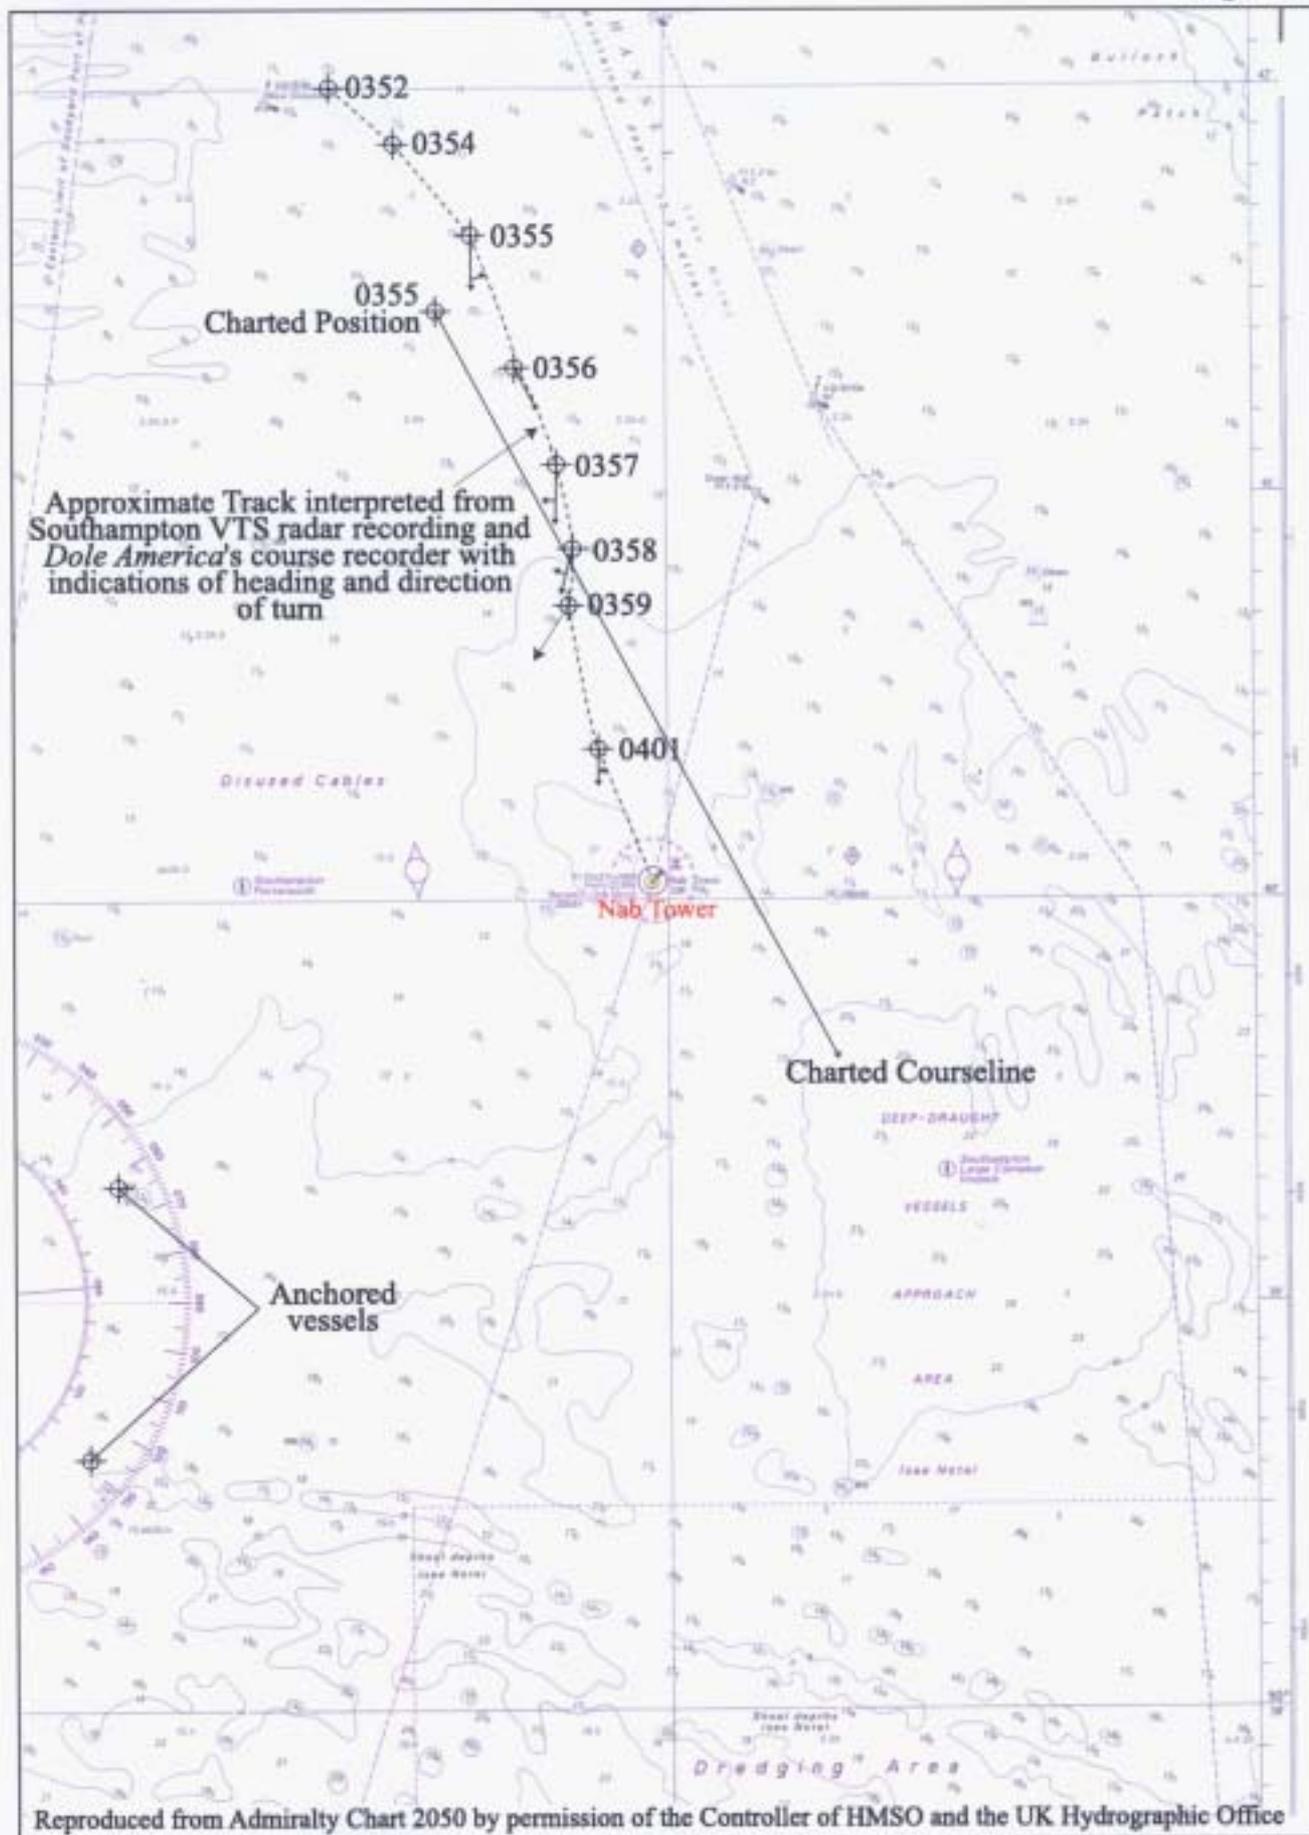
Figure 2

1.2.3 Departure from Portsmouth (Figure 2)

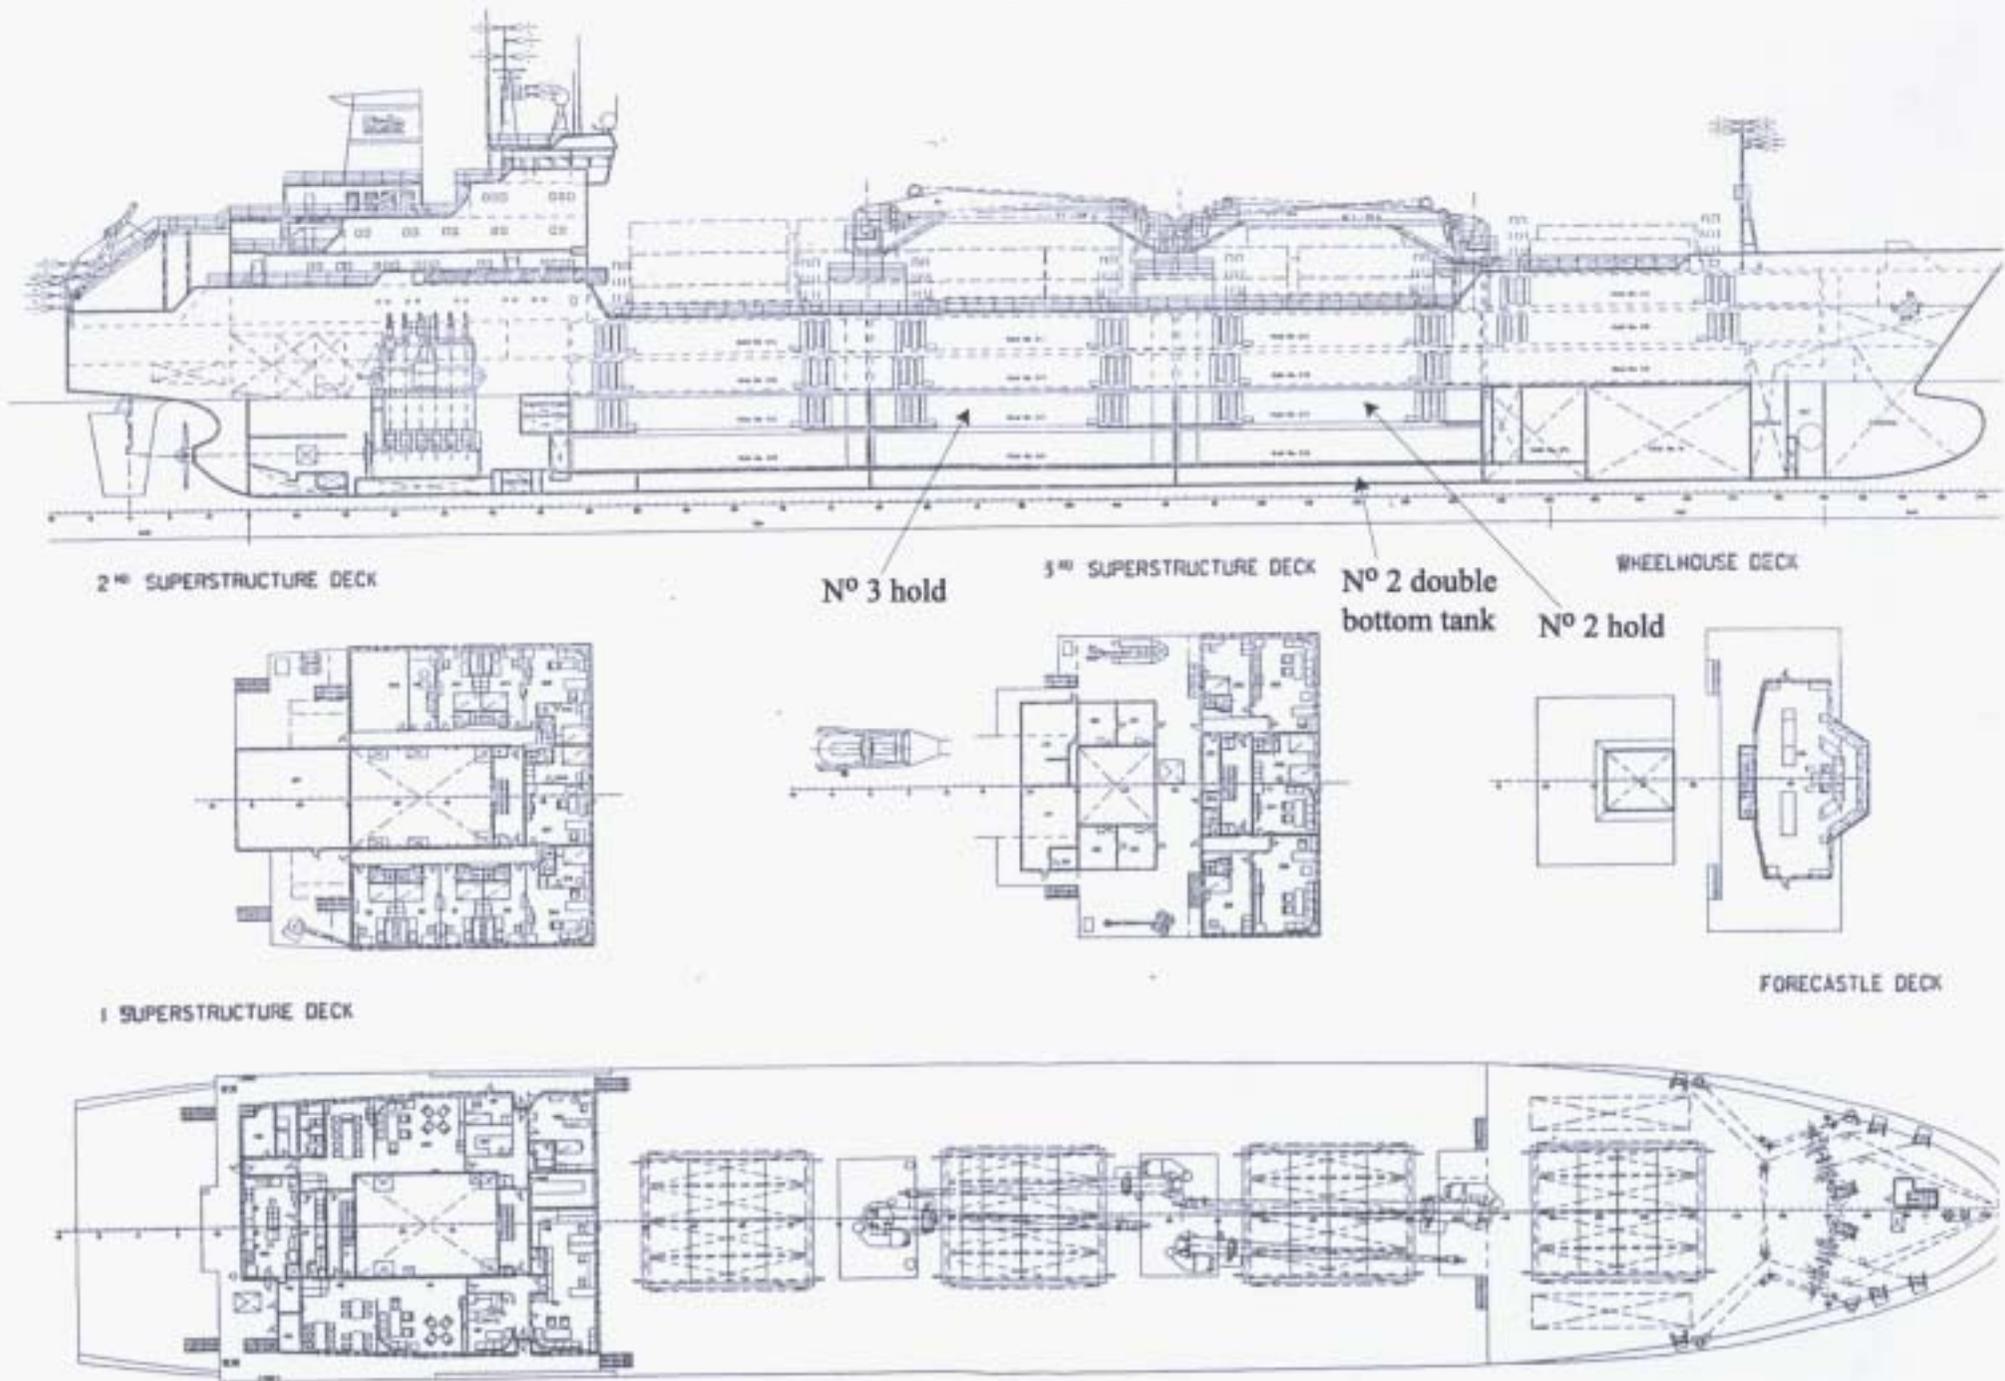
General arrangement plan

The vessel was holed on the starboard side in three places. One hole was on the starboard quarter about 1m above the waterline, measuring approximately 8m long and 2m wide. The hole breached the engine room and ruptured a lubricating oil tank, causing 5,200 litres of lubricating oil to spill into the sea.

The other holes were below the waterline in the vicinity of the bilge keel at Nos 2 and 3 holds. One hole measured approximately 20m long and breached No 2 double bottom tank. The other breached No 3 hold and the double bottom tank below it, causing flooding of No 3 hold, and also of No 2 hold via a damaged transverse bulkhead between the holds.

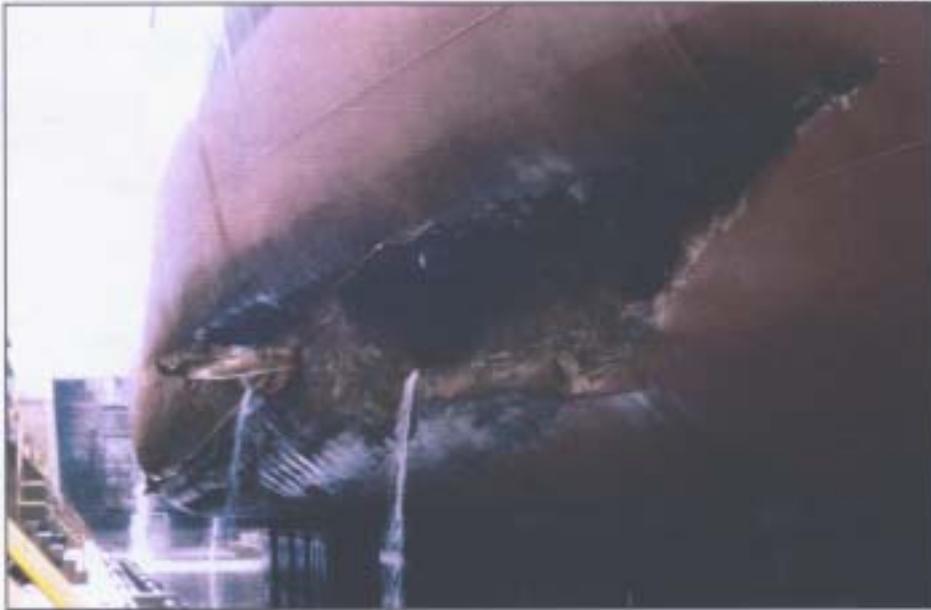
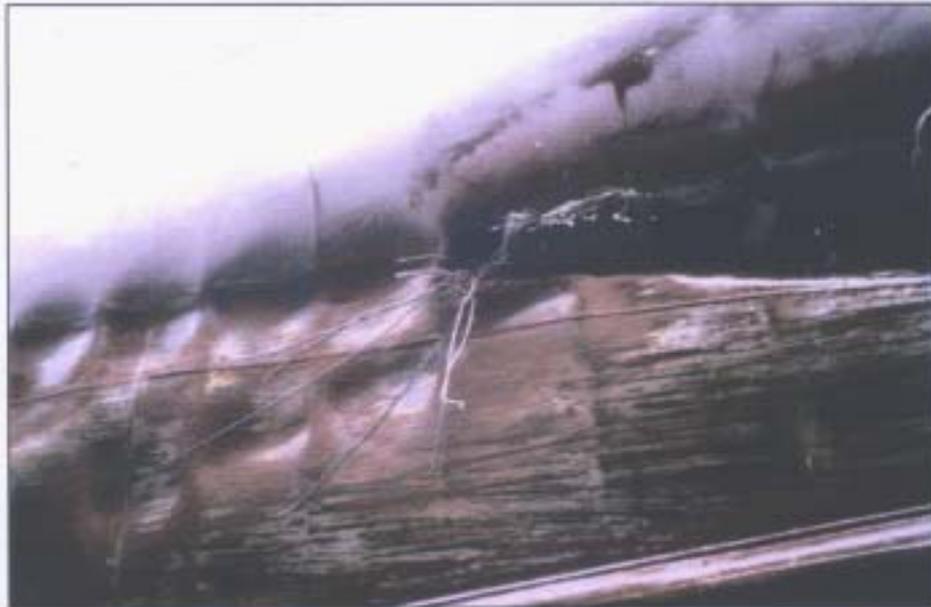
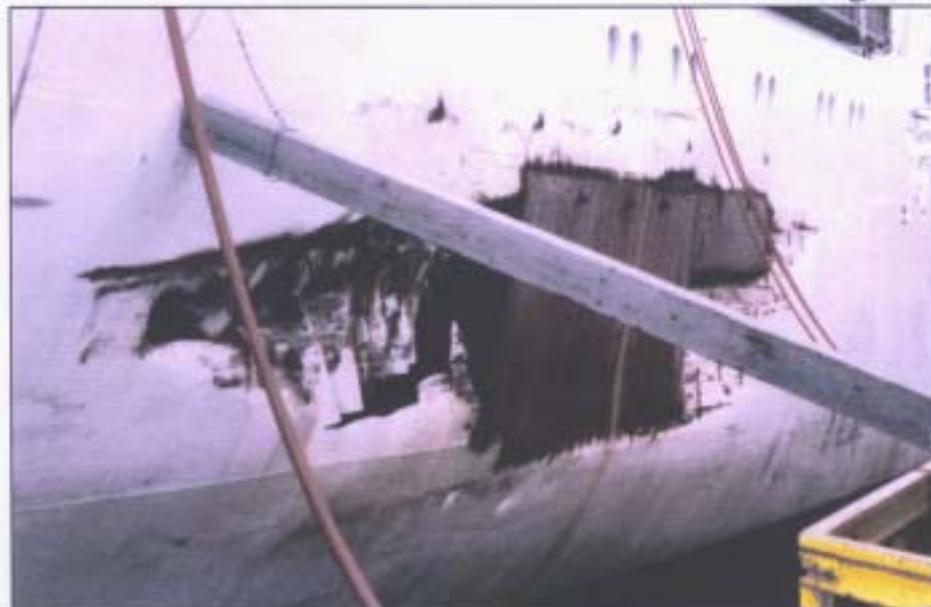
1.6 Extent of damage to *Dole America* (Figures 3, 4, 5 and 6)

Extent of damage

- 3.3.10 As a result of the collision, *Dole America* was holed in three places above and below waterline. [1.6]
- 3.3.11 Personnel on board *Dole America*, and those ashore and on assisting vessels, worked effectively to resolve the immediate emergency and place the vessel in a position of relative safety. This action saved the vessel from foundering. [2.7]

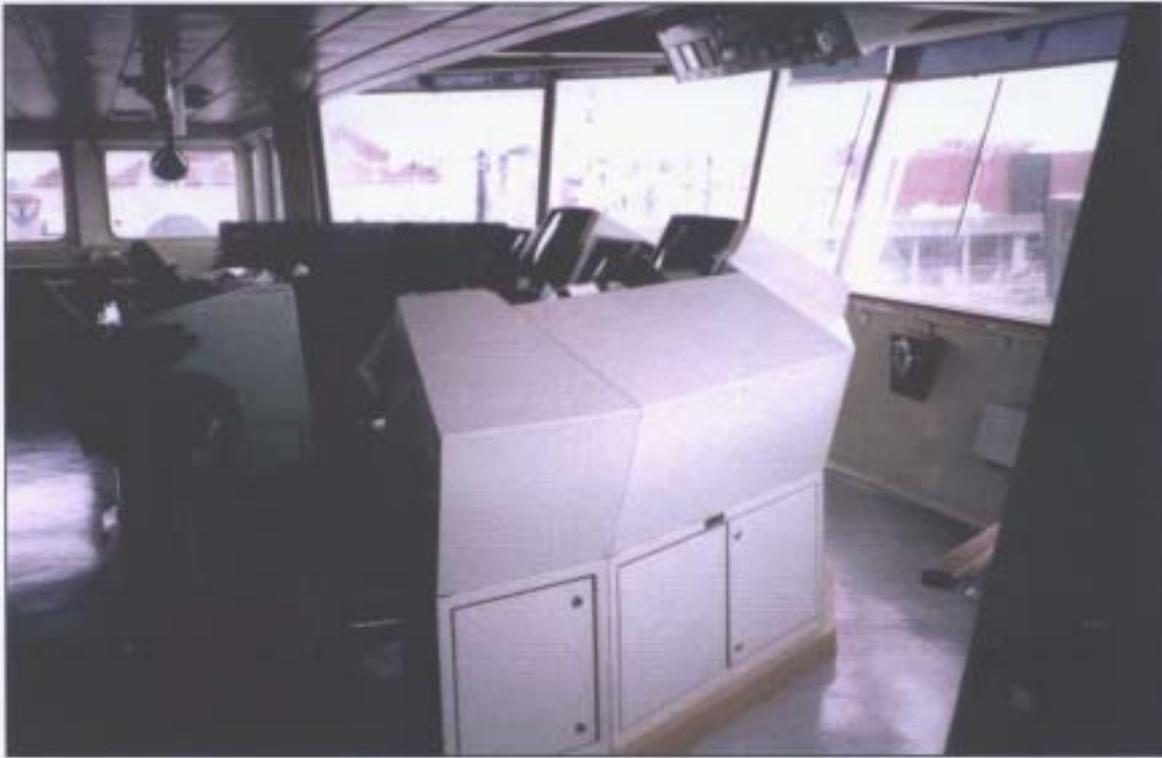
Figure 7

Dole America's bridge was spacious with good visibility ahead and to the sides. A shallow u-shaped central console contained all of the main bridge instruments and the two radars. A central steering console was positioned between two pedestal seats for use by watchkeepers.

Immediately forward of the console and set into the deckhead at an angle was an instrument panel showing a clock, rudder indicator and other instruments which could be clearly seen from behind the central console.

The console was set back from the forward sloping bridge windows with a walkway between them. Anyone standing in front of the console would be unable to see any of the displays on the console or the deckhead instruments.

Bridge layout

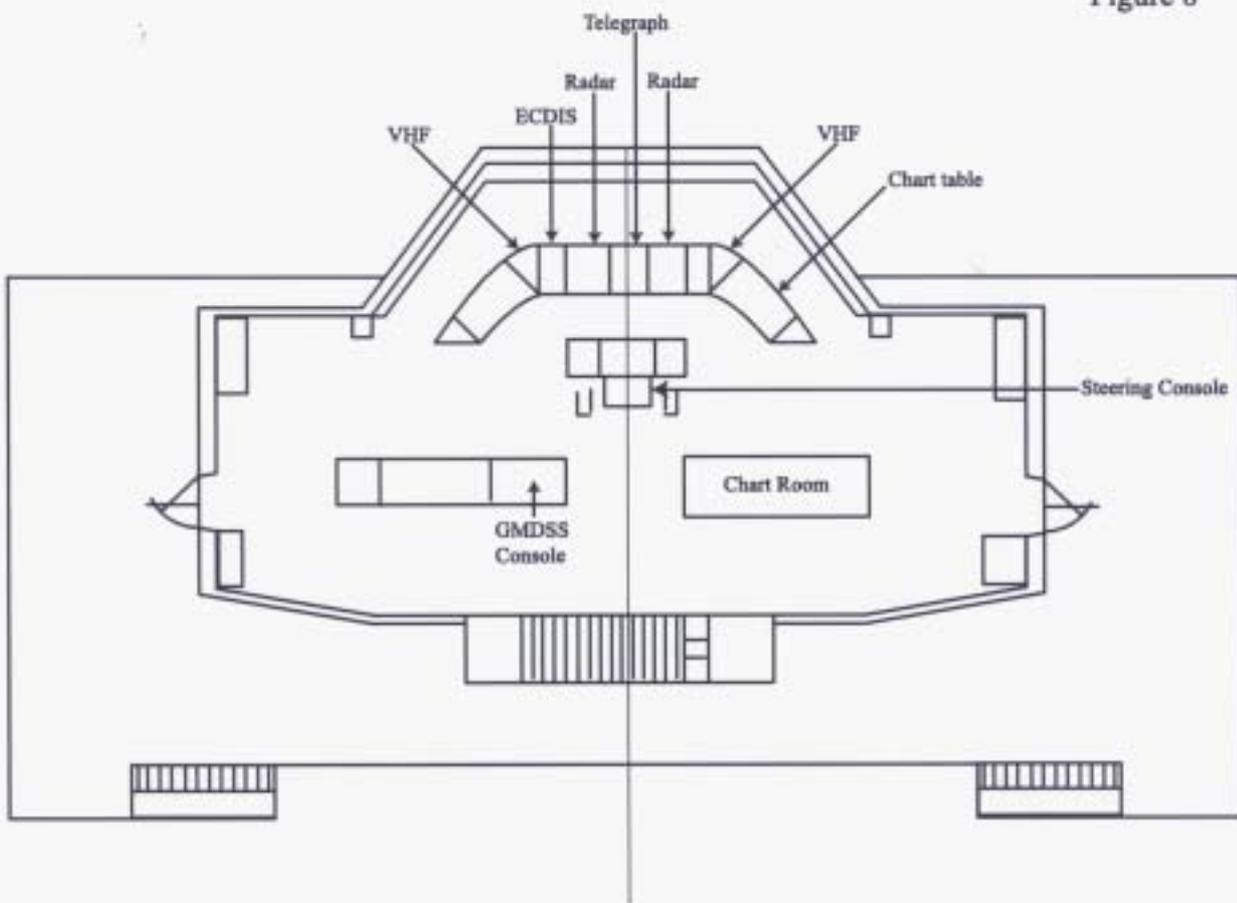
Figure 8

Bridge plan
