**Report of the investigation of a
manoverboard fatality from**

GRADELY

**off the west coast of the Island of Mull
on 28 October 1999**

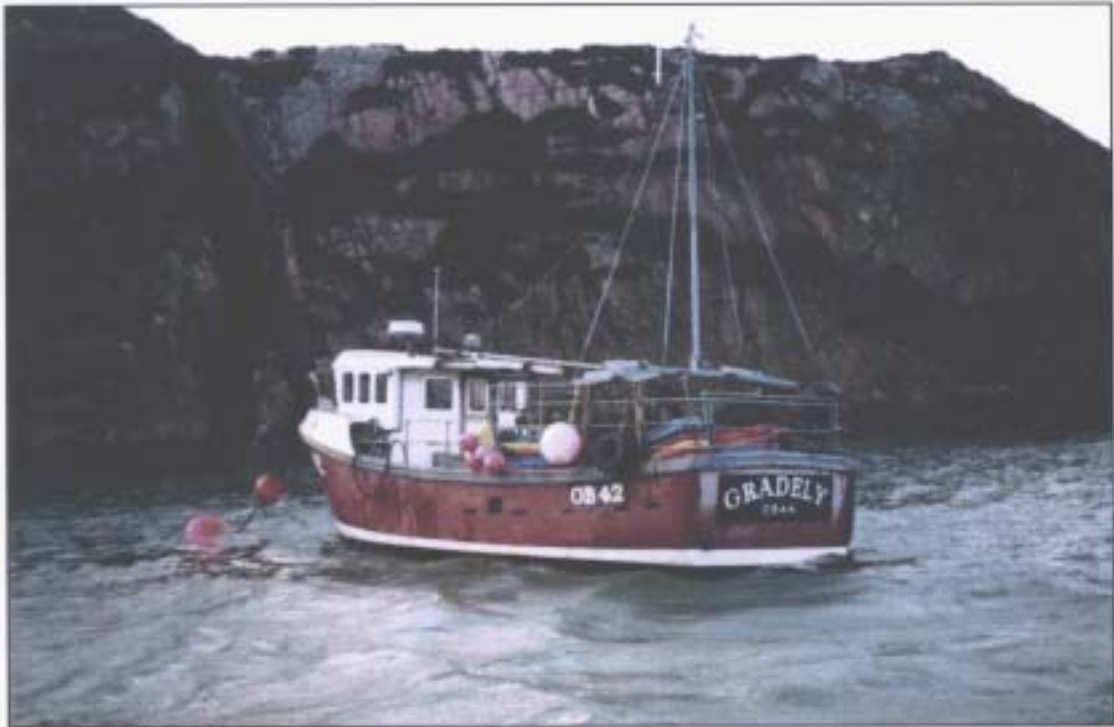
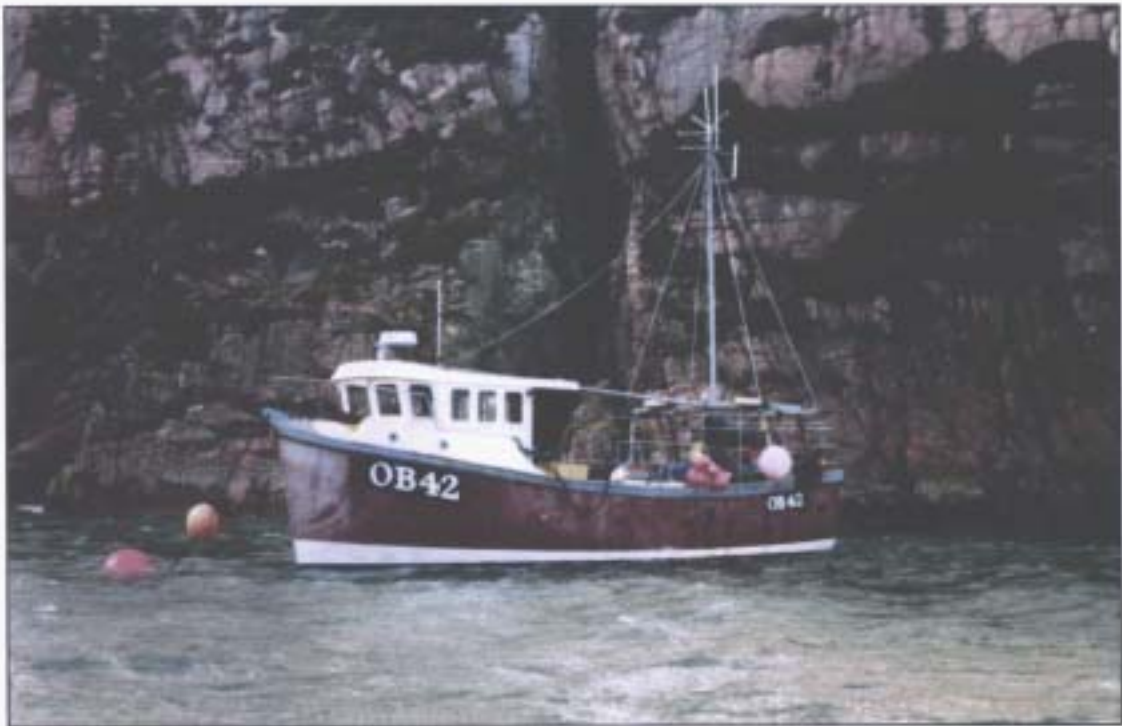
Figure 1 - *Gradelly* anchored at Bull Hole

General views of *Gradely* are shown in **(Figure 1)**.

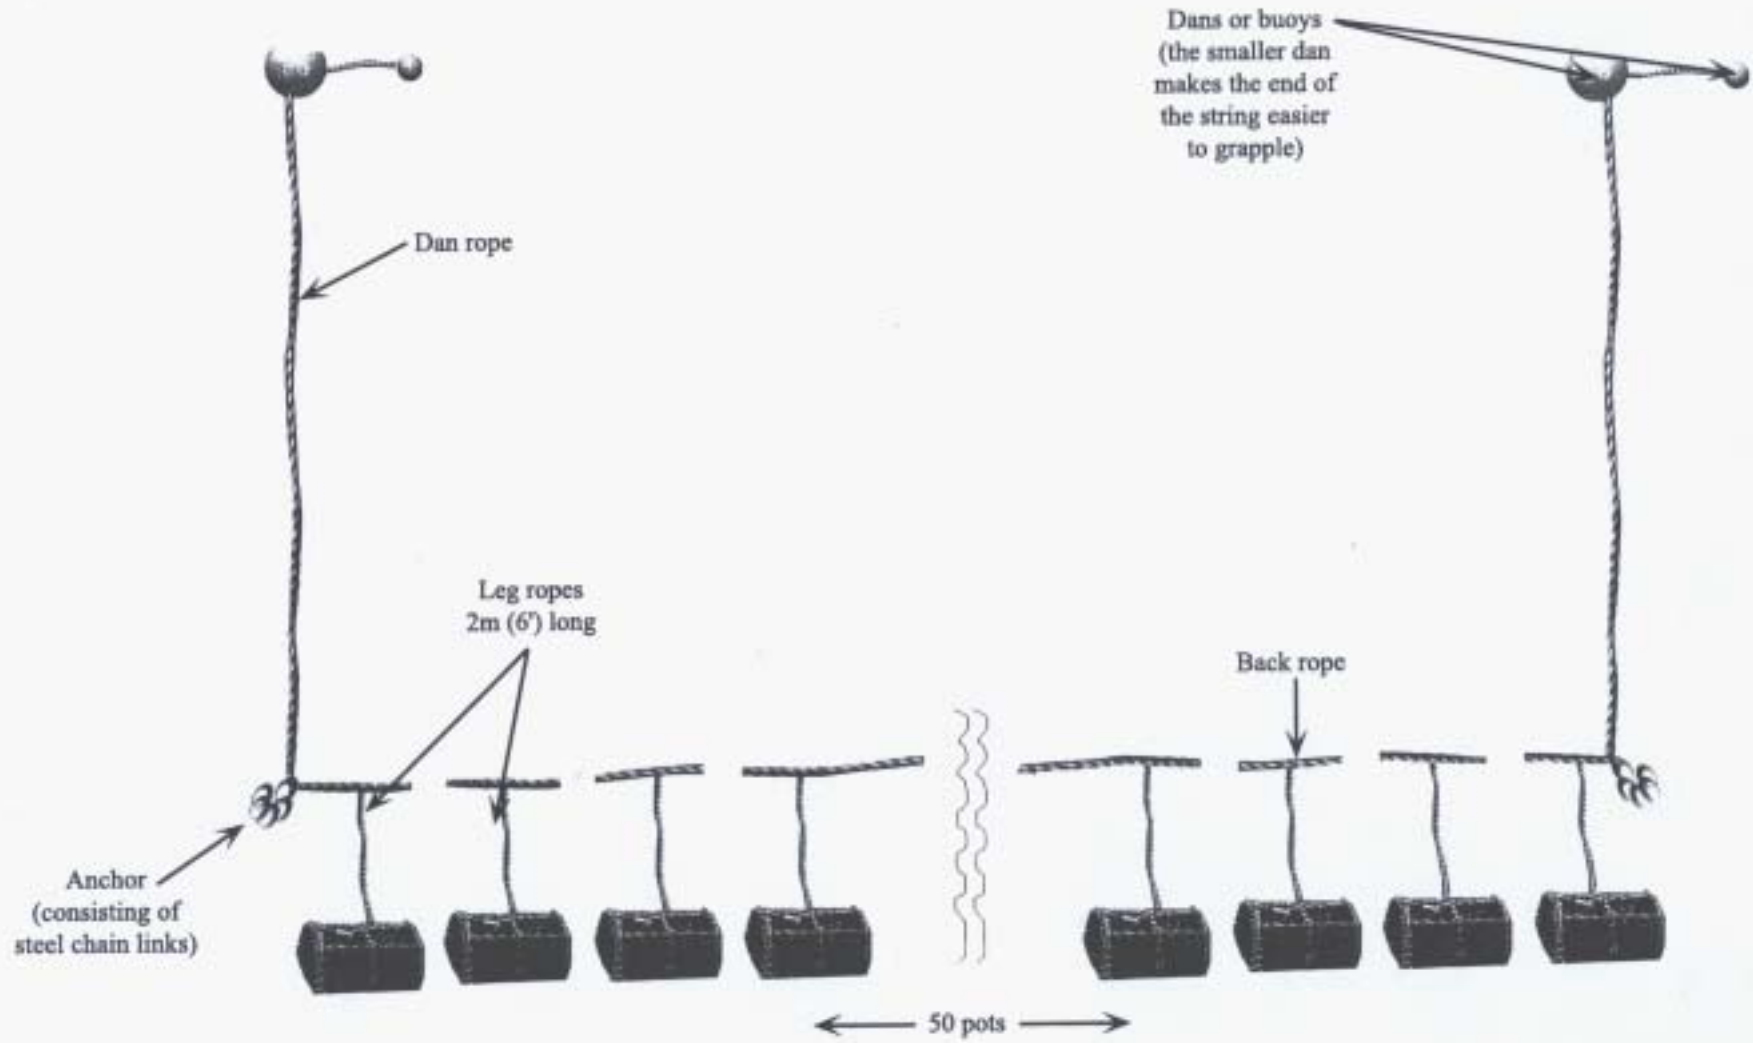
Figure 2 - String of pots

Six strings of pots were usually hauled and shot each day. There were 50 pots to each string (**Figure 2**). A maximum of one string was on board at any time during fishing, although sometimes two strings were carried when pots needed to be shifted to another area, but this was only carried out in fine weather. The pots were laid either east to west or west to east. The sea area being used was very popular with potters; there were about 6000 pots there. To prevent the ropes from getting tangled, they were laid in the same direction. During hauling and shooting, *Gradely* was steered by the auto-pilot.

A string of pots took about 6 minutes to deploy. There was 22m (72') of back rope between each pot. The vessel was motored at about 6 knots, so a pot was deployed about every 7 seconds.

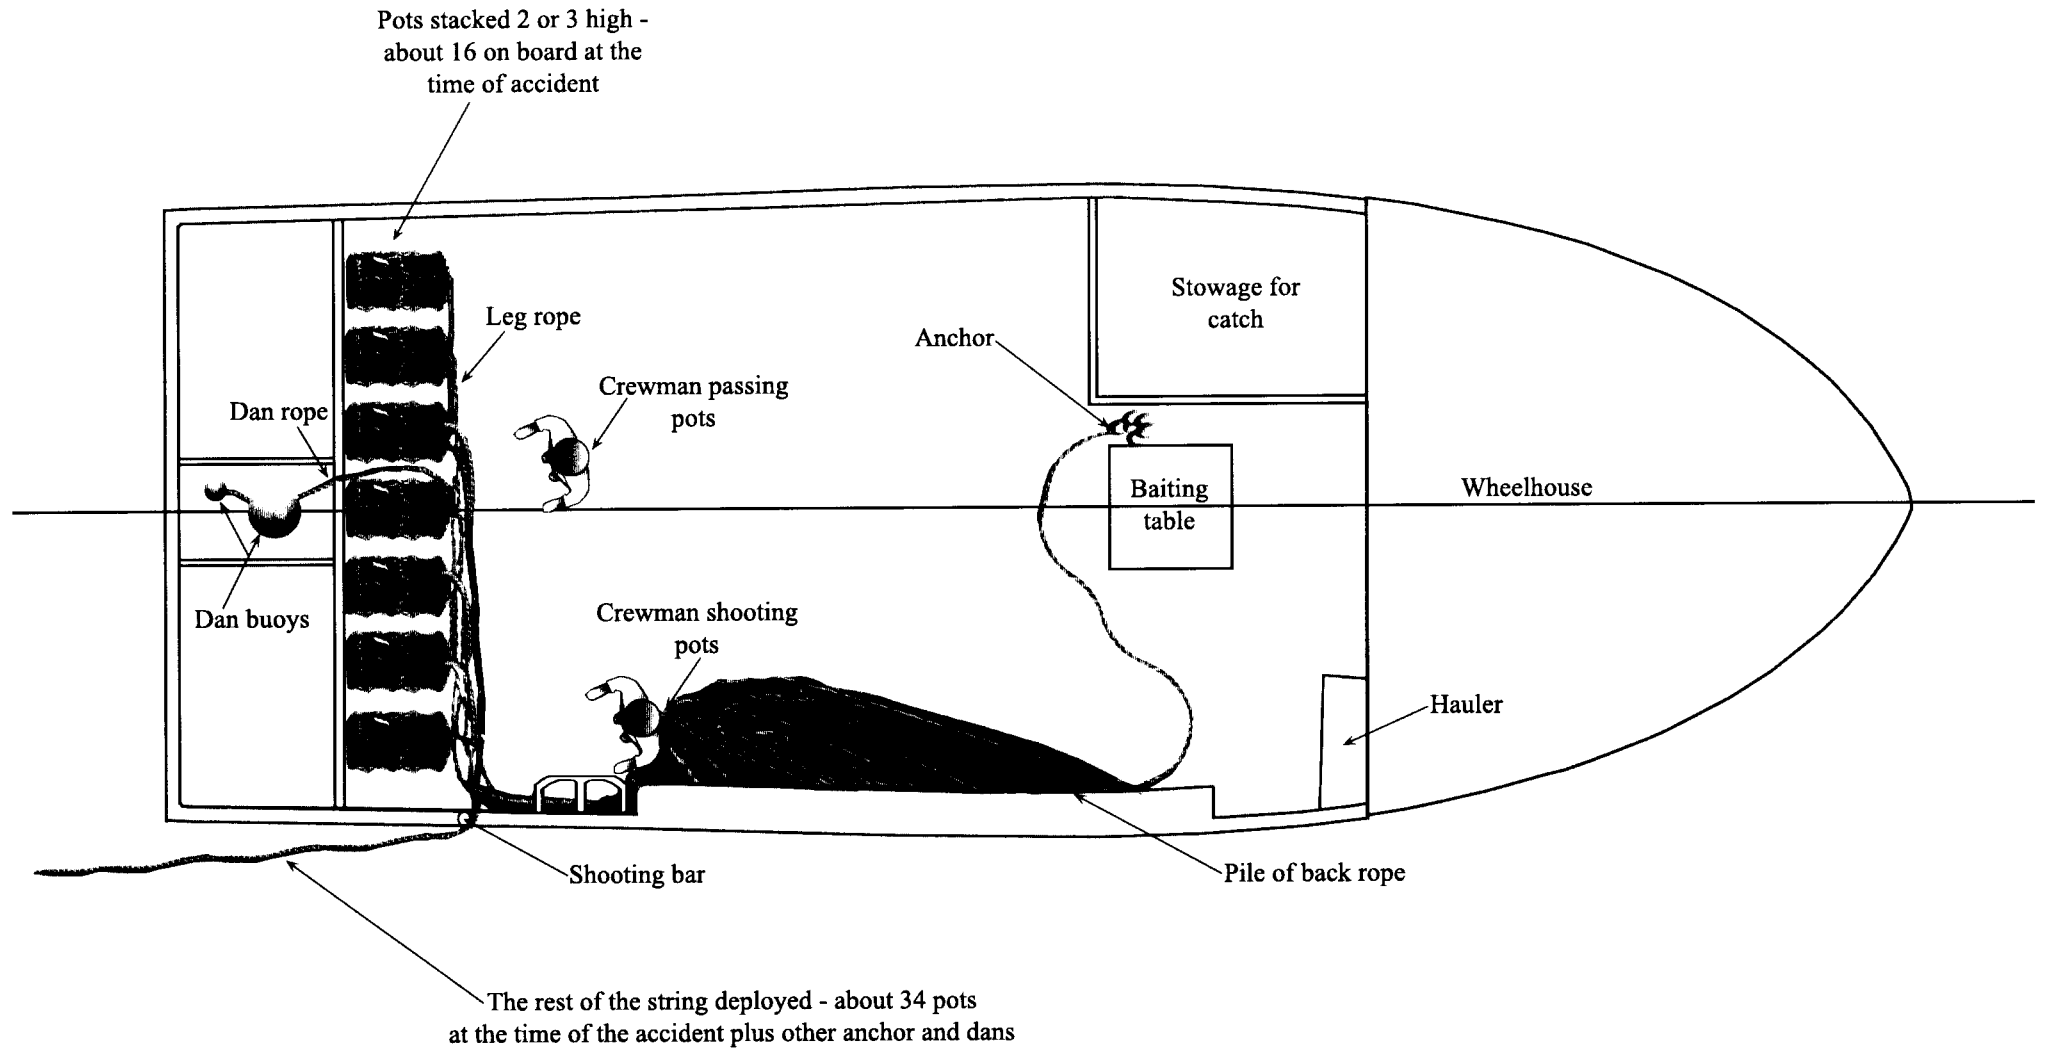
Figure 3 - Shooting operation

The arrangement of equipment and crew on the deck during shooting was as shown in (Figure 3). The leg ropes/back rope were kept tight to the bulwark at the shooting position. It was important that the deckhand undertaking the shooting kept his left foot firmly planted on the deck, so that ropes could not get under his feet; he could shift his right foot to maintain balance if necessary.

The inherent danger with the current shooting arrangement on board *Gradely* (**Figure 3**), which is common on small potting vessels, is the close proximity of the leg ropes/back rope to the feet of the crewman undertaking the shooting of pots. This danger is eliminated by the toggle system (**Figure 8**).

4. The inherent danger with the current shooting arrangement on *Gradely*, is the proximity of the leg ropes/back rope to the feet of the crewman undertaking the shooting. This danger is eliminated by the toggle system. [2.4]

The back rope was in close proximity to his feet when shooting the pots. [2.4]

1. Ensure that basic safety training has been completed by all the crew on board his vessel(s). [3.1.3]
2. Adopt the toggle system, or an equally safe system of work, for shooting pots on board his vessel(s). [3.1.4]
3. Review the operating procedures on *Gradely*, and where there is a reasonably foreseeable risk of crew members falling or being washed or dragged overboard, take all reasonably practical steps to ensure that they wear appropriate lifejackets when working on deck. [3.1.5]

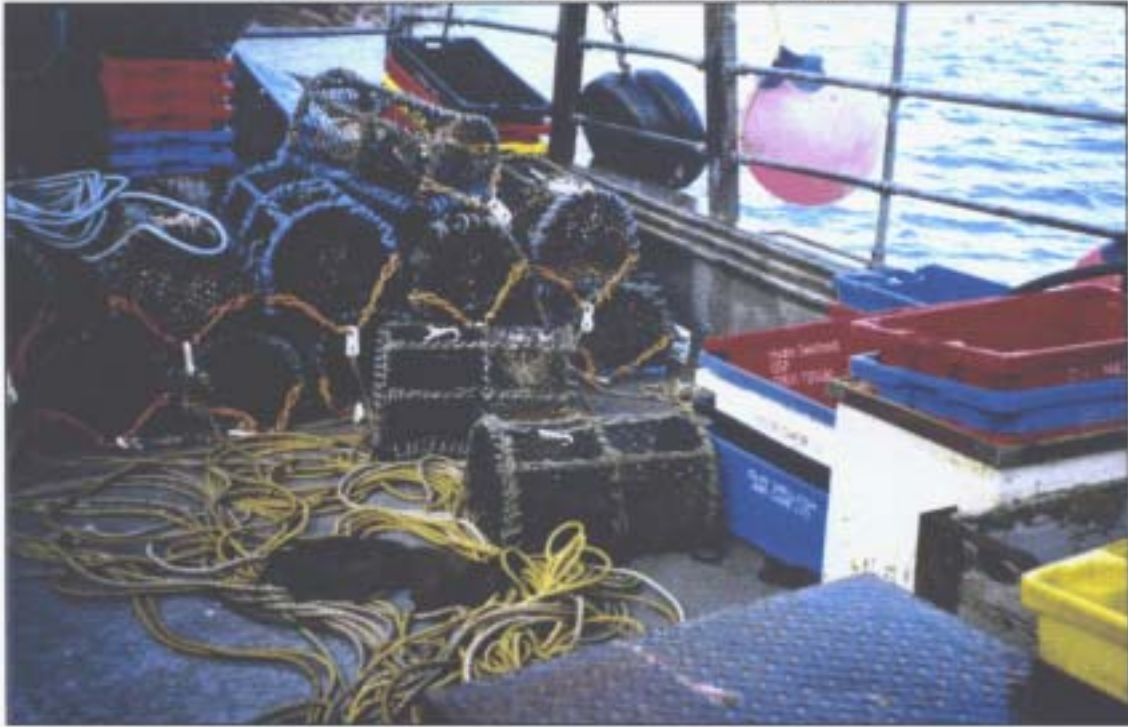
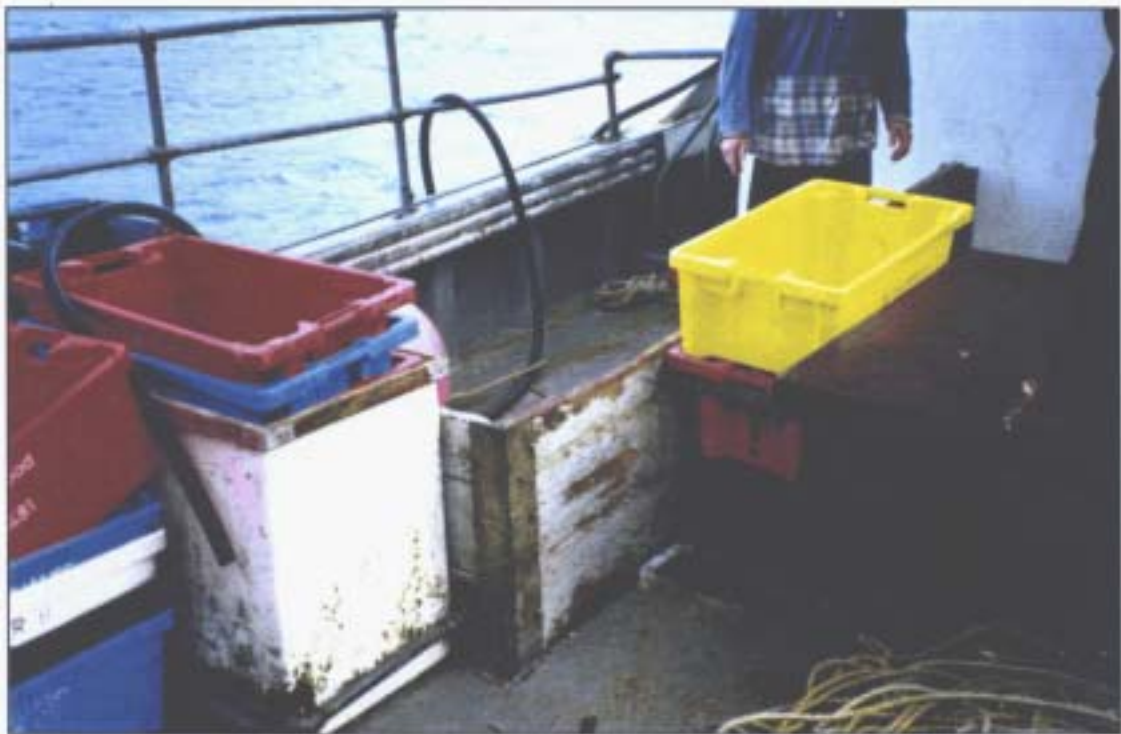
Figure 5 - General views of the working deck

Some general views of the working deck are shown in (Figure 5).

Note: This photograph does not accurately reflect the arrangement of the deck when *Gradely* was fishing

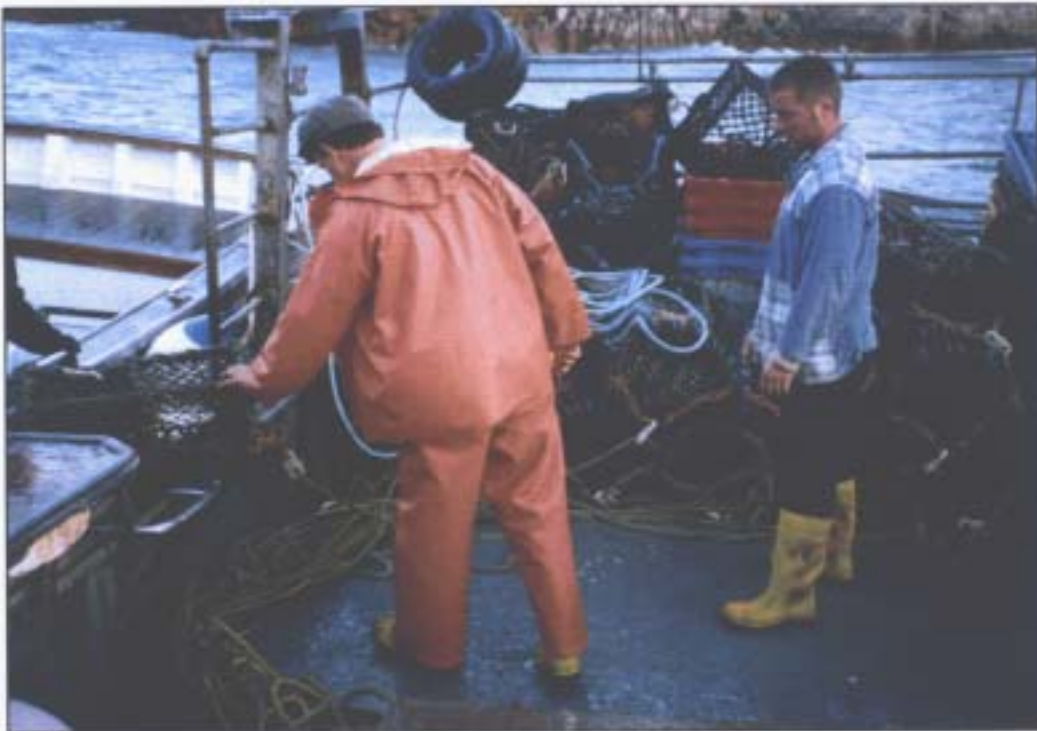
Figure 6 - Deckhands in position for shooting pots

Two fishermen, not related to the accident, were asked to stand in position as if they were shooting pots (Figure 6).

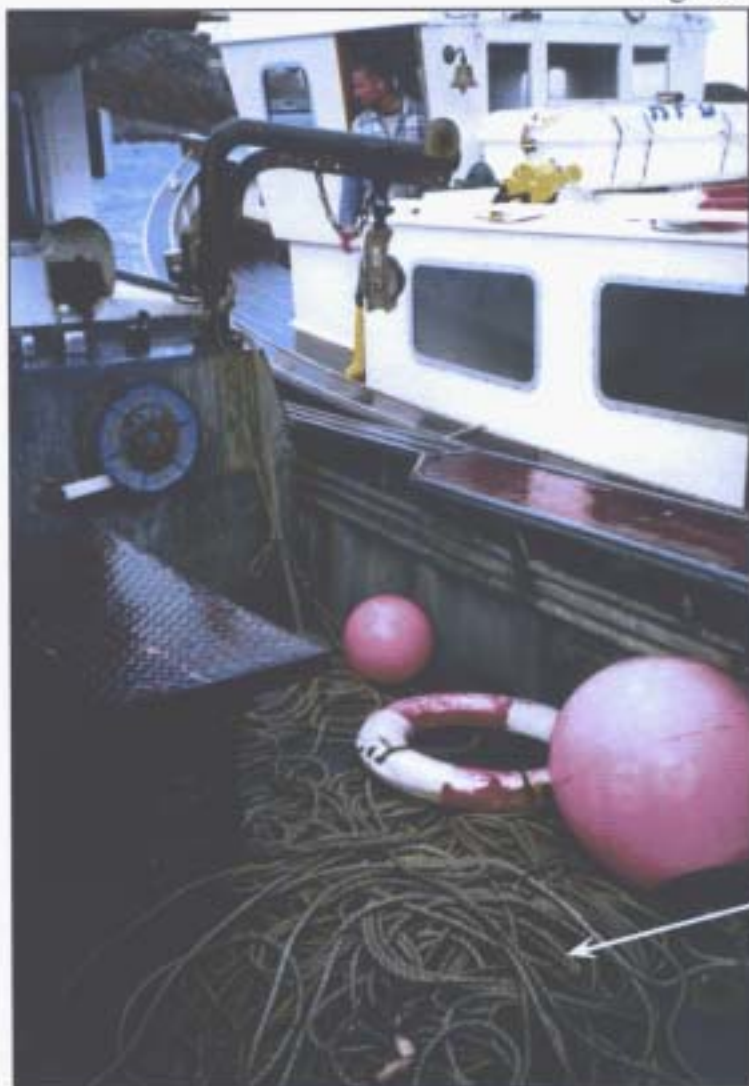
Figure 7

Pile of
back rope
