**Report of the investigation into  
the capsizing of the fishing vessel**

***DONNA M***

**off the coast of the Orkney Islands with the loss of two lives**

**on 31 August 1999**

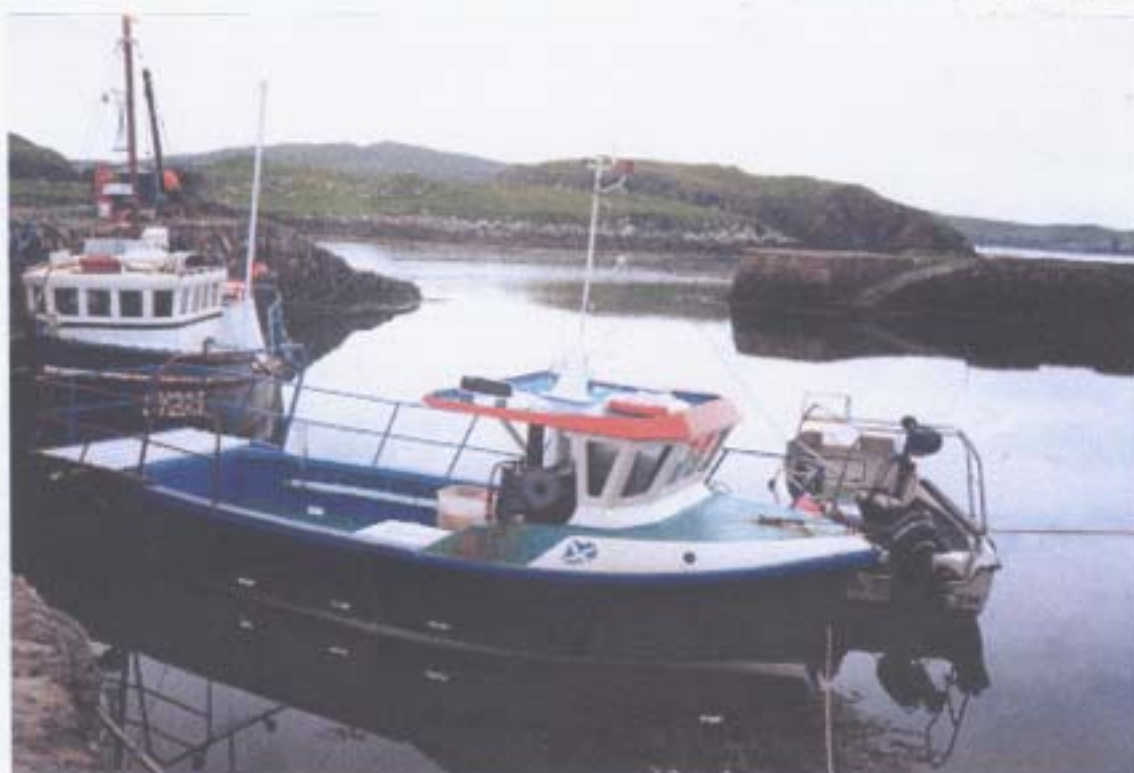
Figure 1

A general view is shown in (**Figure 1**)

*Donna M*'s freeboard was low (**Figure 1**); when unloaded it was only about 115mm at the aft end. Calculations have shown that the freeboard at the position of the aft bulkhead was about 25mm with 700kg of creels loaded on the aft part of the open deck. The freeboard at the aft end would have decreased further when the vessel was making way. Vessels are designed like this because a wave at the stern improves hydrodynamic efficiency (in simple terms a wave crest at the stern tends to push a vessel forward, whereas a trough at the stern tends to pull a vessel back). The low freeboard at the aft end when *Donna M* was loaded and making way has been verified by witnesses.

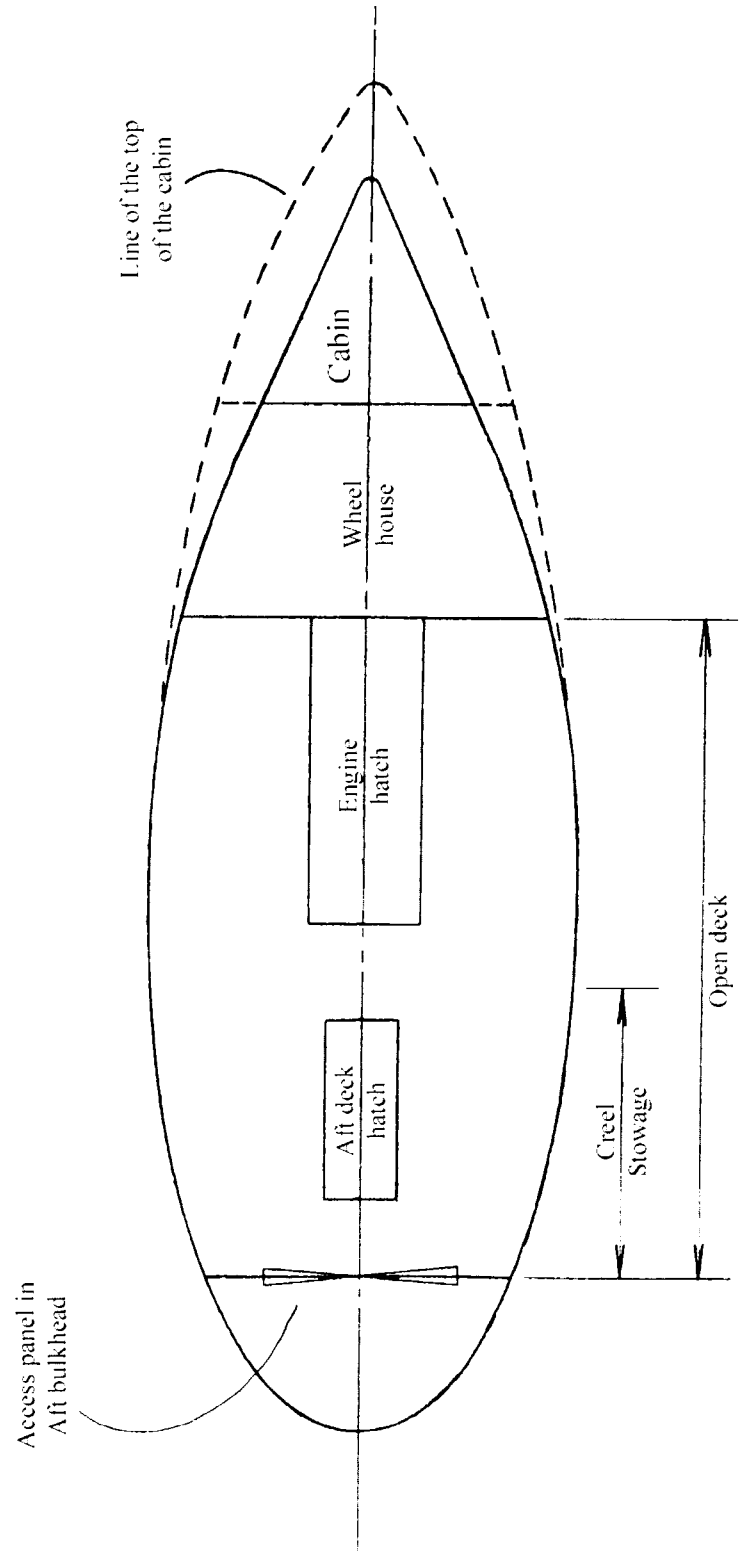
Figure 2

A plan is shown in (**Figure 2**)

The aft deck hatch cover (**Figure 2**) was taken off by removing about 20 screws; the hatch had also been sealed with mastic. Once this hatch cover was removed, a loose bilge float switch was found. There was no bilge alarm, so the switch must have operated the bilge pump directly when it was working. The electric bilge pump could be seen in the lowest part of the hull under the shaft (**Figure 7**), with the wires disconnected. Before it broke, the connection had been made by winding the wires together and covering them with insulating

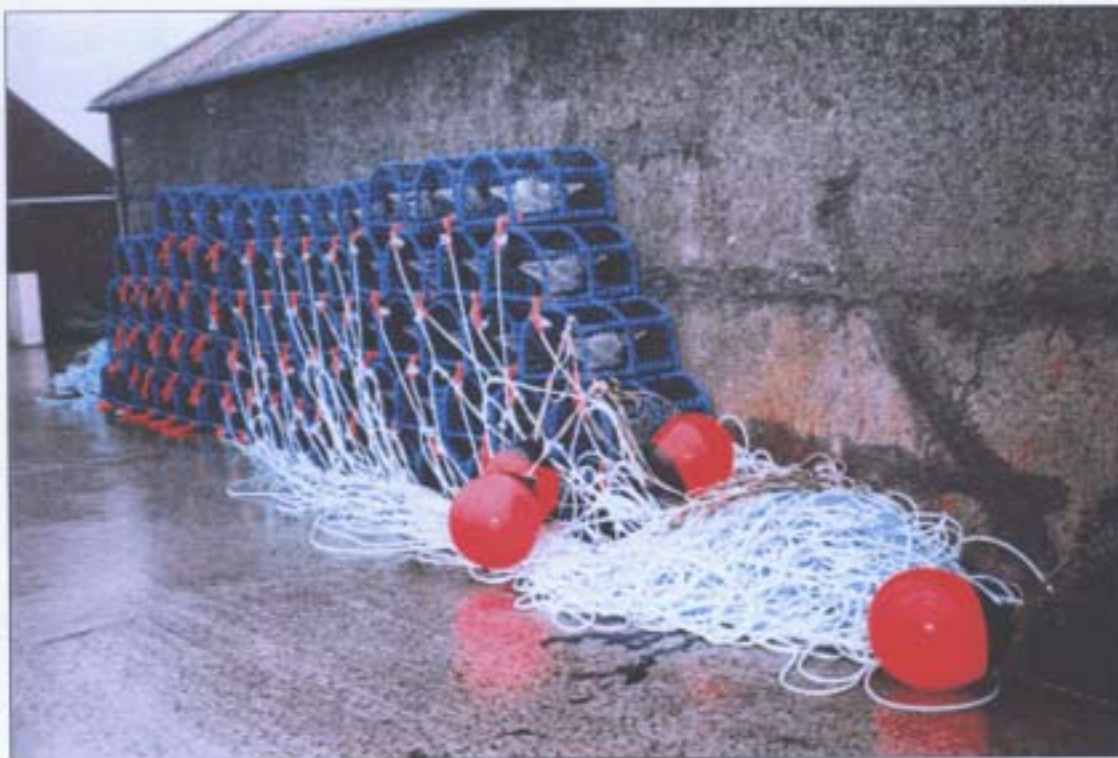
Figure 4

*Donna M* had been using 75 creels. All but two were recovered and stowed on the pier at Kettletoft (**Figure 4**).

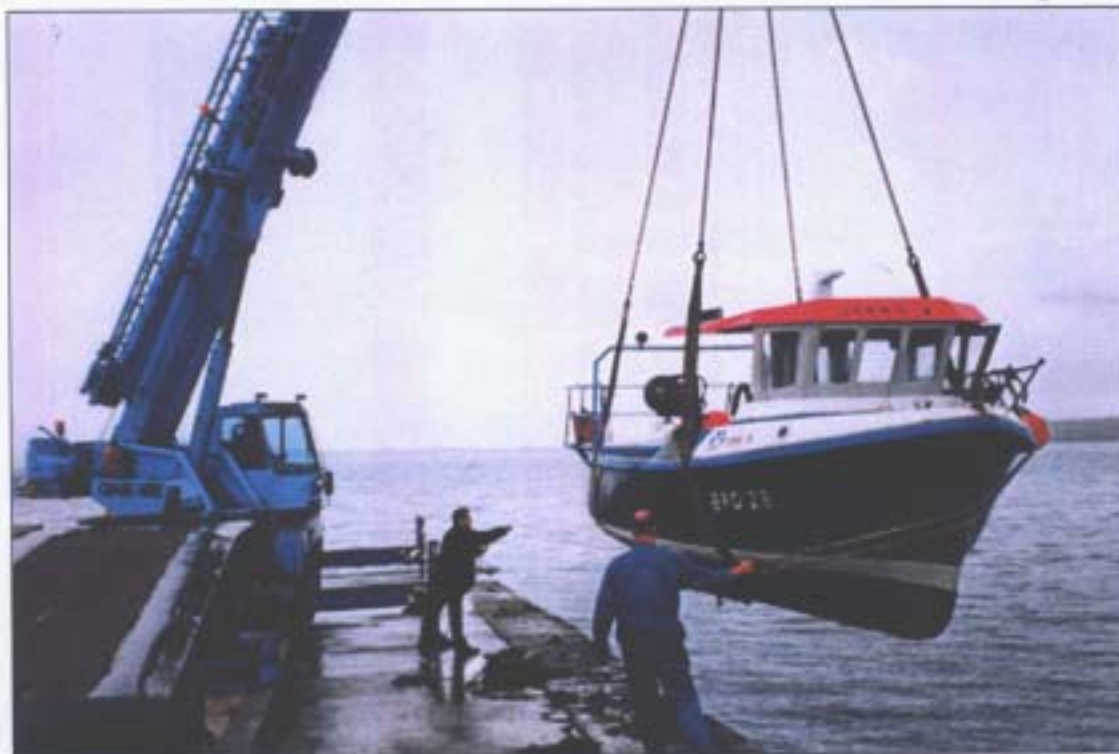
Figure 5

After this inspection, the vessel was moved to a nearby slipway where she was put in the water using a mobile crane (**Figure 5**) so that the freeboards could be measured. Because it was necessary to pump out floodwater in the bilges at the forward end, hoses were connected to the hand bilge pump on the vessel. However, the pump was leaking around the seal in its plastic body, and it was obvious that it was not designed to evacuate a large quantity of water, so an electric pump powered by a mobile generator was acquired. The freeboards were measured (**Figure 6**); the distance from the aft scuppers to the waterline was 115mm (4.5"), no creels were on board. The bottom of the scuppers was at the same level as the open deck. During the in-water test no flooding was noticed, apart from a small amount of rainwater which collected in the bilges, because it was raining. *Donna M* was taken out of the water late on 6 September 1999 and placed in an open compound close to the slipway.

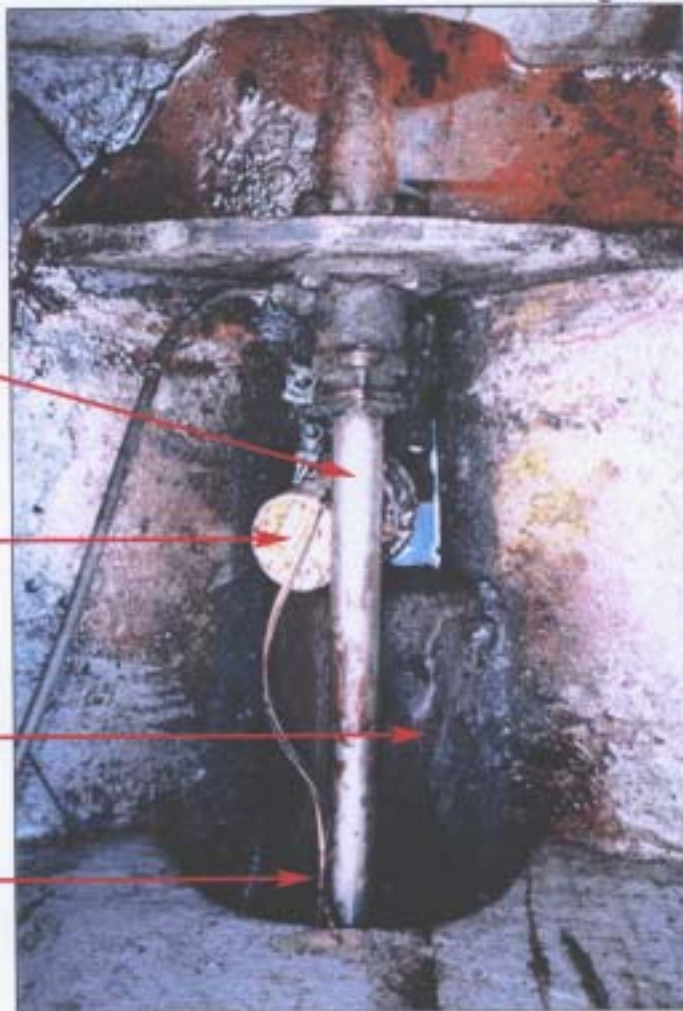
Figure 7

tape. Concrete and pig iron ballast was present (**Figure 7 & 8**). The aft deck hatch cover was not removed while Mr Drever owned the vessel.

Propeller shaft

Electric  
bilge pump

Pig iron  
Ballast

Loose wires

The previous owner had told the skipper that *Donna M* was fitted with ballast (**Figure 7 & 8**), although Mr Drever had not seen it, because since purchasing the vessel the aft deck hatch had not been removed. The skipper was content to carry 50 lobster/crab creels as he thought the previous owner had loaded *Donna M* with a similar weight.

When *Donna M* was recovered, the electric bilge pump was not working. The electrical wire connections close to the bilge pump were not soldered and had come apart. A dry connection does not provide good contact, and had it become wet due to a build-up of bilge water, the pump would have failed. The crew might have tried to complete the circuit by pulling on the wires, and this could have caused the connections to break.

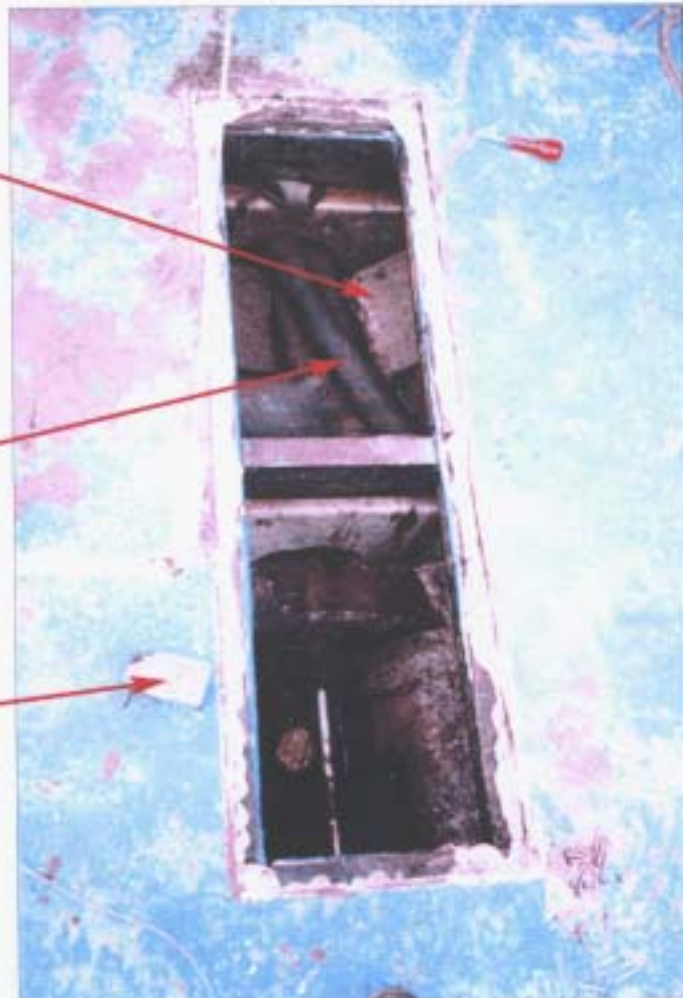
Figure 8 (Aft deck hatch removed)

Concrete  
ballast

Exhaust  
pipe

Disconnected  
float switch

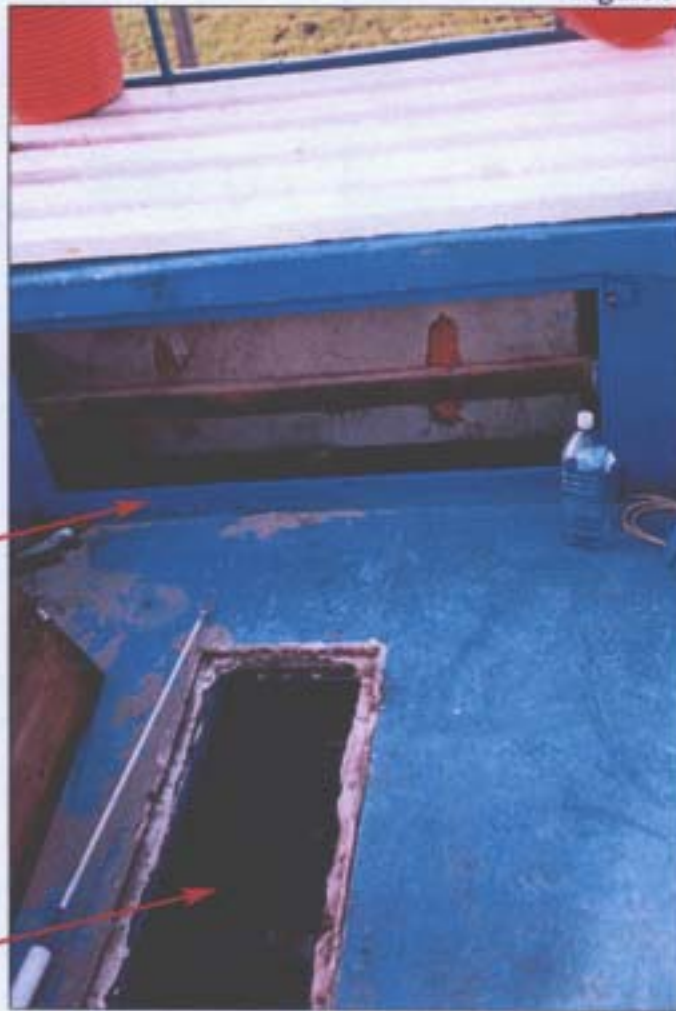
Figure 9

The non-watertight access panel in the aft bulkhead was inspected (**Figure 9**). It was recessed in a groove along the lower edge and secured by two shoot bolts at the top. The body of the fuel tank was behind the access panel. The lip at the bottom was only 92mm (3.6") deep in the middle. When the access panel was removed, a bottle of water was poured through the opening and it flowed forward into the lowest part of the hull by the bilge pump.

Lip at bottom of  
access panel in  
aft bulkhead

Aft deck opening

The access panel in the aft bulkhead could have been sealed with screws and mastic like the aft deck hatch, because regular access was unnecessary. There was no stowage space behind this panel; it only allowed access to the body of the fuel tank.

The non-watertight access panel in the aft bulkhead, in association with the low freeboard, was the main weak point of *Donna M*.

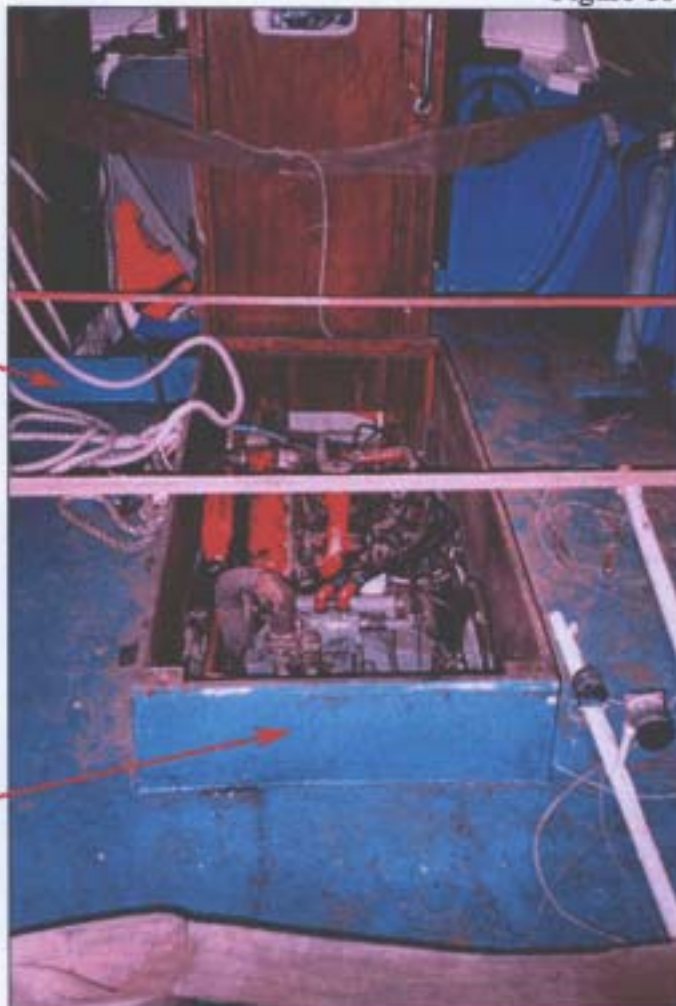
Figure 10

The sill on the door into the wheelhouse was 160mm (6.3") deep, and the coaming around the engine hatch was 255mm (10.0") deep (**Figure 10**). No washboards, which could have been used to raise the sill on the door, were found.

Door sill into  
wheelhouse

Coaming around  
engine hatch

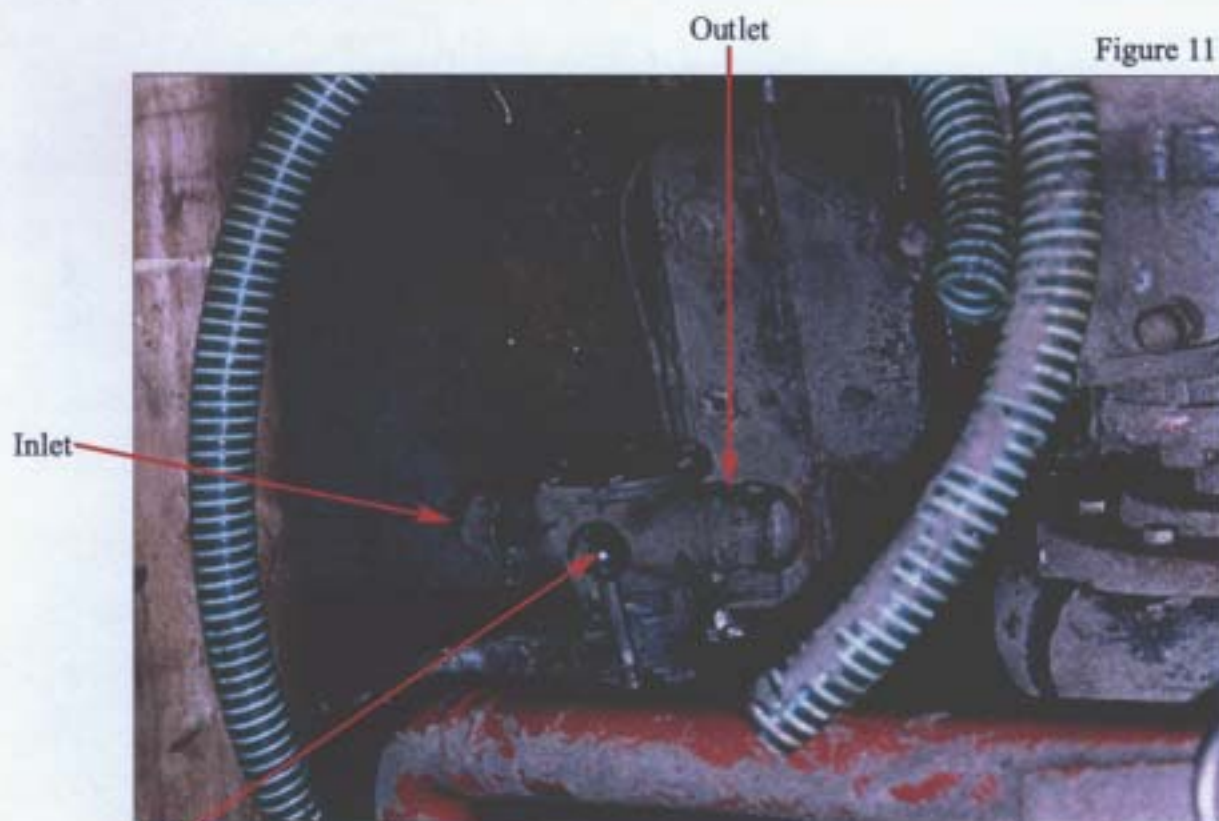
Figure 11

The engine driven pump was also examined (**Figure 11**). The hoses had been removed. The valve in the seawater inlet to the engine driven pump was closed. The vessel's tool kit was normally kept in the wheelhouse; the divers found it close to *Donna M* on the seabed.

The manual pump was inadequate for pumping a large quantity of water. The crew then attempted to jury-rig the engine driven pump; the hoses had been removed indicating that this conversion was underway. The toolkit was found on the seabed close to *Donna M* which indicates it was on the open deck (**Figure 14**) just before the accident (the toolkit would have been needed for the work on the pump). There was no suction hose connected to the manual bilge pump when *Donna M* was inspected by the MAIB; this hose may have been removed just before the capsize, with the intention of fitting it to the engine driven pump.

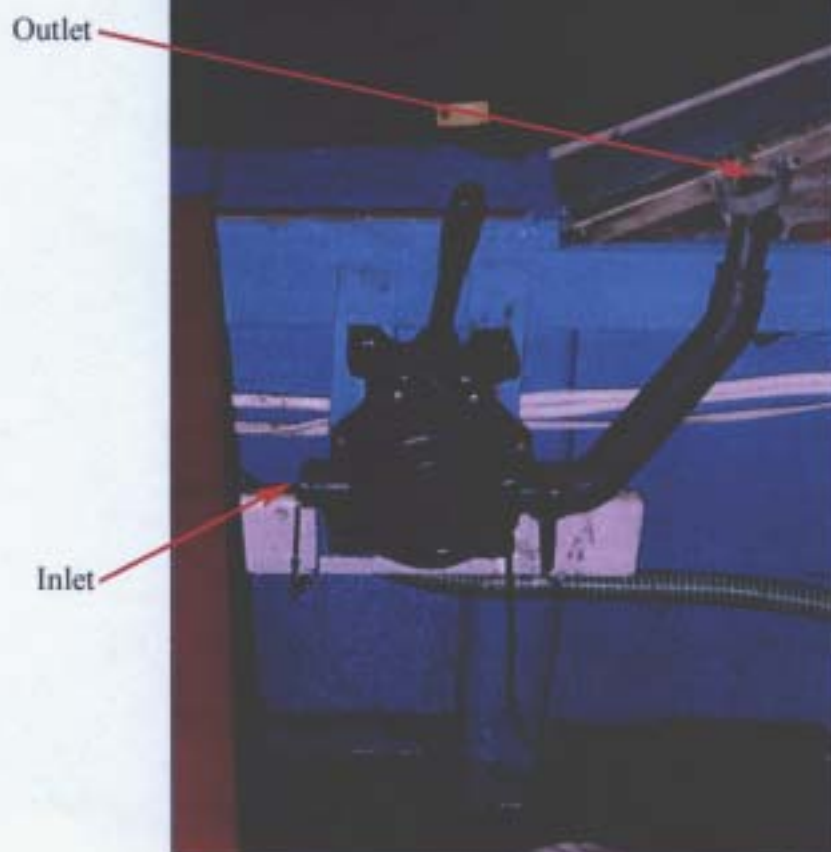
Figure 12

The inlet suction hose had been removed from the manual bilge pump (**Figure 12**).

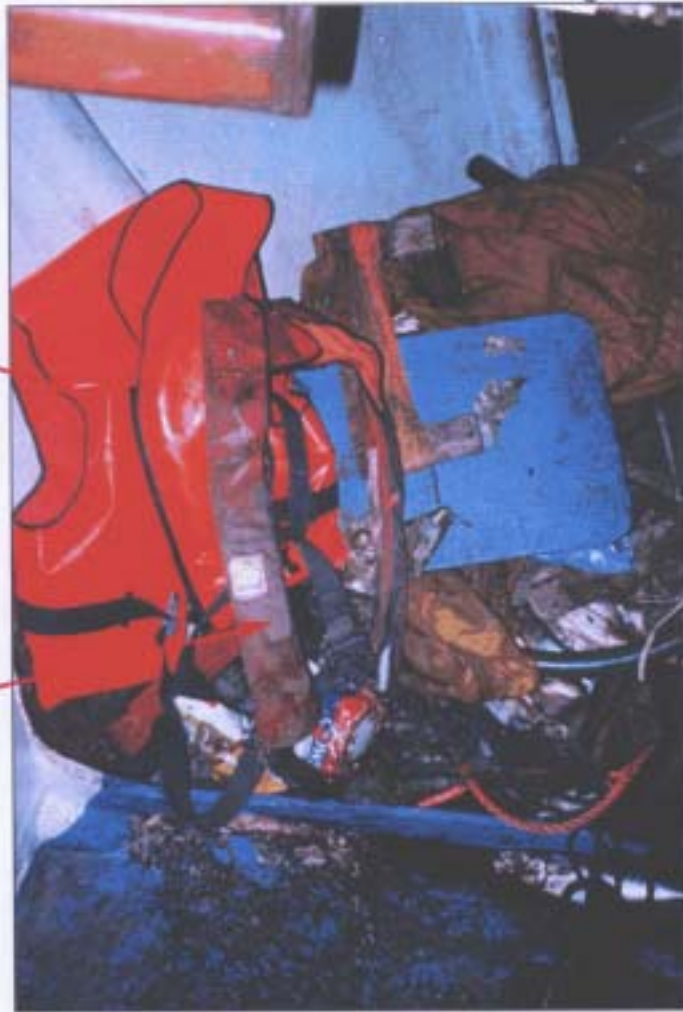
Figure 13

An inflatable lifejacket and a buoyancy waistcoat were found in the wheelhouse (**Figure 13**). The buoyancy waistcoat was normally kept on the back of the wheelhouse chair.

Buoyancy  
waistcoat

Inflating  
life jacket

The skipper was not wearing a lifejacket when his body was found. A lifejacket and a buoyancy waistcoat were on board *Donna M* when she was recovered, which suggests the skipper's father was not wearing any form of buoyancy aid either.
