**Report on the Investigation of  
the capsize of the fishing vessel**

***FRAOCH BAN***

**off the coast of the Shetland Islands  
on 15 August 1999**

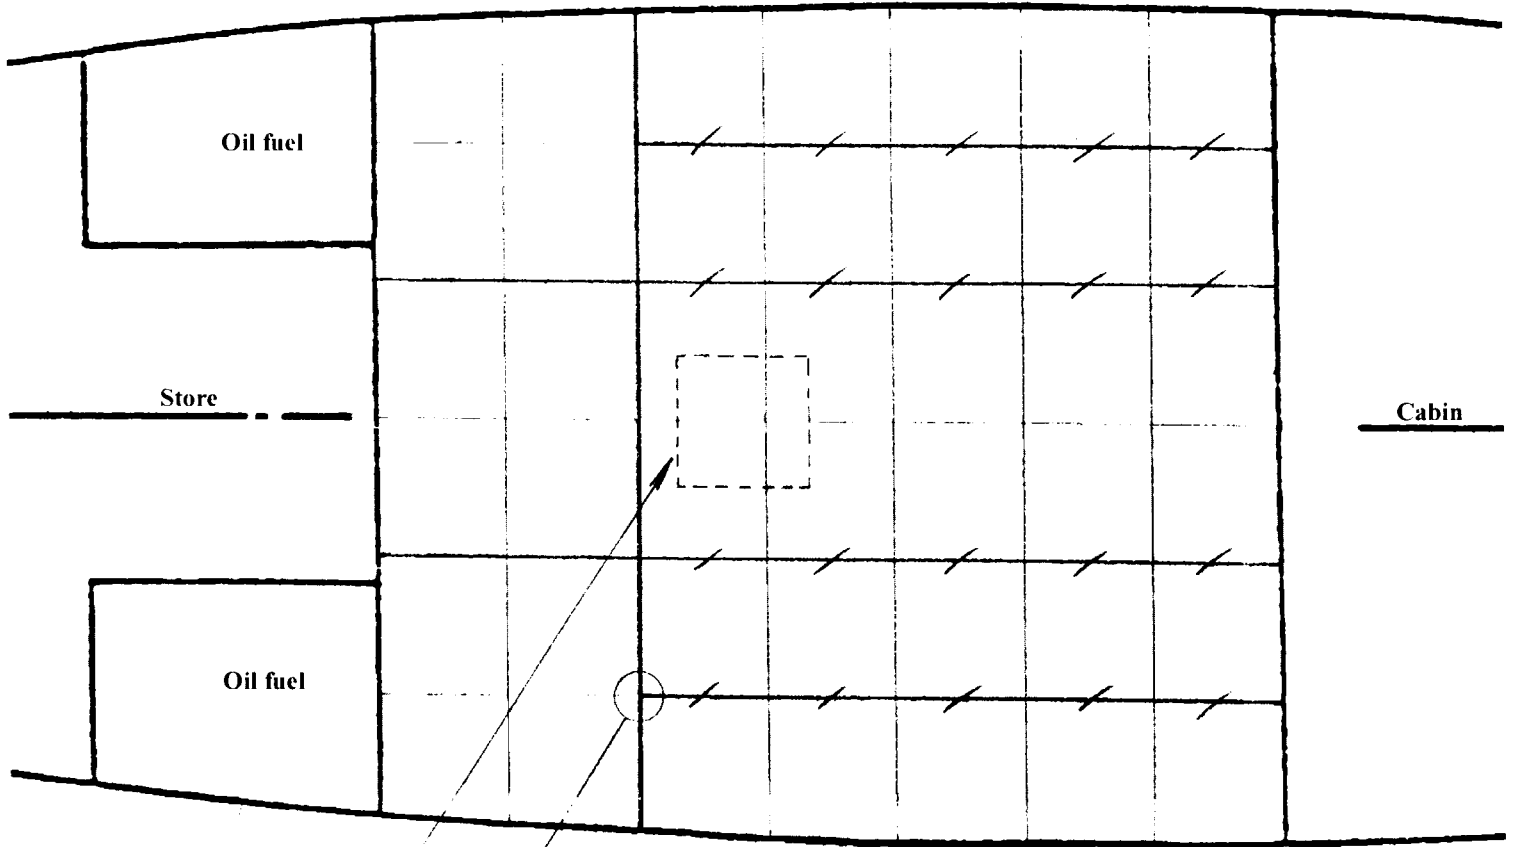
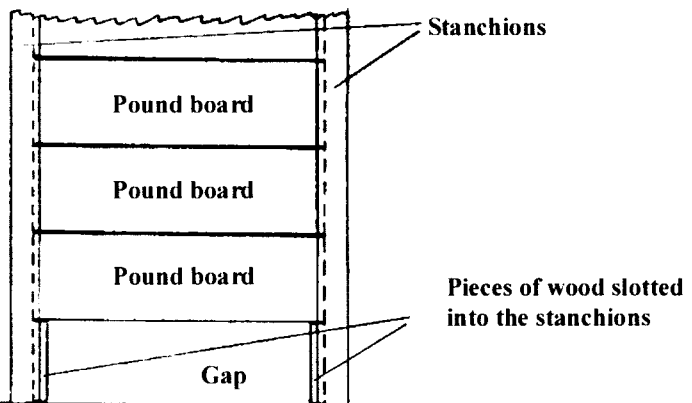
### Layout of pound boards in fish hold

It is not known exactly how the sand eels were stowed in the fish hold, but the most likely arrangement is shown in **(Figure 3)**. Pound boards divided the hold into six rows athwartships and seven longitudinally, making 42 squares. The two aft corners, comprising four squares each, were blocked off with pound boards fitted from the deck to just below the deckhead, so that those parts of the hold were not used, although it was intended to open them up later in the season. Pound boards were fitted elsewhere in the fish hold, but pieces of wood slotted into the stanchions prevented the pound boards from reaching the deck, leaving a substantial gap. This allowed the fish to be stowed more easily, because when the sand eels were dropped through the hatch they were able to spread through most of the space.

Deckhand 2 remembers looking down into the fish hold to try to see if the cargo was shifting as *Fraoch Ban* was listing. The port outer longitudinal row of pound boards, which were fitted up to about chest height, could not be seen by deckhand 2 and the sand eels were spilling to the extreme port side of the hold.

The pound board arrangement of the fish hold **(Figure 3)** with a load of 25 tonnes of sand eels, provided enough free surface to capsize *Fraoch Ban*. The arrangement of the divisions in the main part of the fish hold did not break up the free surface satisfactorily, because the catch could move from one section to another through the gaps under the pound boards. A bulk cargo of sand eels is more viscous than sea water; it would shift with the vessel movement, but more slowly than a pure liquid. Sand eels are small fish with a slippery skin surface, and will readily slide over one another, especially just after being caught.

As noted above there might have been cross-flooding between the tanks. However, the incorrect use of the pound boards (**Figure 3**), particularly with gaps under them, produced a large free surface. This is considered to be the most likely reason the vessel capsized.

1. The large free surface in the fish hold was the main cause of the accident. The incorrect use of the pound boards, particularly the gaps under them did little to lessen the free surface, which was enough to capsize the vessel. [2.1]
