Report on the investigation
of the foundering of the
fv Radiant Star III PD251
60 miles north-east of Fraserburgh
on 6 August 1999

Marine Accident Investigation Branch
First Floor, Carlton House
Carlton Place
Southampton
SO15 2DZ
☎ 023 8039 5500

Report No 14/2000

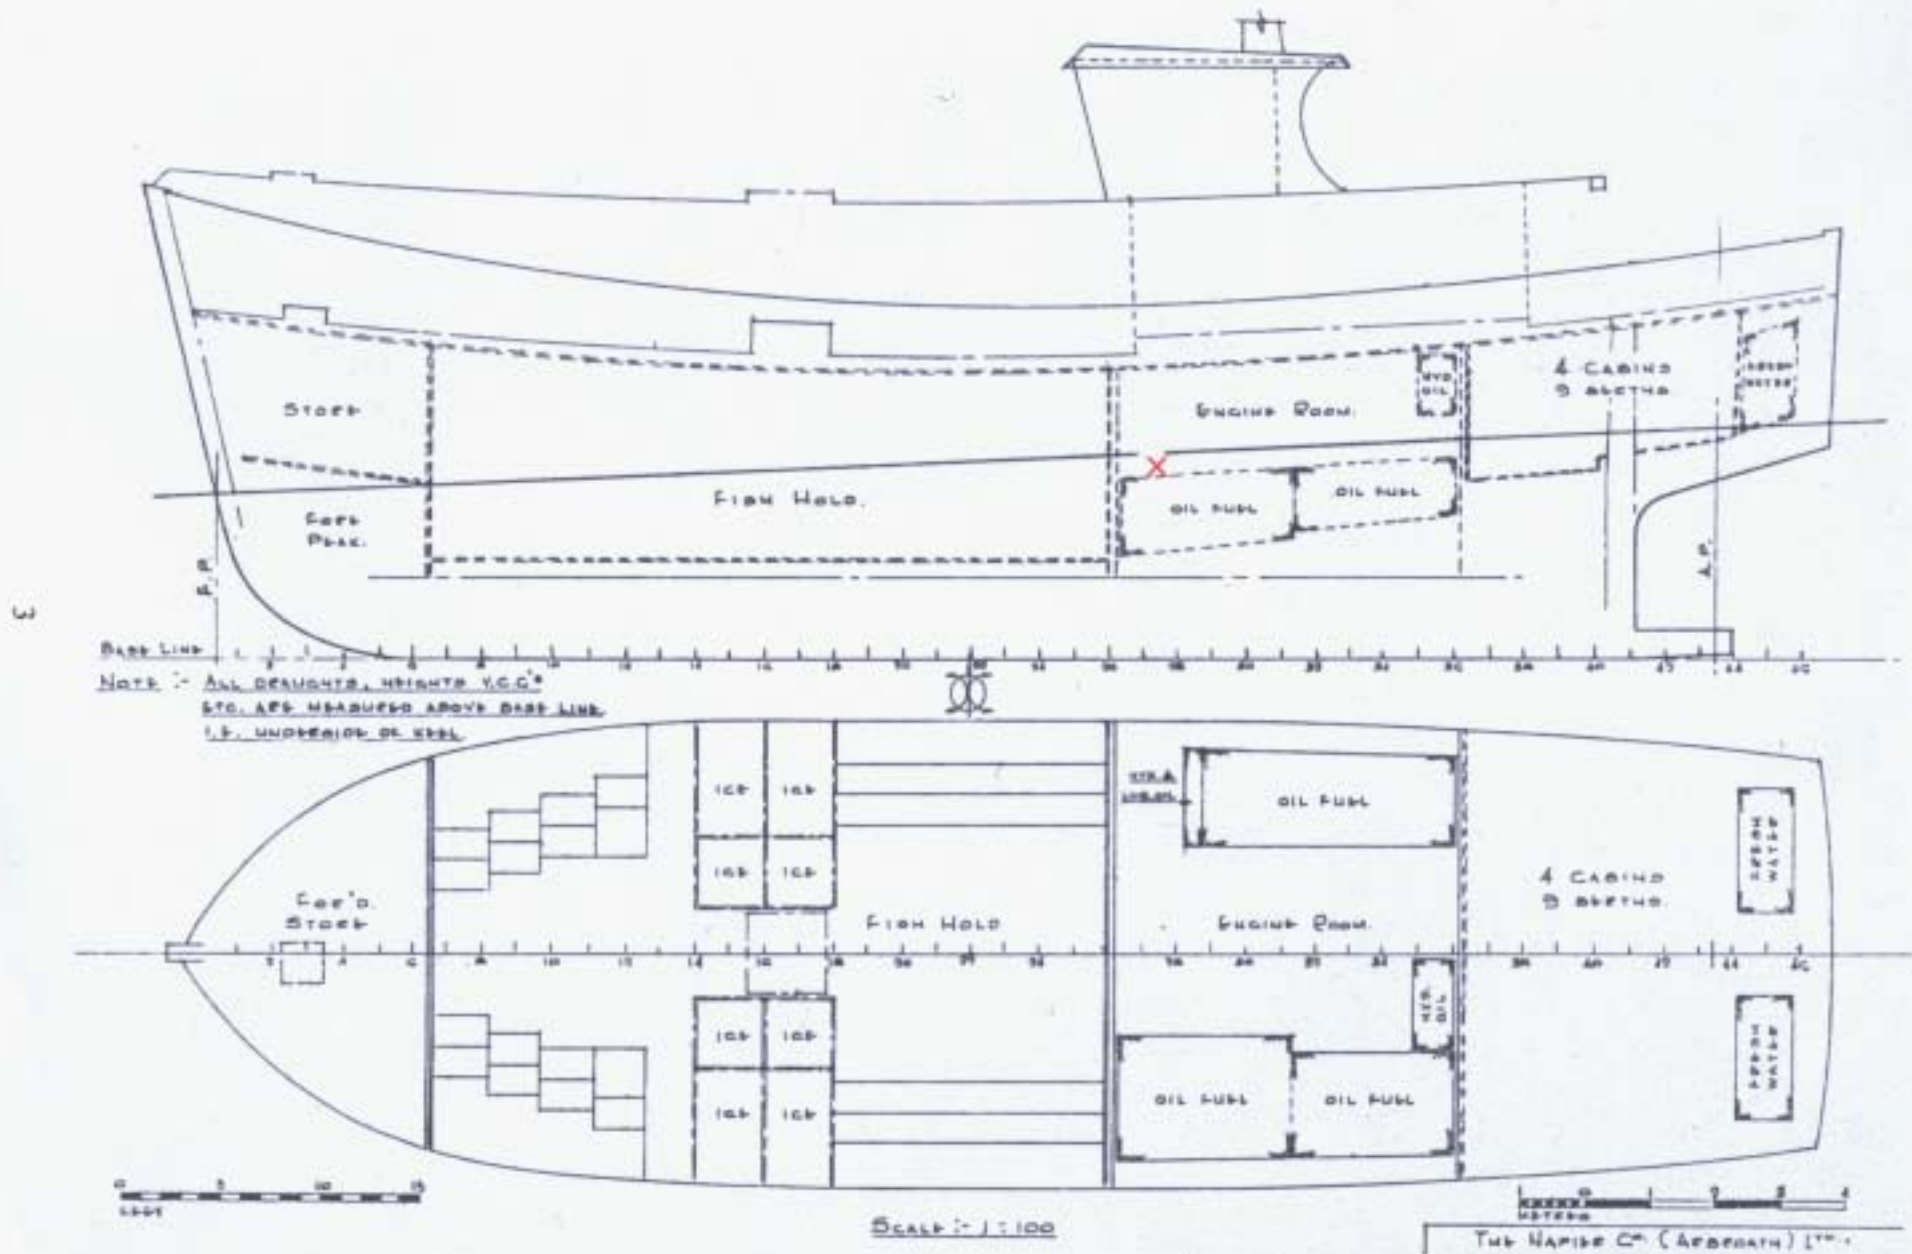
General arrangement

A general arrangement of the vessel is shown in **Figure 2**.

X Approximate position of damage

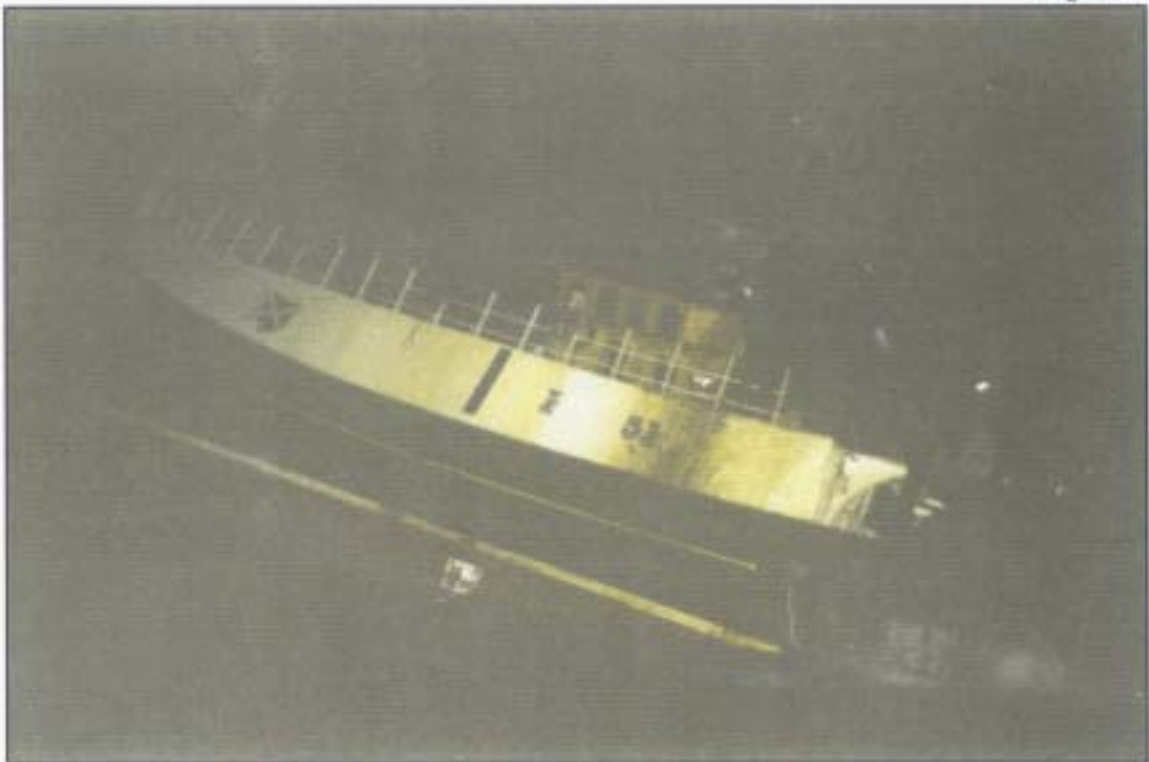
Figure 3

Constant Faith stood by the stricken vessel. *Radiant Star III* slowly rolled on to her starboard side, revealing an area of white nylon sheathing (about 0.6m square) where the antifouling had been rubbed off (**Figure 3**), just below the waterline on her port side amidships. Air was venting from this location, which appeared to correspond with the damaged plank seen in the engine room.

Photograph of *Radiant Star III* as she was sinking

At least one strake of planking had been broken and forced inboard by about 150mm. This damage created a horizontal, triangular gap about 800cm² in area between adjacent planks (the frame spacing was 550mm). The rate of flooding, if this gap was about 1 metre below the waterline, is estimated to have been at least 6 tonnes per minute - which would have sunk the vessel within a few hours of leaving Peterhead. Since she actually sailed for over eight hours without a problem, the observed damage was not present when she sailed. A pre-existing weakness in the hull planking cannot be ruled out.

The precise location of the damage on *Radiant Star III* is well documented. What is not known, is which part of *Constant Faith*'s stern she hit. Contact with the flat face of the transom could not have caused the damage. It was probably caused by contact with the transom's port edge, which would have been much stronger than the side planking of *Radiant Star III*.
