**Report on the investigation
of the flooding
of the UK charter fishing vessel
RANDOM HARVEST
south-west of Brighton
on 3 July 1999**

Marine Accident Investigation Branch
First Floor Carlton House
Carlton Place
Southampton
SO15 2DZ

Report No 28/2000

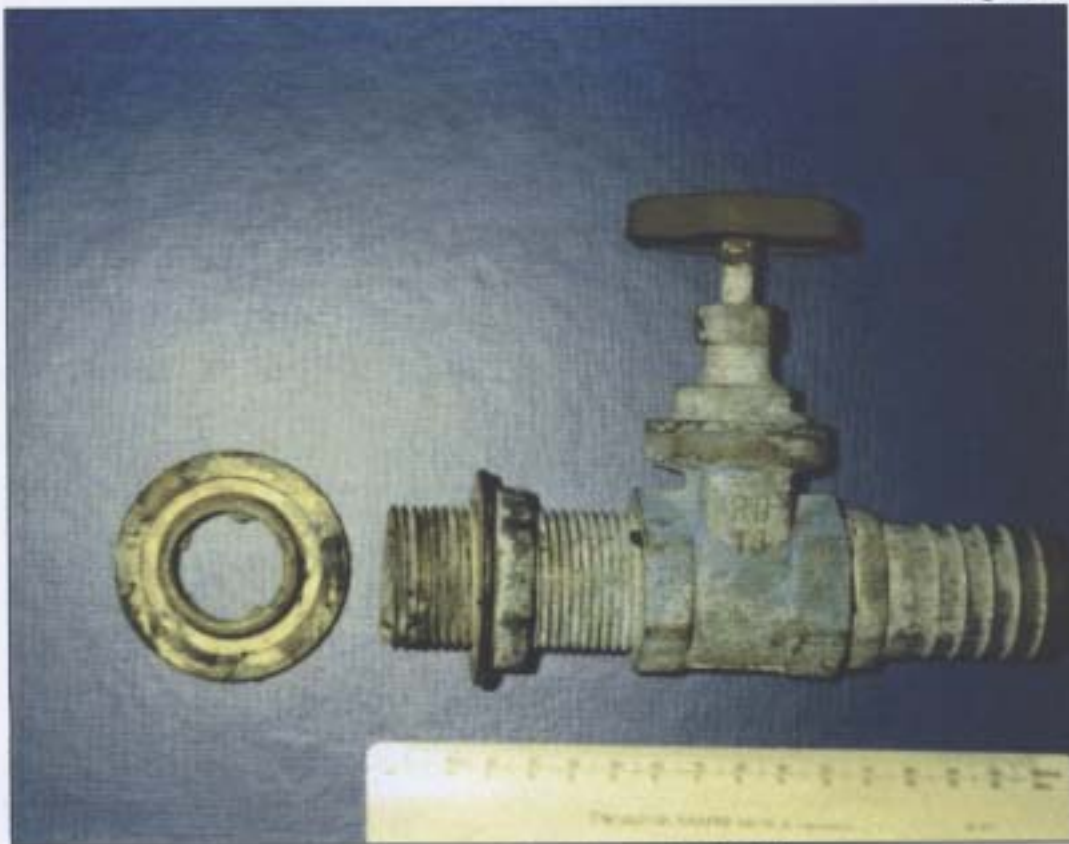
Figure 3

The cause of the leak was found to be a failure of the brass 25mm diameter through-hull fitting to the toilet seawater inlet, which had broken close to its flange at the start of the screw thread. The fitting had failed from dezincification which had probably been accelerated by stray electric currents.

Once alongside in the marina the vessel was pumped dry. The cause of the leak was found to be a failure of the 25mm diameter through-hull fitting to the toilet seawater inlet (**Figure 3**), which had broken close to its flange at the start of the screw thread. The owner replaced both this, and the nearby toilet seawater outlet fitting as a precaution.

Random Harvest's failed through-hull fitting

1. The source of the flooding was the failure of the 25mm diameter through-hull fitting to the toilet seawater inlet. [1.1]
2. The failure was due to dezincification, which had advanced through the thickness of the metal into the root of the screw thread. [1.4]

1. Improve the safety of *Random Harvest* by:
 - Replacing the toilet through-hull fittings with ones made from a material approved by the classification societies;
 - Inspecting all through-hull fittings on the vessel for possible electrolytic corrosion;
 - Disconnecting all through-hull fittings from the vessel's cathodic protection system;
 - Improving access to the toilet through-hull fittings;
 - Raising the battery well above the bilge to protect it from flooding;
 - Fitting a battery isolation switch connected to the positive poles of the batteries and isolate the batteries whenever the vessel is left at her marina berth;
 - Having the wiring installation on the vessel inspected and upgraded as necessary by a competent marine electrician to reduce the likelihood of stray currents.

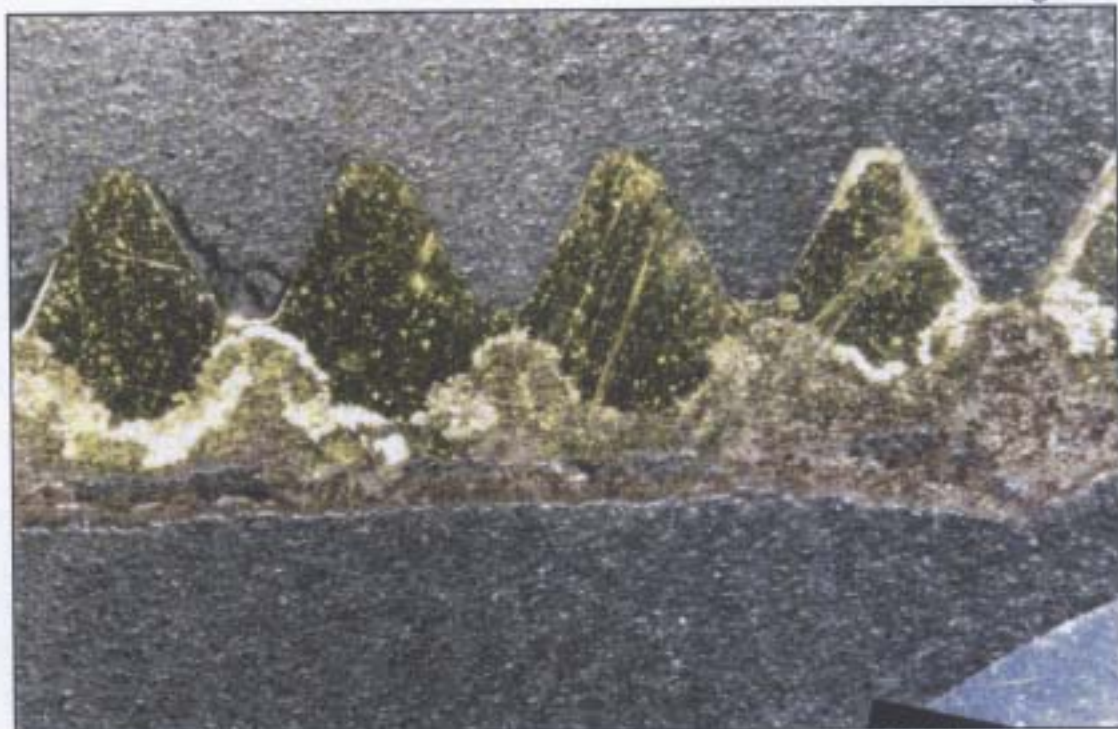
Figure 4

A section taken lengthwise through the wall of the failed fitting
(magnification x 14.7)

Both of *Random Harvest*'s toilet fittings were installed when they were new. One of them failed 16 months later. The failure was in the root of the thread where the material was about 1.7mm thick, indicating a rate of corrosion of 1.275mm per year. The dezincification was non-uniform, known as ‘plug’ type corrosion, and peaked under the roots of the thread where the stresses, from tightening the fitting, were greatest (**Figure 4**).

There is also evidence that the rate of corrosion can be substantially greater in areas of high stress (**Figure 4**) which is undesirable in a component which has to be screwed tight against the hull to prevent leaking. As only one of the fittings showed this stress-related corrosion, it had probably been over tightened.

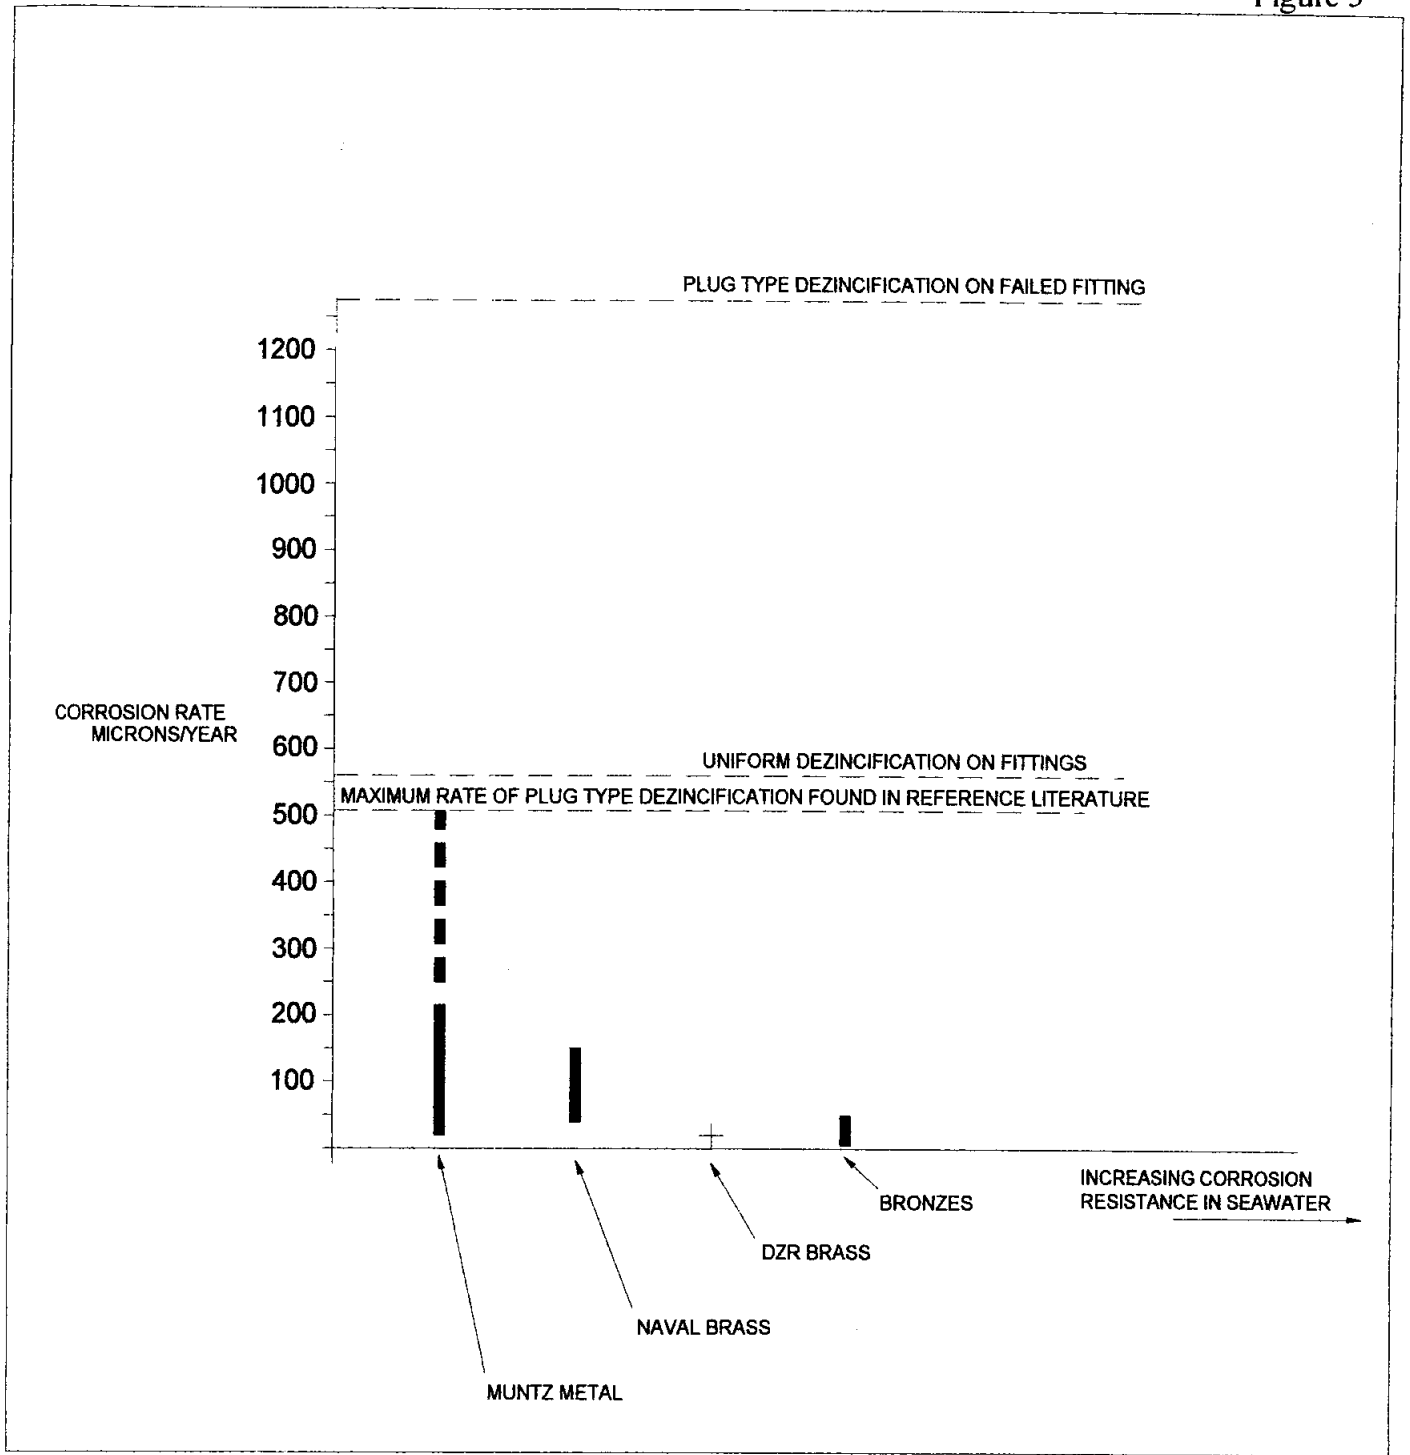
Figure 5

Data from the Copper Development Association and other sources (**Figure 5**) provides a rough guide to the rates of corrosion in seawater that can be expected of the copper alloys. It shows that some brasses can corrode at over 0.2mm/yr. There is also a report of plug type dezincification reaching 0.5mm/yr.

Expected corrosion rates of various copper alloys in seawater

The rate of corrosion on the failed fitting was about twice the maximum rate for plug type dezincification found in reference literature (**Figure 5**). High stresses under the thread roots appear to be an important factor, causing corrosion rates in these regions to be double the underlying uniform rate.

As the uniform corrosion rate itself is double the worse that could have been expected (**Figure 5**), there are probably other factors involved.

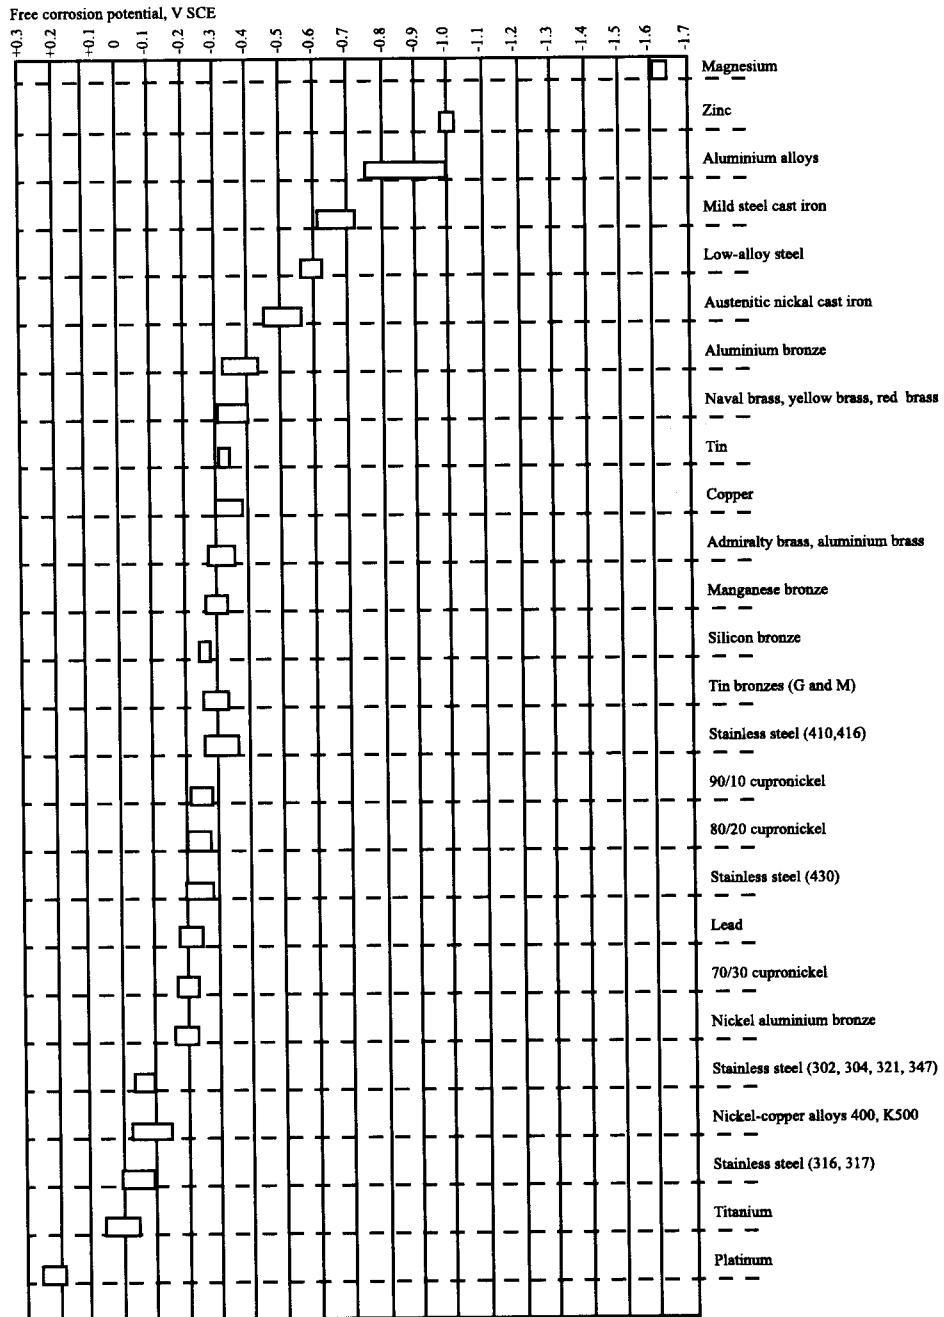
Figure 6

One possibility is galvanic corrosion due to the proximity of the fittings to the copper ground plate for the vessel's electronic equipment, to which they would probably have been connected. But, given the closeness of brass and copper in the galvanic series of metals (**Figure 6**), and the relatively small difference in exposed area between the fittings and the ground plate, this was unlikely to be important.

The galvanic series for metals immersed in seawater
