**Report on the investigation
of the flooding
of the UK charter fishing vessel
RANDOM HARVEST
south-west of Brighton
on 3 July 1999**

Marine Accident Investigation Branch
First Floor Carlton House
Carlton Place
Southampton
SO15 2DZ

Report No 28/2000

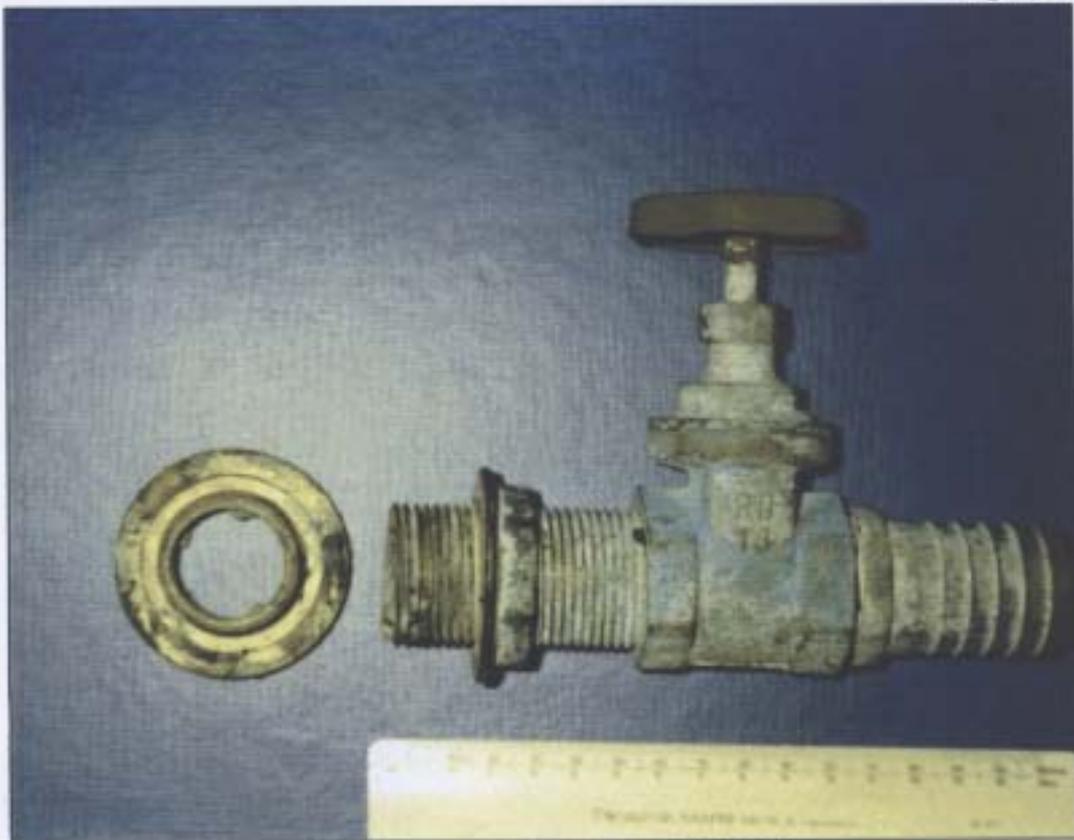
Figure 3

The cause of the leak was found to be a failure of the brass 25mm diameter through-hull fitting to the toilet seawater inlet, which had broken close to its flange at the start of the screw thread. The fitting had failed from dezincification which had probably been accelerated by stray electric currents.

Once alongside in the marina the vessel was pumped dry. The cause of the leak was found to be a failure of the 25mm diameter through-hull fitting to the toilet seawater inlet (**Figure 3**), which had broken close to its flange at the start of the screw thread. The owner replaced both this, and the nearby toilet seawater outlet fitting as a precaution.

Random Harvest's failed through-hull fitting

1. The source of the flooding was the failure of the 25mm diameter through-hull fitting to the toilet seawater inlet. [1.1]
2. The failure was due to dezincification, which had advanced through the thickness of the metal into the root of the screw thread. [1.4]

1. Improve the safety of *Random Harvest* by:
 - Replacing the toilet through-hull fittings with ones made from a material approved by the classification societies;
 - Inspecting all through-hull fittings on the vessel for possible electrolytic corrosion;
 - Disconnecting all through-hull fittings from the vessel's cathodic protection system;
 - Improving access to the toilet through-hull fittings;
 - Raising the battery well above the bilge to protect it from flooding;
 - Fitting a battery isolation switch connected to the positive poles of the batteries and isolate the batteries whenever the vessel is left at her marina berth;
 - Having the wiring installation on the vessel inspected and upgraded as necessary by a competent marine electrician to reduce the likelihood of stray currents.

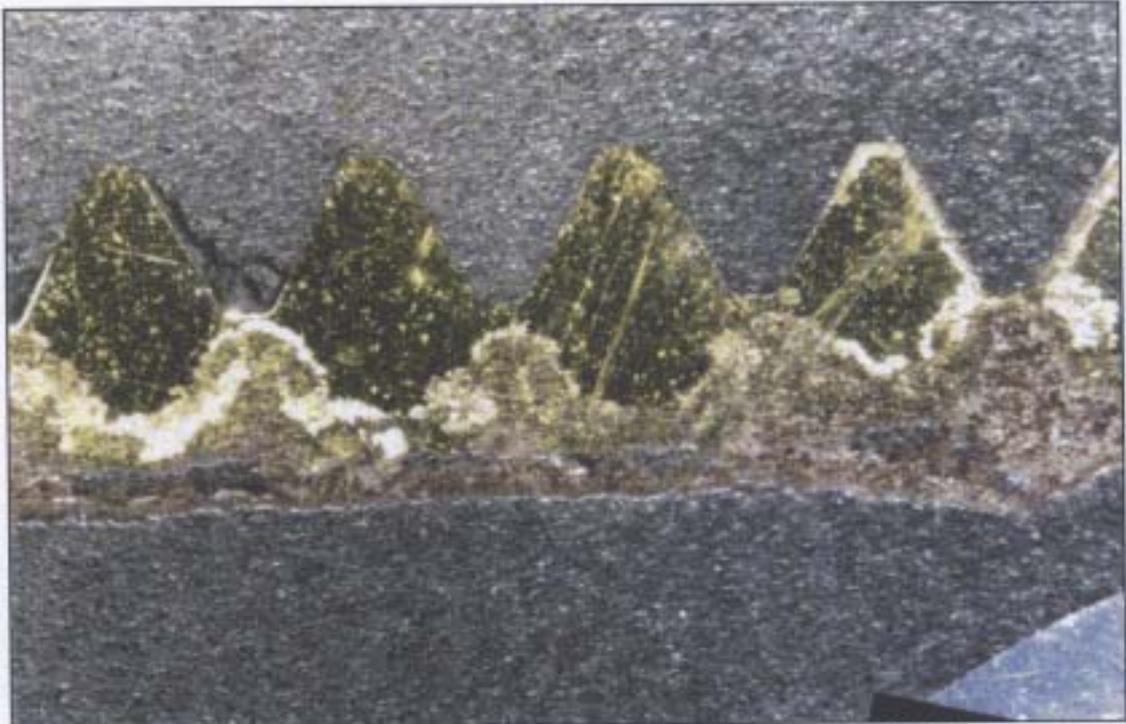
Figure 4

A section taken lengthwise through the wall of the failed fitting
(magnification x 14.7)

Both of *Random Harvest*'s toilet fittings were installed when they were new. One of them failed 16 months later. The failure was in the root of the thread where the material was about 1.7mm thick, indicating a rate of corrosion of 1.275mm per year. The dezincification was non-uniform, known as ‘plug’ type corrosion, and peaked under the roots of the thread where the stresses, from tightening the fitting, were greatest (**Figure 4**).

There is also evidence that the rate of corrosion can be substantially greater in areas of high stress (**Figure 4**) which is undesirable in a component which has to be screwed tight against the hull to prevent leaking. As only one of the fittings showed this stress-related corrosion, it had probably been over tightened.
