Report on the Investigation  
of the collision between

**mfv *LUC* and  
mv *Toisa Puffin***

8.5 miles due east of the River Tyne  
on 13 June 1999

Report No 13/2000

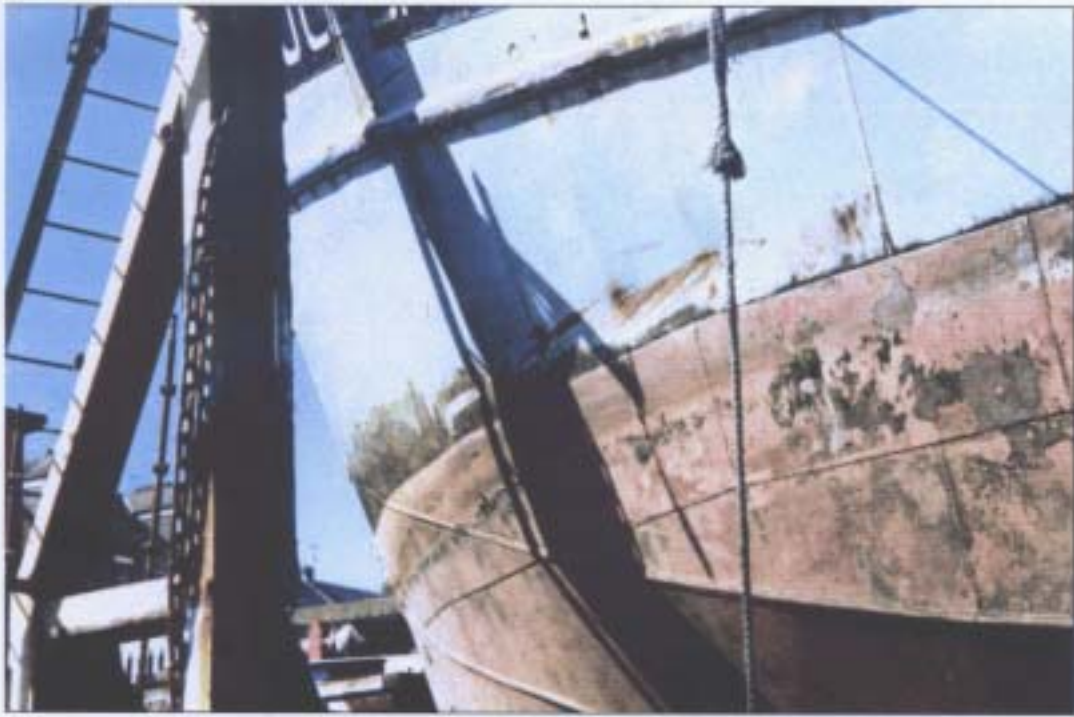
Figure 5 - Damage to *LUC*

At 1608, immediately after the collision, *LUC*'s skipper contacted Tyne Tees Coastguard and reported the situation. The mate went below into the engine room to check for damage. Several plates above the waterline had buckled, but there was no ingress of water.

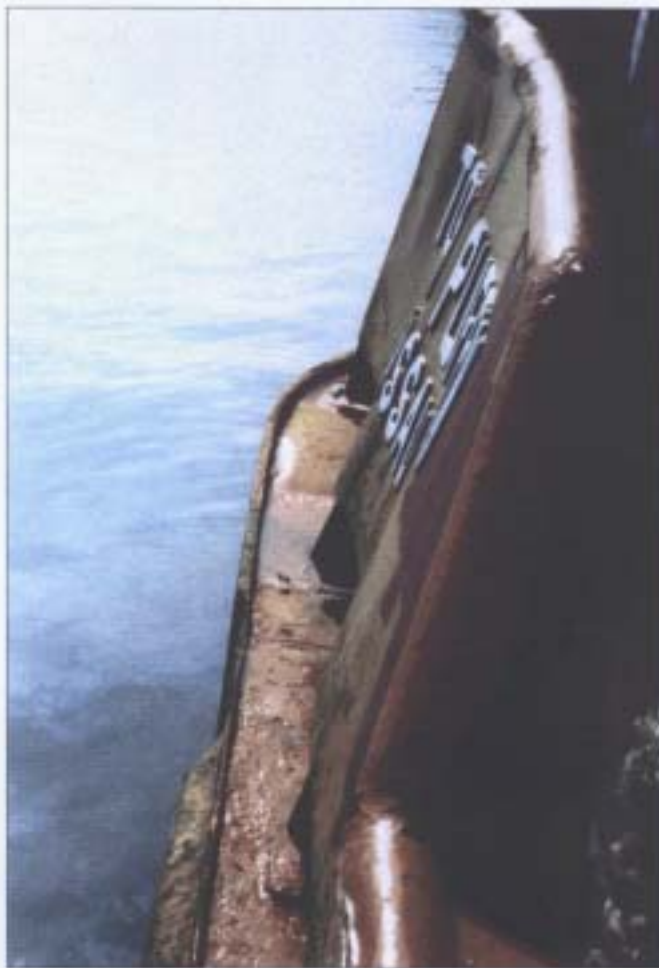
Figure 6 - Damage to *Toisa Puffin*

<b>Name</b>	:	<b><i>Toisa Puffin</i></b>
Type	:	Offshore safety stand-by vessel
Port of Registry	:	Nassau
LR Number	:	8010001
Built	:	Halter Marine Inc Moss Point Mississippi USA 1980
Construction	:	Steel
Owner	:	Toisa Ltd
Manager	:	Sealion Shipping Ltd, Farnham, Surrey
Gross Tonnage	:	782
Length Overall	:	54.96m
Breadth	:	12.19m
Depth	:	4.27m
Propulsion	:	2 x Detroit diesels 1909kW Twin Screw
Crew	:	12
Damage	:	Starboard quarter bulwark pushed in over length of 4 metres
Injuries	:	None
<b>Name</b>	:	<b><i>LUC</i></b>
Type	:	Fishing vessel (stern trawler)
Port of Registry	:	North Shields
Fishing Number	:	SN 36
Built	:	Wallsend, Tyne and Wear, 1980
Construction	:	Steel
Owner	:	Mr D Clarke, 28 Dilston Ave Whitley Bay, Tyne and Wear
Gross Tonnage	:	56.72
Length Overall	:	17.80m
Length Registered	:	16.95m
Breadth	:	5.82m
Depth	:	3.44m
Propulsion	:	Gardner Diesel, 172kW single screw shaft
Crew	:	Two
Injuries	:	None
Damage	:	Port side forward shell plating and frames indented

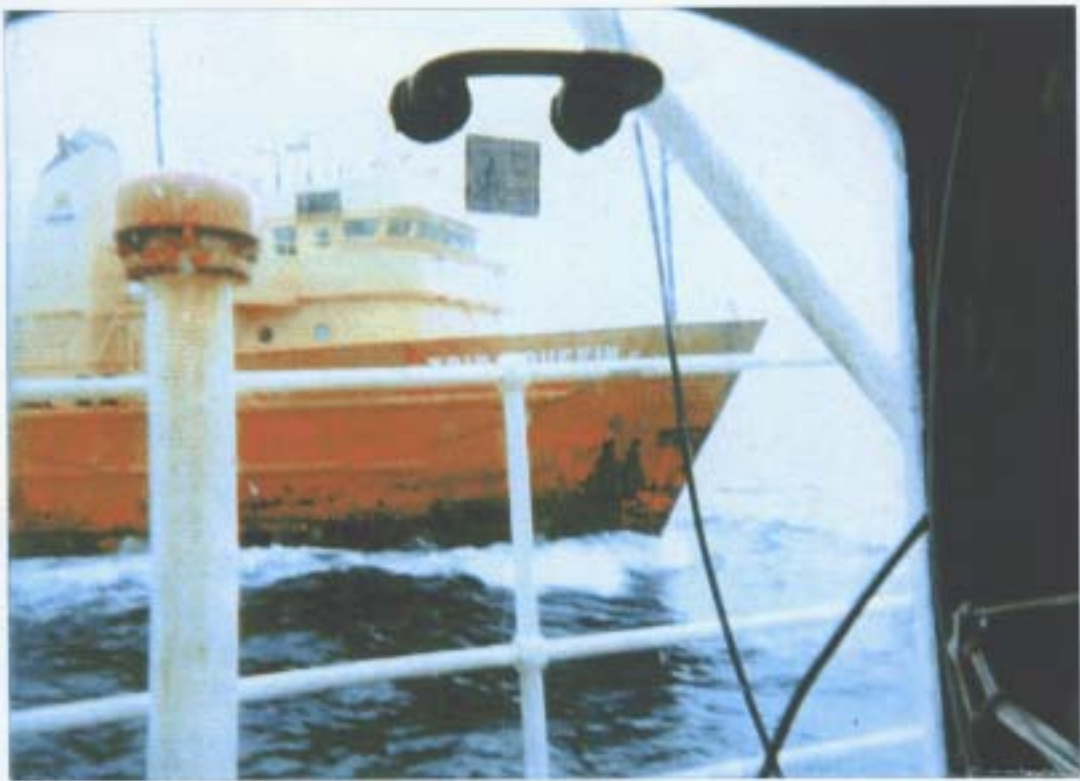
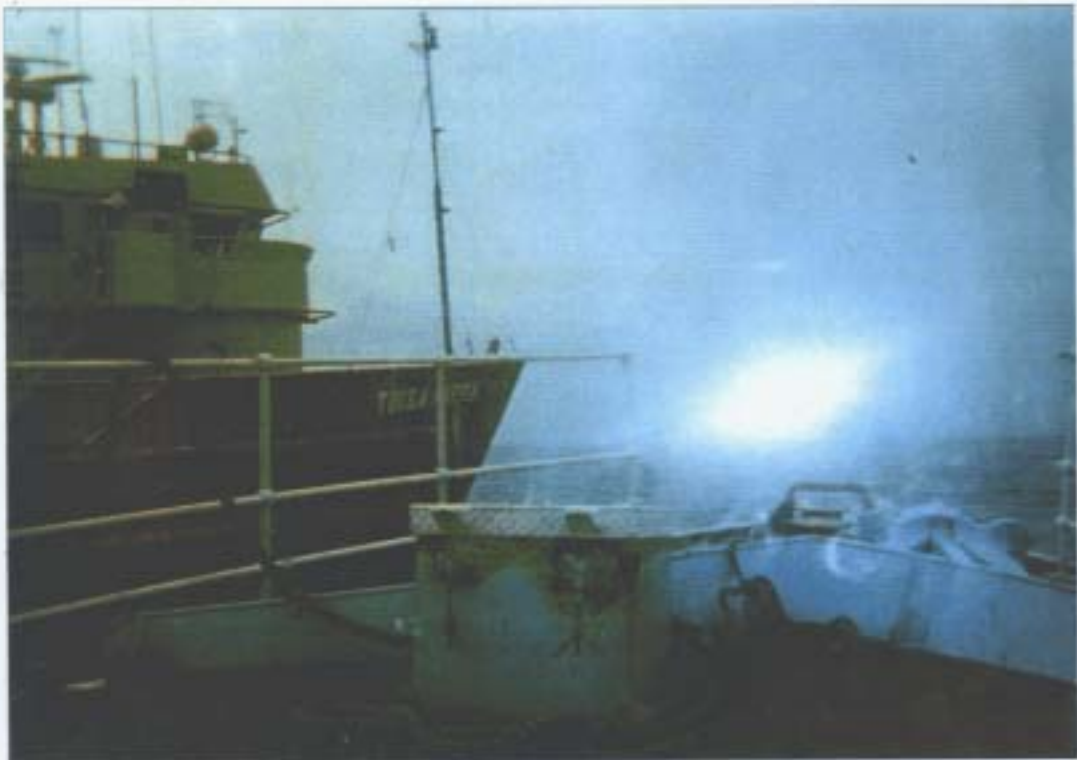
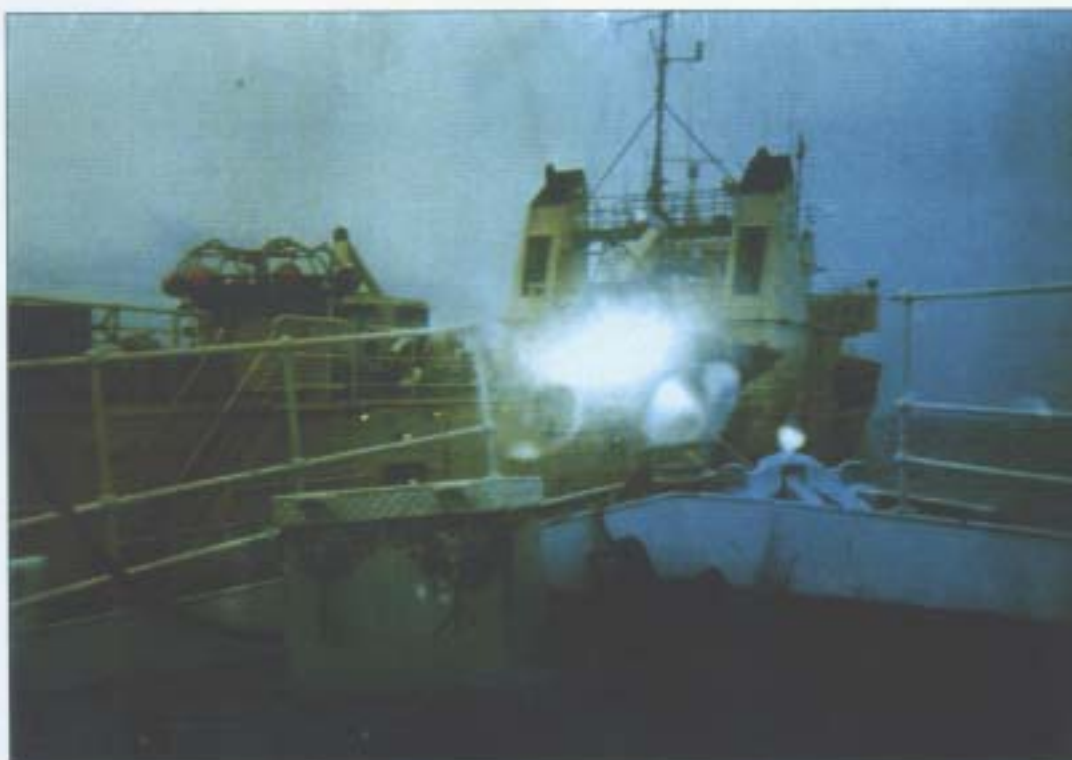
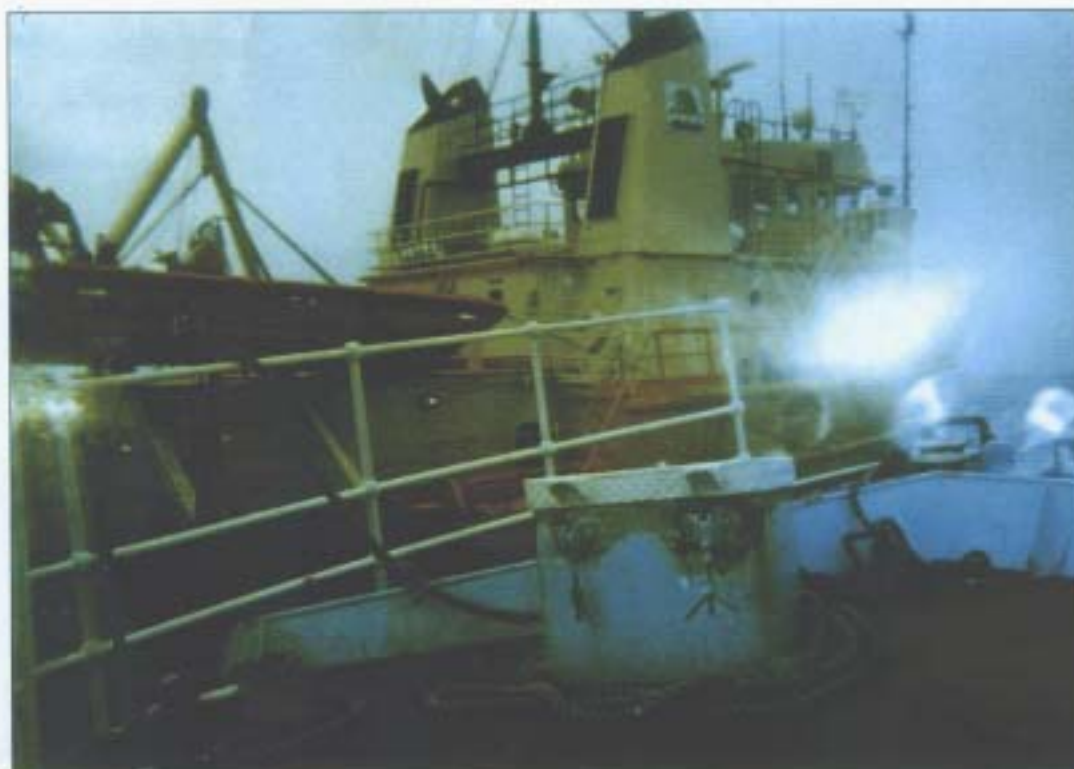
Figures 7, 8, 9, 10 - Sequence of photographs immediately before collision

He received no reply, so called again. The skipper then eased back on main engine revolutions to reduce speed. Both the skipper and the mate then donned their lifejackets as a precaution. The distance between the vessels had now reduced to less than 200m. In a last attempt to avoid a collision, the skipper de-clutched the propeller in the hope that the weight of the fishing gear would pull the vessel astern. He then sounded the whistle to attract attention.

Having been alerted, the mate on board *Toisa Puffin* looked up from the chart table and realised that a collision was imminent. He hurried forward to the helm control, switched from autopilot to hand steering and began taking avoiding action by first altering course hard to port, and then reducing main engine revolutions. He was unable to alter course to starboard because of the close proximity of the other vessel, which was now less than 50m away. The mate interpreted that *LUC* had altered course to port since the last time he had monitored her.

As *Toisa Puffin* came hard to port, her starboard quarter collided with *LUC*'s port bow, before she eventually passed ahead.
