**Report of the Investigation
of the crushing and subsequent death
of a bargehand between the**

**tug *Willem-B sr* and the
bottom dump barge, *R8***

**at Nab Tower Dumping Grounds
on 6 June 1999**

MAIB 1/10/193

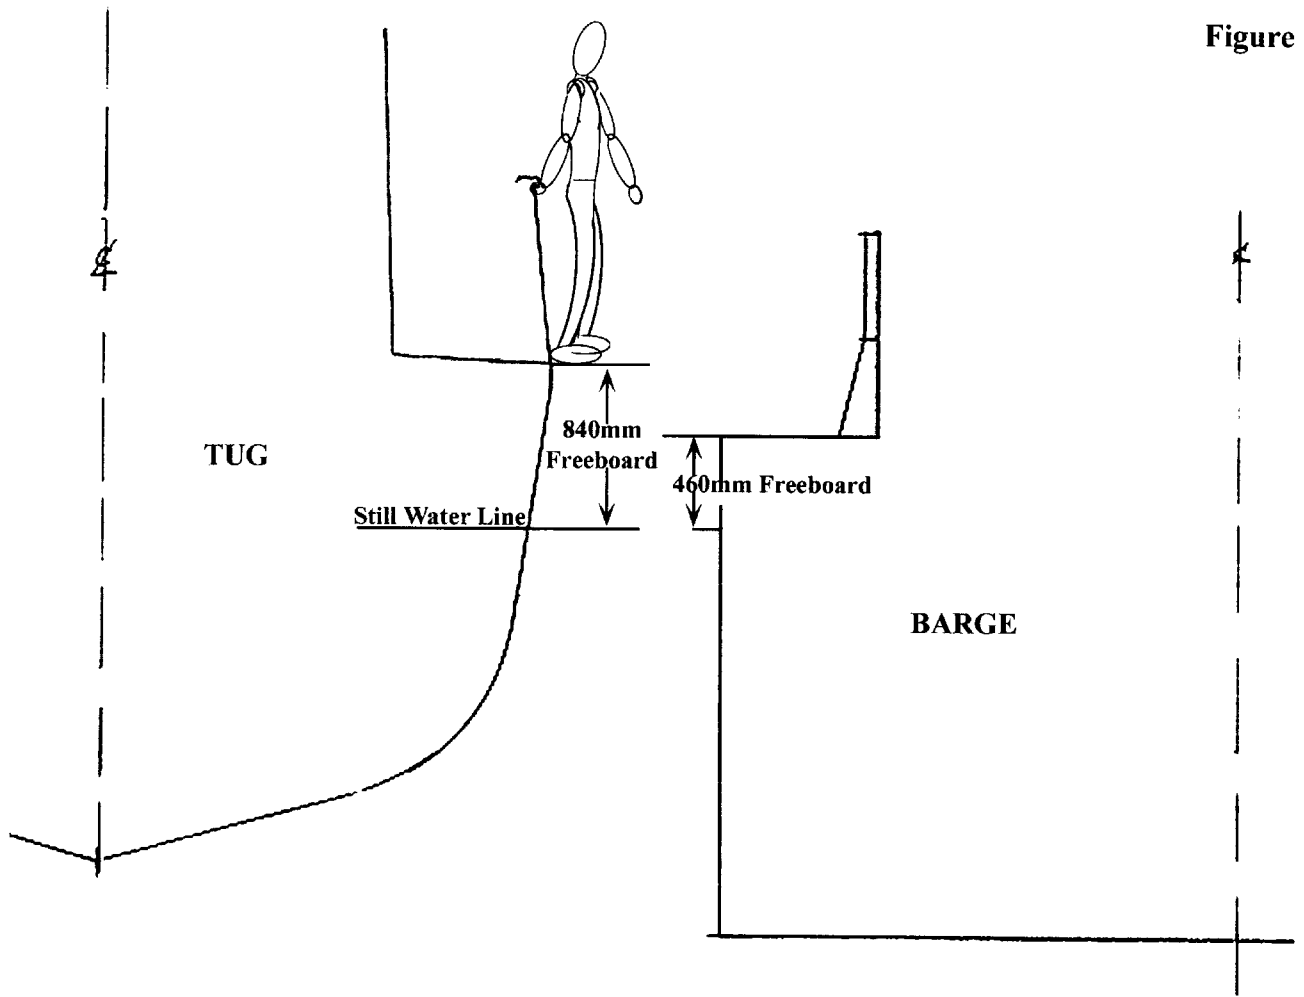
Figure 1

1. Still water condition when loaded prior to transfer

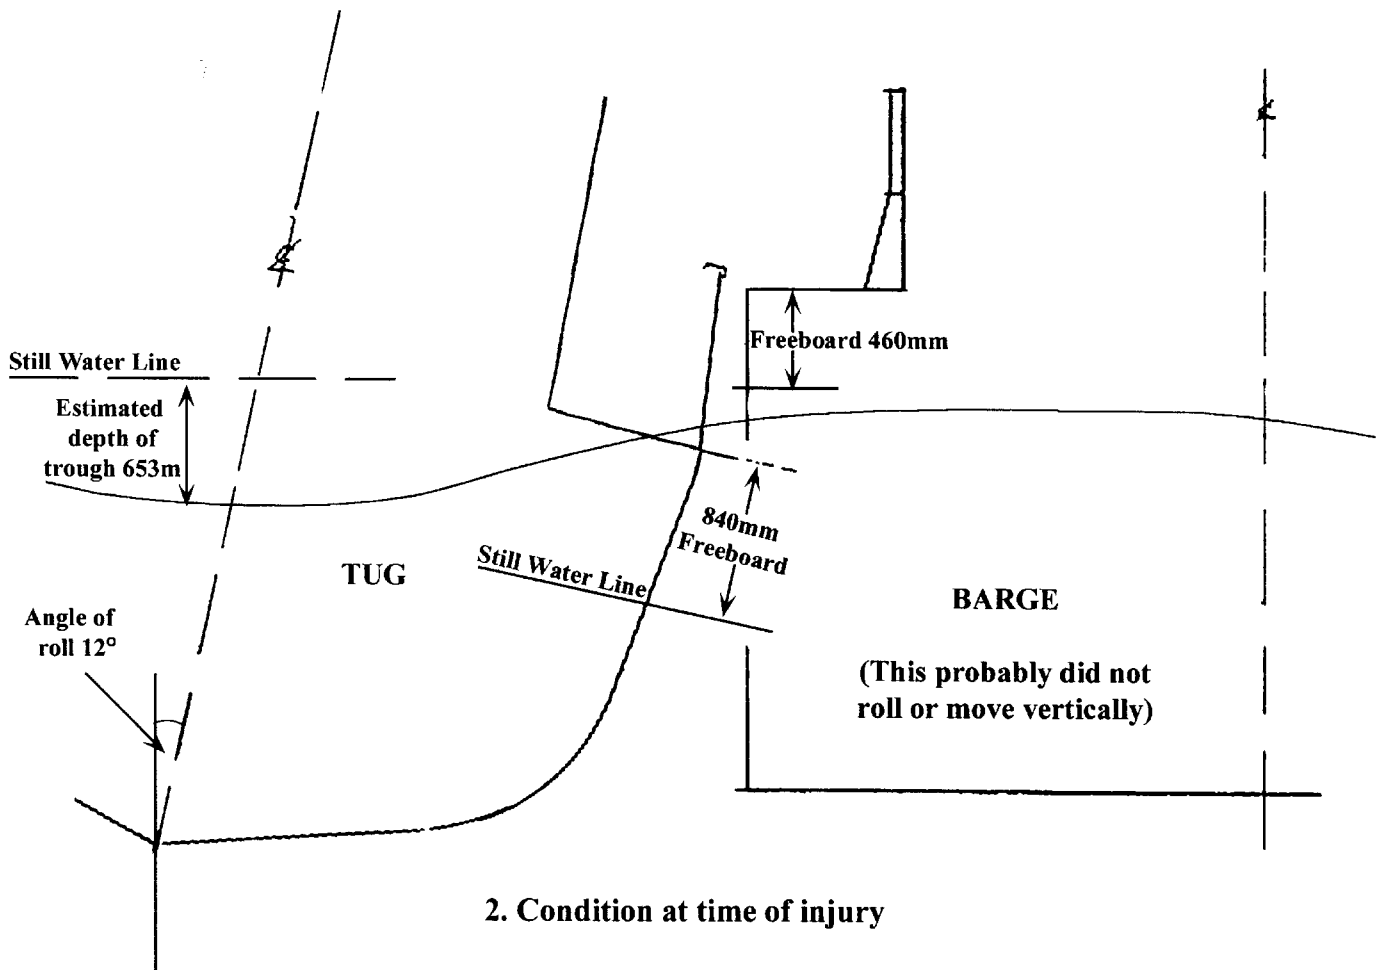
As the tug slowly moved towards the barge on a parallel course, the sea conditions made the tug roll slightly. At about 0145 the tug came within 1m of the barge. The tug dropped into the trough, simultaneously rolling towards the barge (see Fig 1). Unfortunately, Mr Danton, who was still standing outboard of the bulwark waiting for the right moment to make the transfer, was close to the point of minimum clearance. The combined downward and inward rolling movement of the tug was such that the deck edge of the barge and the gunwale of the tug's bulwark came close to touching. The mate, who was standing by Mr Danton, was not conscious of the vessels touching, but he did hear Mr Danton groan and realised that he had been crushed.

2. Condition at time of injury

- 3.2.1** The cause of the accident was the dropping and rolling of the tug towards the barge as a result of a trough developing between both vessels while close alongside at sea.
- 3.2.2** A major contributory cause of the injuries, was the exposed and unsafe position used to effect an inter-vessel transfer.
