**Report of the Inspection of an
unnamed dory which sank on**

Loch Awe

with the loss of three lives on 29 May 1999

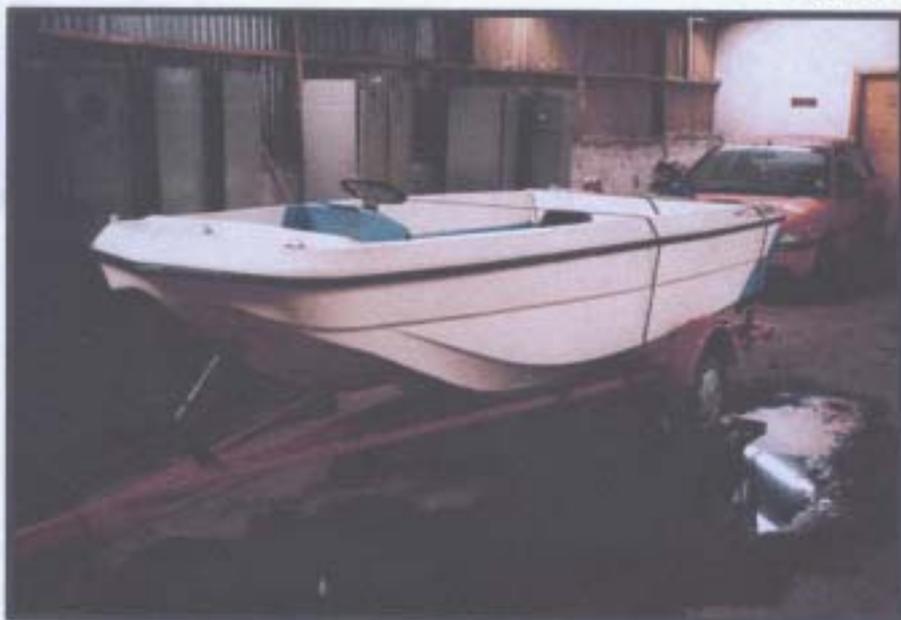
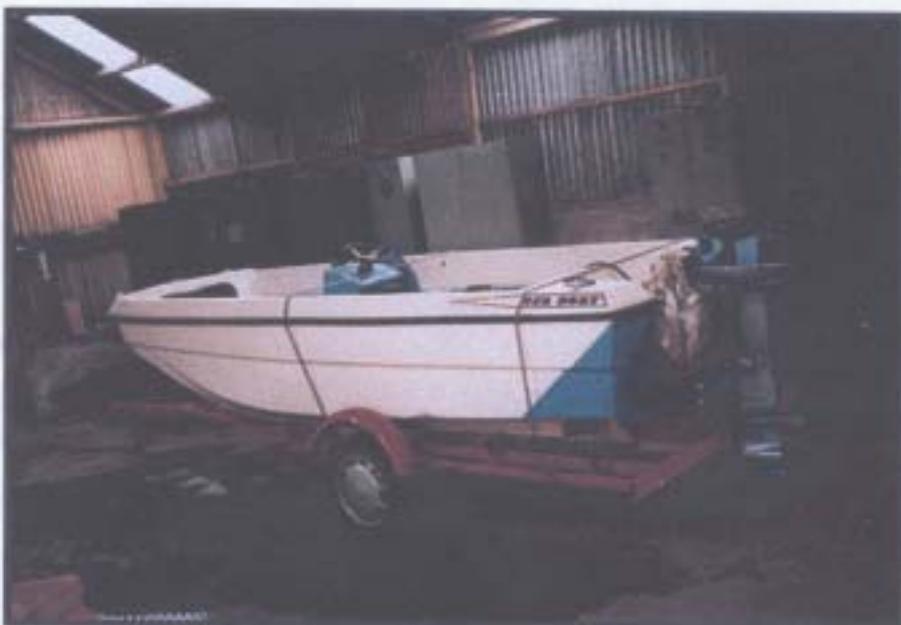
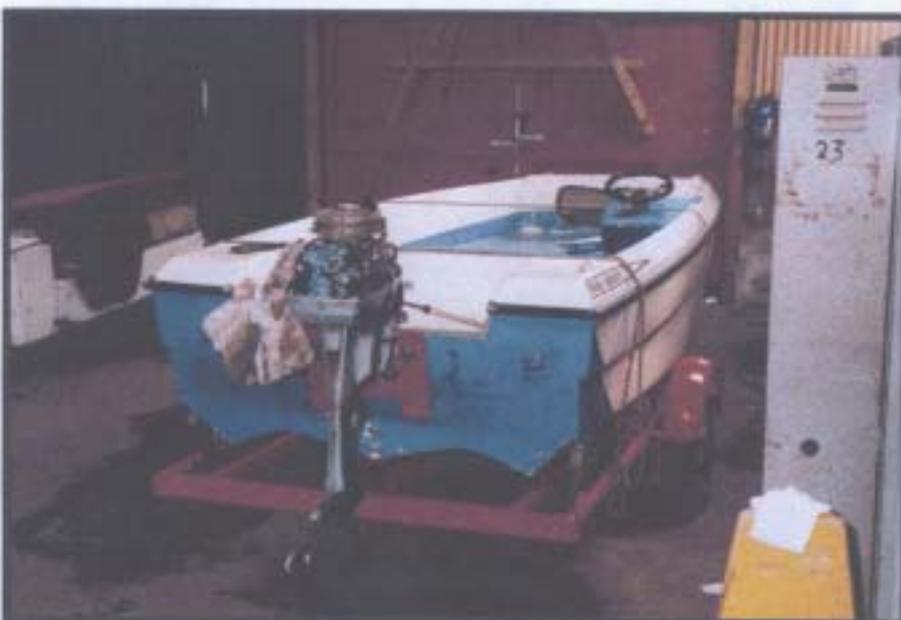
Figure 2

Some general views of the dory are shown in **(Figure 2)**.

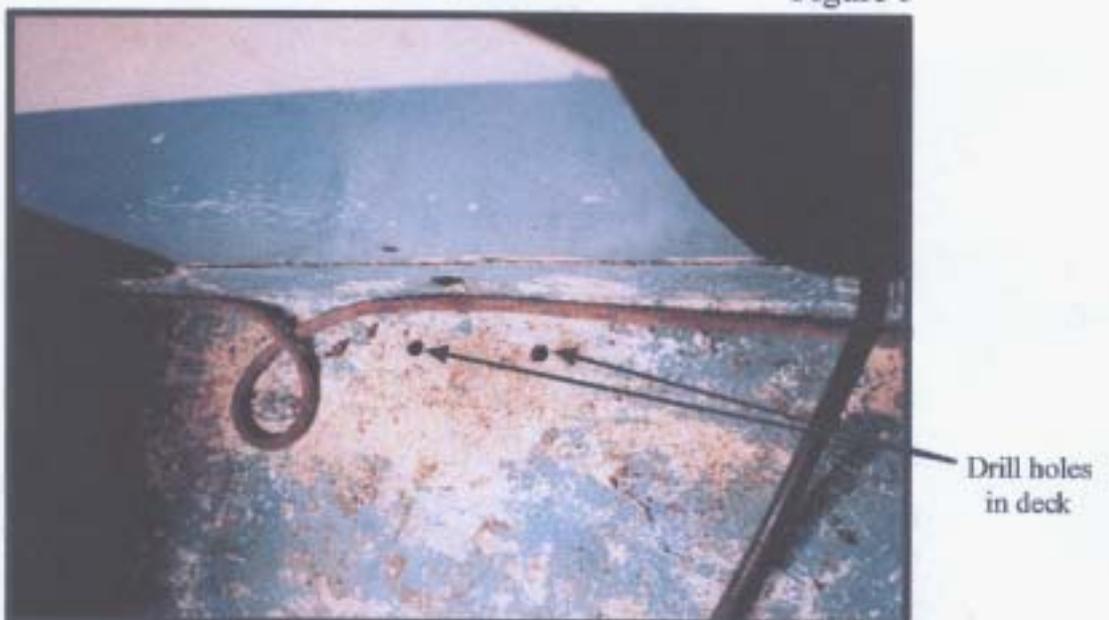
Figure 5

The unseaworthiness caused by the damage to the keel was made worse by the two holes in the deck (**Figure 5**), which would allow rain water to drain into the void. The holes may have been drilled to mount a ski pole for towing a water skier, with this item being removed at a later date. The upper plug hole in the transom was intended to drain the deck (**Figure 3**), but water would probably have run into the void through the two drill holes in preference to the proper drain.

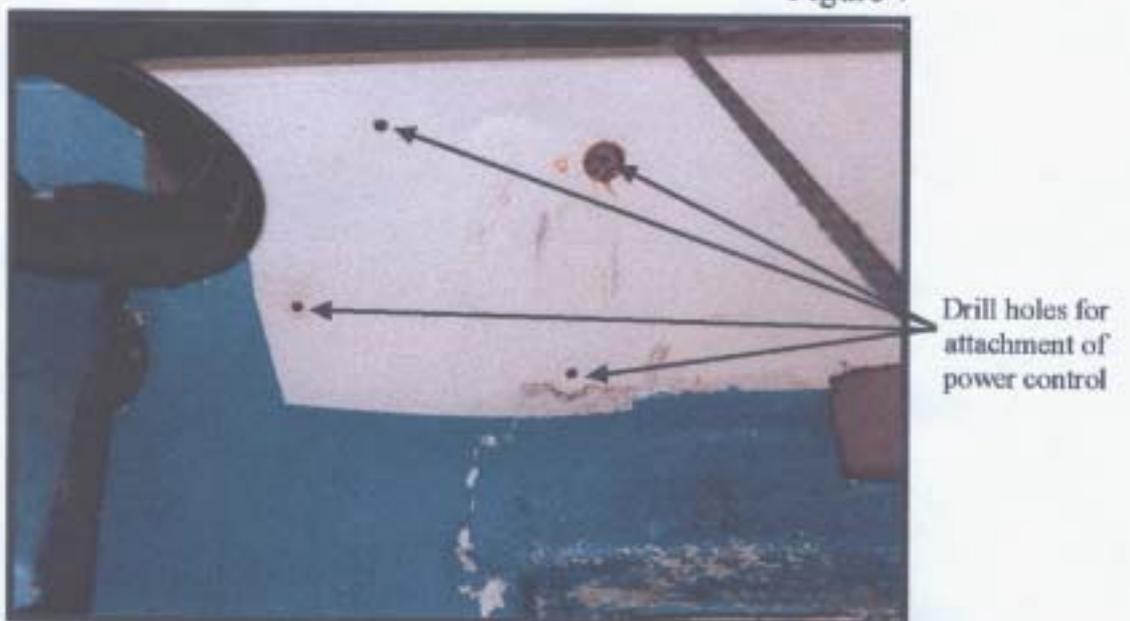
Figure 7

The power control of the outboard motor was originally attached to the starboard side of the dory immediately adjacent to the steering wheel, but was removed, leaving four holes in the inner moulding (**Figure 7**). Therefore the power setting could only be altered at the outboard motor position, hence the person steering could not control the power.

Looking from inside the boat

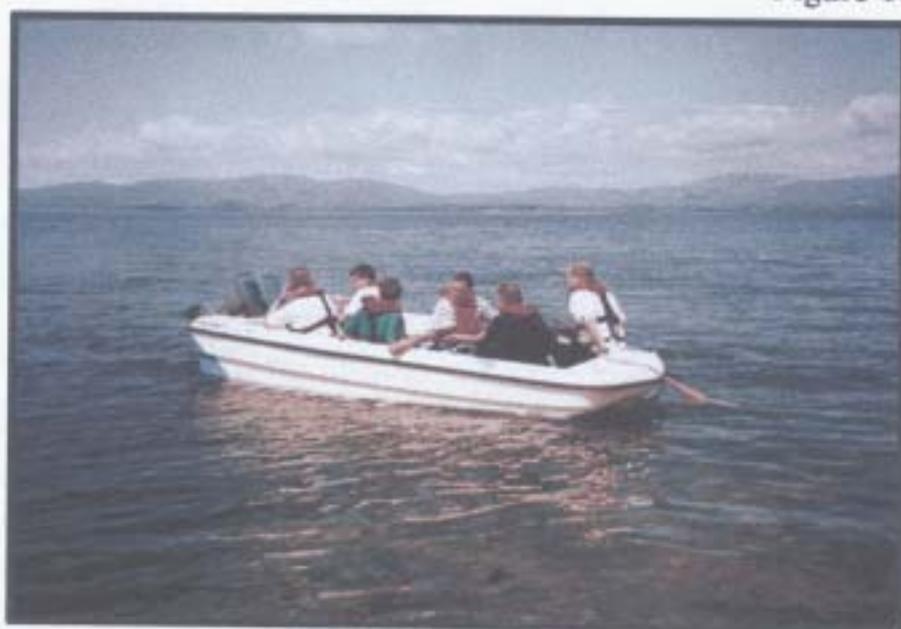
Figure 11

For the inspection afloat the dory was launched off its trailer at a beach near Oban. The dory was loaded with the engine and six adults to represent as closely as possible her condition prior to the accident **(Figure 11)**. It was recognised that the dory was inspected in sea water, whereas the accident occurred in fresh water, but this was not considered to be significant (a boat displaces about 2.5% more fresh water than salt water). It was also recognised that one of the crew in the accident was a child. These two weight discrepancies would tend to cancel each other out.

The freeboards were measured in four places from the centre of the rubbing strip down to the water level. The measurements were as follows:

Forward port corner	0.24m
Forward starboard corner	0.24m
Aft starboard corner	0.46m
Aft port corner	0.46m

When the dory was tested by the MAIB (**Figure 11**), the void was initially dry, however, a freeboard of only 0.24m at the forward end is not considered to be satisfactory for prevailing sea conditions. Two persons seated forward

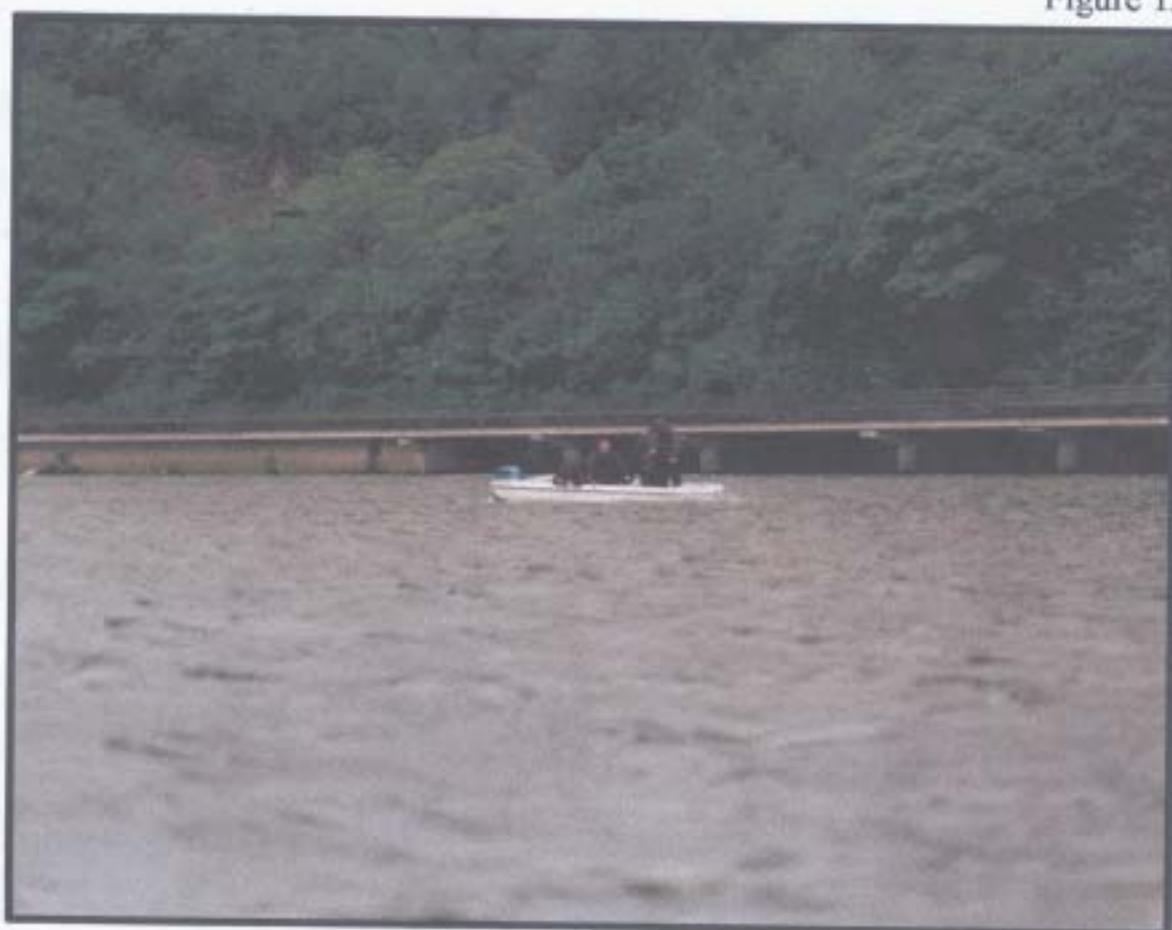
Figure 12

The dory was photographed on 29 July 1999, just prior to the accident (**Figure 12**), by a member of the public on another boat. The road on the north side of the loch can be seen in the background. The chine on the side of the dory is only visible at the aft end.

Just prior to the accident the dory looked very low in the water (**Figure 12**). The low freeboard was caused by the overloading and the flooding of the void.

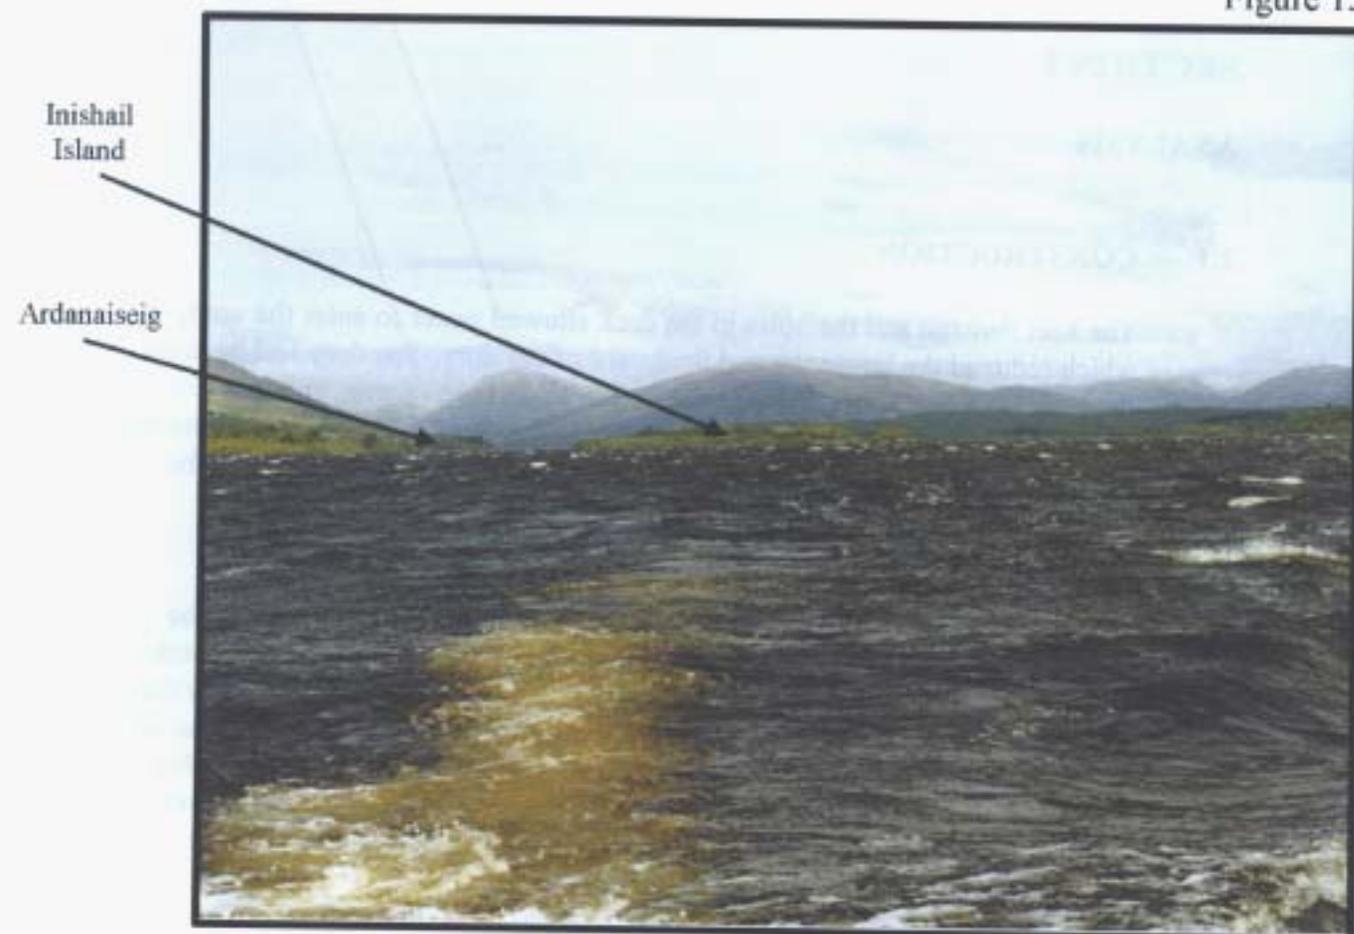
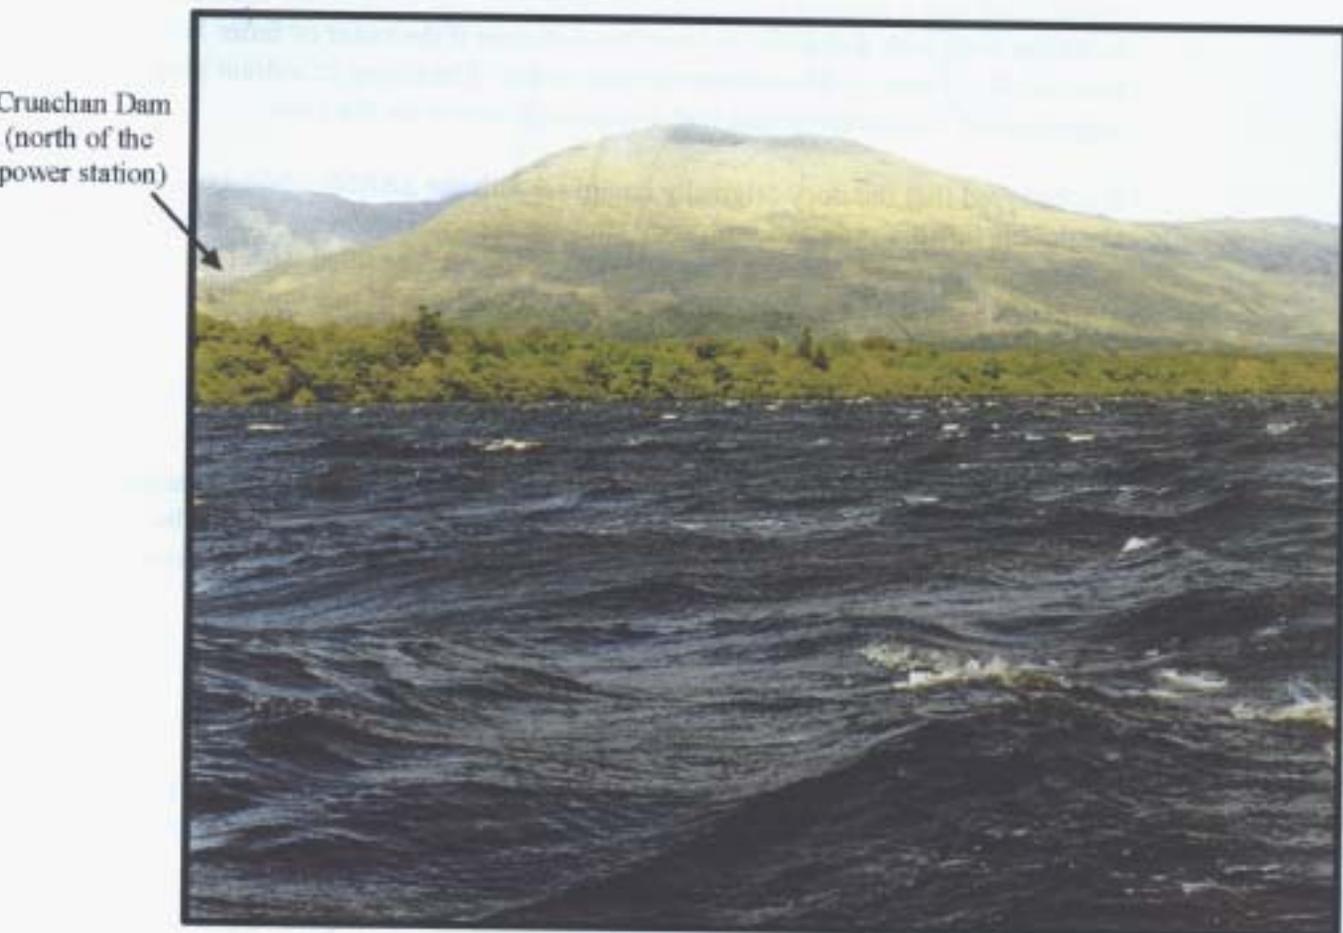
Figure 13

The weather conditions were severe when the accident occurred. The crew of another boat in the area at the time has commented that the conditions were the worst that they had seen on the loch, and photographs were taken as a record (**Figure 13**).

The crew who took the photographs of the waves (**Figure 13**) passed through the area of the accident, but it was too rough to use a camera there, so photographs were taken to the south-east of Ardanaiseig on the way back to Ardbrecknish. The waves in the main part of the loch were breaking in the area of the accident due to the shallow water. These steep sided waves are particularly dangerous to dories with low freeboard.

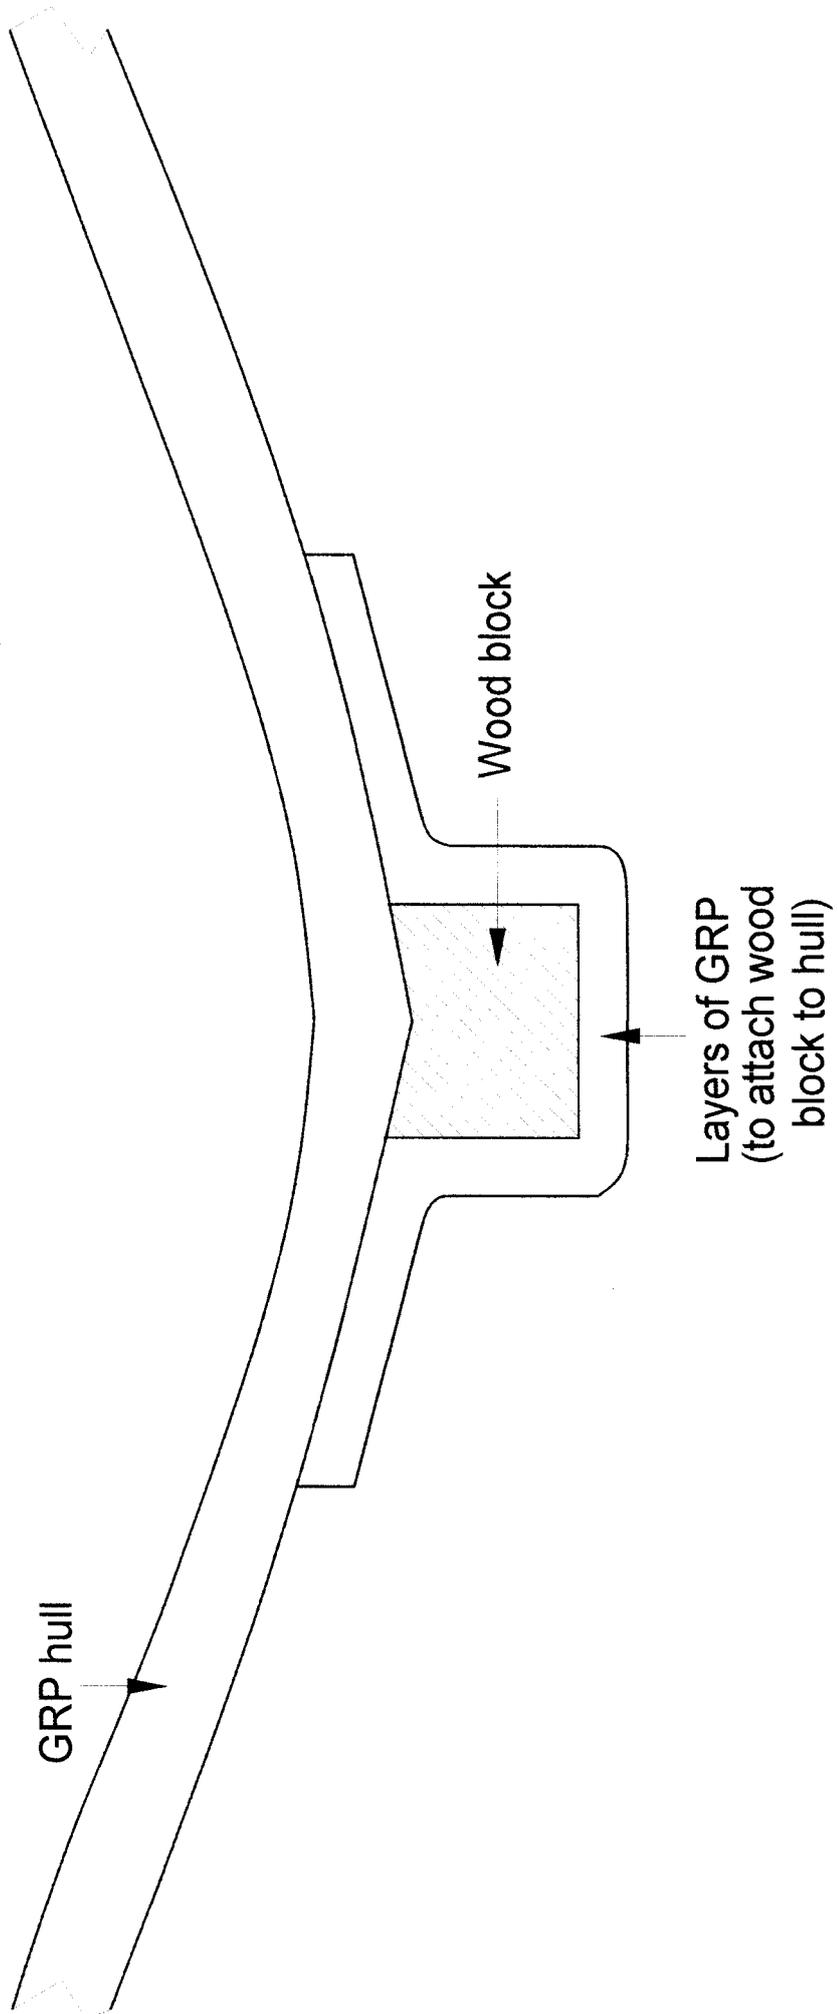
It is evident that this had been a problem earlier in the life of the dory as the damage on the keel at the forward end had been patched, although this patch had been damaged as well at some stage. When the dory was inspected by the MAIB, it was evident that water had been dripping from two places further aft on the keel indicating that the keel was damaged there as well. Better quality GRP dories are constructed with a wood keel grafted on to the hull (**Figure 14**), which protects the bottom of the dory and prevents water ingress into the void.

In order to restrict the flooding of the void, better dory designs have the void sub-divided into a number of sealed compartments. An even better solution is to fill the void with a closed cell foam, so that even if the outer or inner hull is penetrated, no part of the void can fill with water. The fitting of a drain plug suggests that it was recognised that water might penetrate the void.
