Report of the investigation of
two lifting wire failures
on starboard Fast Rescue Craft davit
of safety stand-by vessel
Dea Fighter
on 13 May and 16 July 1999

Marine Accident Investigation Branch
First Floor, Carlton House
Carlton Place
Southampton
SO15 2DZ

Report No 39/2000

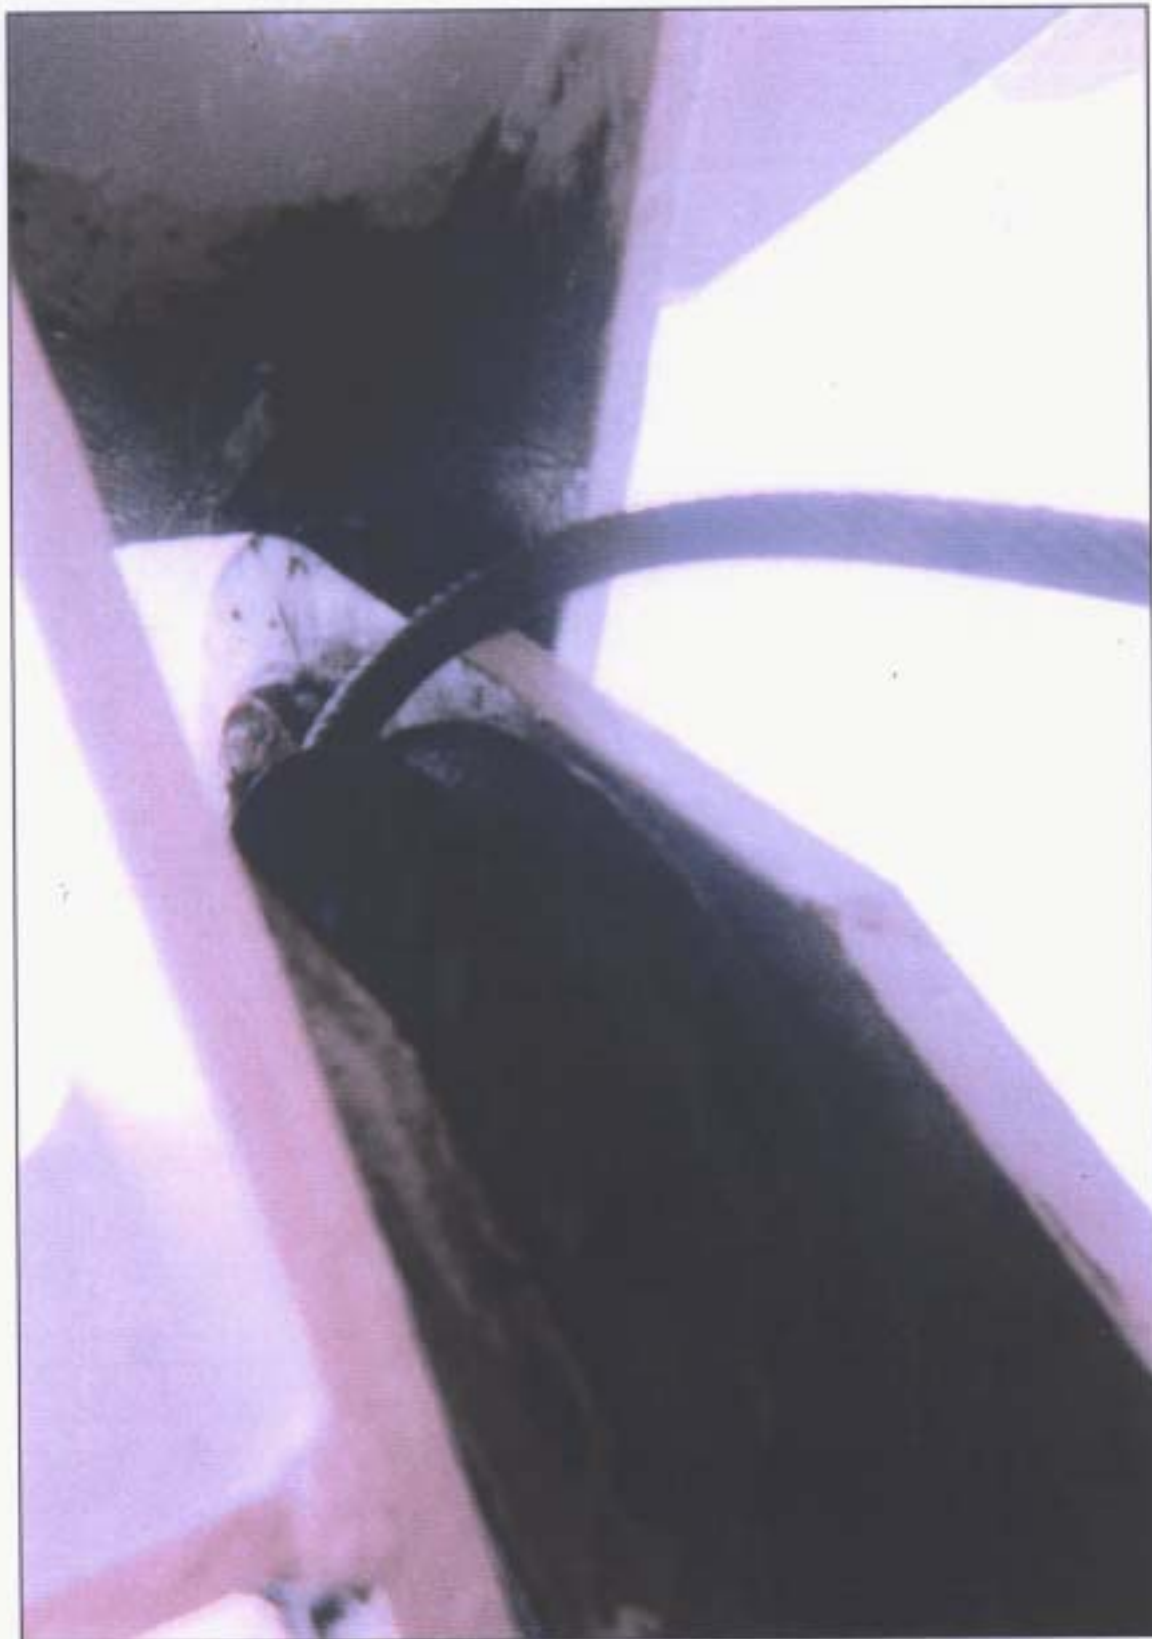
Figure 3

Following recovery of an FRC, it is normal procedure on *Dea Fighter* to secure the FRC in its cradle and allow the davit's wire to slacken. The degree of wire slack is not known, and cannot be easily monitored, but is sufficient to allow the docking head on tele-leg to partially disengage from FRC lifting frame. The amount of slack wire generated is unlikely to be consistent between recovery operations, but has been recorded as being sufficient to allow the wire to ride over the sides of an undersized top sheave (see **Figure 3**).

View of slack wire, clear of undersized top sheave

This practice has little significance when the correct size top sheave is fitted. However, the smaller sheave fitted is sufficiently narrow to allow the wire to drop from sheave's groove when slack is removed during the next launching operation. The wire may then be unable to regain its proper position on the sheave until the FRC is next recovered, and even then would probably require manual assistance.

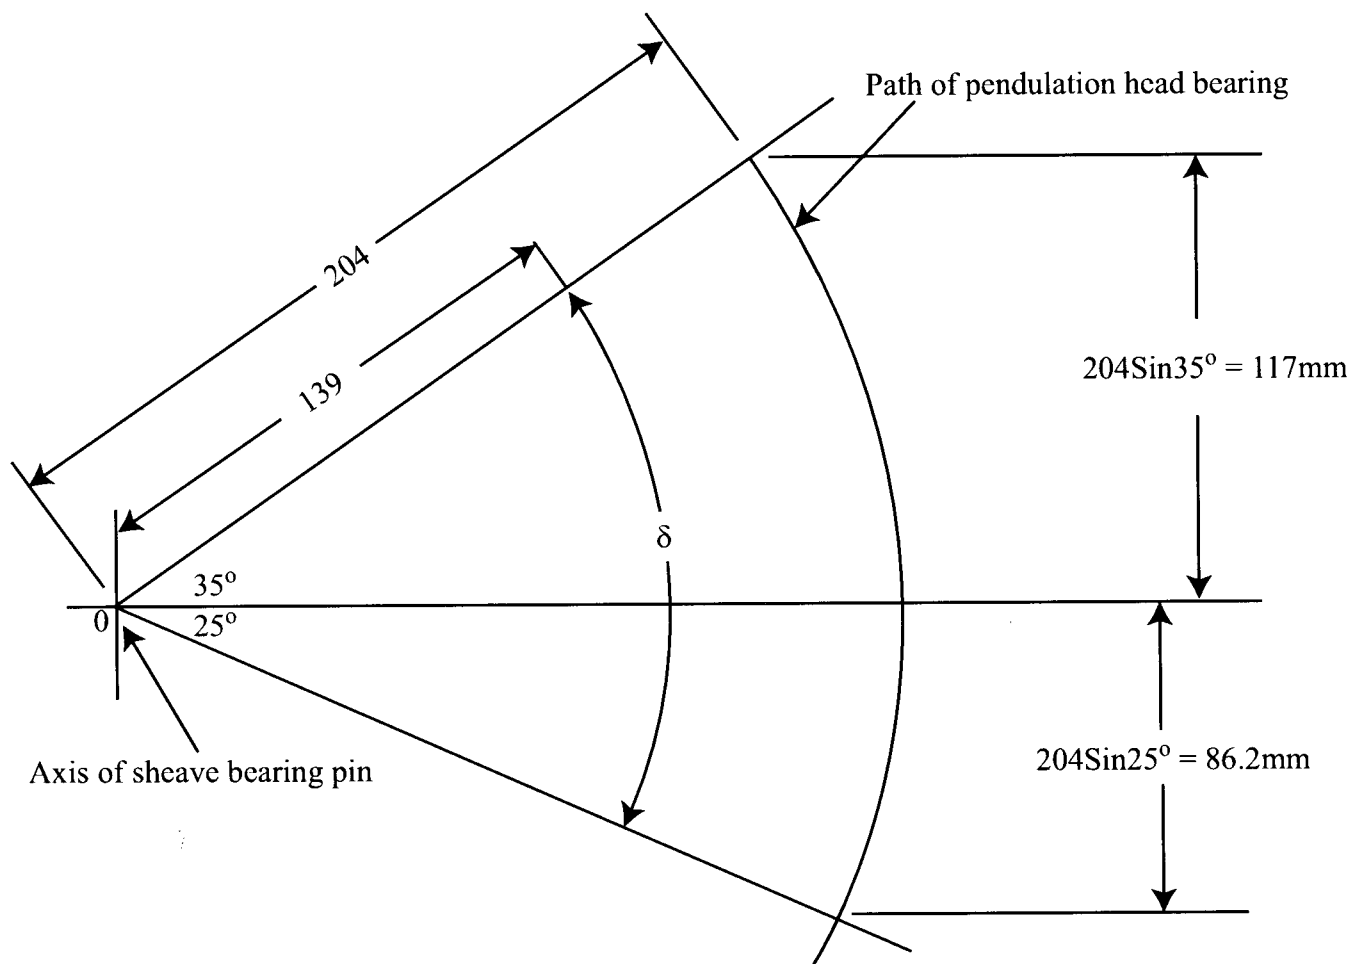
ANNEX C

Wire run off sheave of 139mm effective radius

$$\delta = \frac{139(35^\circ + 25^\circ)2\pi}{360^\circ} = 145.56 \text{ mm}$$

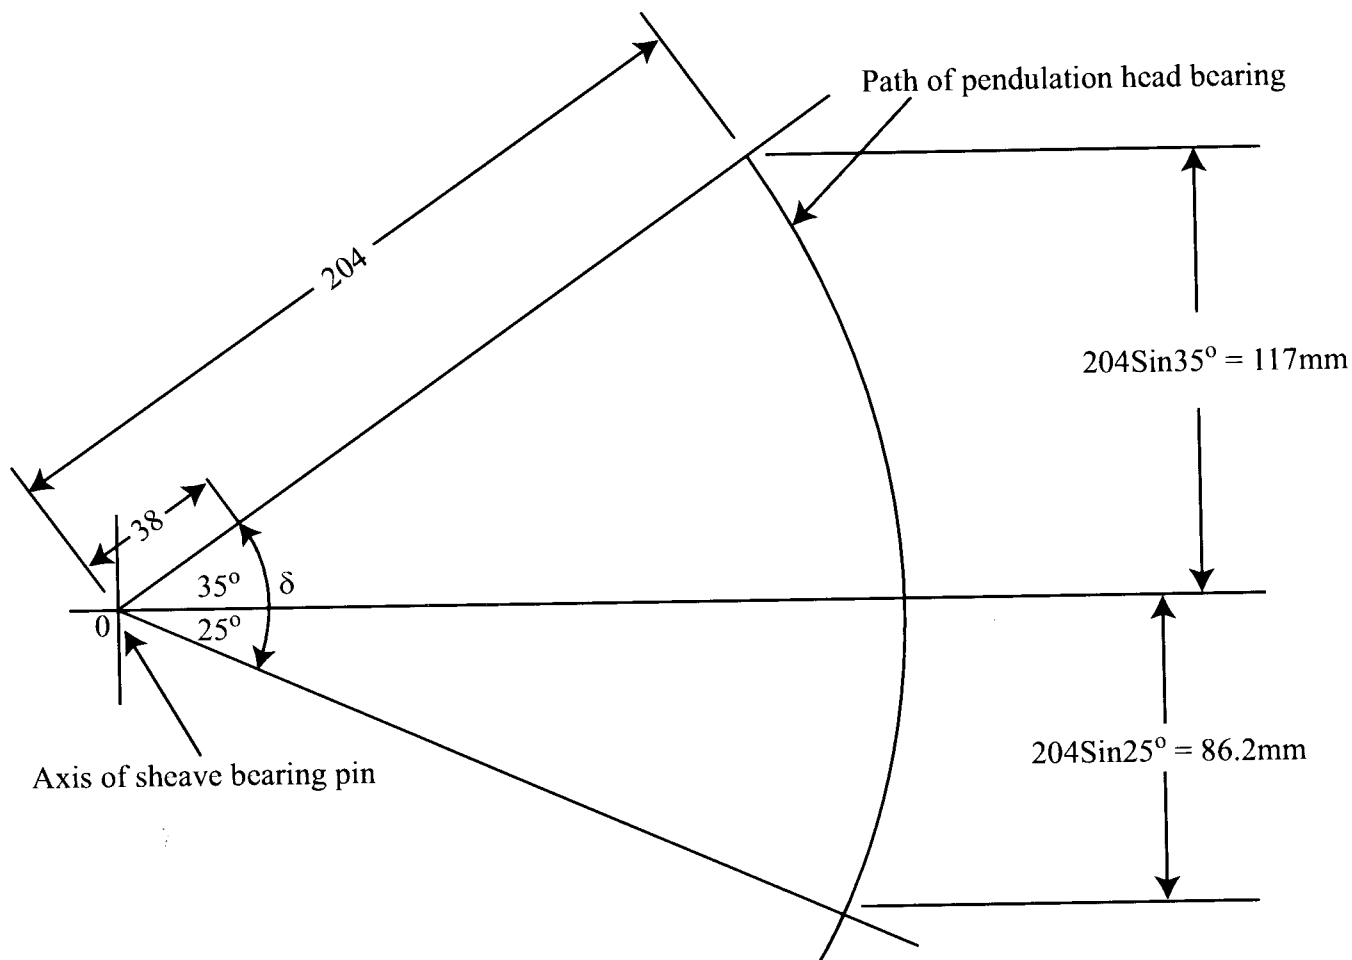
ANNEX D

Wire run off sheave pin of 38mm effective radius $\delta = \frac{38(35^\circ + 25^\circ)2\pi}{360^\circ} = 39.79\text{mm}$

Relative to axis of sheave bearing pin;
 pendulation head bearing drops $117 + 86.2 = 203.2\text{mm}$
 length of wire run off sheave $= 39.79\text{mm}$
 difference $= 163.41\text{mm}$
