Report of the investigation of the fire on board

Multitank Ascania

in the Pentland Firth

Report No 22/2000

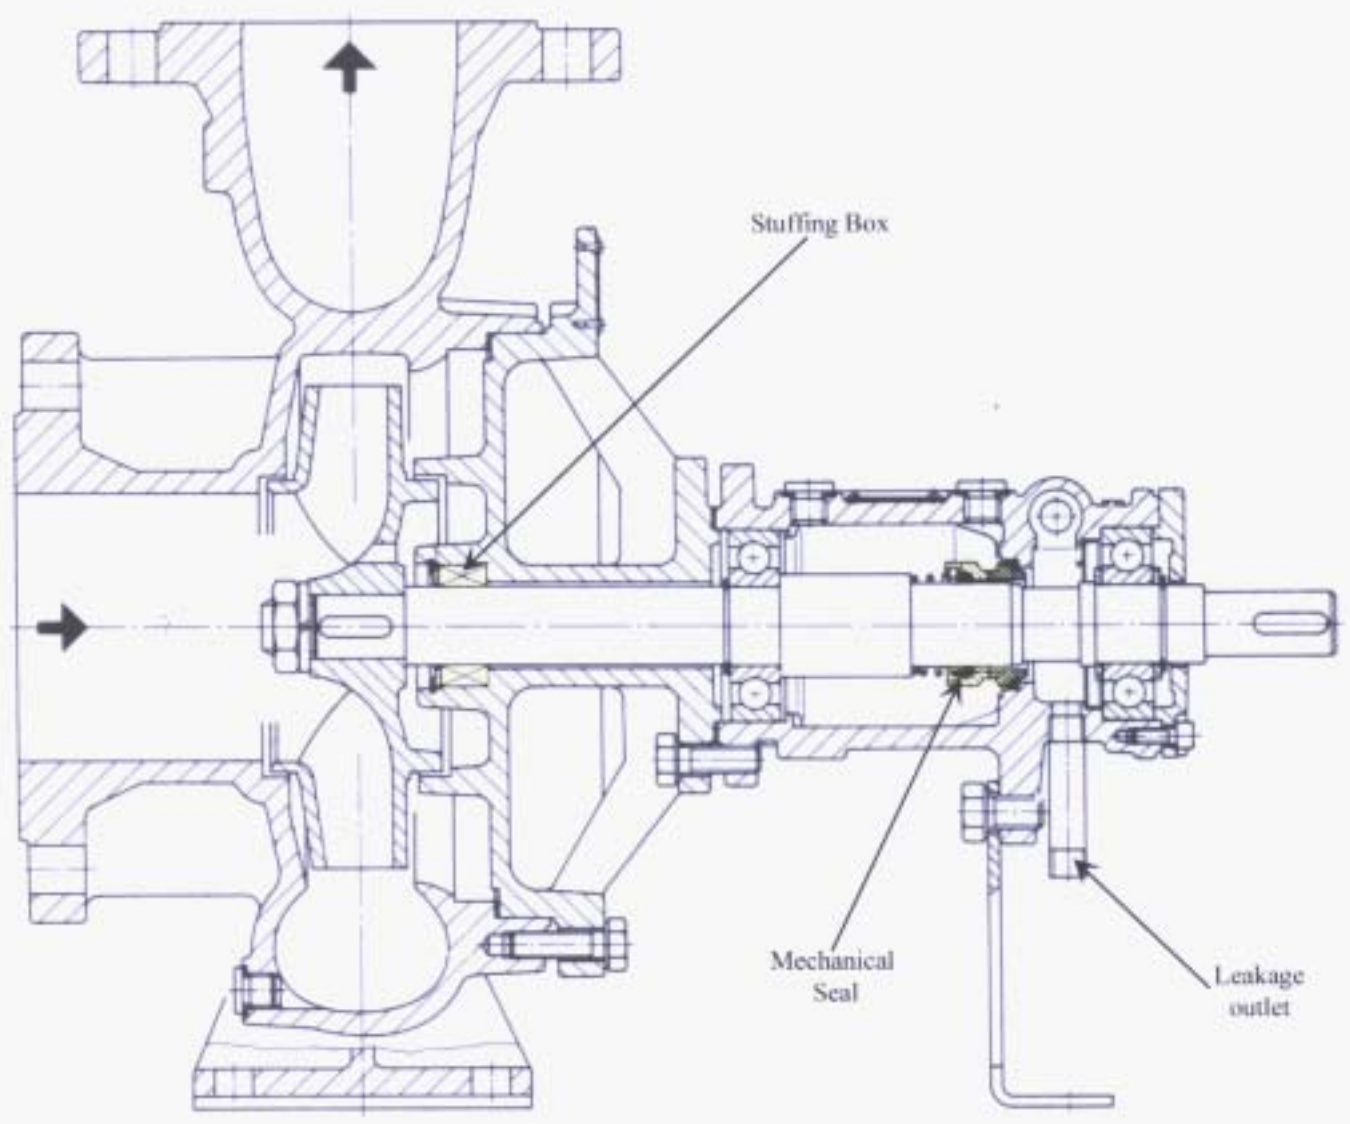
Thermal oil pumps

- 1.10.2** The mechanical seal on the upper centre pump had failed about two months before the fire. On that occasion, leakage was seen to be modest, reported as being in the form of a drip rather than a spray. Following this failure, a new mechanical seal was fitted.

However, during the earlier leakage incident, oil was seen as a drip rather than a spray. Owing to the pump’s double seal design, and the drainage arrangements for leaking fluid, this would be the expected symptom of a mechanical seal failure.

Although leakage due to failure of the pump’s mechanical seal cannot be completely discounted, such a failure would not have produced a spray of fluid. Nor would any leakage have been in the form of a jet.

- 2.2.2 The seal casing design was such that oil leakage past the mechanical seal drained through an orifice at the bottom of the casing (see **Figure 4**). From there oil would be able to drip on to the mounting platform of the pump, eventually running on to other pumps and piping below. The pumps’ design made provision for this leakage orifice to be connected to a collecting tank. No arrangement of this type was in place on *Multitank Ascania*. Had it been so, any leakage would have been comparatively innocuous and would probably have continued unnoticed until the system’s low-level alarm on the header tank sounded. The installation of such a system on *Multitank Ascania* and, if relevant, her sister vessels, would be a sensible precautionary measure.
