**Report on the Investigation
of the grounding of the passenger ferry**

Quiberon

in Plymouth Sound

Report No 16/2000

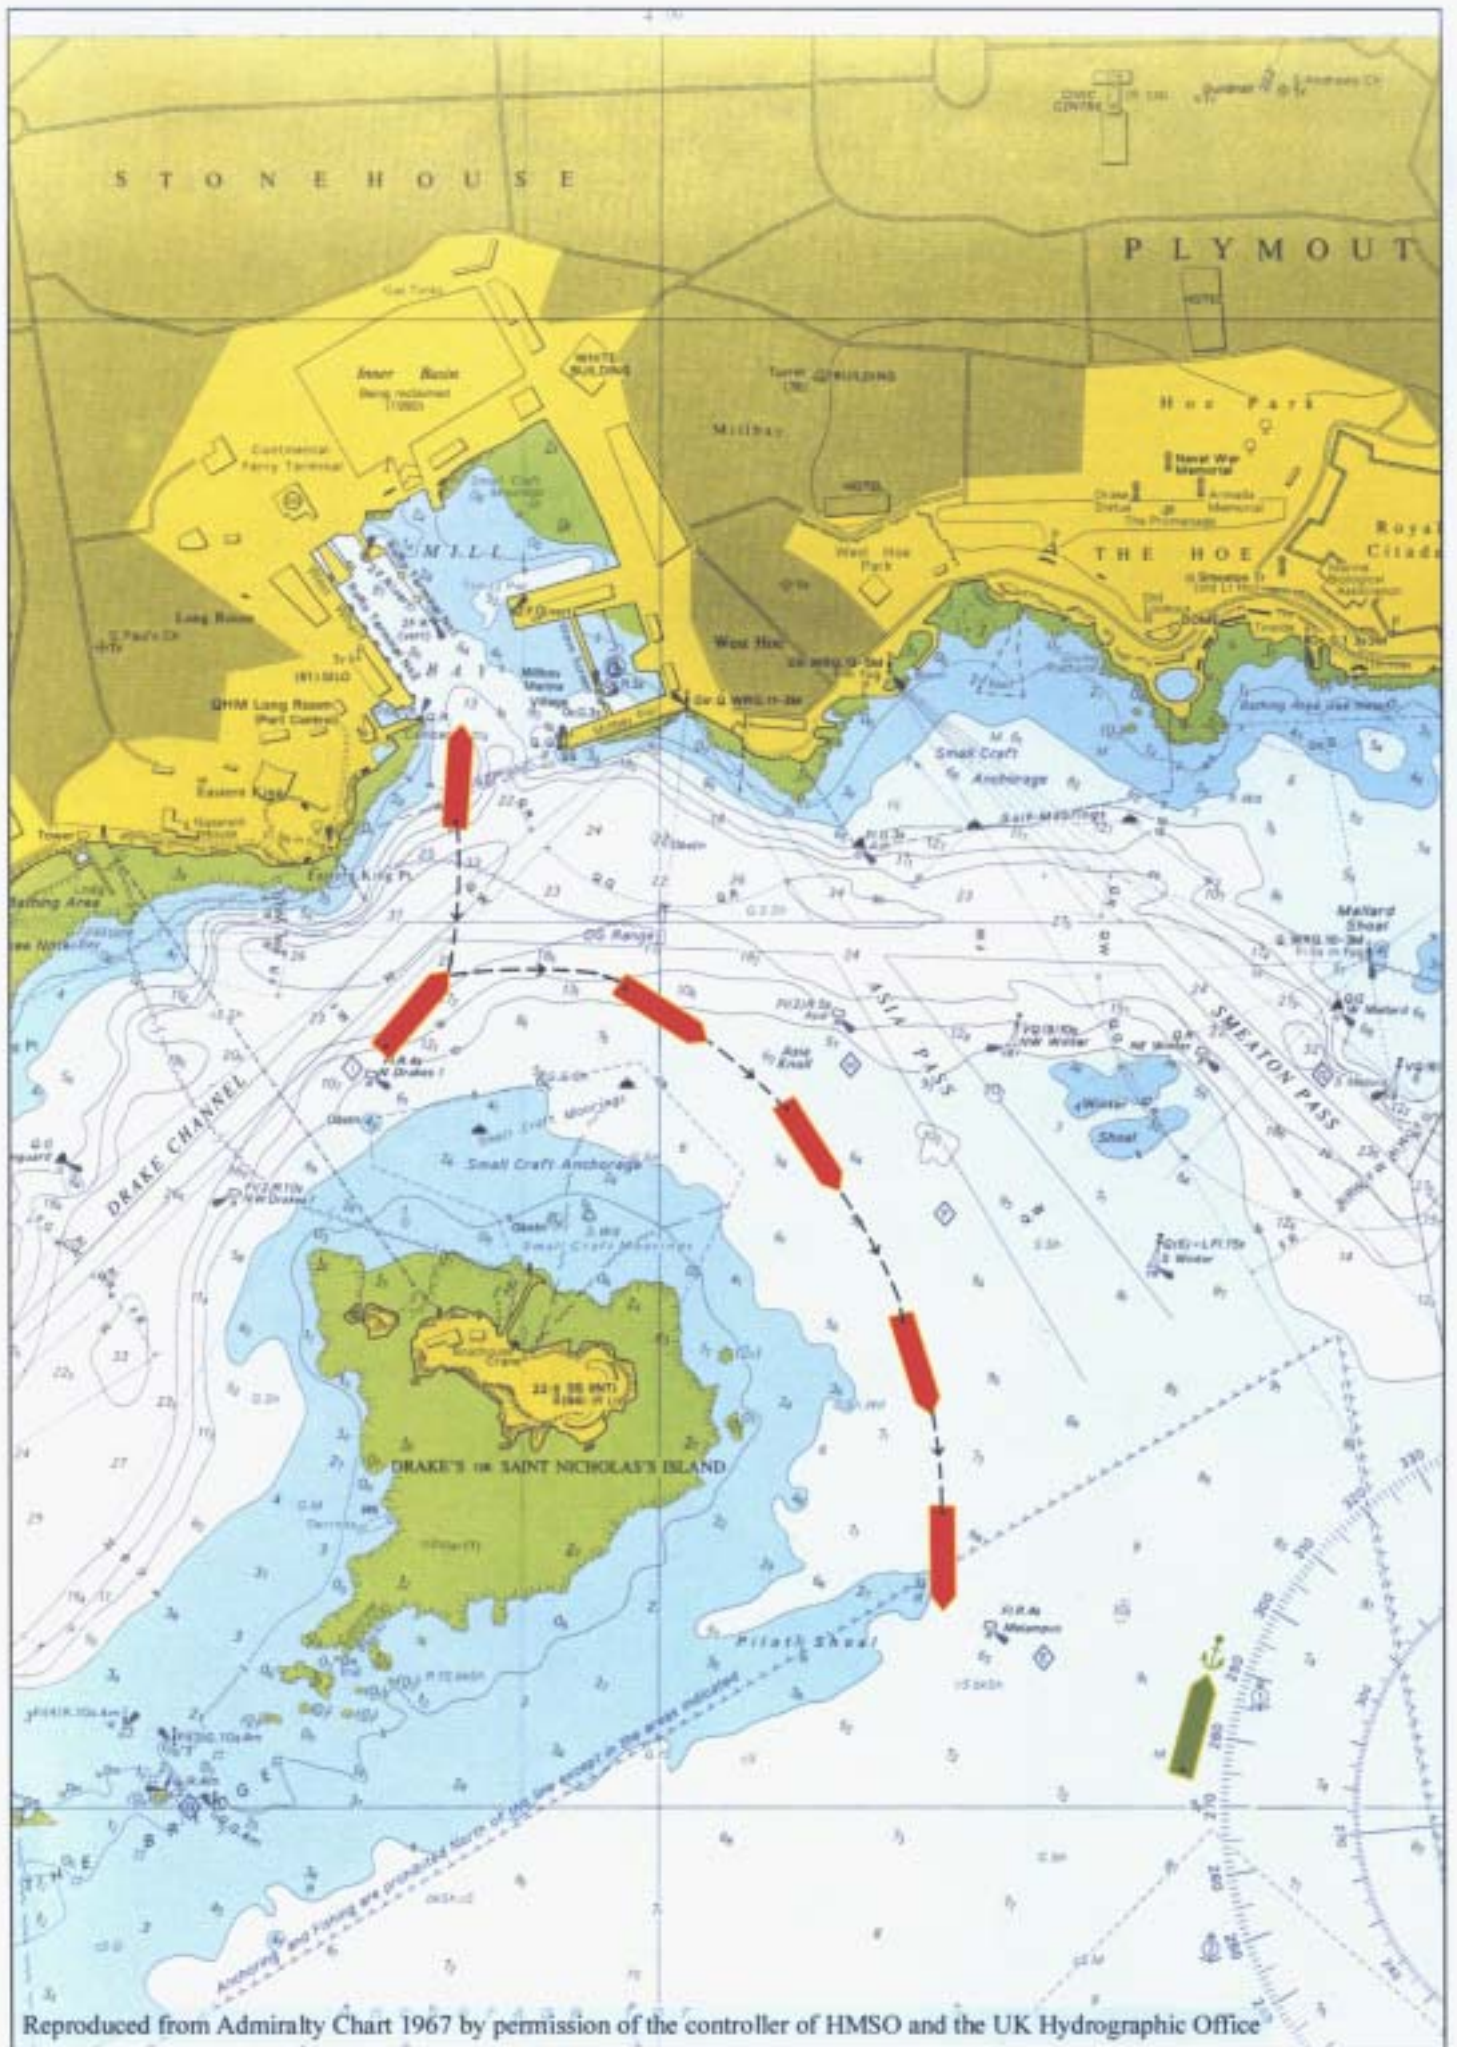
The vessel moved astern out of Mill Bay and into Drake Channel. With the stern close to N Drakes Island buoy she was swung, bow to starboard, towards a south-easterly heading to begin the passage out to the west of Asia Pass (**see chart extract**).

As the master conned the vessel towards the buoy, both he and the chief officer were judging the vessel's position and her distance from the buoy by eye. It was dark, there was a new moon and the buoy itself could not be seen. Only its light was visible, flashing red every four seconds. The vessel's position and distance off the buoy was misjudged, and the vessel grounded on the easterly end of Pilot Shoal.

The distance between the end of Pilot Shoal and Melampus buoy is only 80m. The depth of water over the east end of Pilot Shoal was about 4.2m at the time of the grounding. The vessel's maximum draught was 5.05m and her beam is 21m. The safety of the vessel and, ultimately, that of her crew and passengers, depended on the buoy being in the correct charted position and on the master's ability to judge exactly the distance of a flashing light at night and to con the vessel precisely to pass within metres of the buoy. In the event, the master misjudged the situation and failed to pass close enough to the buoy.

It is impossible to judge exactly the distance from a flashing light at night solely by eye. Even if radar had been used to assist the navigators, the tolerances allowed to pass safely between the buoy and the shoal were too small. There was an 80m wide passage that may have been reduced to 55m by the scope of the buoy. *Quiberon's* beam is 21m.
