**Report on the Investigation  
of the grounding of the passenger ferry**

***Quiberon***

**in Plymouth Sound**

**Report No 16/2000**

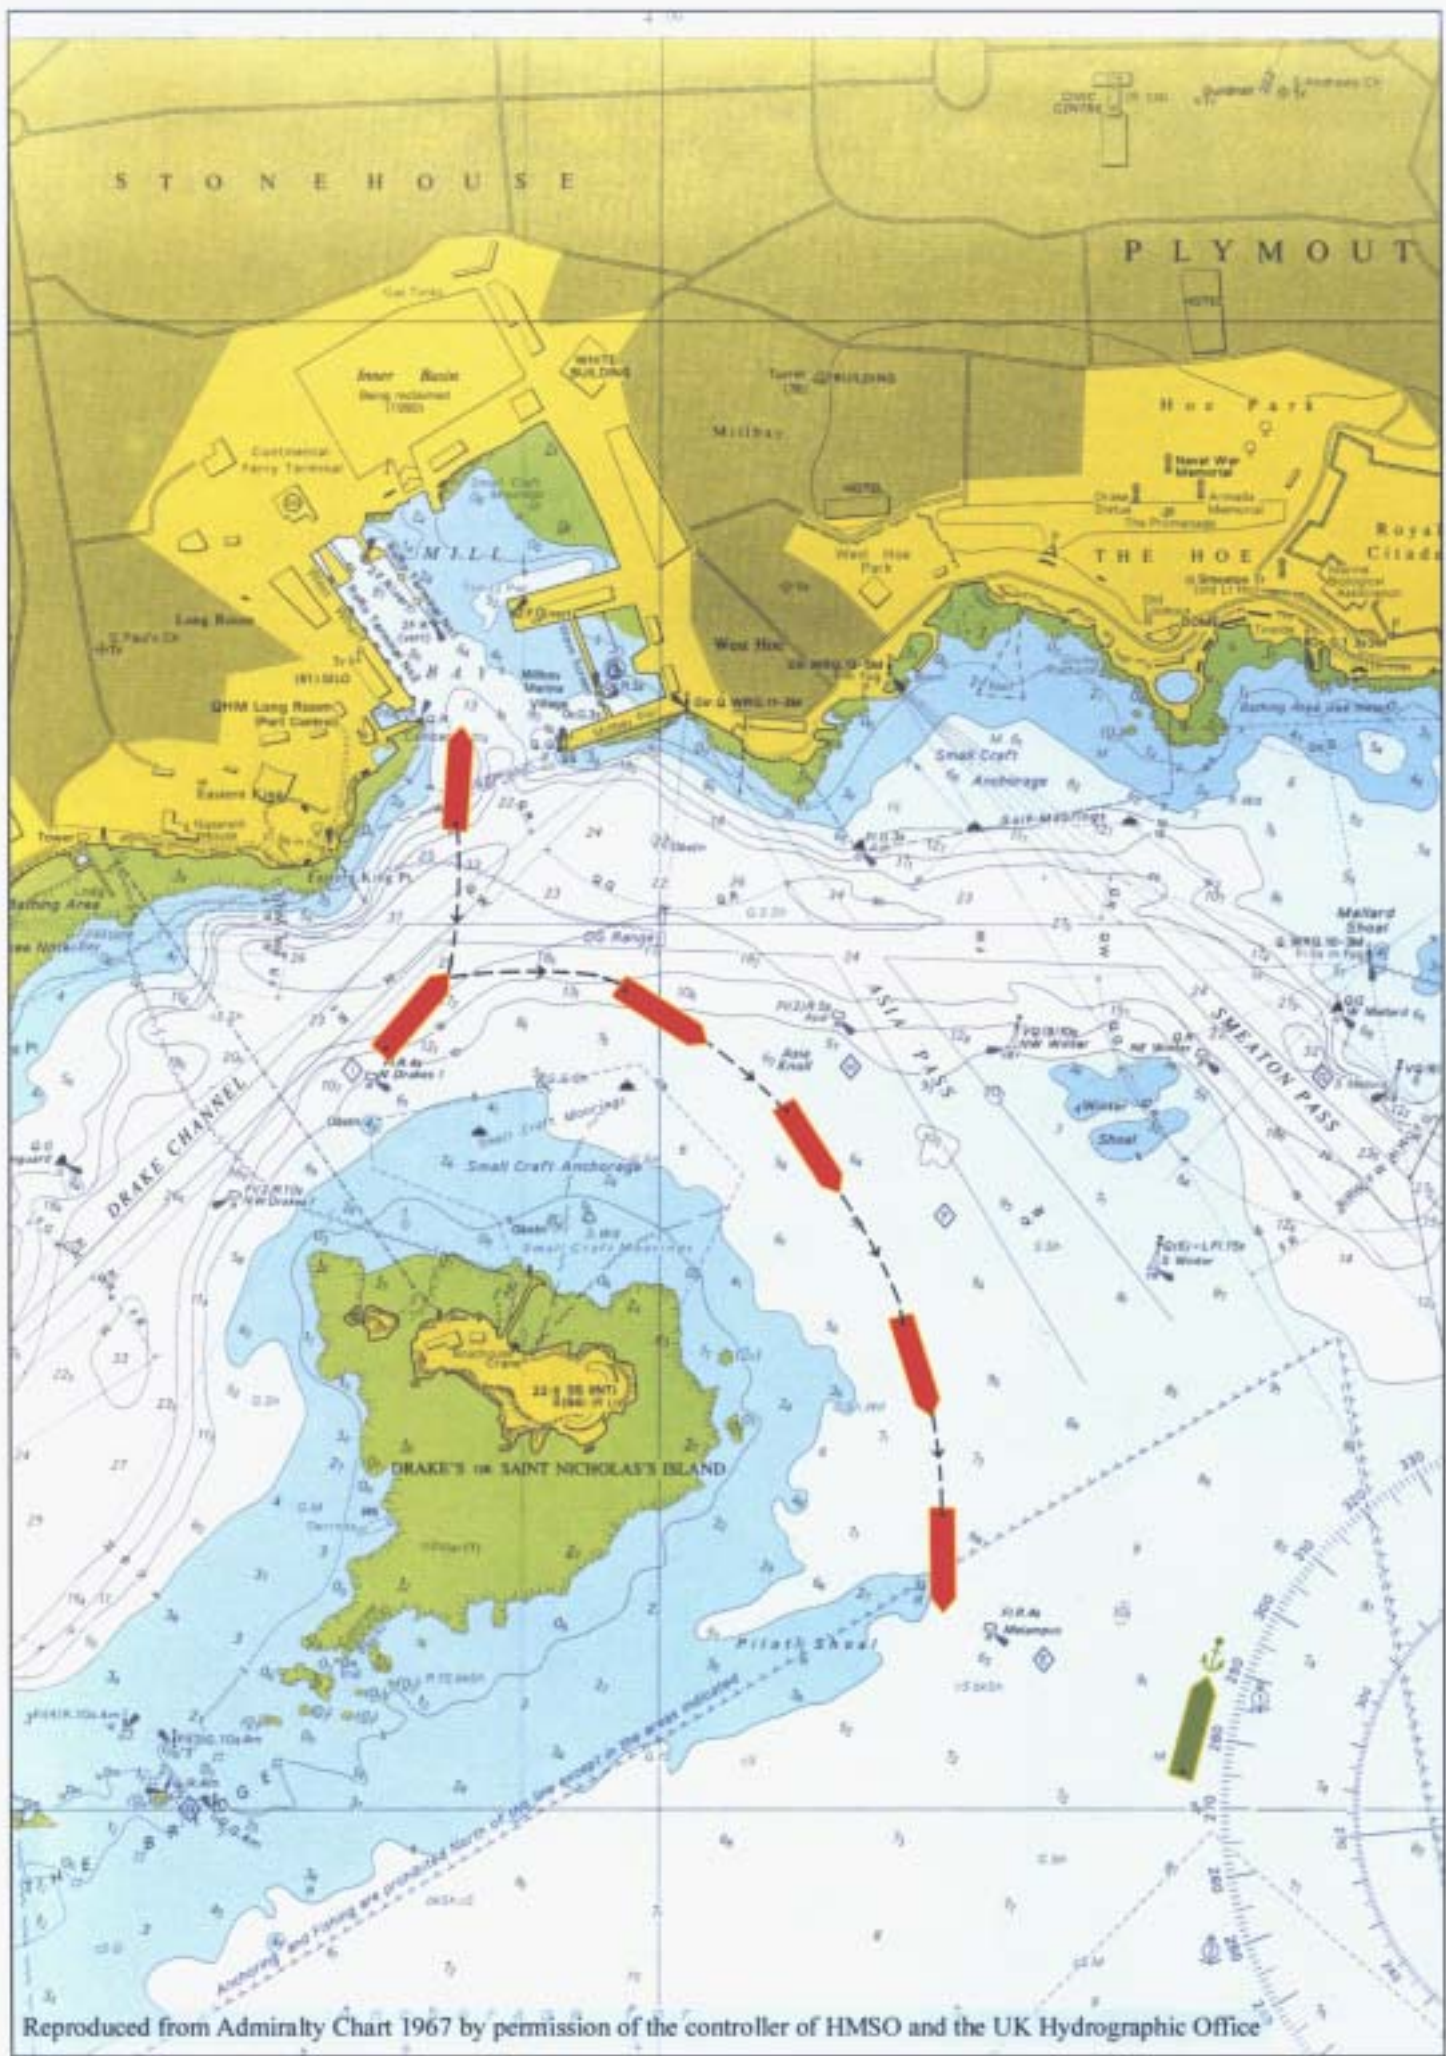
Reproduced from Admiralty Chart 1967 by permission of the controller of HMSO and the UK Hydrographic Office

The vessel moved astern out of Mill Bay and into Drake Channel. With the stern close to N Drakes Island buoy she was swung, bow to starboard, towards a south-easterly heading to begin the passage out to the west of Asia Pass (**see chart extract**).

As the master conned the vessel towards the buoy, both he and the chief officer were judging the vessel's position and her distance from the buoy by eye. It was dark, there was a new moon and the buoy itself could not be seen. Only its light was visible, flashing red every four seconds. The vessel's position and distance off the buoy was misjudged, and the vessel grounded on the easterly end of Pilot Shoal.

The distance between the end of Pilot Shoal and Melampus buoy is only 80m. The depth of water over the east end of Pilot Shoal was about 4.2m at the time of the grounding. The vessel's maximum draught was 5.05m and her beam is 21m. The safety of the vessel and, ultimately, that of her crew and passengers, depended on the buoy being in the correct charted position and on the master's ability to judge exactly the distance of a flashing light at night and to con the vessel precisely to pass within metres of the buoy. In the event, the master misjudged the situation and failed to pass close enough to the buoy.

It is impossible to judge exactly the distance from a flashing light at night solely by eye. Even if radar had been used to assist the navigators, the tolerances allowed to pass safely between the buoy and the shoal were too small. There was an 80m wide passage that may have been reduced to 55m by the scope of the buoy. *Quiberon's* beam is 21m.
