**Investigation into the collision between
the UK registered cargo vessel**

Hoo Robin

Arklow Marsh

on the River Trent on 2 March 1999

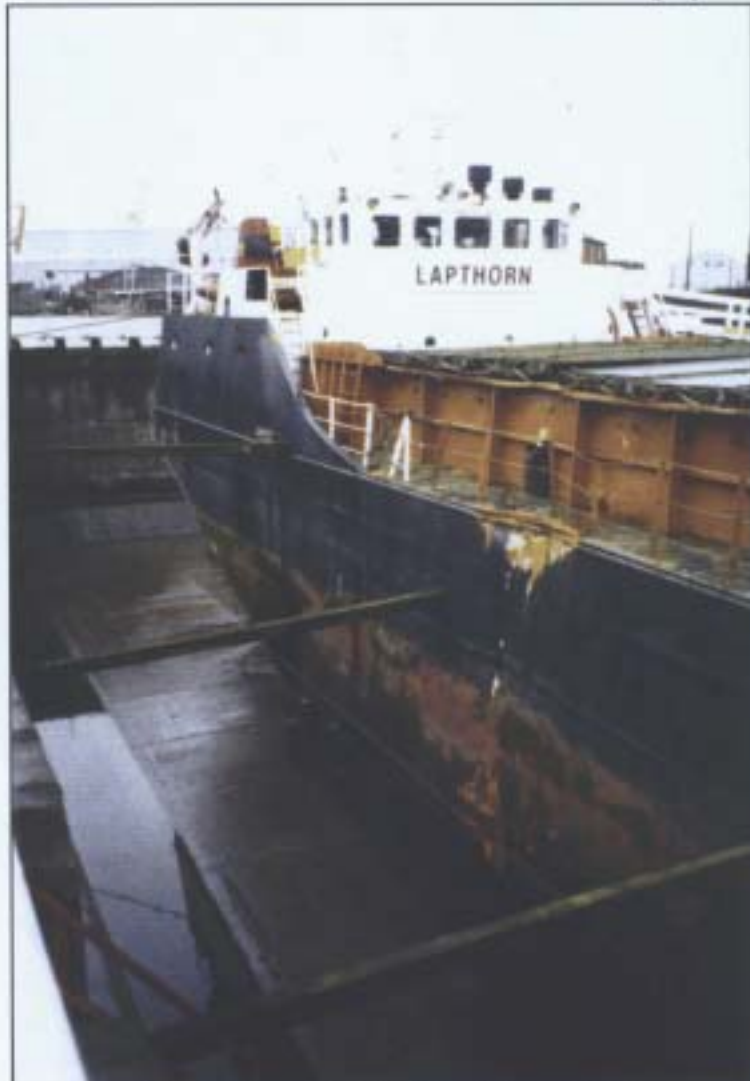
Photograph 2

At 1830 *Arklow Marsh's* bow collided with *Hoo Robin's* starboard side causing damage to both vessels (**Photograph 2**). Both vessels stopped and drifted or stemmed the tide to let other vessels pass while they assessed the damage. Subsequently *Arklow Marsh* was able to continue to Keadby and *Hoo Robin*, despite taking water into her hold, was able to move under her own power to Hessle where she berthed at 2040.

Damage to starboard side of *Hoo Robin*

A full inspection revealed serious damage to *Hoo Robin*. There had been no injuries and no pollution.

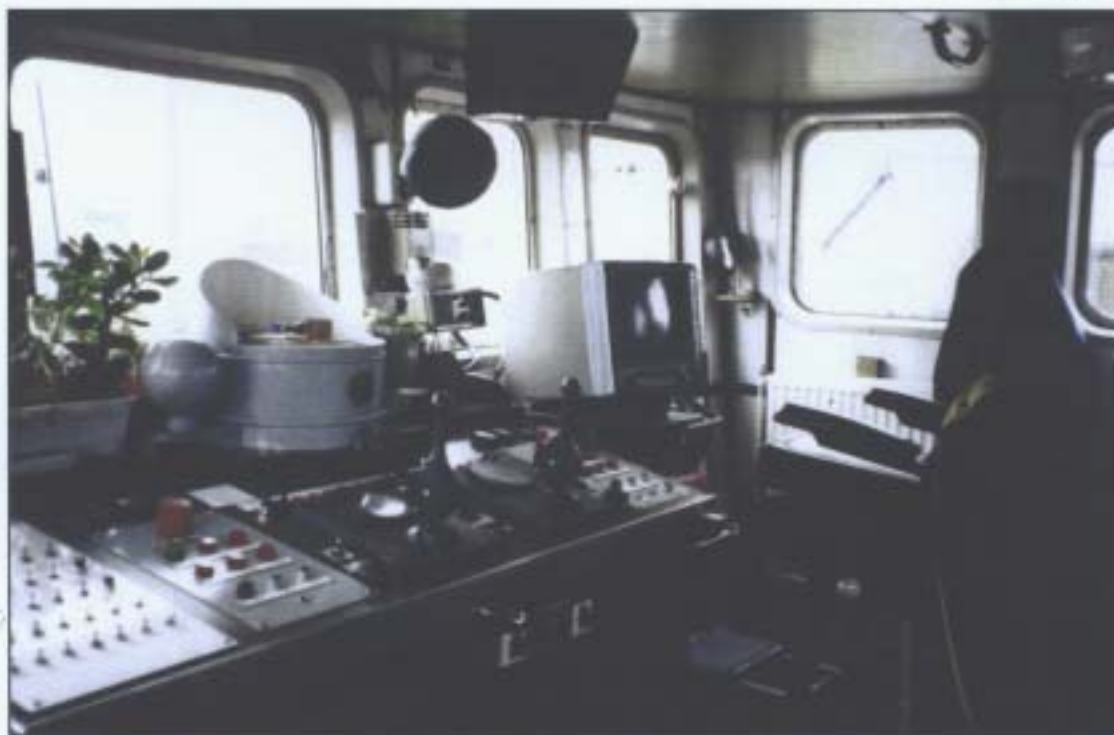
Photograph 3

Hoo Robin is a low air draught dry cargo coaster. Her low wheelhouse is situated aft on the vessel abaft her single hold. The watchkeeper's field of view from the wheelhouse is restricted by the nature of the vessel but is adequate for safe navigation. The wheelhouse is well equipped with old but functional instruments (see **Photograph 3**). All the navigational

instruments including the radar were working correctly on 2 March. The master, who was alone on the bridge at the time of the collision, was standing and steering using the azimuthing propulsion units. The radar and VHF radio are sited within reach of the steering position.

The wheelhouse
