Marine Accident Report No. 4/99

Report on the Underwater Survey  
of the Stern Trawler

**GAUL H. 243**

and the supporting Model Experiments  
August 1998 – January 1999

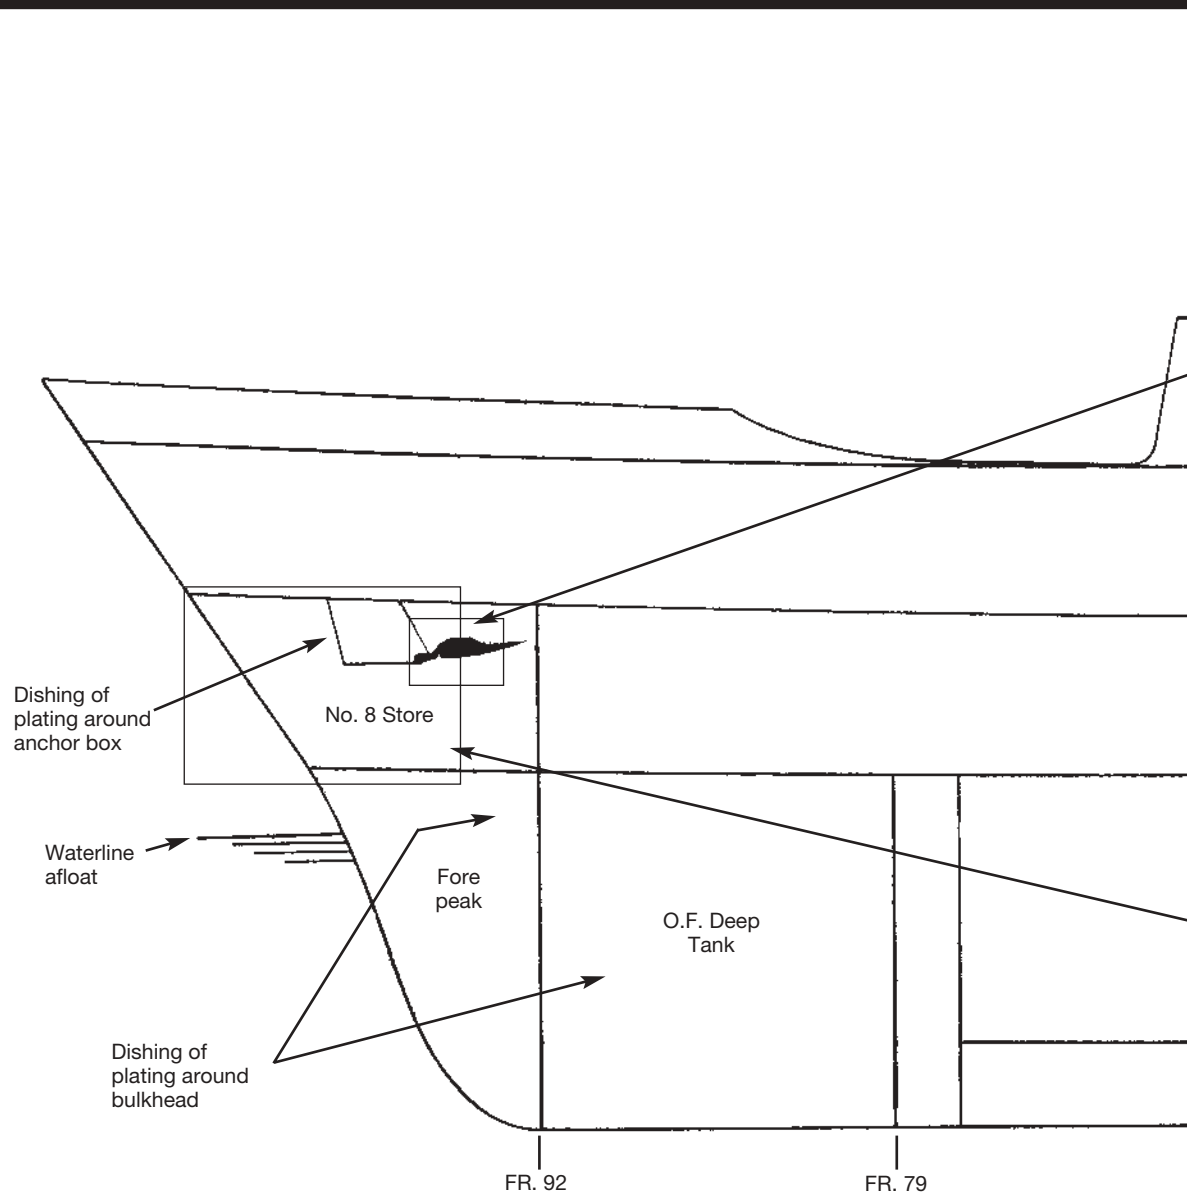
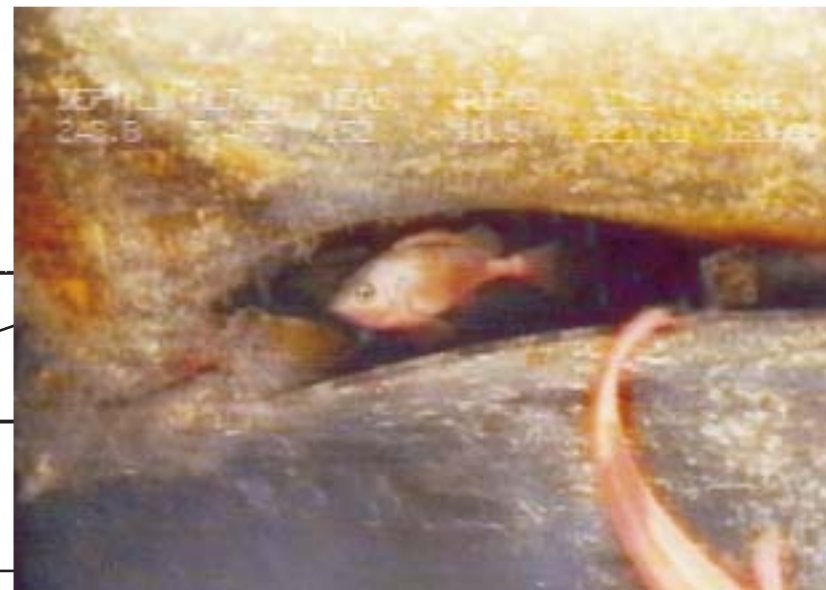
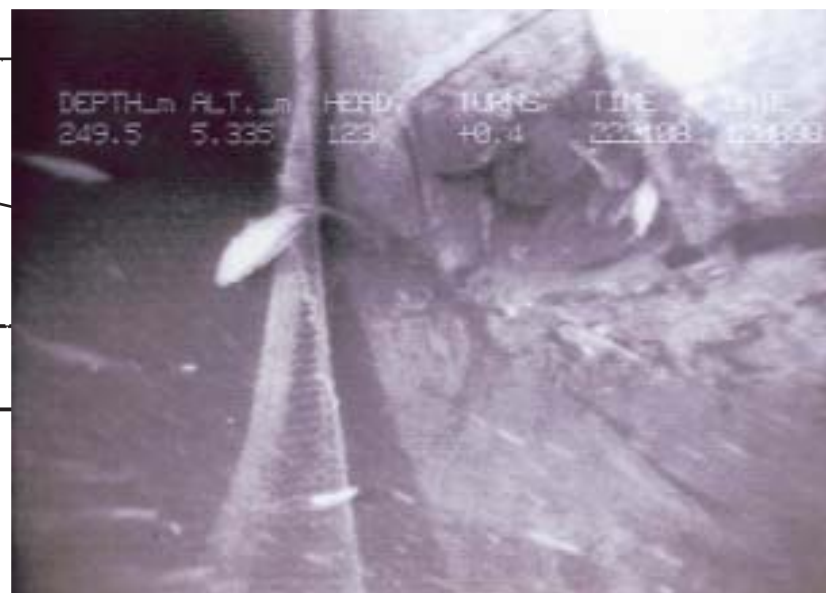
Figure F: Damage to plating of port bow

The exterior of the wreck was examined in detail and revealed, among other things, that some weathertight hatches were open. There was also evidence of pressure damage at the bows. A miniature camera was inserted into a number of cabins through their portholes to try and find evidence of human remains. None was found.

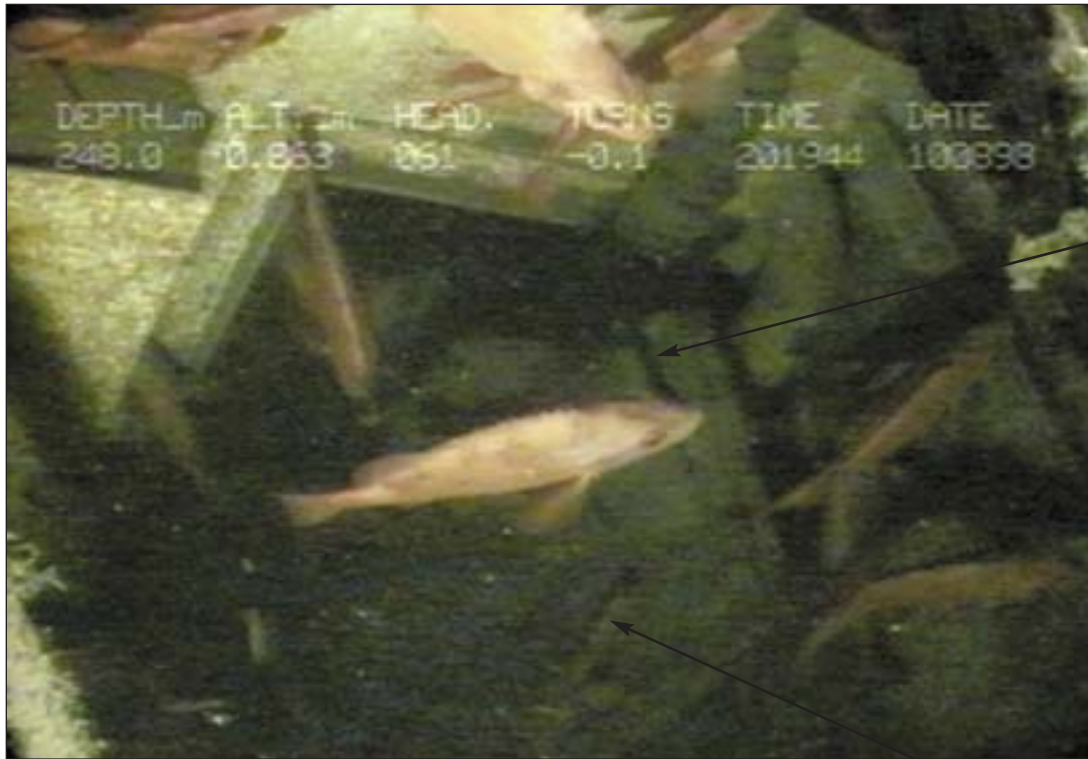
Figure H: Door to engine room emergency escape

- Note: 1) Door is wide open.  
2) The two securing clips visible in the photograph are in the open position.

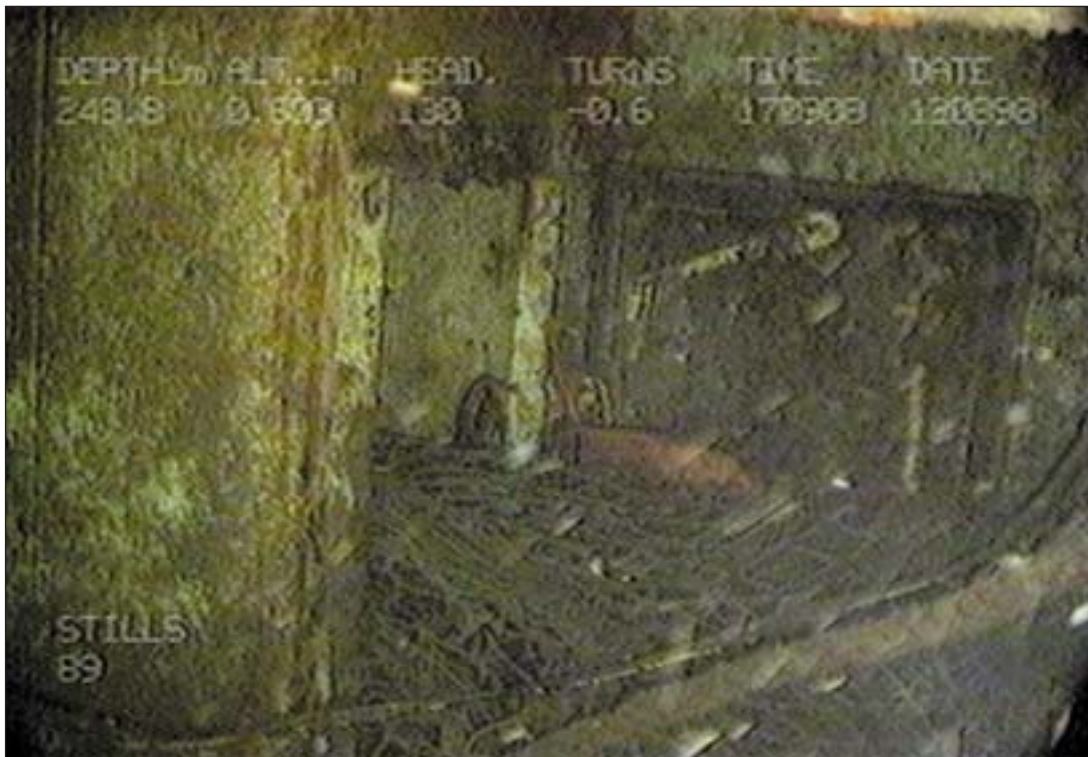
Figure I: Door to factory from trawl deck

- Note: 1) Door is wide open.  
2) Doorway is two-thirds full of fishing net

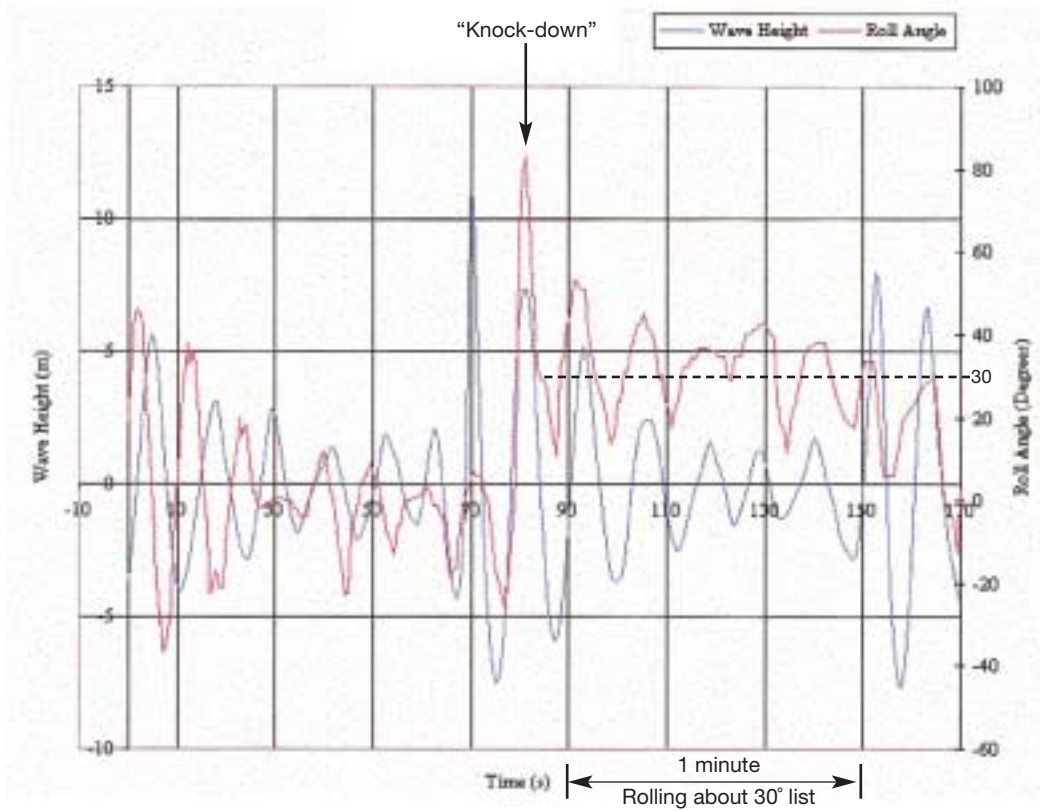
Figure K: Measured roll angles and wave heights

A trace of the wave heights and the roll motion of the GAUL model for Run 28, during which a *knock down* occurred. The height of the first steep wave of the wave group was 18m from crest to trough. This wave became a breaking wave and was responsible for the *knock down*. The wave trace represents the wave profile at the model's mean position at the start of the run.

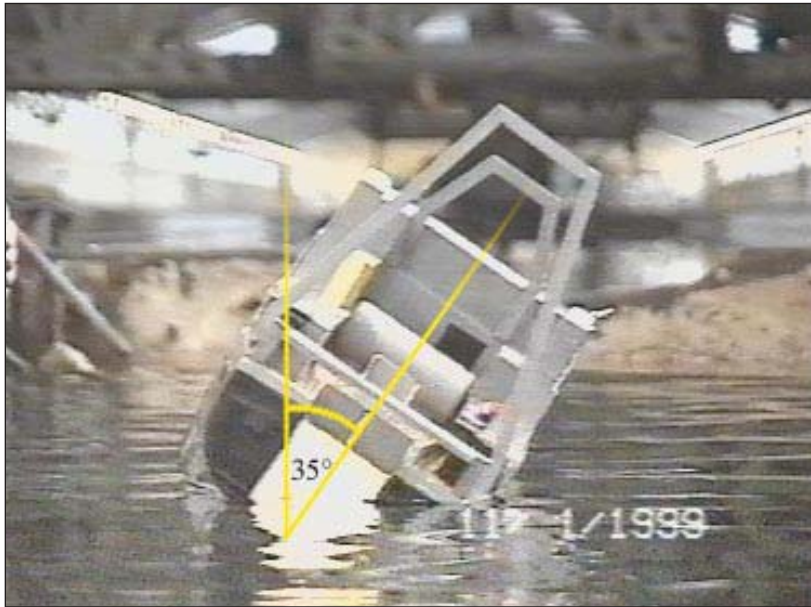
**At 35° list**

1. Bulwarks around trawl deck (aft) submerged.
2. Ventilator to net store submerged, (not on model).

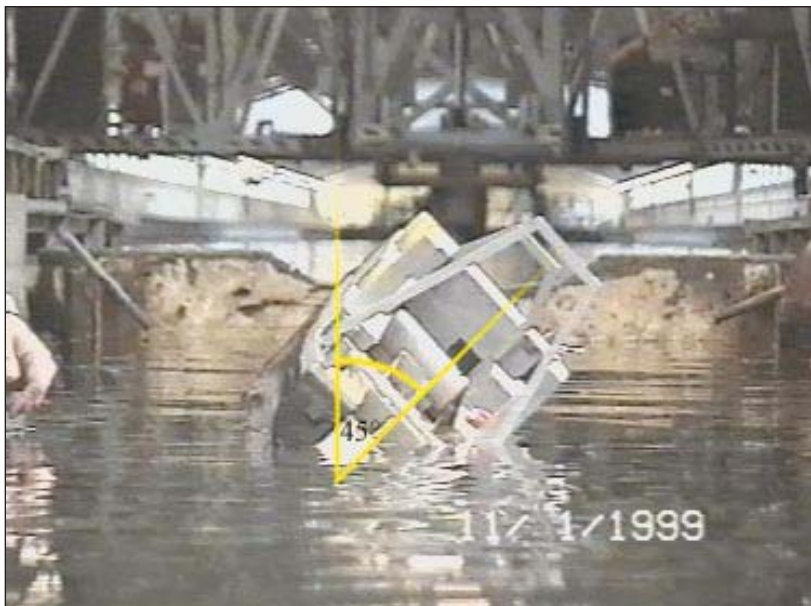
**At 45° list**

1. Door to engine room escape completely submerged.
2. Door to factory deck completely submerged.
3. Outboard edge of starboard fish loading hatch submerged.

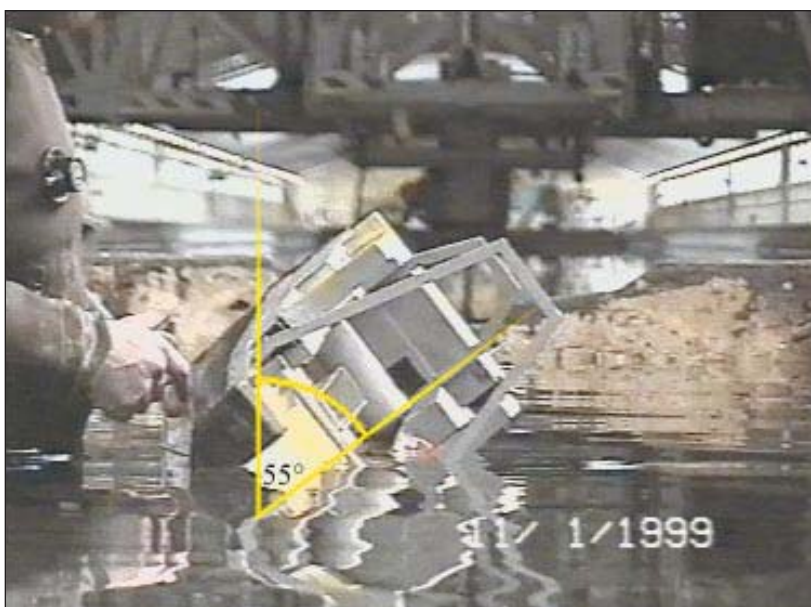
**At 55° list**

1. Lower edge of engine room ventilation ducts in starboard funnel immersed.

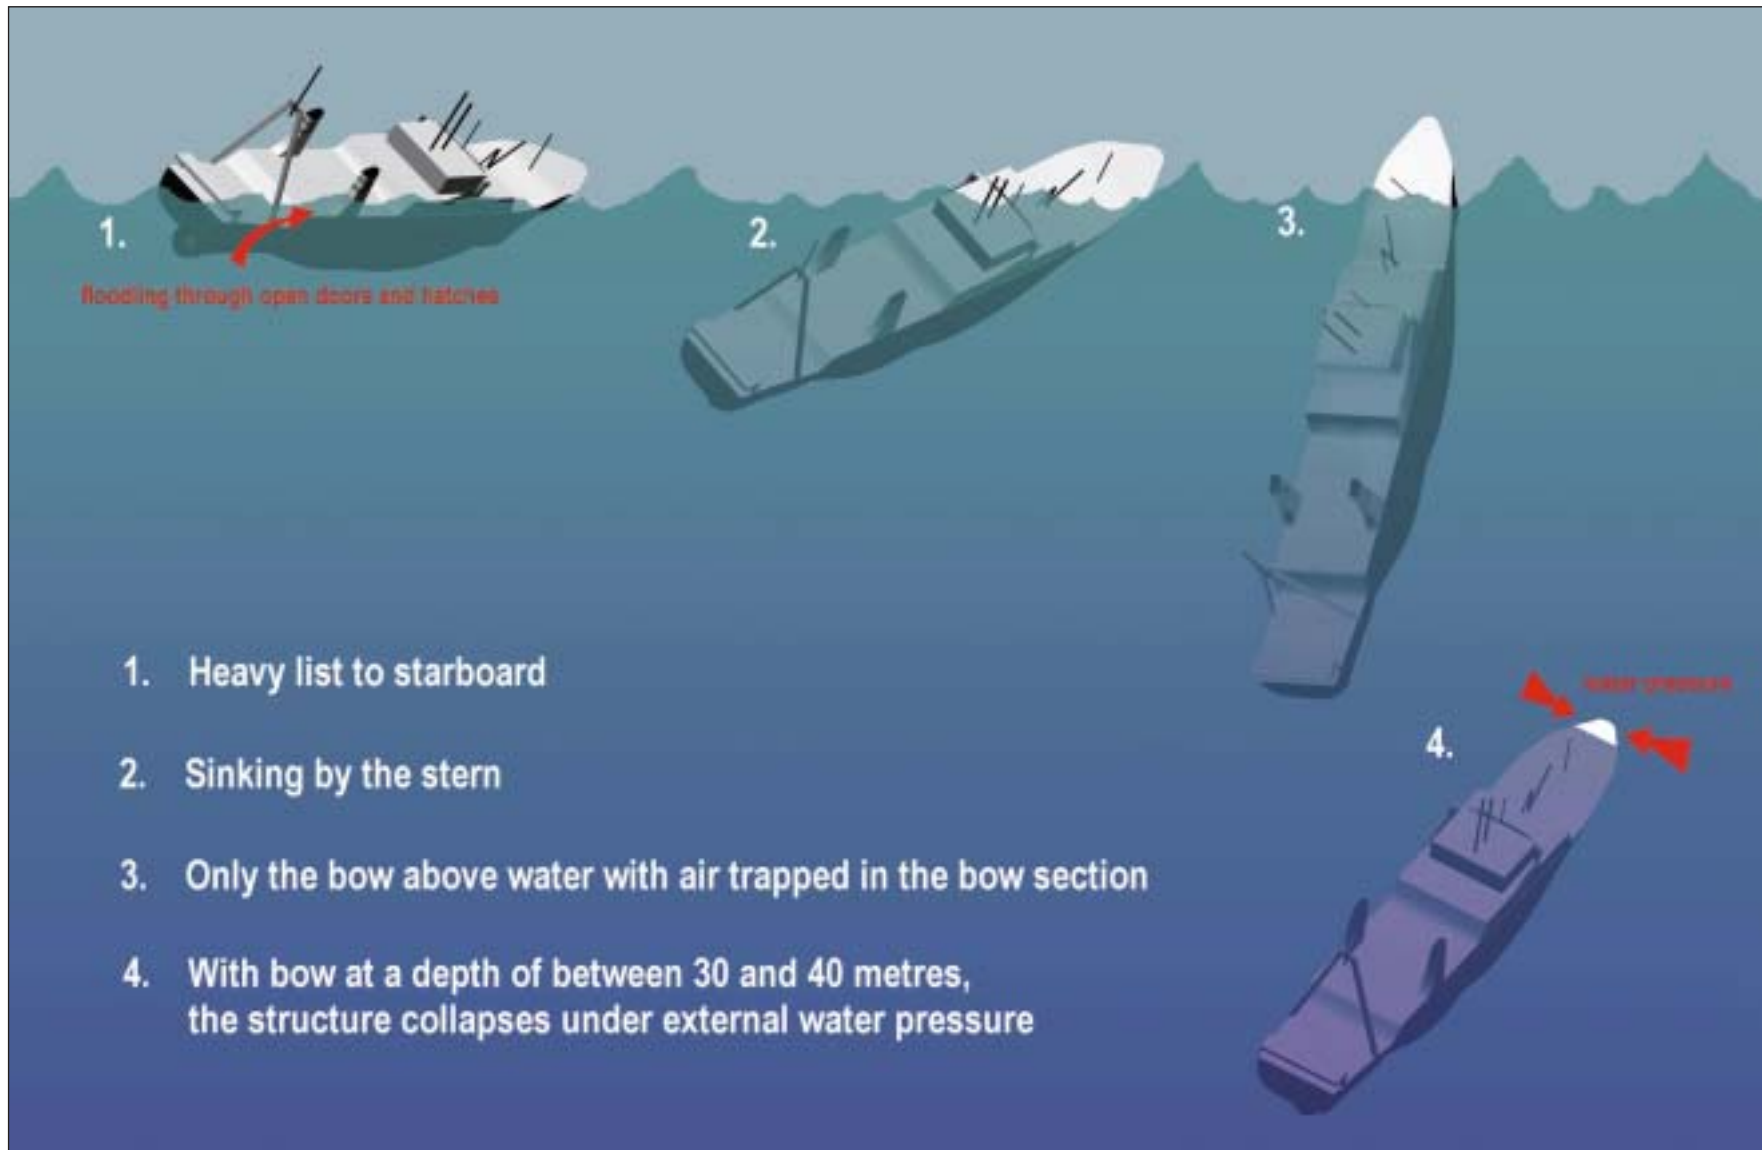
Figure M: Gaul Sinking

Once continuous downflooding to the interior of the vessel had started, sinking was inevitable. *Gaul* probably began to sink within minutes of the initial knock-down and she would have completely submerged within 10 minutes.
