**Marine Accident Investigation Branch**

**Investigation of**

**The Capsizing of a Dinghy in**

**13 December 1998**

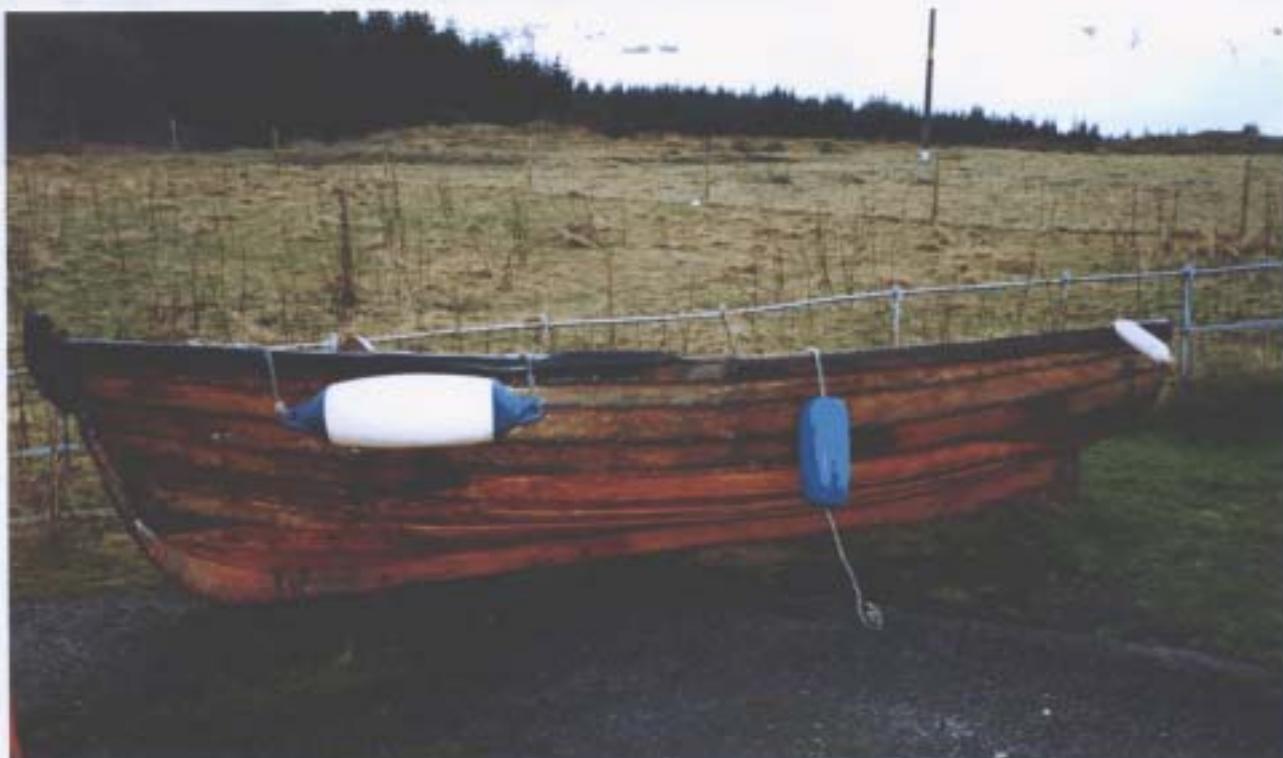
The 4.27m (14ft) dinghy had been in the same family for about 24 years and had a reputation as a good solid craft that been used in many weathers on a regular basis. It had carried various loads up to about one tonne and had previously carried five people.

The accident was caused by the dinghy failing to rise to an oncoming wave in the dark at about 0225 on 13 December and shipping sufficient water to destroy residual buoyancy. The dinghy capsized almost immediately afterwards and the five occupants were thrown into the sea.

External view of the recovered dinghy

The MAIB also strongly advises that any open boat used for transporting people across the Sound of Iona has some form of additional buoyancy on board and also a means of attracting attention in the event of it getting into difficulty.

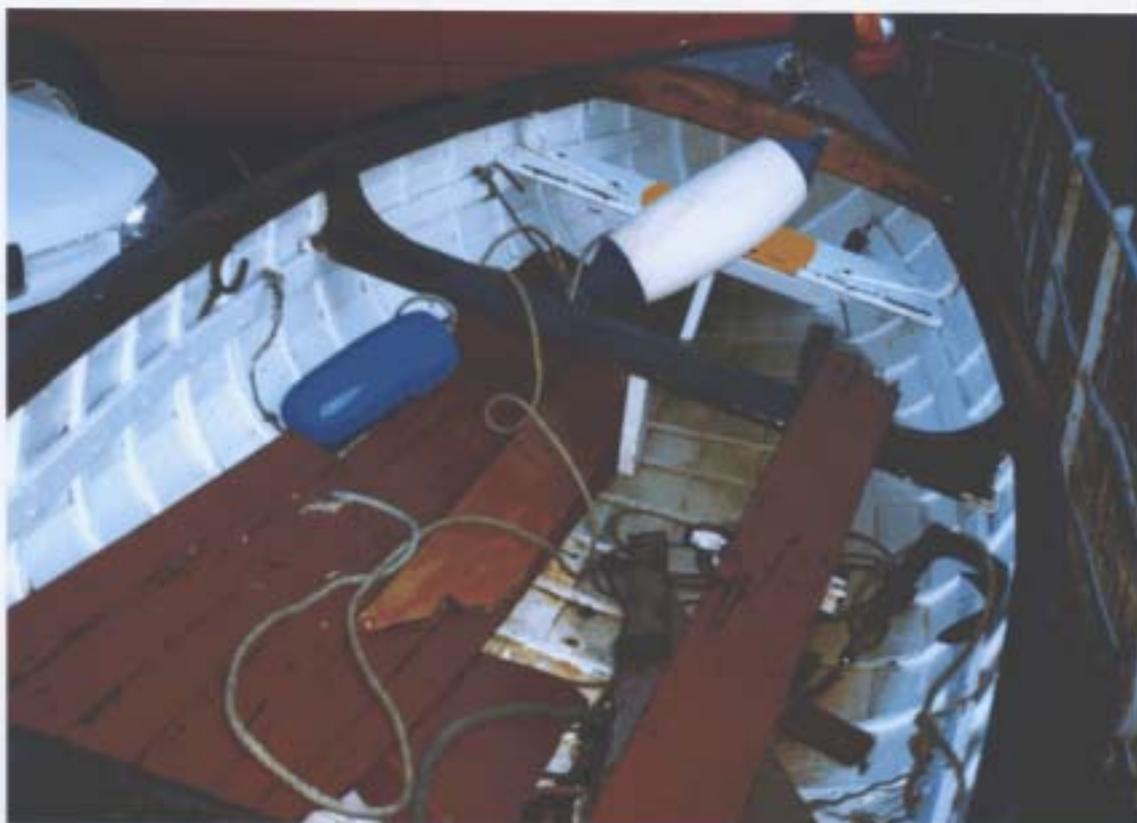
At the time of the accident, the way the dinghy was loaded trimmed it by the head, with the lowest freeboard being forward of the mid point.

It is assessed the dinghy was being propelled at its maximum speed at the time it shipped water and, with its weight distribution forward, failed to rise to the wave. Instead it nosed right into it. The water poured in to destroy any residual buoyancy.

Inside the recovered dinghy looking forward

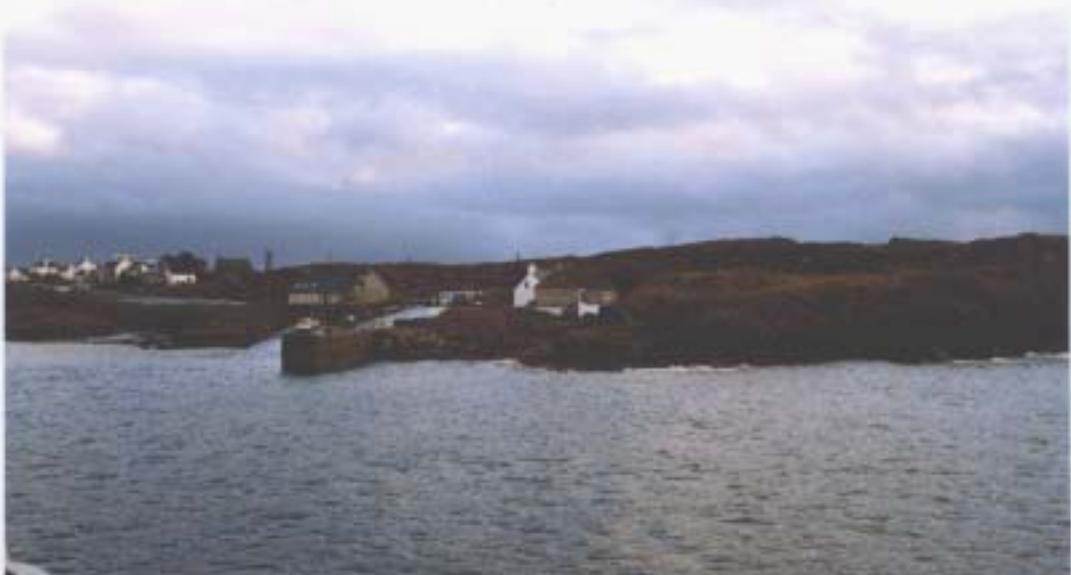
The Fionnphort jetty lights were not functioning at the time the five re-embarked for the return crossing. Although it is impossible to say whether working lights would have made any difference, they might have provided sufficient illumination for an appraisal to be made of the prevailing conditions before setting off.

The jetty at Fionnphort
