**Report of Inspector's Investigation**

**into lifeboat winch failure on**

**passenger cruise ship**

***Arcadia***

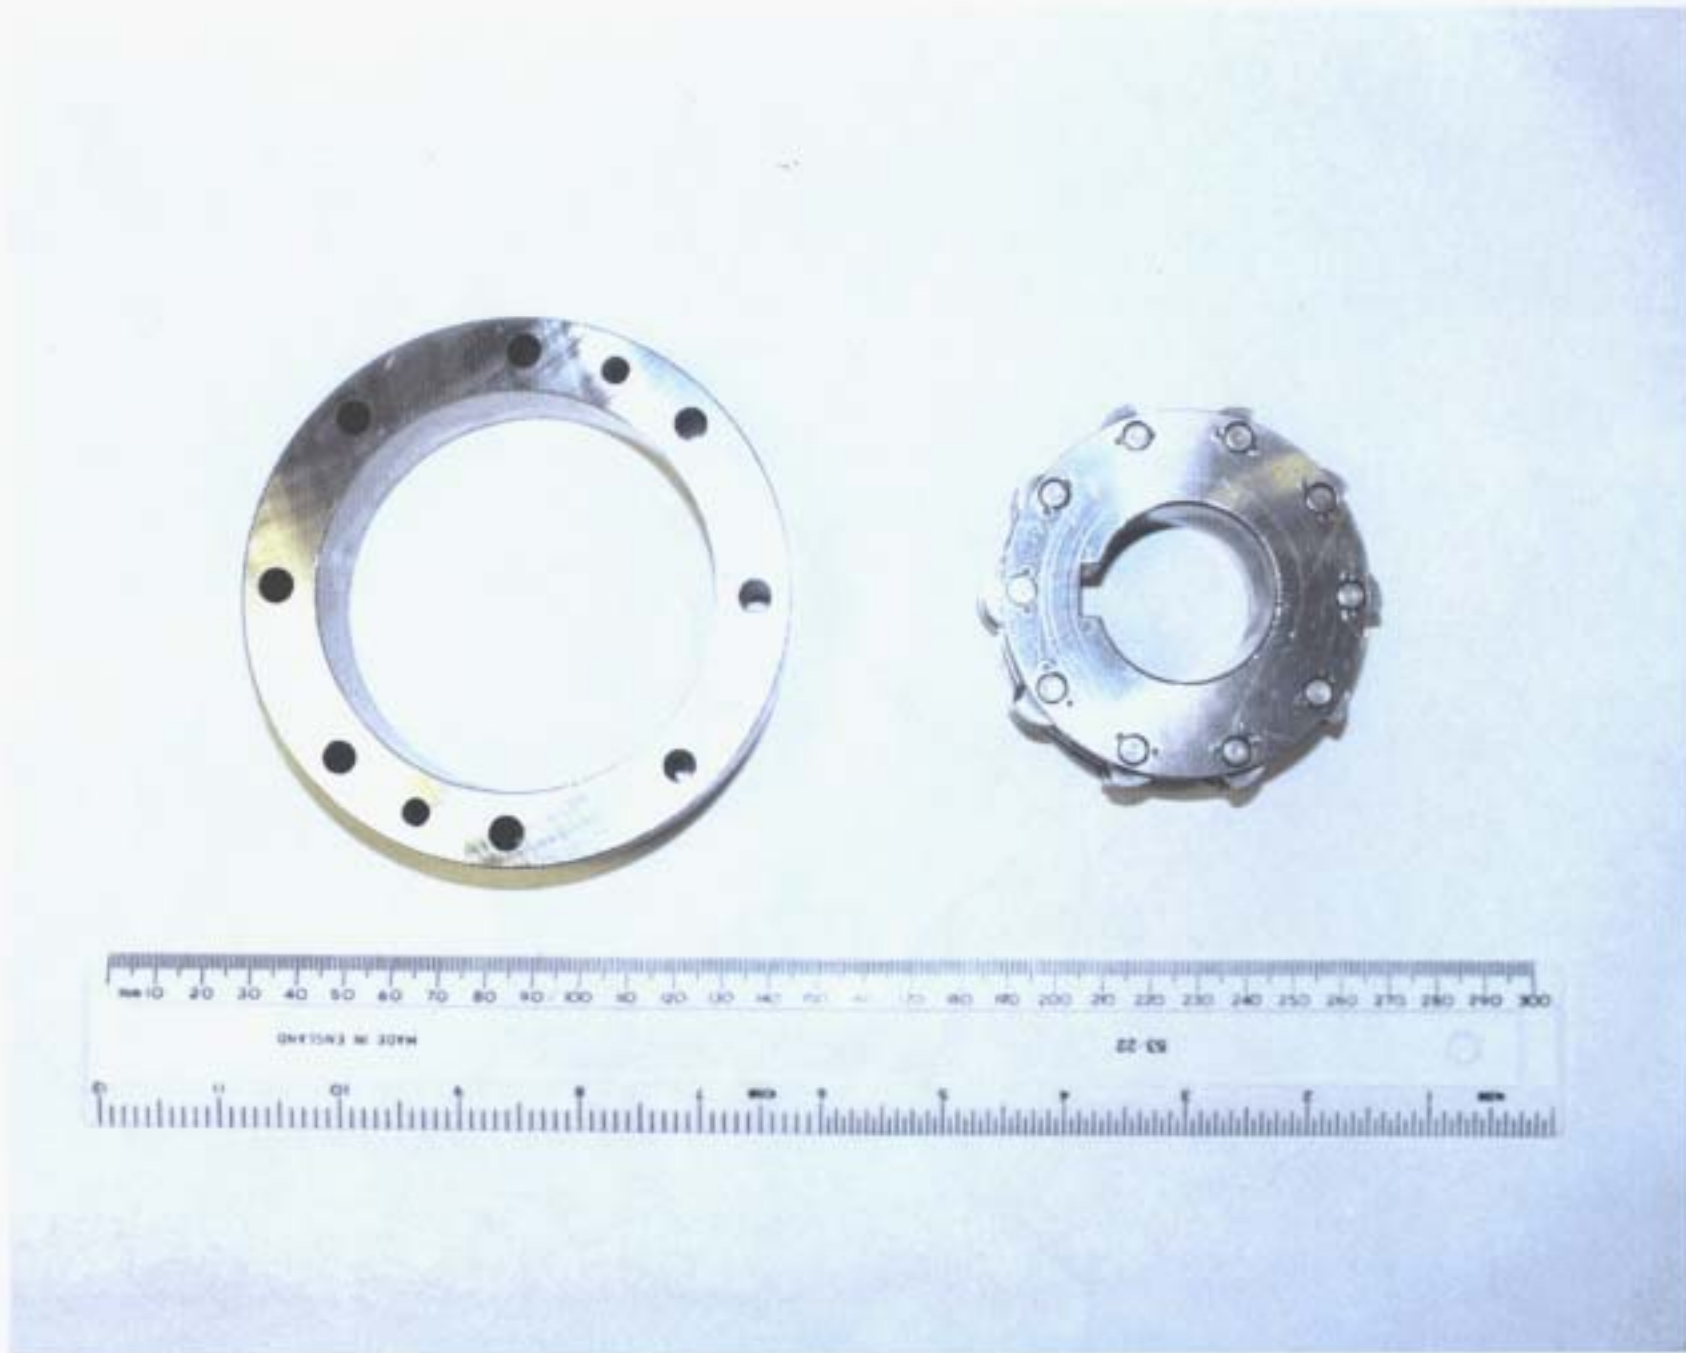
Figure 1

The stop brake and centrifugal brakes were found to be in good working order. The inside surface of the outer race of the freewheel clutch had severe wear, scuffing with signs of overheating.

Schat-Harding reported that No 5 davit winch failed because the oil used in the gearbox was too viscous, preventing the coupling locking mechanism from operating. Slipping of the coupling would cause the oil to overheat. Lubricating properties would then be lost resulting in damage to running surfaces.

Freewheel Sprag Couple

Schat-Harding advised that only the oil specified in the maintenance manual should be used. Subsequent to the accident, the oil in the other winches installed on board was replaced by specified oil.

1. Draw the attention of sea staff onboard its ships to the dangers of using the wrong lubricating oil in davit winches fitted with freewheel sprag couplings.
2. Insist that whenever a malfunction with a lifeboat launching installation arises, any action taken is planned and executed.

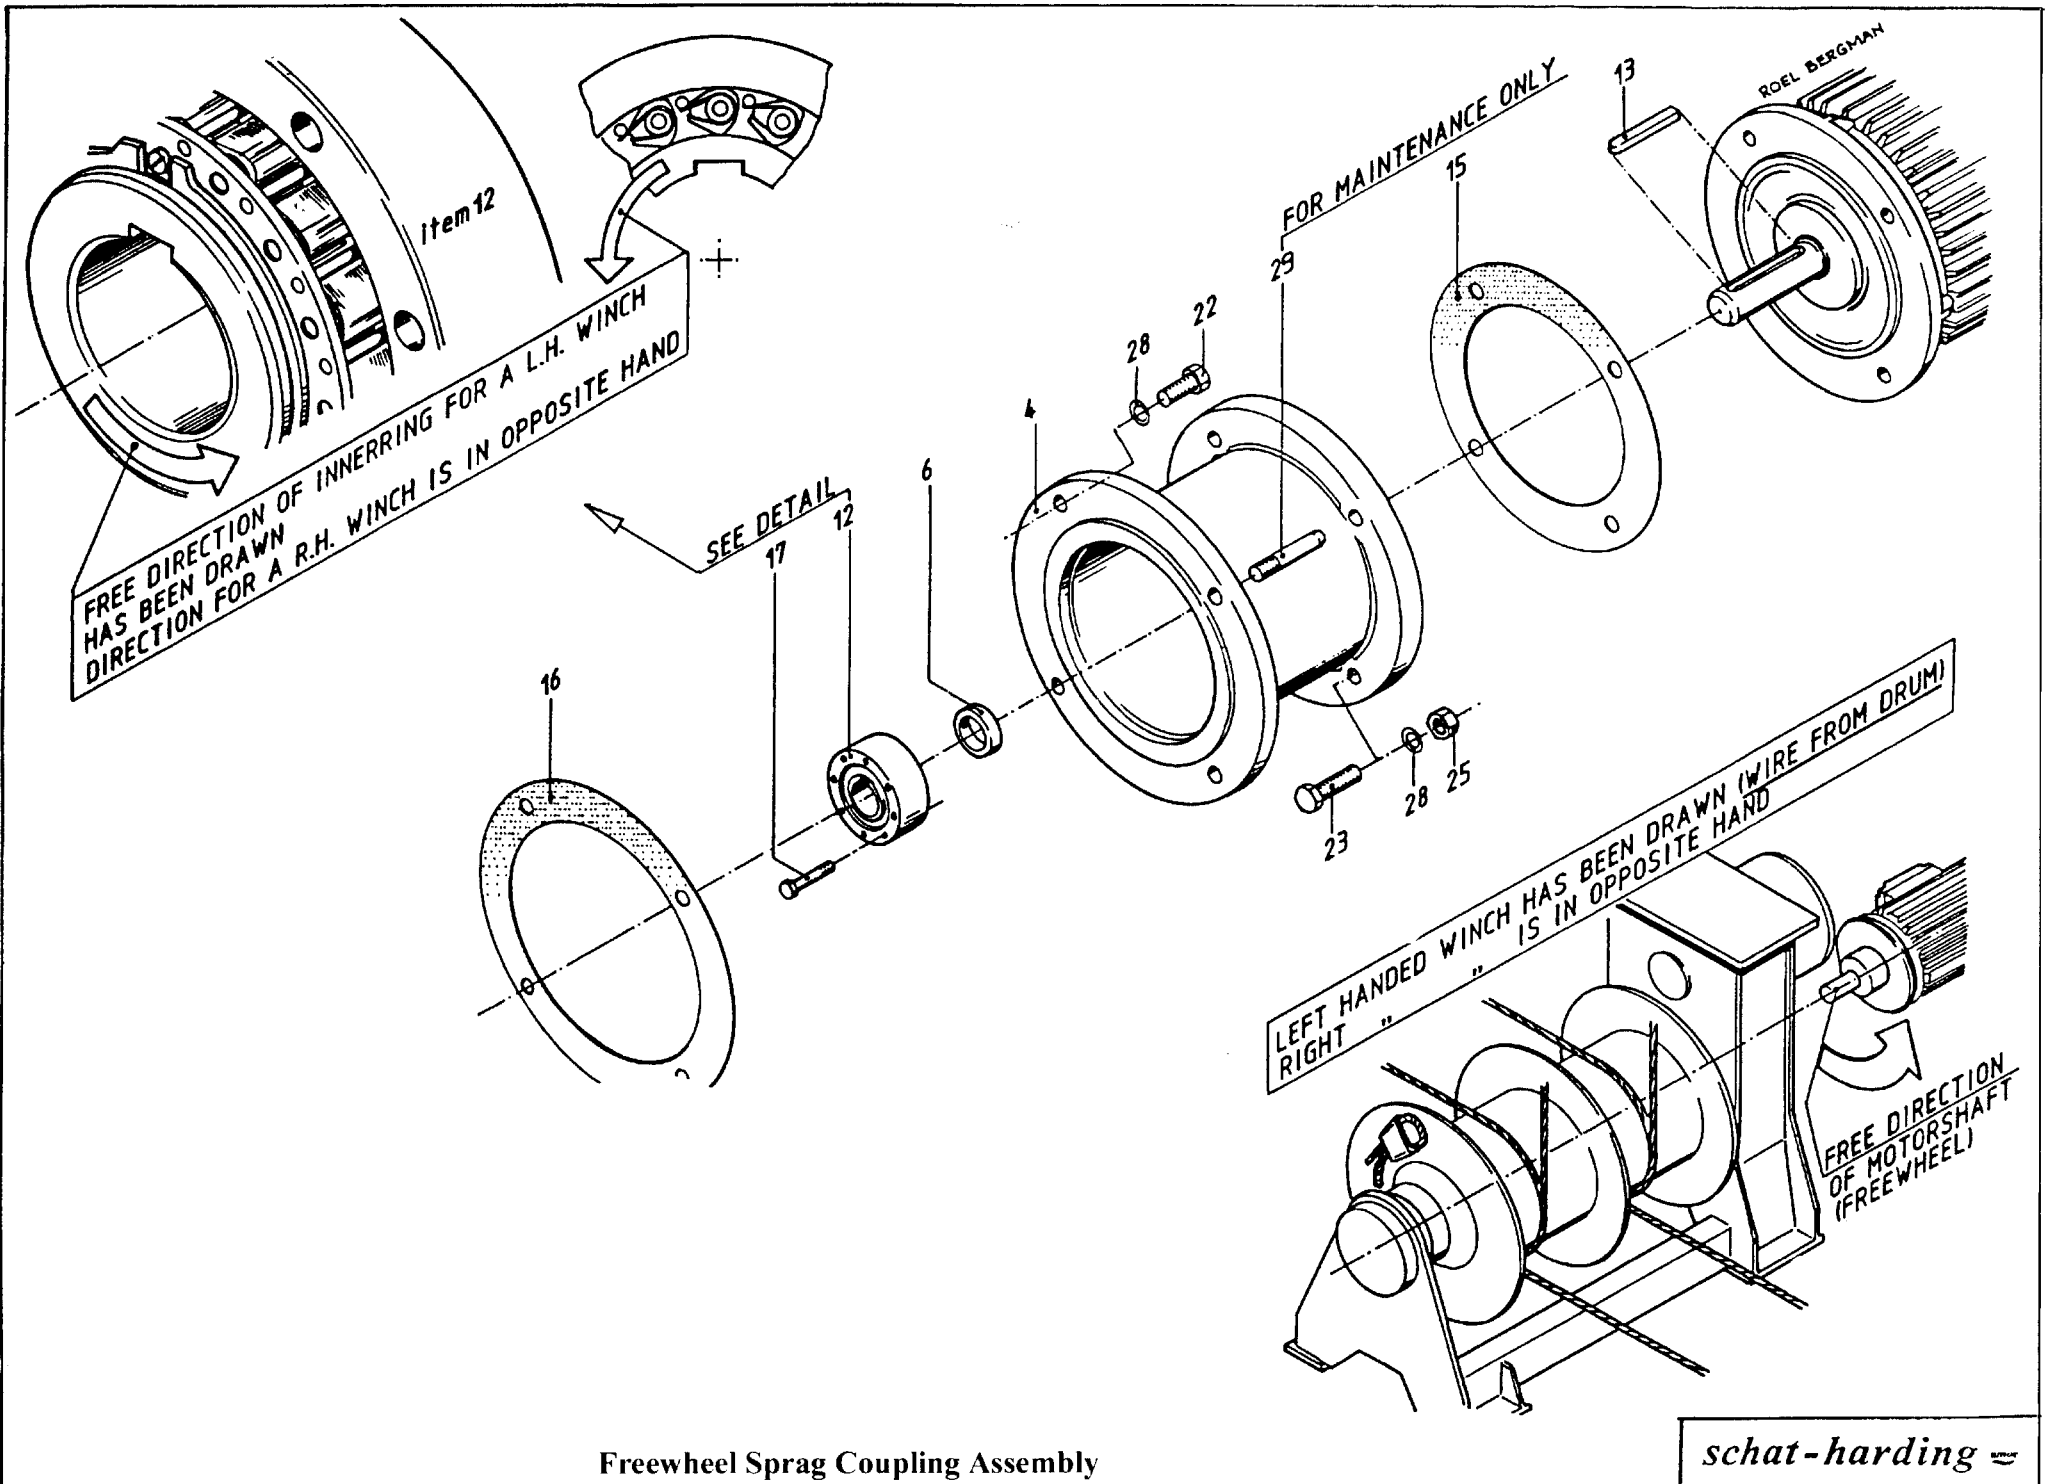
Figure 2

Freewheel Sprag Coupling Assembly

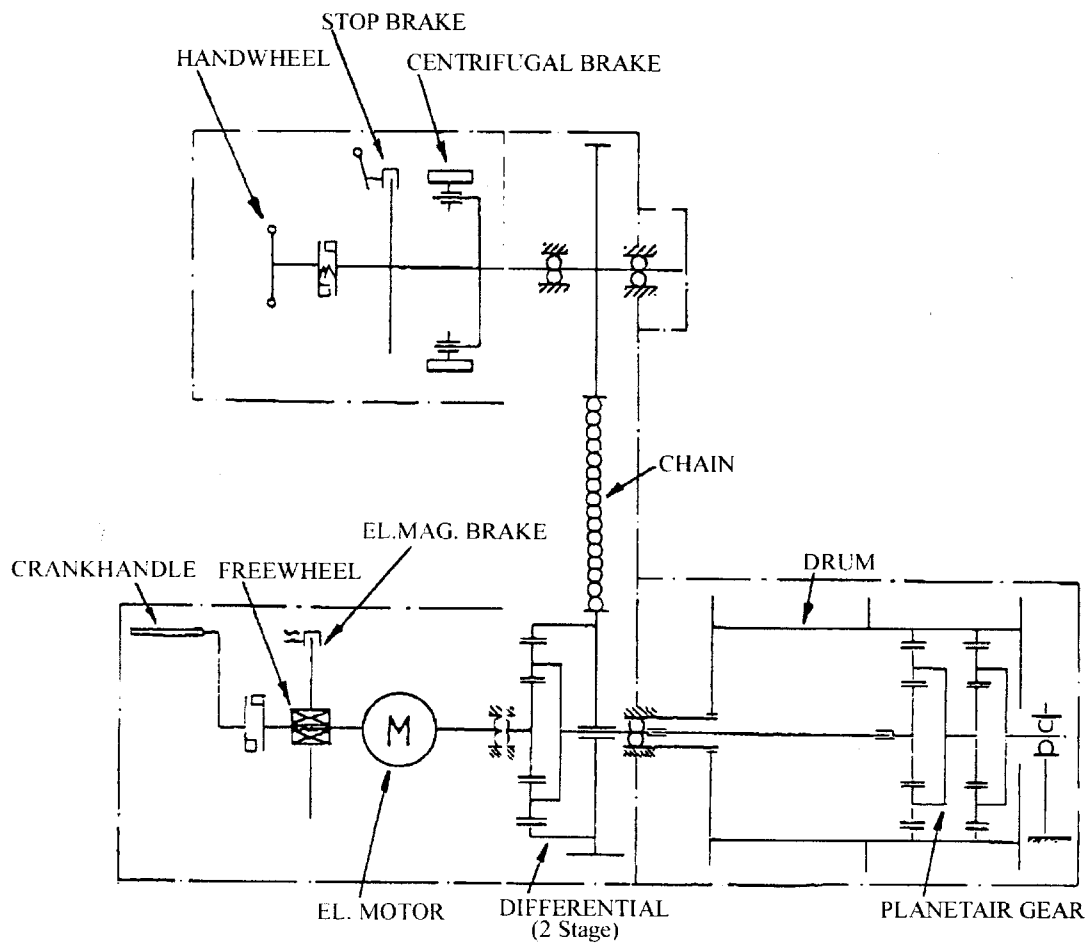
In the motor driving hoist mode, the motor turns the winch drum through the input and output shafts of the differential gear driving a two stage epicyclic gear in the winch drum. The housing for the differential gearbox has a toothed wheel which is connected to the brake arrangement by a chain drive. The engaged stop brake prevents the housing from turning.

In the hoisting mode the sprags of the free wheel coupling are lifted free by centrifugal force. When hoisting is stopped springs engage the sprags which couple the inner and outer race in the lowering direction. The differential gear input shaft and the motor drive shaft are prevented from turning.

In the gravity lowering mode, with the stop brake off, the load at the drum drives through the epicyclic gear. The differential gearbox housing drives the centrifugal braker via the chain connection. The centrifugal brake controls the speed of descent.

No5 Life Boat Davit Gear Drive Arrangement

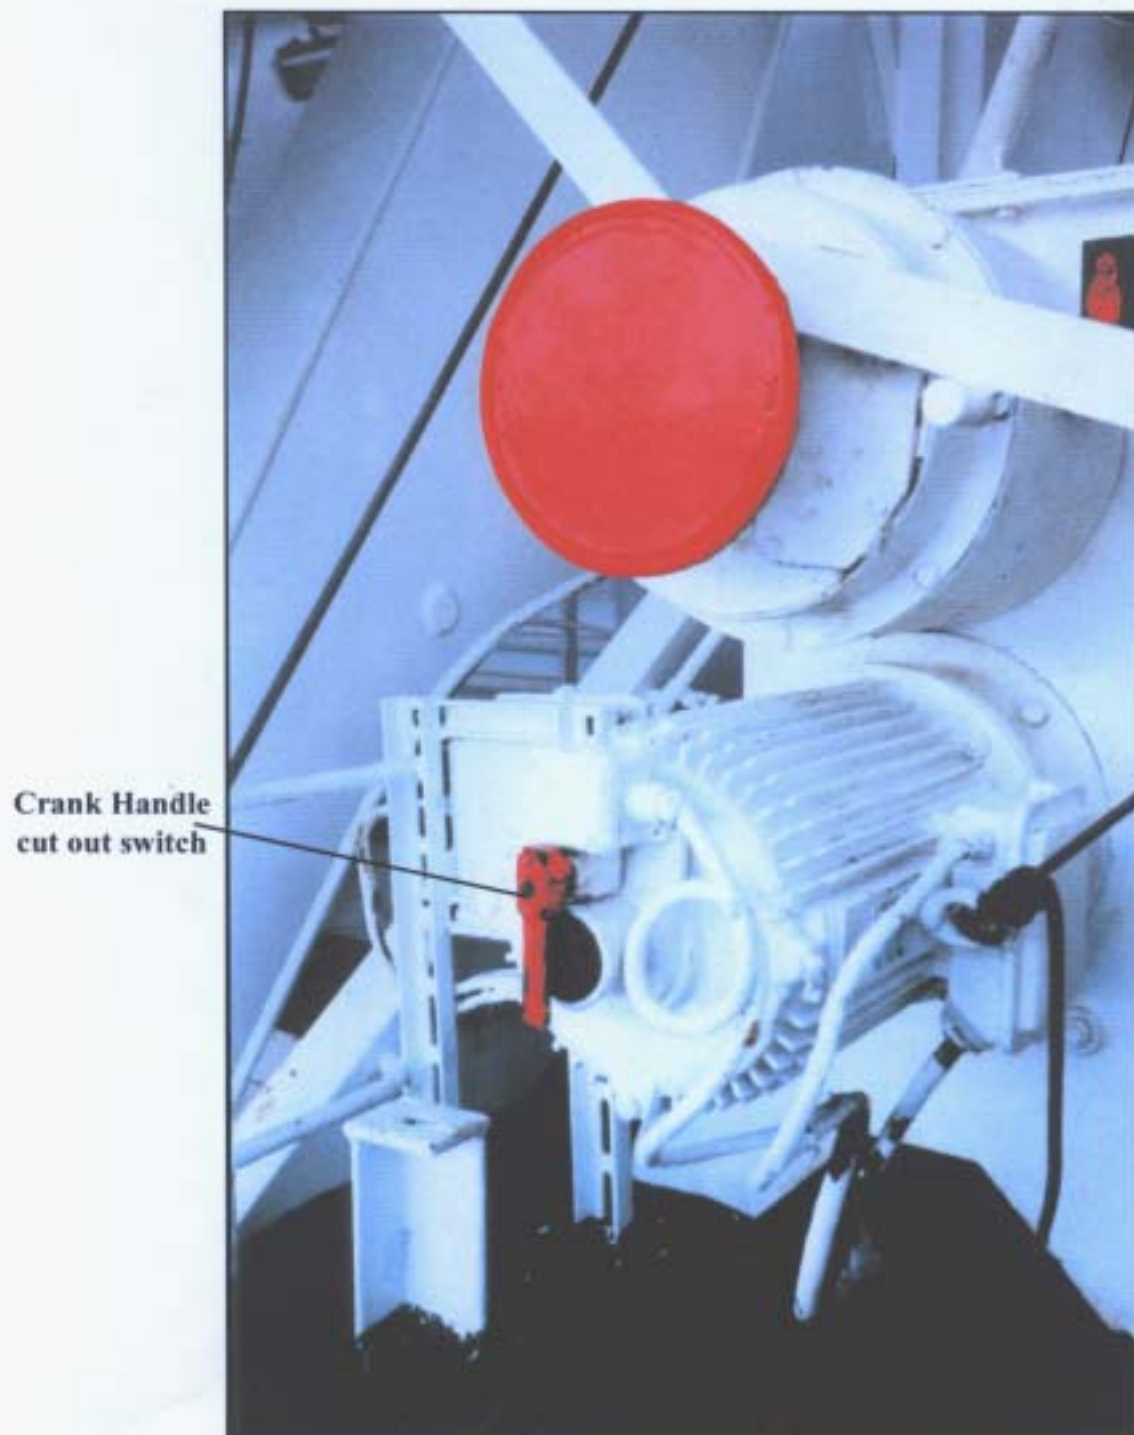
So that the crew could investigate the winch failure, they had to wind the falls back onto the winch drum. The lifeboat was again detached from its fall blocks and the crew tried to start the winch. It would not start because of a fault on the hand crank electrical cut-out switch. They started to wind the falls back by hand using the hand crank. Meanwhile, the electrician by-passed the cut-out

switch (**Figure 4**) to regain electrical supply to the winch to speed up the operation.

In the launching position, hand cranking of the falls onto the drum is a tiring and time consuming effort. Winching the falls back onto the winch drum is far easier. The well intentioned action of by-passing the cut-out switch was a direct cause of the electrician being injured. He eliminated the very safeguard designed to prevent such an accident.

Having accepted that it was necessary to by-pass the switch, compensating safety procedures, properly understood, should have been in place. The lack of planning and procedure for the situation was a contributory factor to the accident.

Crank Handle  
cut out switch

No 5 Life Boat Winch Motor
