Report of Inspector's Investigation

into lifeboat winch failure on

Arcadia

on 9 December 1998

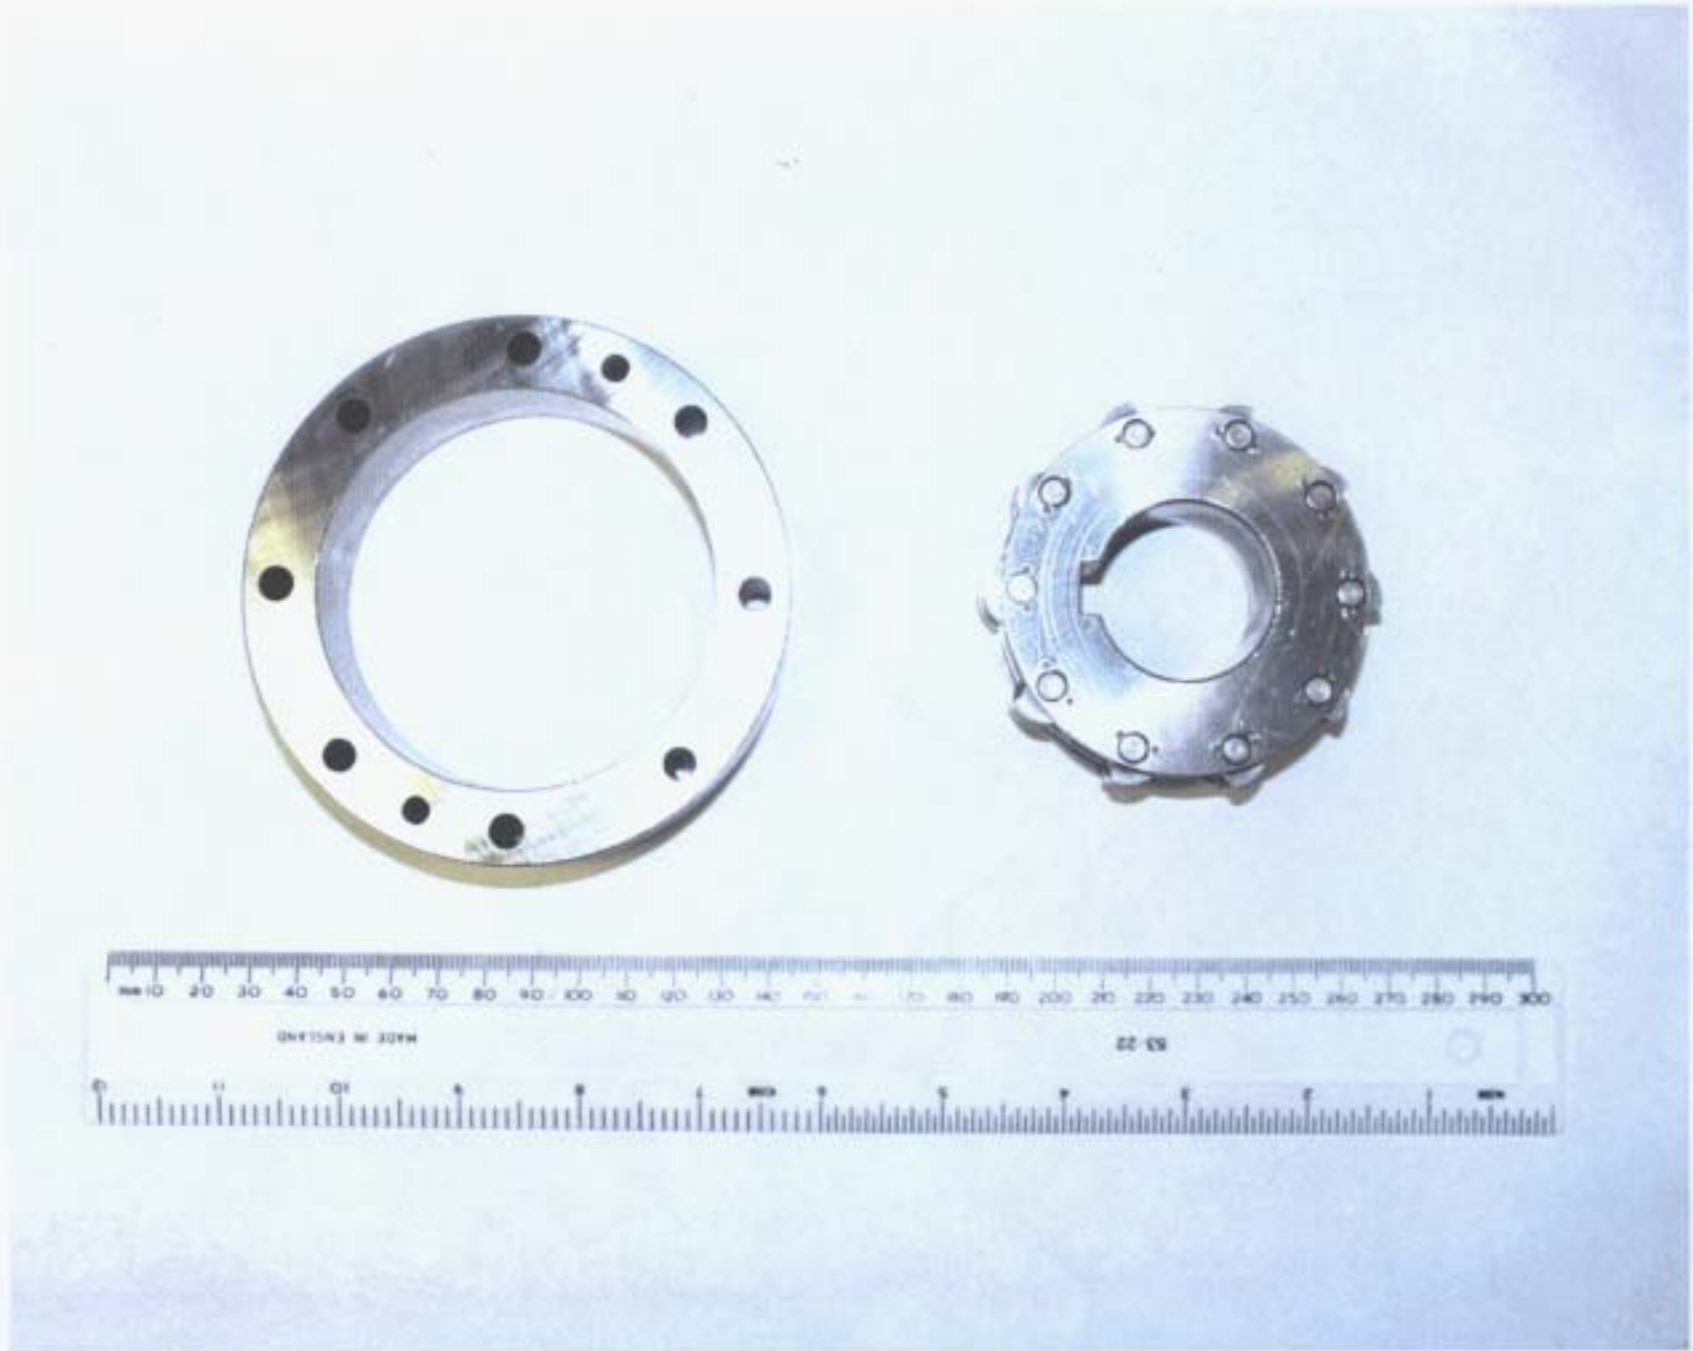
Freewheel Sprag Couple

The stop brake and centrifugal brakes were found to be in good working order. The inside surface of the outer race of the freewheel clutch had severe wear, scuffing with signs of overheating.

Schat-Harding reported that No 5 davit winch failed because the oil used in the gearbox was too viscous, preventing the coupling locking mechanism from operating. Slipping of the coupling would cause the oil to overheat. Lubricating properties would then be lost resulting in damage to running surfaces.

Schat-Harding advised that only the oil specified in the maintenance manual should be used. Subsequent to the accident, the oil in the other winches installed on board was replaced by specified oil.
