**Report of an investigation  
into the loss of  
PESCALANZA PZ744  
and six lives  
on  
2 November 1998**

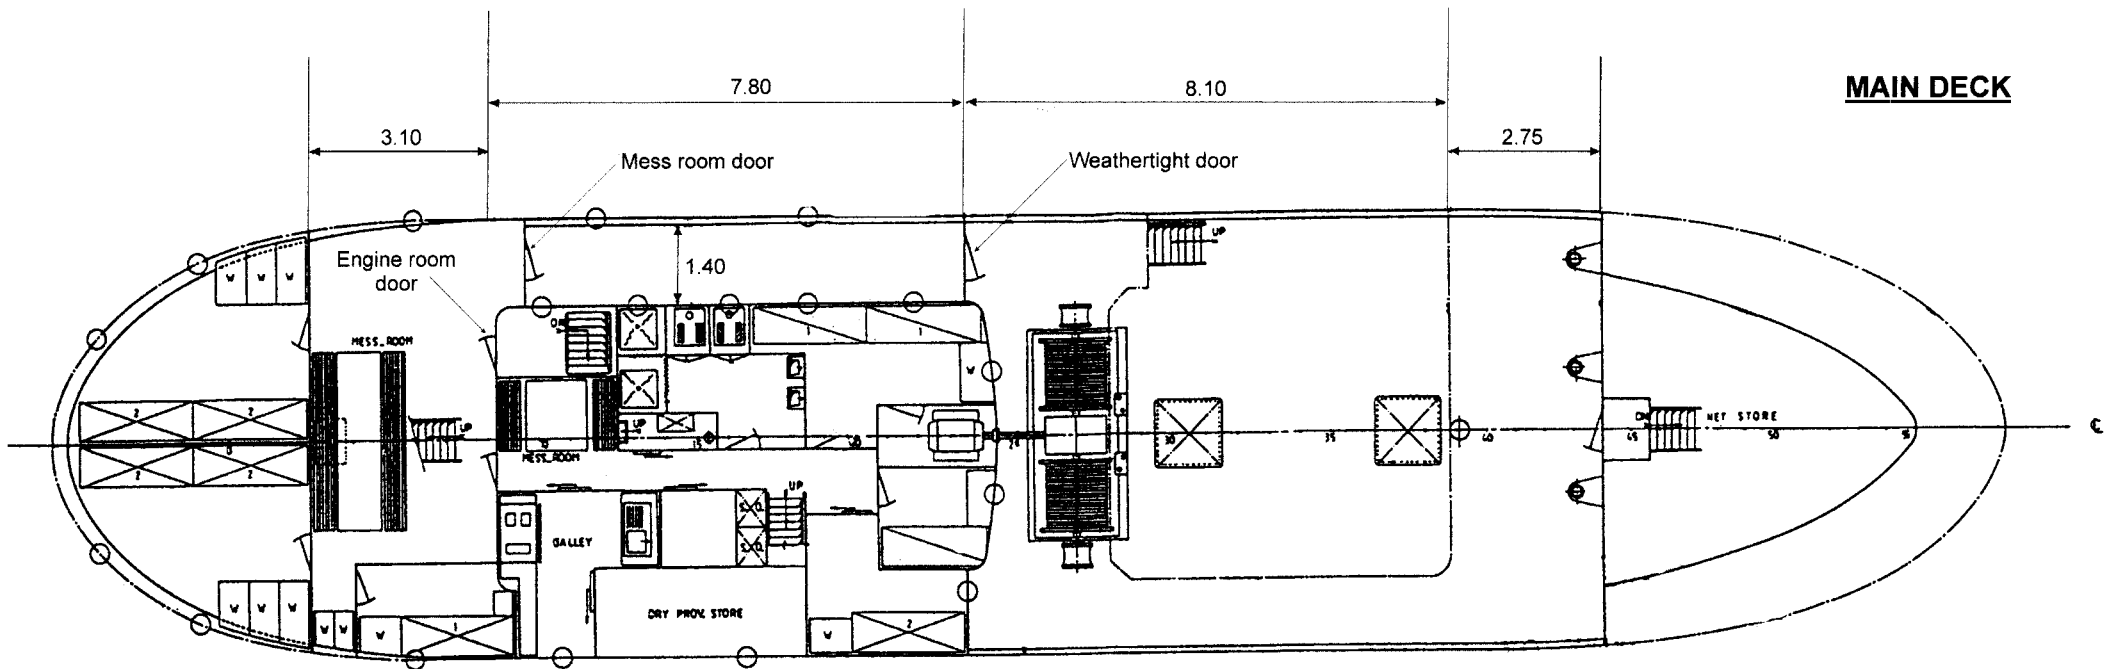
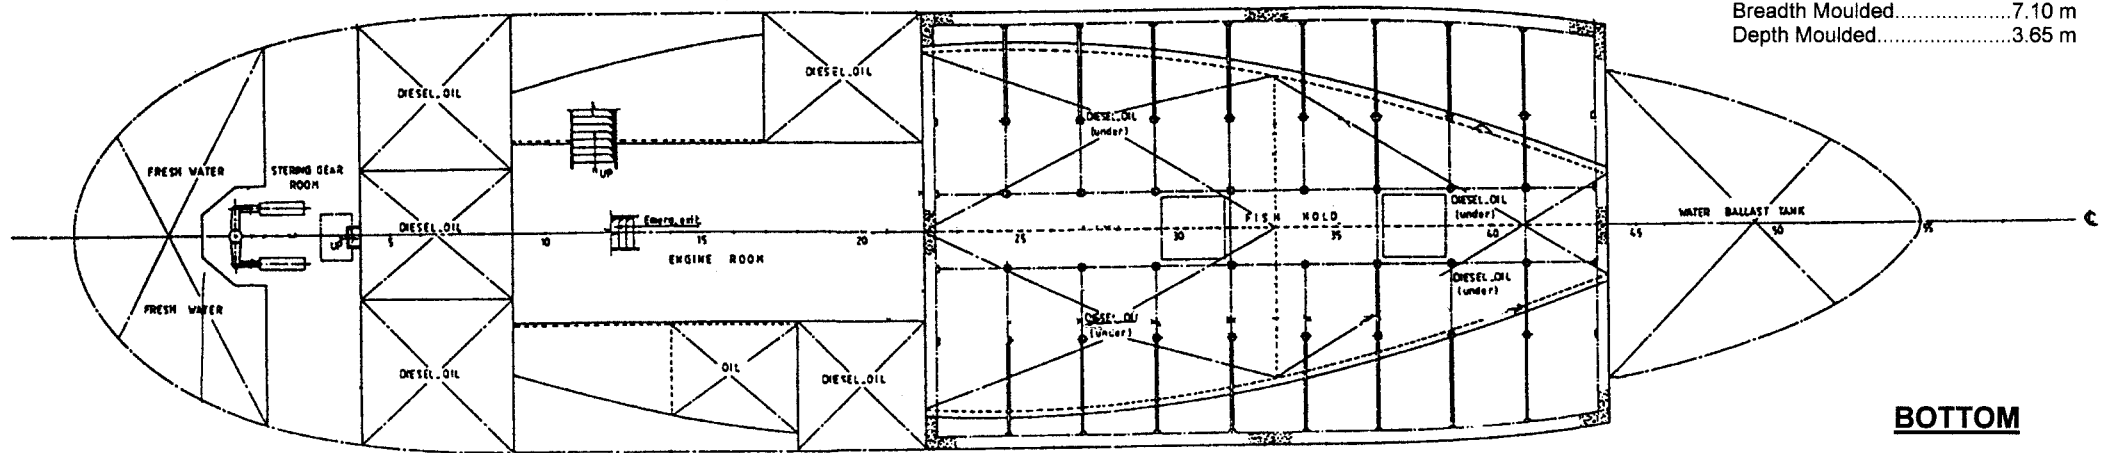
Figure 2 - FV Pescalanza PZ-744

There is insufficient evidence available to the MAIB to identify precisely how water entered *Pescalanza* but it is obvious she shipped a substantial quantity very quickly. As there is no report of structural damage from eye-witnesses, it is reasonable to suppose water entered through the weathertight door protecting the shelter from the main deck area which had been left open while recovering the trawl gear.

This would allow water to flow into the shelter. Not only did *Pescalanza* list heavily to port, but she also took up a stern trim and this is indicative of the doors to the mess room and the engine room also having been left open, allowing sea water to enter and downflood. (Figure 2)

1. The fundamental cause of the sinking of the fishing vessel *Pescalanza* was the entrapment of water on board during net retrieval operations when the vessel was most vulnerable and beam on to the sea.
2. It is probable that water was trapped between the shelter deck and the main deck on the port side and downflooded through an open door to the engine room.

1. advise all skippers of fishing vessels under its management of the importance of keeping weathertight doors closed, except when used for access, and point out that vessels, where the buoyancy effects of shelters have been considered when assessing stability, may not comply with stability requirements if certain weathertight doors are left open when at sea.
